# Anchored Real Estate Inspections

## PROPERTY INSPECTION REPORT

By: David Blade, TREC #24692 Cell: 832-974-0107 11/03/2022  
(Name and License Number of Inspector) (Date)

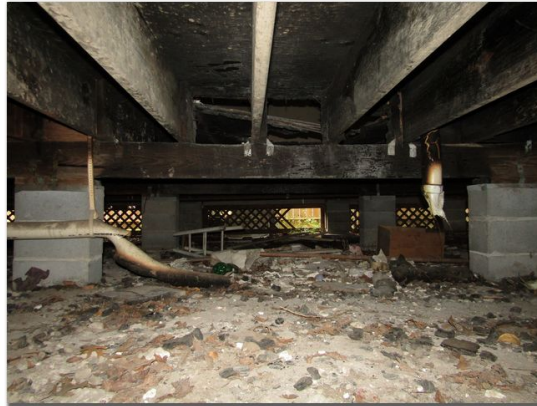
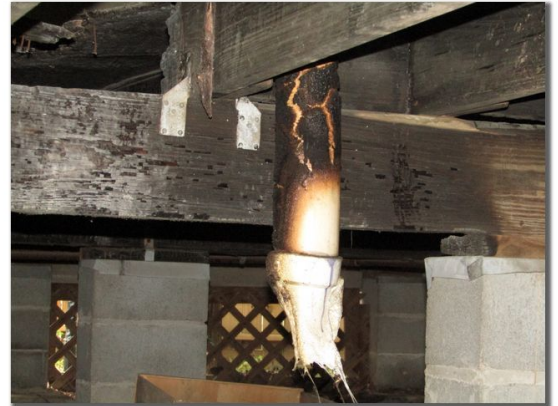
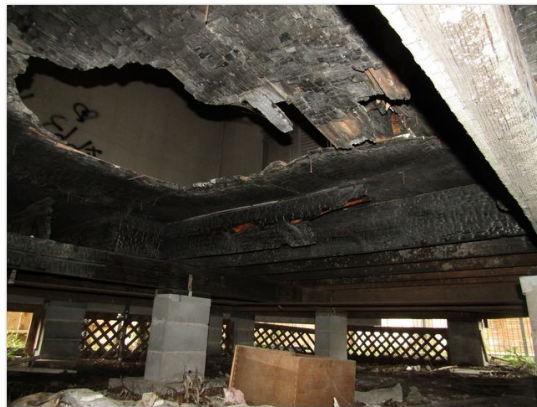
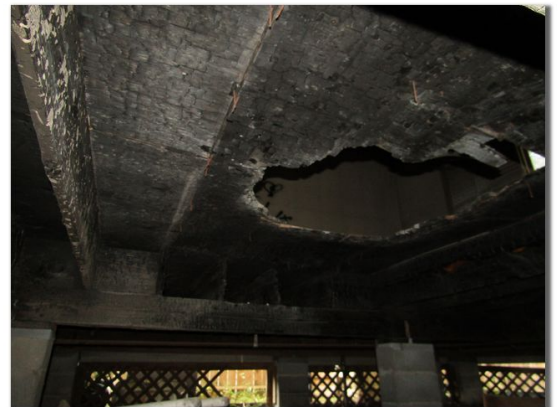
#### Deficient Item(s): Foundation

- X Girder is deteriorated and has fire damage. This may need to be replaced.
- X Observed Several floor joist that are missing due to fire damage.
- X Observed signs of pests (rodents) in crawlspace (nests, droppings). Pests have been known to damage various components.

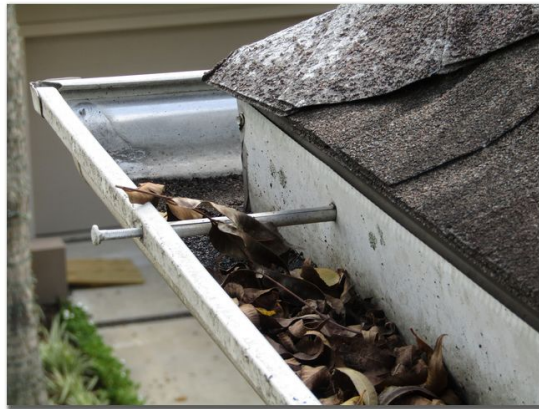
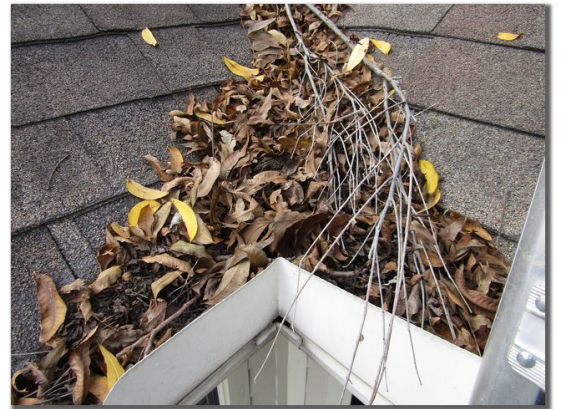
**Deficient Item(s): Grading and Drainage**

- X Gutters are rusting/rusted in one or more places and appear to be leaking at joints, end caps, etc.
- X Gutters have some debris/ are full of debris and need cleaning.
- X Damaged gutters observed at the all sides of home.
- X Gutters pulling loose at the all sides of home.

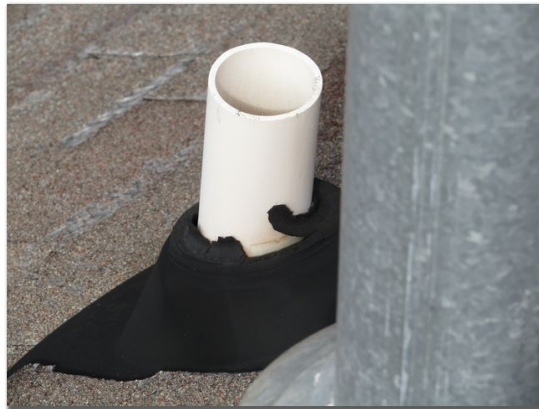
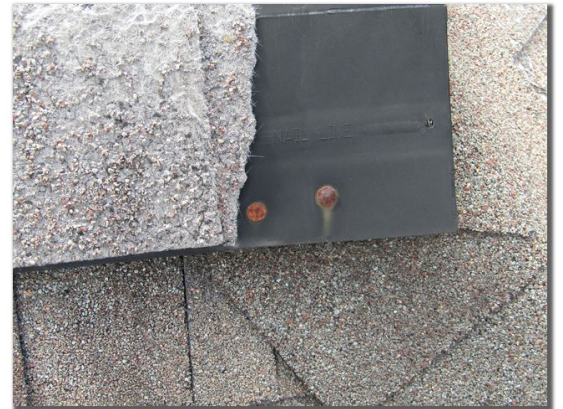
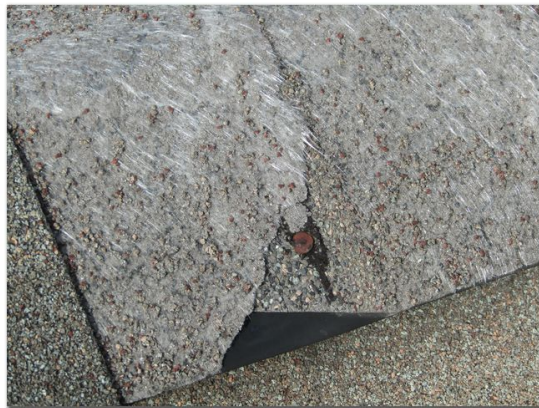
**Deficient Item(s): Roof Covering Material**

- X** The roof appears to be showing signs of age. Observed areas where some of the shingles are cracking, it appears that tree limbs have rubbed against the shingles, the shingles feel brittle when walked on, and some of the shingles have worn/thinning granules and are shining /glistening at the edges (exposed fiberglass) which means the shingle is failing.
- X** Surface granules on the composition shingles are worn/thinning. The roof does not appear to be leaking at the time of inspection.
- X** Exposed nail heads and/or staples at ridges and/or flashing areas need to be sealed with caulk.
- X** Trees near the structure need to be trimmed at least 5 feet away from the roof.
- X** PVC vent stack pipes above the roofline should be painted with a water-based paint to provide protection from ultraviolet (UV) radiation.

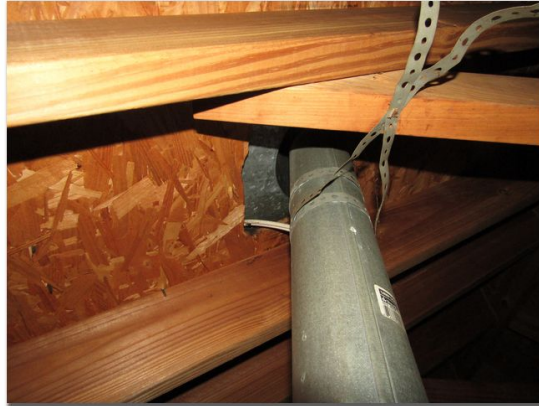
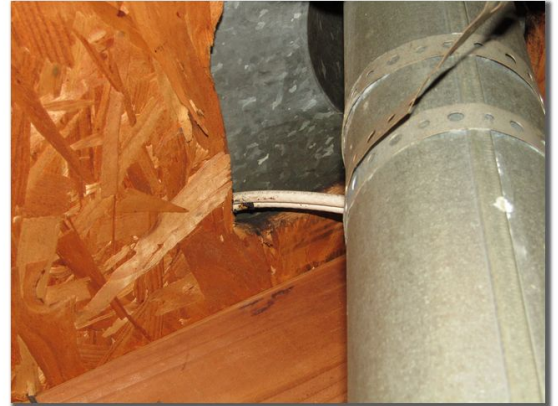
**Deficient Item(s): Roof Structure & Attic**

- ✗ Attic insulation is covering some recessed lights and needs to be pulled away; it is recommended that these be covered or protected by insulation barrier.

- ✗ The attic access ladder should have weather-stripping around the perimeter of the door/ladder or around the perimeter of the access opening. This helps the ladder to act as a fire-blocking agent.

- ✗ Attic insulation is not evenly distributed. Recommend leveling where possible.
- ✗ Some areas of the attic have no insulation. Recommend insulation be added to these areas.

- ✗ I did not observe fire blocking in place at the attic penetration of the chimney flue. Fire blocking is any fire retardant material, (sheet metal is used now) that surrounds and closes off the hole to keep any fire that might escape the firebox from venting up into the attic and spreading flame throughout the house by way of the attic.

- ✗ The satilight wires are coming under the water heater exhaust vent flashing.

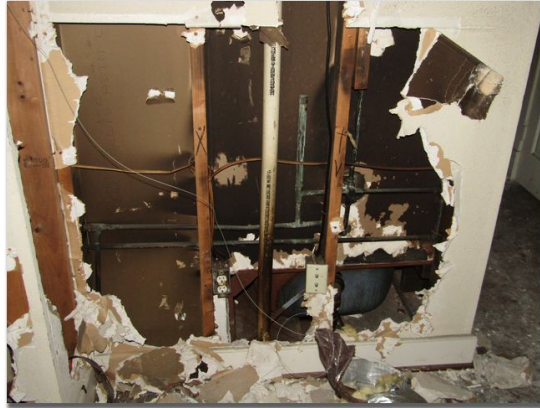
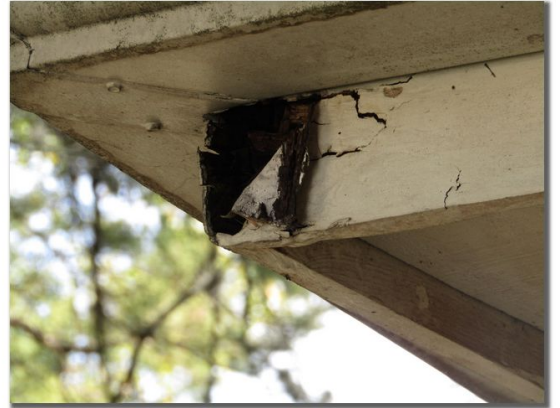
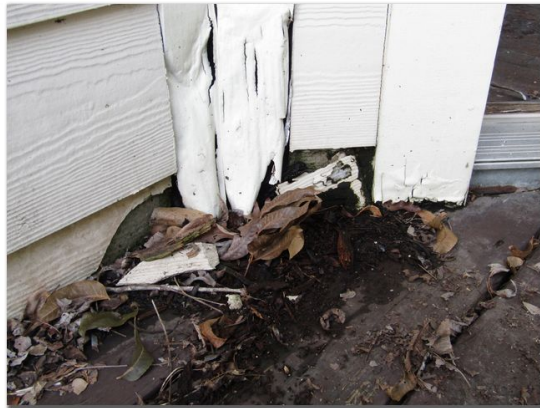
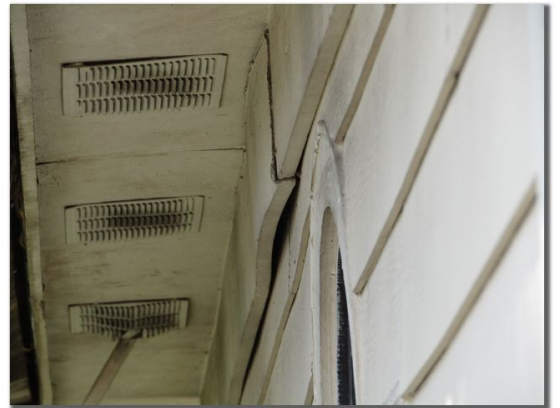
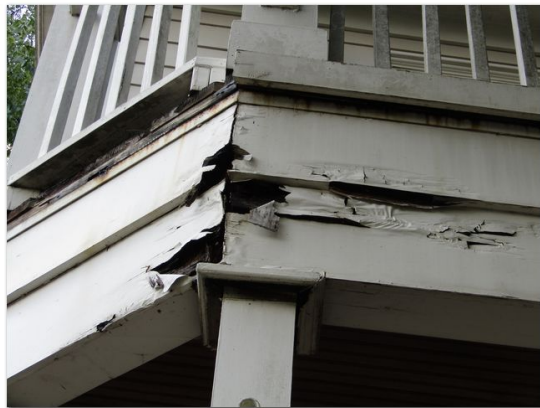
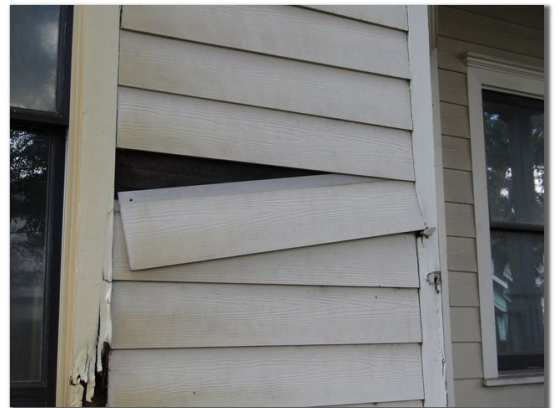
**Deficient Item(s): Walls (Interior & Exterior)**

- X Caulking needed at/or around some/ all of the window frames, at the brick window sills, at the vertical joints and around the base of the exterior lights.
- X Observed cracks/separations at eave board.
- X Observed cracks/separations at fascia board.
- X Observed cracks/separations at the window casement trim.
- X Observed water damaged/deteriorated siding/trim.
- X Observed evidence of previous moisture penetration on the interior window sill in one or more places.
- X Observed some rot to the siding
- X Exterior wood siding is damaged, rotted, buckling, pulling loose at the all sides.
- X Rot at fascia at the all sides of home.
- X Observed damage/deterioration/rot of the eave at the all sides

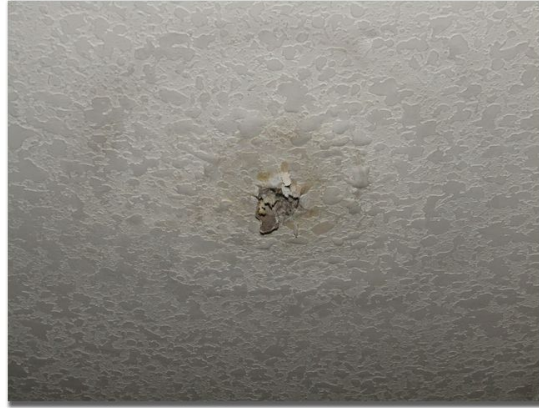
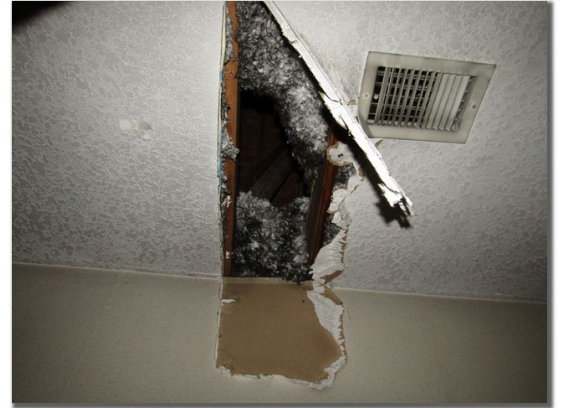
Deficient Item(s): Ceilings & Floors

- X Observed what appears to be previous water stains (brown) on the ceiling in one or more places. Unable to determine if these are active or ongoing leaks.
- X Observed some rising/sloping on the floors in one or more places on the second floor.

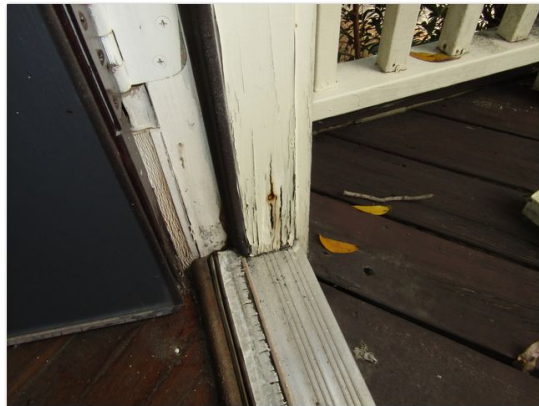
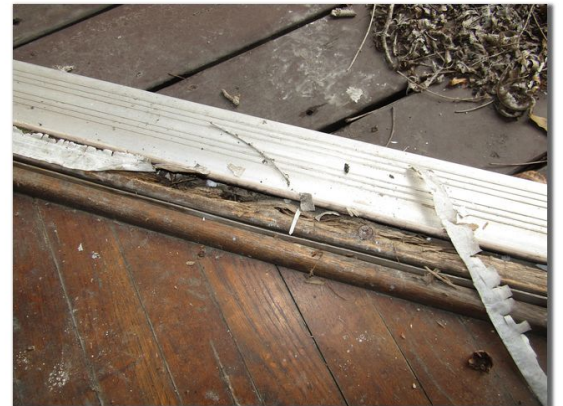
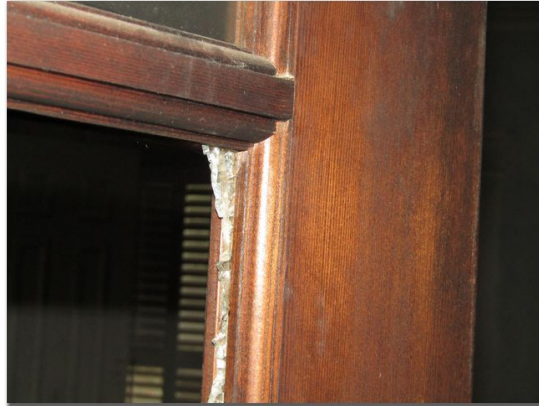
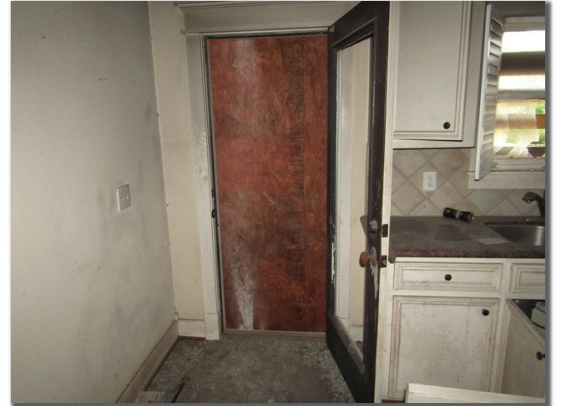
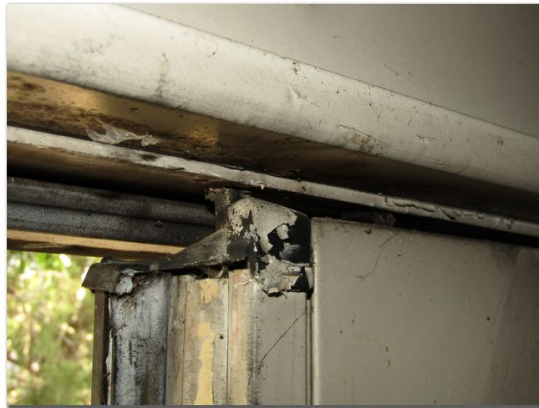
**Deficient Item(s): Doors (Interior & Exterior)**

- X Door frame out-of-square at the front entry
- X Door(s) not latching (misaligned with striker plate) in one or more places.
- X Door(s) binding on door trim in one or more places.
- X Observed evidence of previous water penetration (damage, deterioration, rot) at the bottom of the door frame.
- X Doorframe for the entry doors are damaged.
- X The glass is cracked, missing from several doors.
- X With front/rear door closed, light can be seen around weather-stripping.
- X Weather stripping on all doors is damaged/deteriorated.

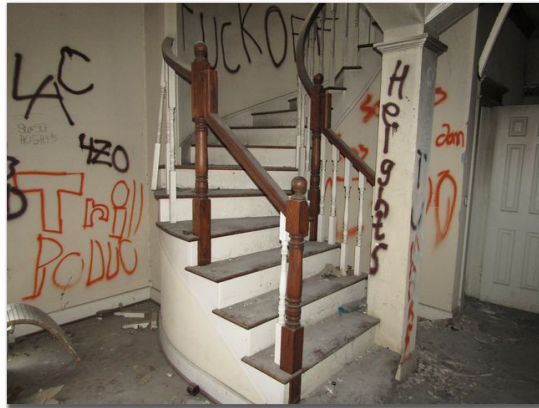
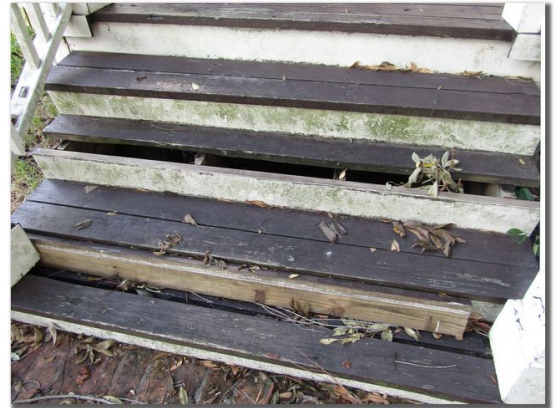
**Deficient Item(s): Stairways**

X The handrail/guardrail on the stairway has openings greater than 4 inches between balusters. The 4 inch rule is designed to keep children from getting through or becoming stuck in the balusters. Balusters are missing and damaged.

X The front door steps are rotted and sinking. Missing treads on step.

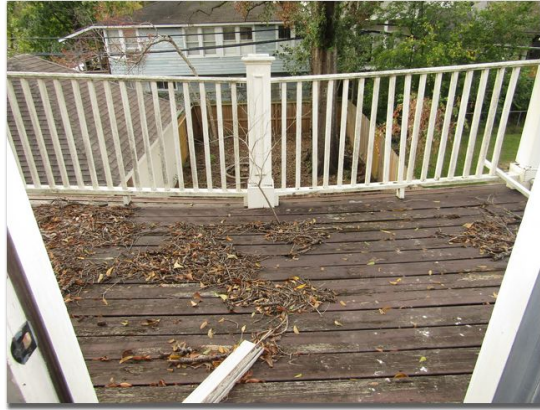
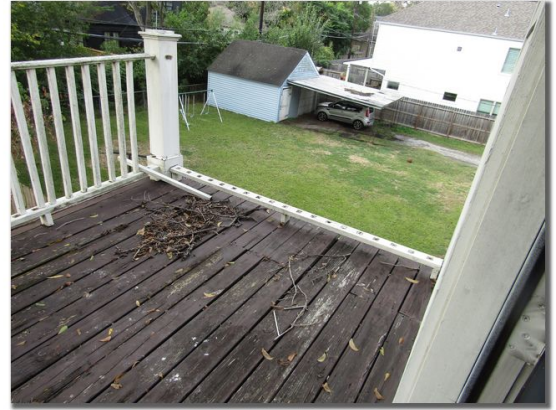
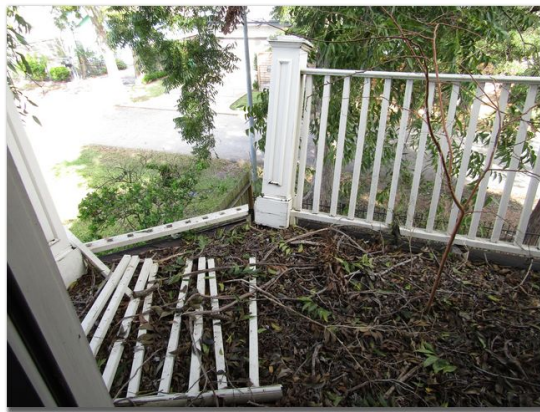
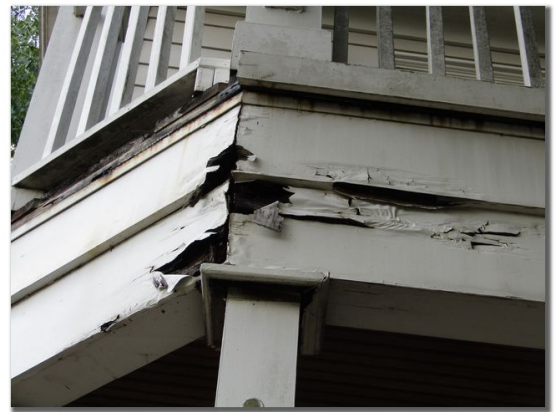
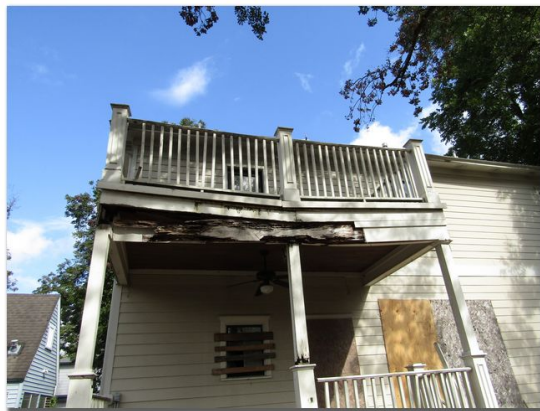
**Deficient Item(s): Porches, Balconies, Decks and Carports**

X Observed loose/damaged/rotted/deteriorated boards on the deck/balcony. These

need to be replaced or repaired.

- X The boards on the deck/balcony have some signs of age or "weathering"; some maintenance (such as sealing or renailling) may be required.
- X No handrail on stairway. Grippable handrail is required if there are 4 or more risers.

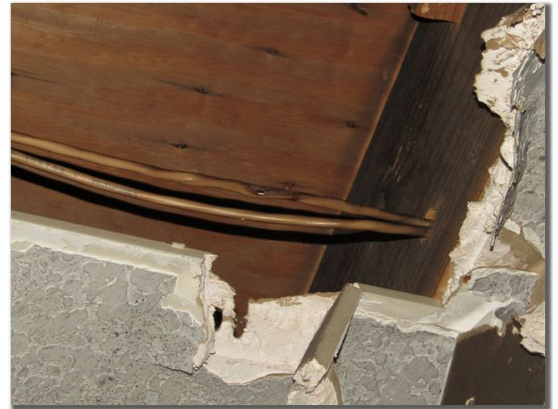
Note: Electrical service was not on, I was not able to test the outlets or switches. There are several wires that have been damaged due to the fire.

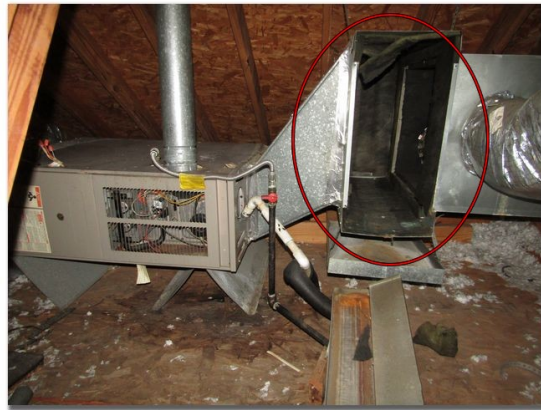
Note: The copper condenser units and evaporators we missing from the property. It appears that there were stolen.

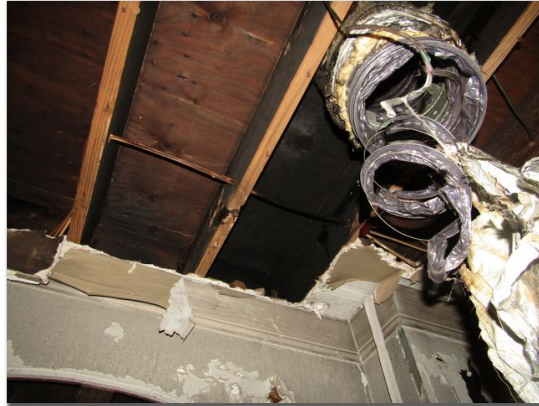
**Deficient Item(s): Duct System, Chases and Vents**

- X Metal ducts in the attic space are crushed in some areas.
- X Metal duct insulation is peeling off in some areas of the attic space.
- X Many registers and duct work damaged from fire.

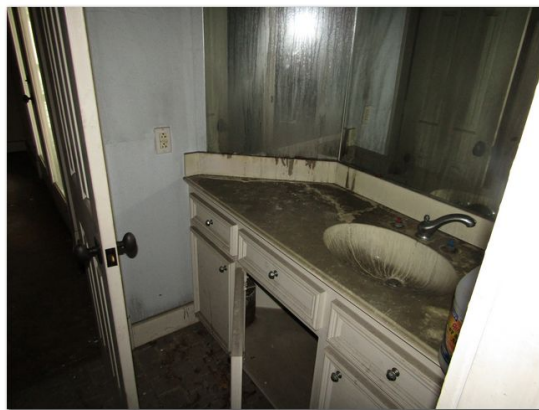
Note: Most faucets appear to have damage to them.

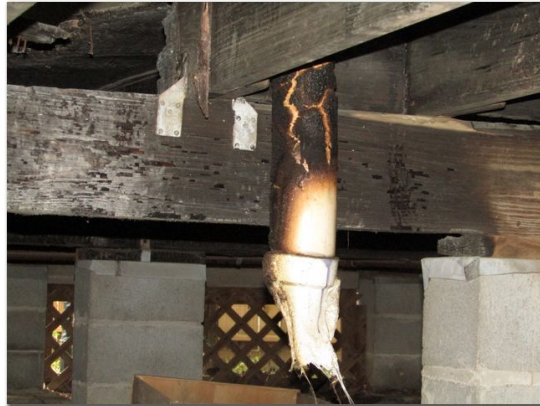
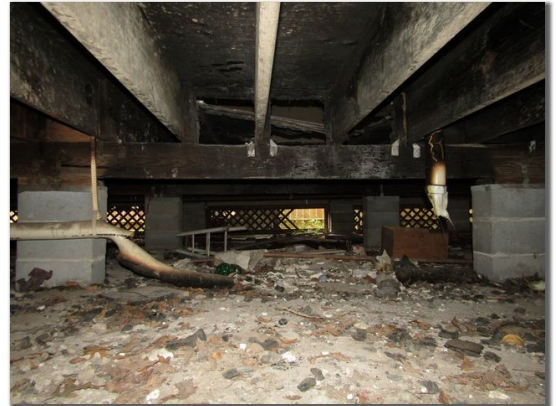
**Deficient Item(s): Drains, Wastes and Ventilation**

**X** The main drain in the crawl space was melted in the fire.

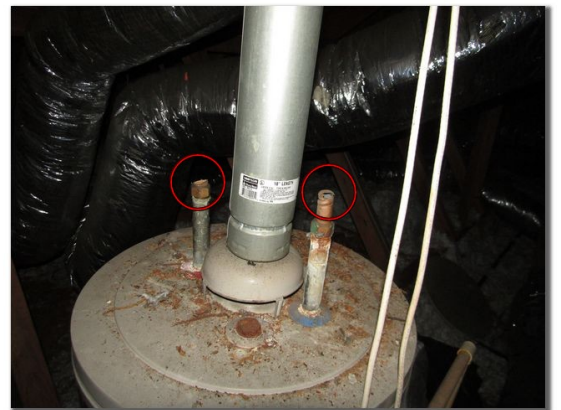
Note: No water to the house to test unit. The copper piping was scavenged from the unit in the attic.
