NOVEMBER 4, 2022

PROPERTY INSPECTION REPORT

1843 Sul Ross St, Houston, TX 77098

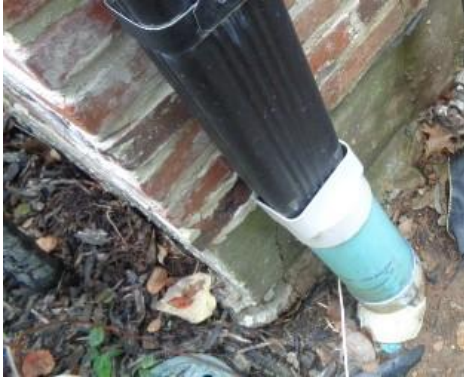
Comments: The front right corner of the foundation is cracked/popped. Seal/repair the cracked popped foundation corner.

Popped corner

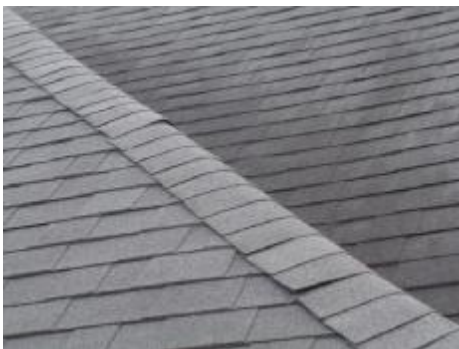
Comments: The roof inspection is limited by height and design. The roof has raised shingles and fiberglass showing on the front. Have a roofer evaluate and repair.

Roof raised shingle

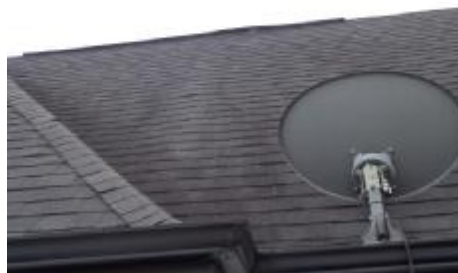
Roof raised shingle/fiberglass

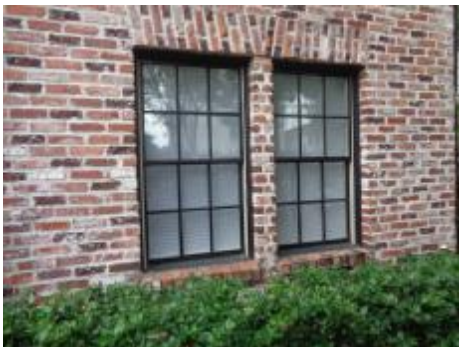
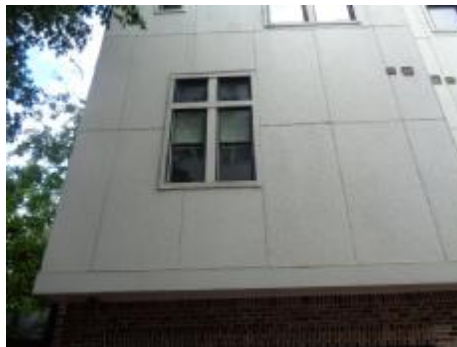
Comments: All operable windows on the home are missing the screens. Install window screens for safety.

Window screens missing

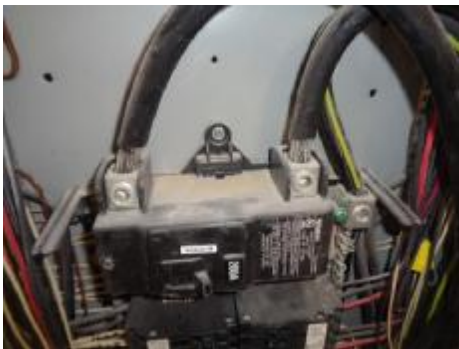
Missing anti-oxidant paste

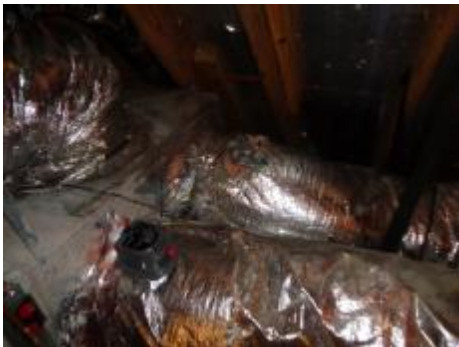
- Ducts *The ducts in the attic are damaged. Repair the damaged ducts for proper operation. The ducts in the attic closet are touching each other and the wall. Separate ducts to prevent moisture damage.*
- Supply Air Flow
- Supply/Return Plenums

Damaged ducts

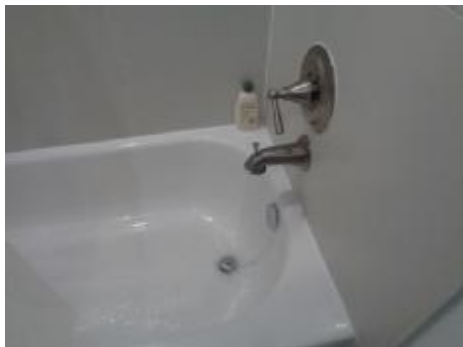
- Bath Room Group(s) Downstairs (3)
 - Lavatory(s)
 - Faucet Assembly(s)/Supply Pipes/Valves There is continuous water flow from the tub faucet when the shower diverter is in operations. Repair or replace the shower diverter for proper operation.
 - Drains/Pipes/Stops
 - Tub/Shower Units
 - Faucet Assembly(s)/Supply Pipes/Valves
 - Drains/Pipes/Stops
 - Enclosures(s)/Shower Pan
 - Commodes
 - Supply Pipes, Valves, Bowl, Tank, Anchorage

Diverter

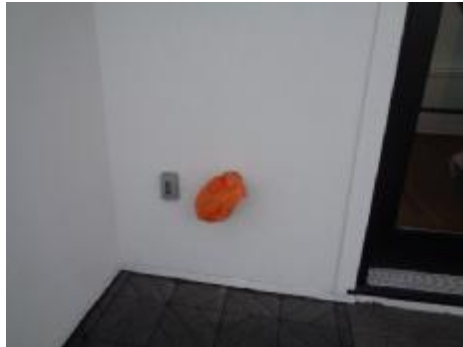
- Exterior Faucets/Fixtures* Exterior faucets not inspected due to winterization.
- Backflow Prevention* present absent

All exterior faucets Winterized

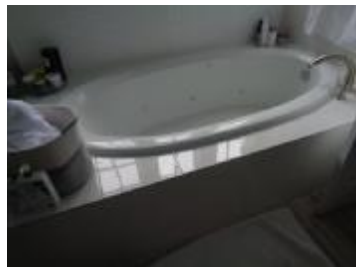
The pump/motor for the hydro tub is not accessible. Install an access panel to the pump/motor.

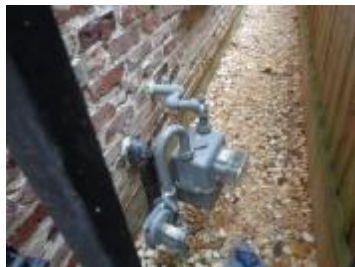
Are gas lines bonded yes no The gas distribution system is not bonded. Bond the gas distribution system,
