Home Inspection Report

1843 Sul Ross Street, Houston, TX 77098

PROPERTY INSPECTION REPORT

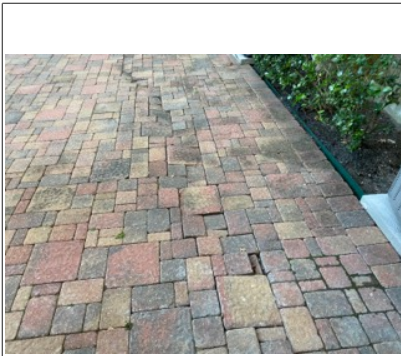
Minor erosion observed under the pavers in the driveway.

Erosion observed under pavers outside garage door.

Comments: The driveway should be sealed where it meets the house.

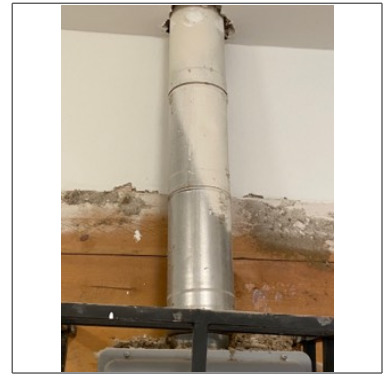
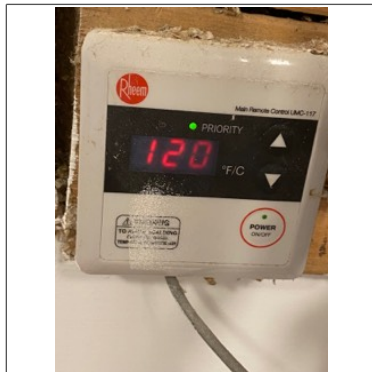
Comments: The location of the water heater is considered unsafe. This situation should be remedied for improved safety.

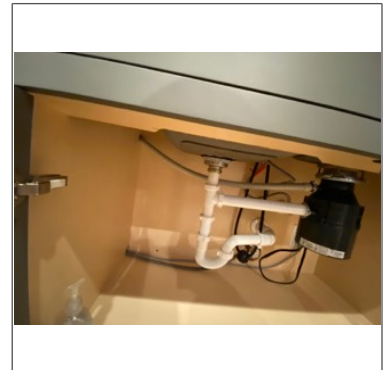
Comments: The food waste disposer is excessively noisy. Repairs may be necessary.
