INSPECTION REPORT

7443 Field Creek Estates Drive
Bryan TX 77808

PROPERTY INSPECTION REPORT

Concerning: 7443 Field Creek Estates Drive, Bryan TX 77808

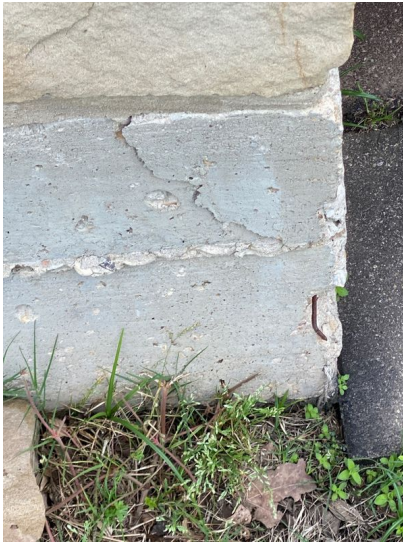
Corner Crack:

Corner cracks are common cosmetic defects at foundation edge due lack of rebar support in this area.

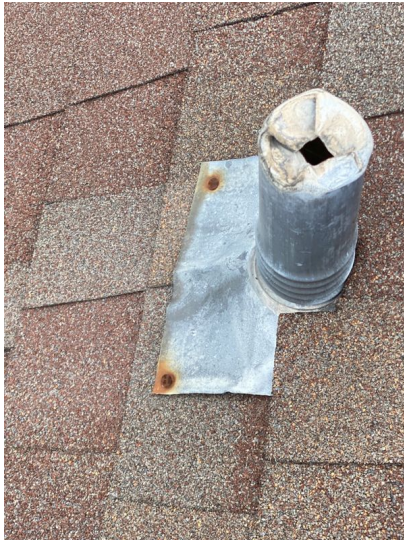
1: Exposed Nails

Under-driven or exposed nails were found in one or more roof coverings. Recommend a qualified roofer evaluate and correct.

Recommendation: Contact a qualified roofing professional.

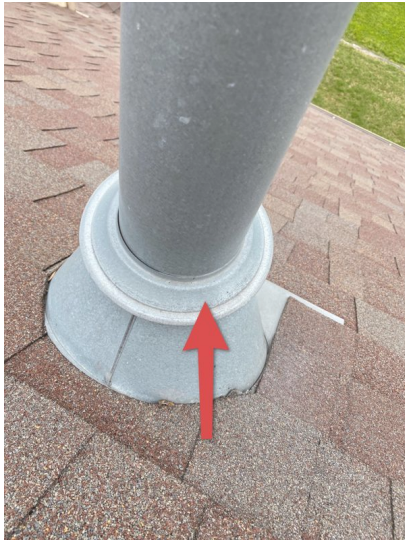
2: Storm Collar Not Sealed

This is a potential source of moisture penetration. Water can trickle down side of flue and saturate internal components

Recommendation: Contact a qualified professional.

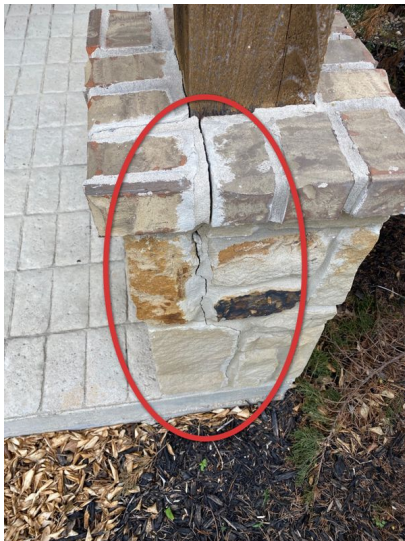
2: Gaps At Exterior Wall

Seal all gaps at joints and/or utility penetrations to prevent moisture and pest intrusion.

- Utility holes
- Expansion joints
- Brick ledge/Window transition
- Brick ledge/siding transition

Recommendation: Contact a qualified handyman.

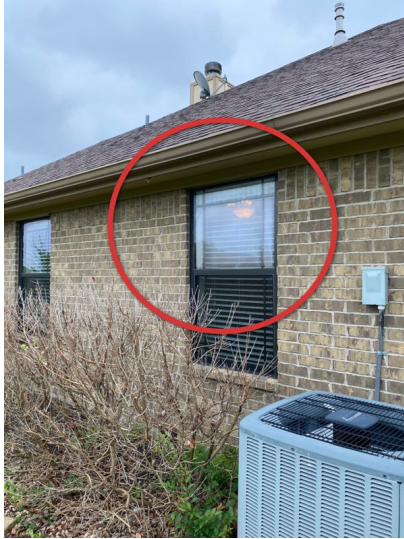
1: Failed Seal

Observed condensation between the window panes, which indicates a failed seal. Recommend qualified window contractor evaluate & replace.

Recommendation: Contact a qualified window repair/installation contractor.

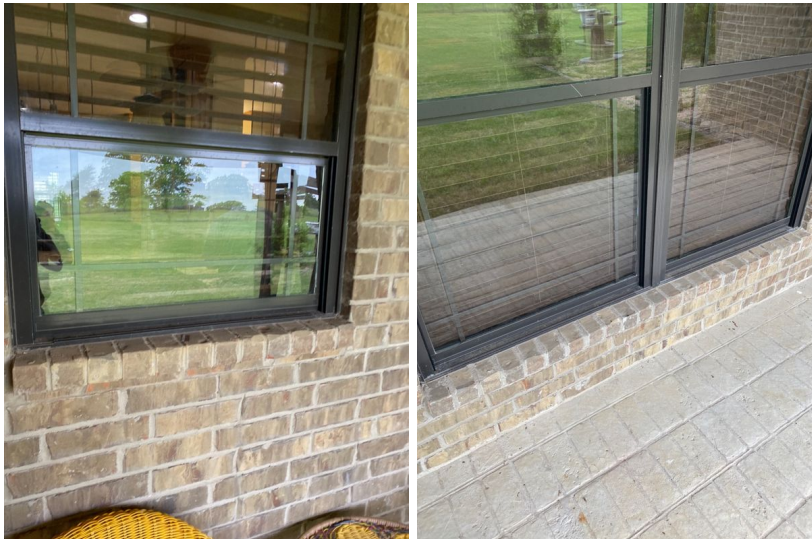
2: Missing Screen(s)

One or more windows are missing a screen. Recommend replacement.

Recommendation: Contact a qualified window repair/installation contractor.

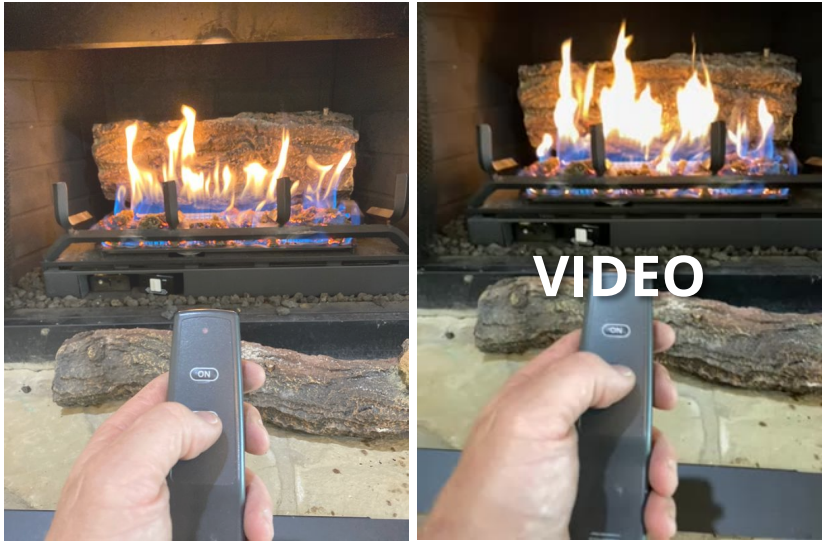
1: Defect:

Remote system did not appear operational

Recommendation: Contact a qualified professional.

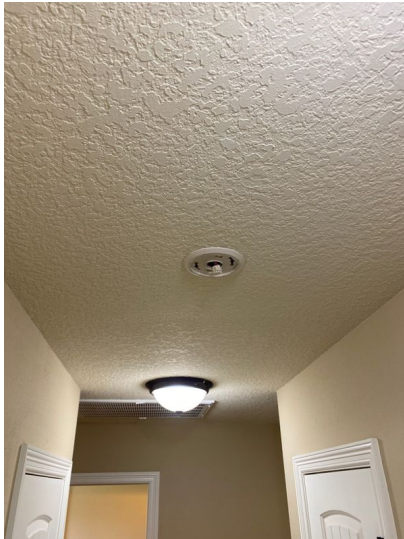
1: Smoke Detectors Missing

Smoke detectors should be in each bedroom

Recommendation: Contact a qualified professional.

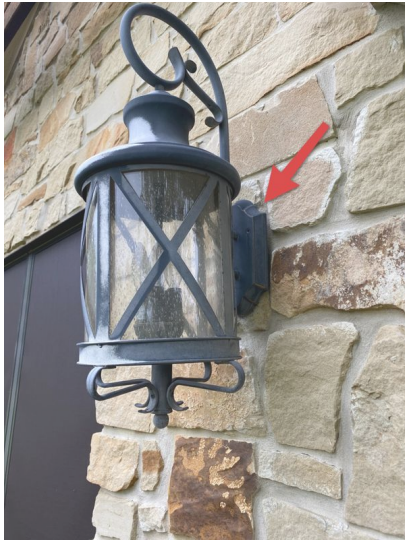
Loose

2: Damaged/Loose Light Fixture

Recommendation: Contact a qualified professional.

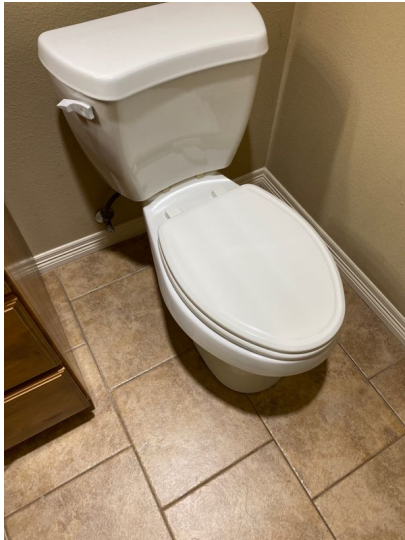
Hall Bathroom

1: Loose Commode

Check for loose or unsecured mounting bolts or worn out wax ring.

Recommendation: Contact a qualified plumbing contractor.

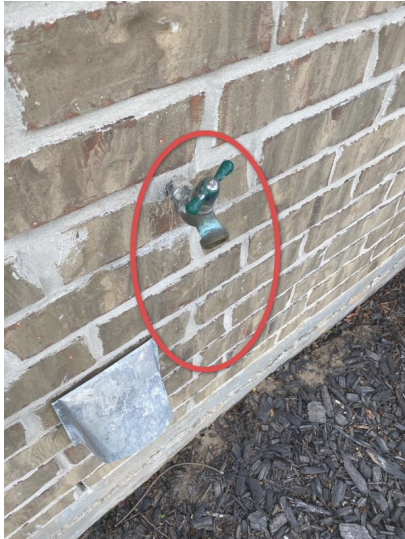
2: Missing Vacuum Breakers

Exterior hose bibs should have a one way vacuum breaker installed to prevent dirty water from entering homes water supply.

Recommendation: Contact a qualified professional.

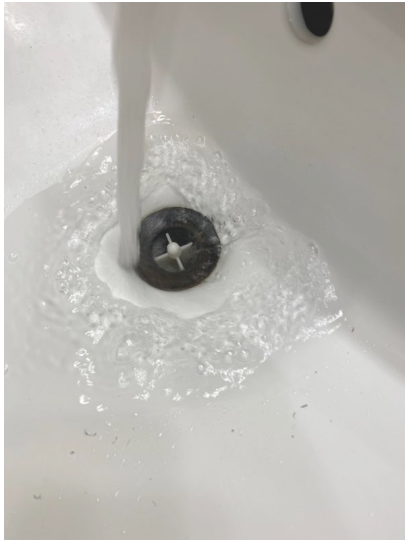
Hall Bathroom

1: Missing/Damaged Drain Stop

Missing drain components should be replaced to prevent large objects from entering/obstructing the drain.

Recommendation: Contact a qualified professional.

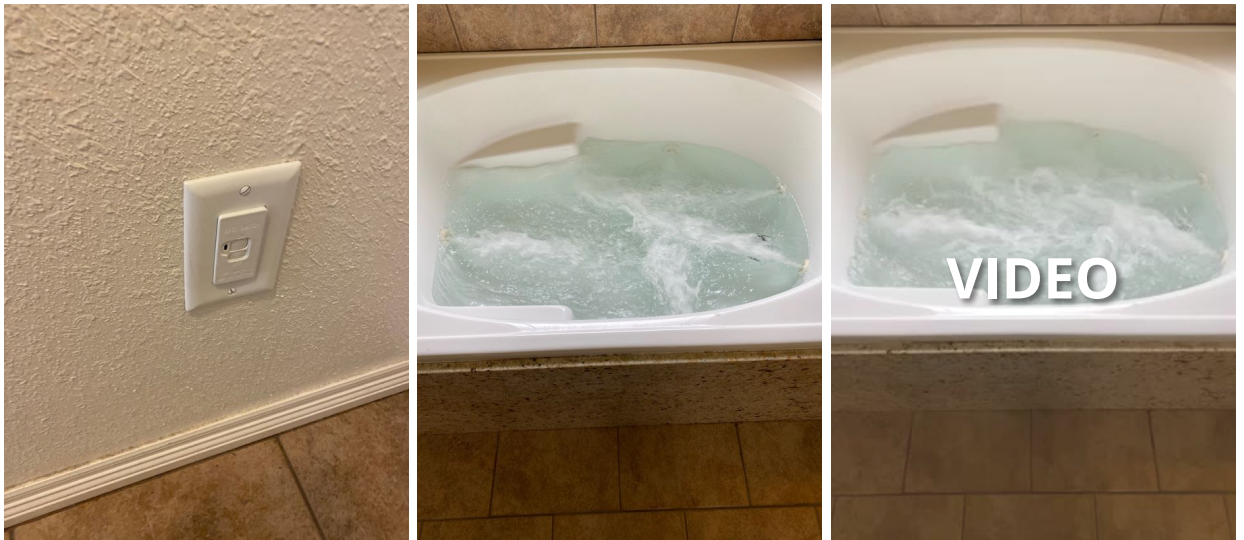
1: Plumbing Not Accessible

Access to pump and plumbing is strongly suggested

Recommendation: Contact a qualified professional.

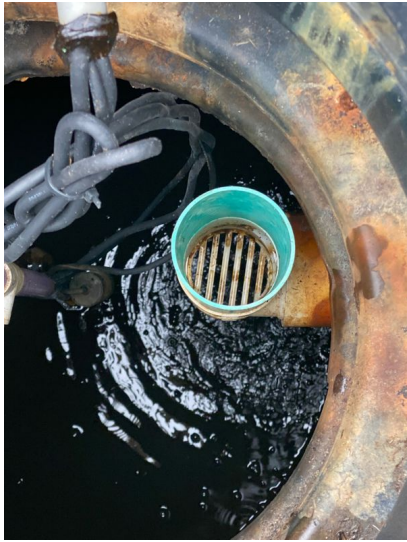
1: Chlorine Needed

System is low or out of chlorine and is not properly treating the water.

Recommendation: Contact a qualified professional.
