## PROPERTY INSPECTION REPORT

**Prepared For:** Hoang Tran  
(Name of Client)

**Concerning:** 4639 Clear Creek Drive, Sugar Land, Texas  
(Address or Other Identification of Inspected Property)

**By:** Scott Hinsley TREC # 7050 12/13/2021  
(Name and License Number of Inspector) (Date)

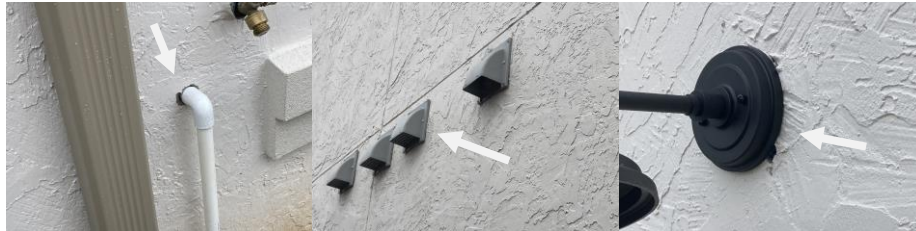
Numerous areas of patching and painted noted.  
 Observed several areas of baseboard missing noted.  
 Stucco exterior veneer observed.  
 Recommend completing/sealing all exposed exterior wood as required.  
 All exterior wall penetrations should be sealed at left from sprinkler wiring conduit, all vent covers and front right sconce light.
