Wood Destroying Insect Report

2/7/2023

902 Rolling Mill Dr

TEXAS OFFICIAL WOOD DESTROYING INSECT REPORT

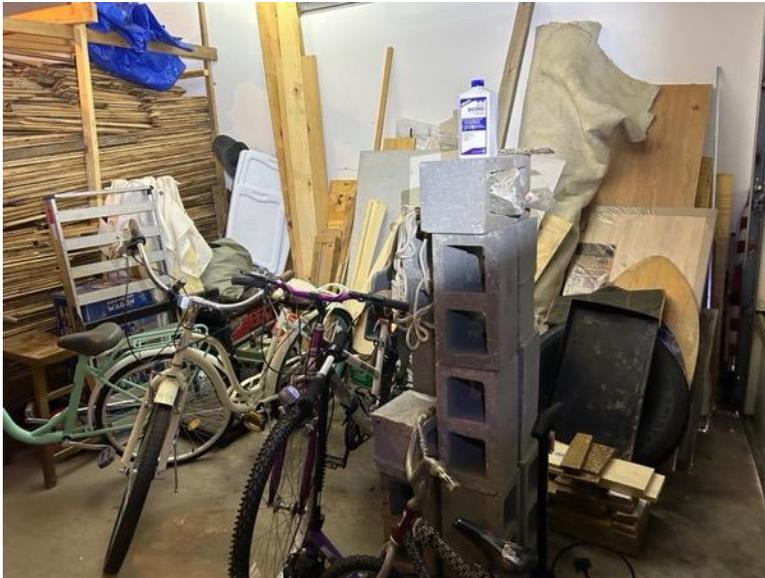
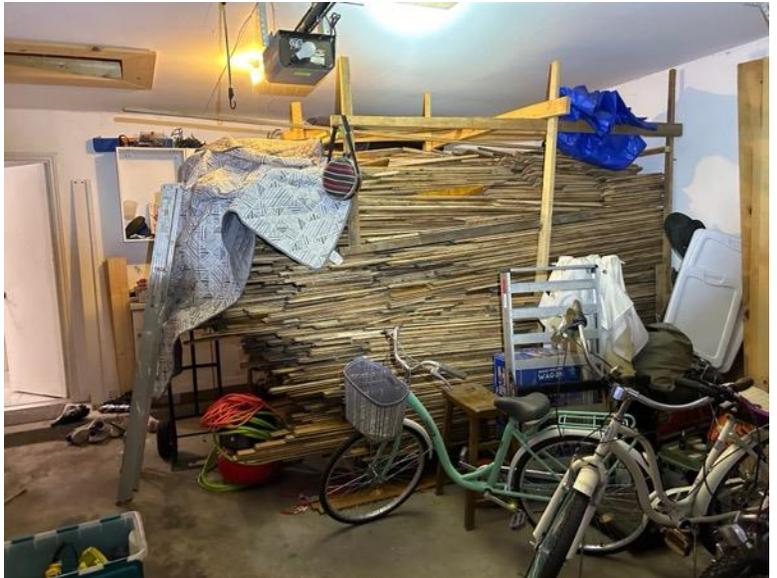
Stored items in garage.

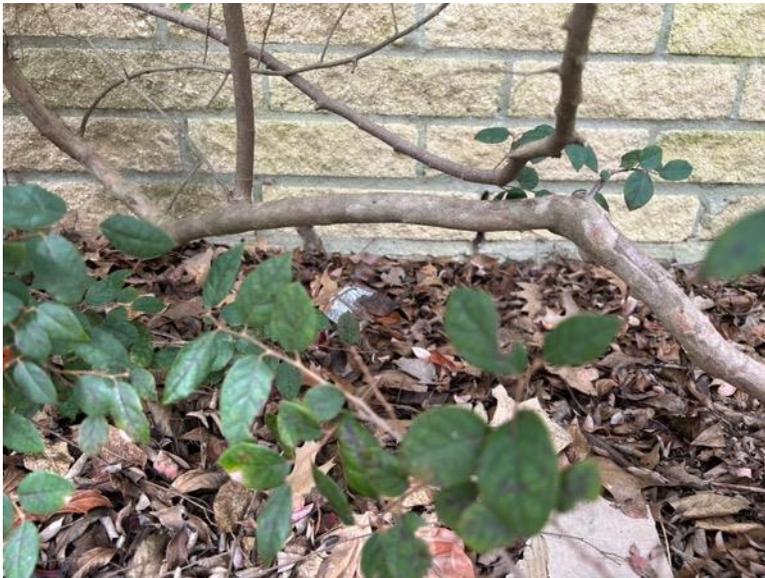
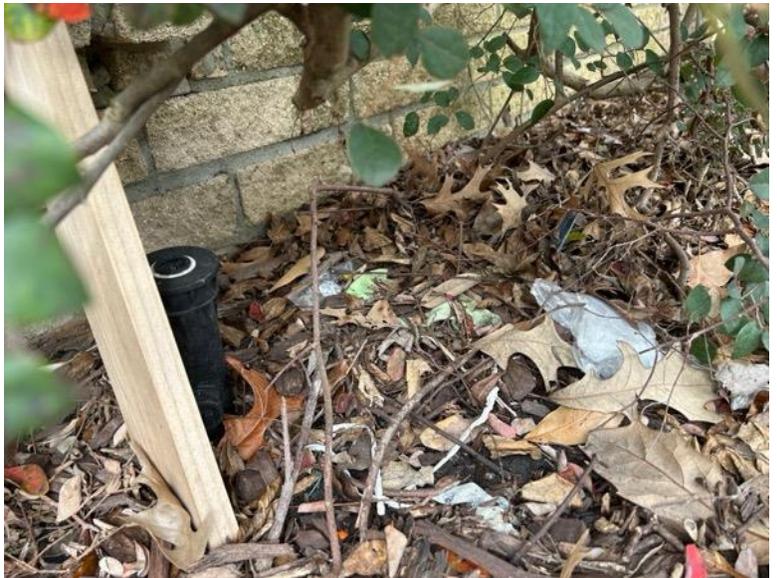
High soil should be lowered.

Comments: (L) High Soil - Soil should be lowered to below the top of the foundation.

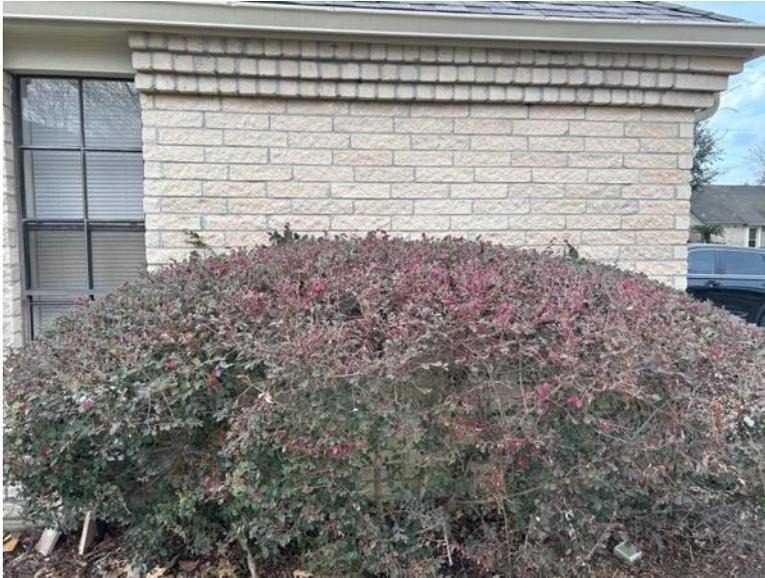
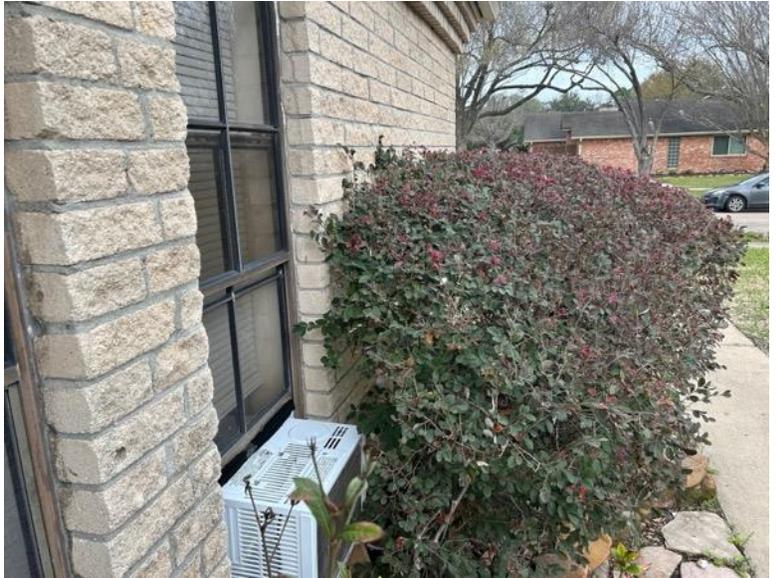
Heavy foliage should be trimmed back from structure.

(N) Heavy Foliage - Foliage should be cut back to provide at least 3 inches of clearance to the structure.

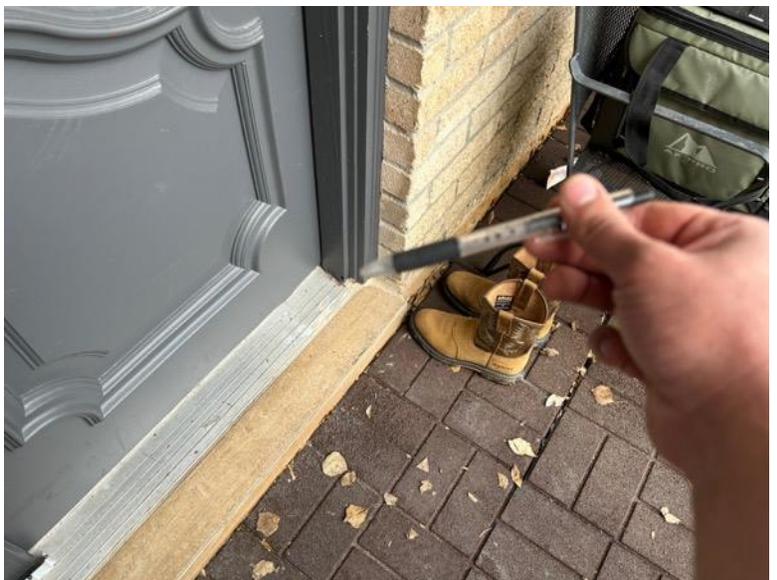
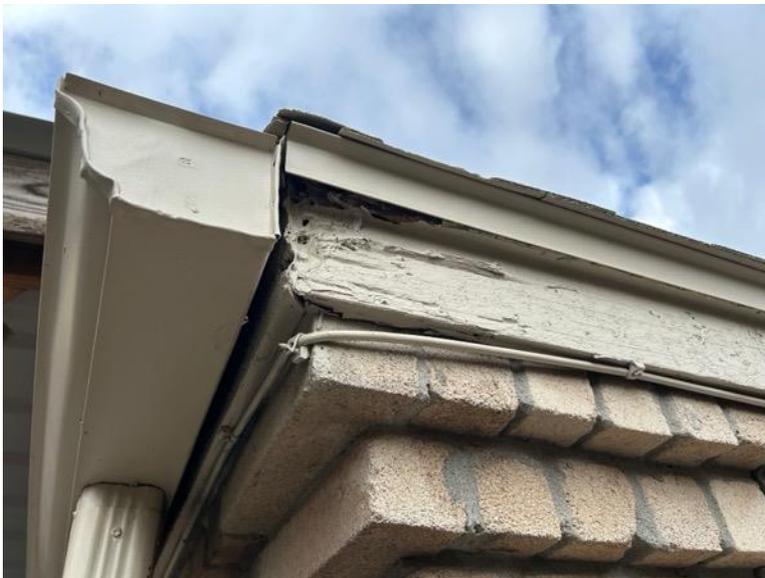
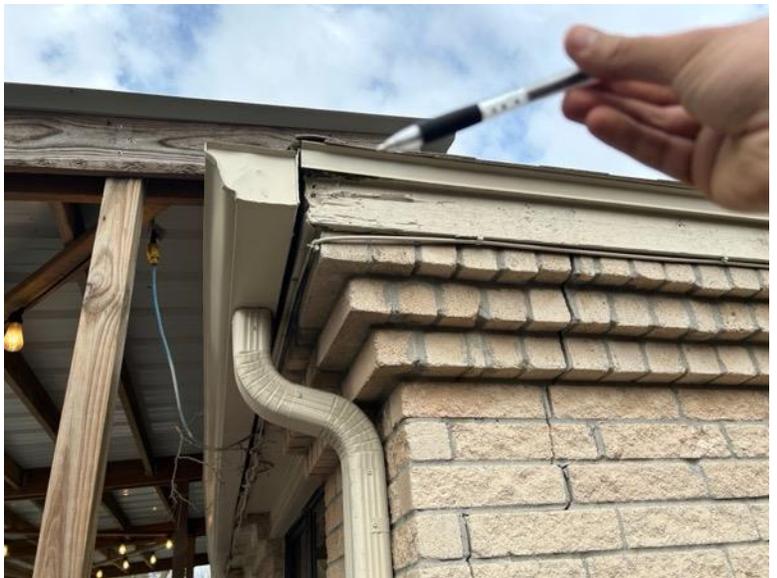
Wood rot should be repaired.

(M) Wood Rot - All damaged or affected wood materials should be properly repaired or replaced.

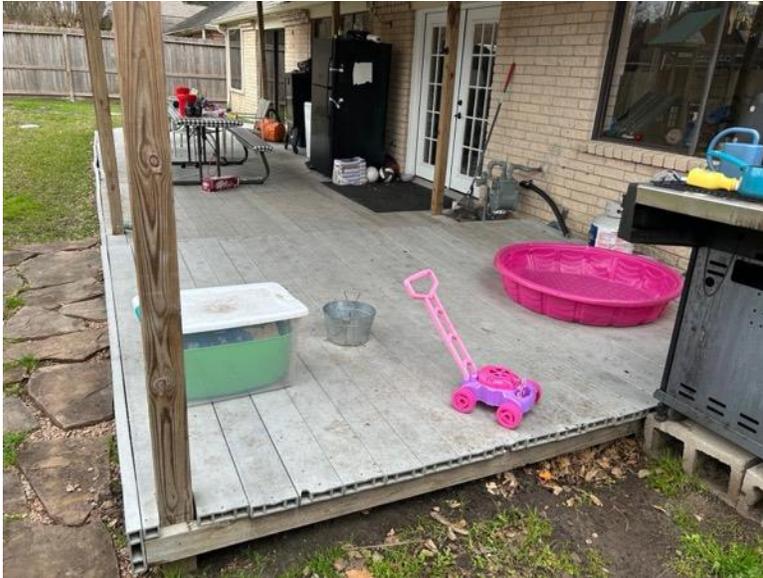
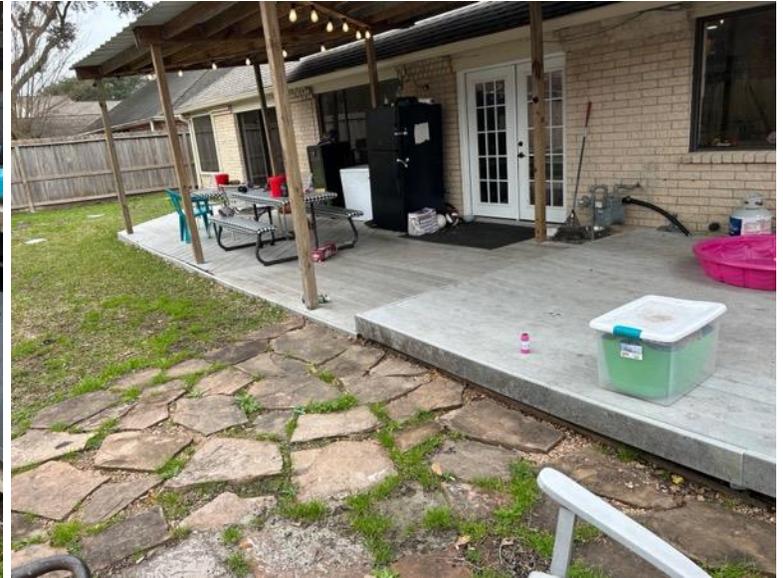
Wood to ground contact – Deck should be monitored for insect activity.

(G) Wood to Ground Contact - Wood decks/porches are conducive by design - Area should be monitored for insect activity.

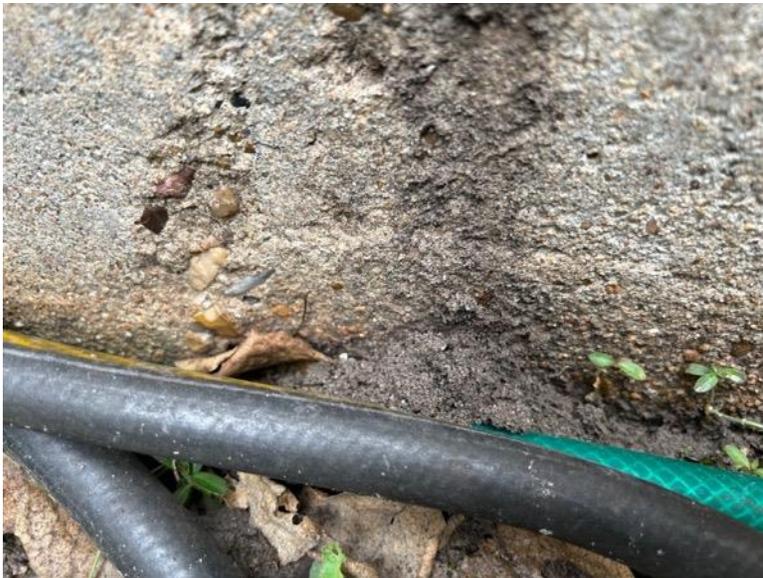
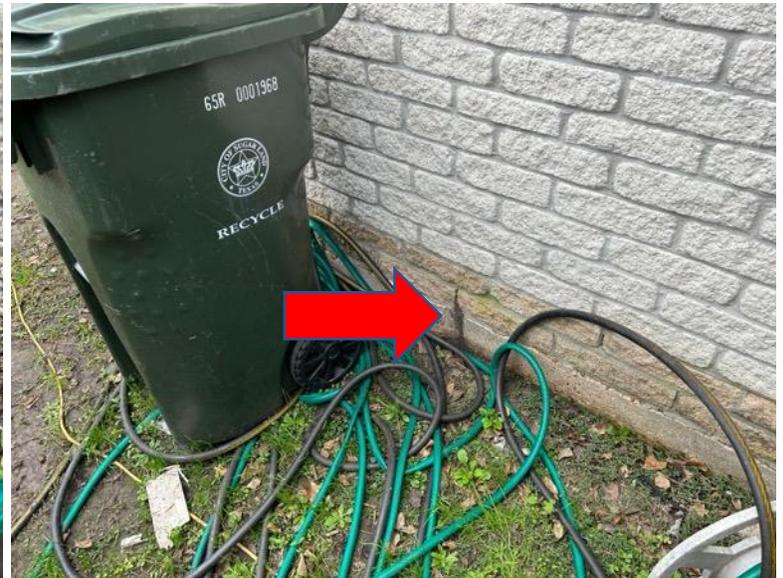
Ant mound was observed around the structure.

Although this report does not include pest infestations, we noticed evidence of pest infestation during the course of our inspection. The following conditions were observed that indicate current or previous pest activity. Further investigation is recommended with the owner regarding the condition(s) and with a pest control company to obtain a cost estimate for any needed treatment to resolve the issue.

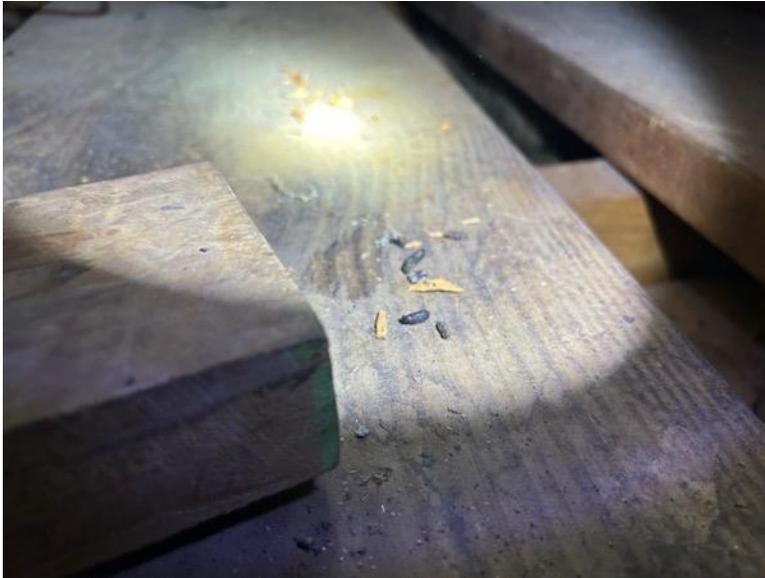
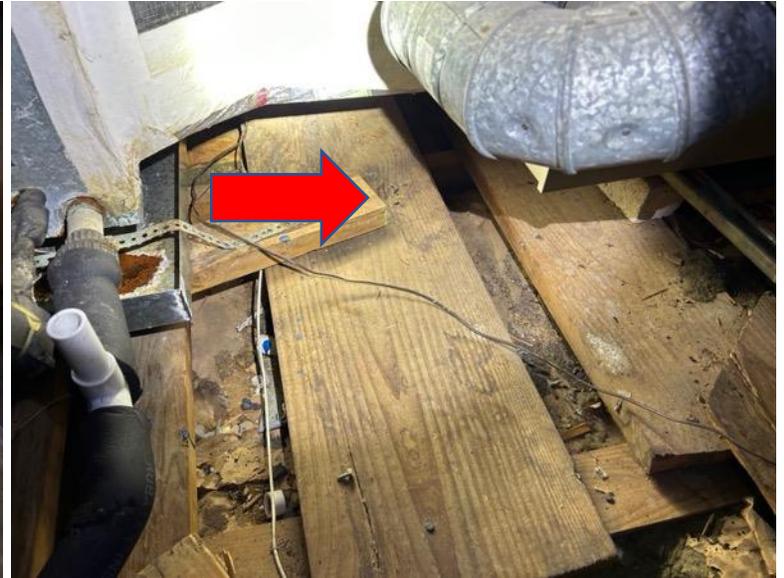
Rodent activity was observed in attic.
