Inspection Report

Property Address:
4614 Harbor Sham Street
Rosharon Texas 77583

JV Real Estate Inspection

PROPERTY INSPECTION REPORT FORM

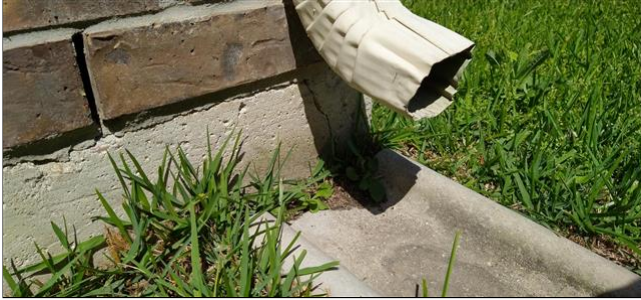
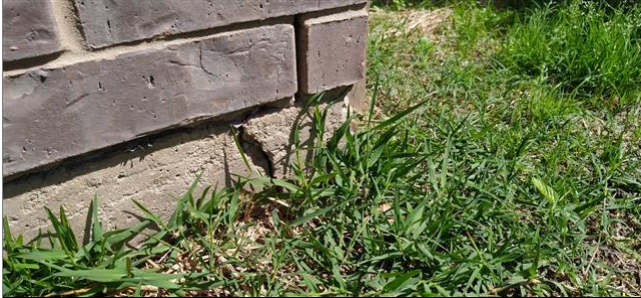
(2) Corner cracks and / or missing concrete were found at corners of the foundation. This is a common condition found with this type of foundation and appears to have caused no structural problems.

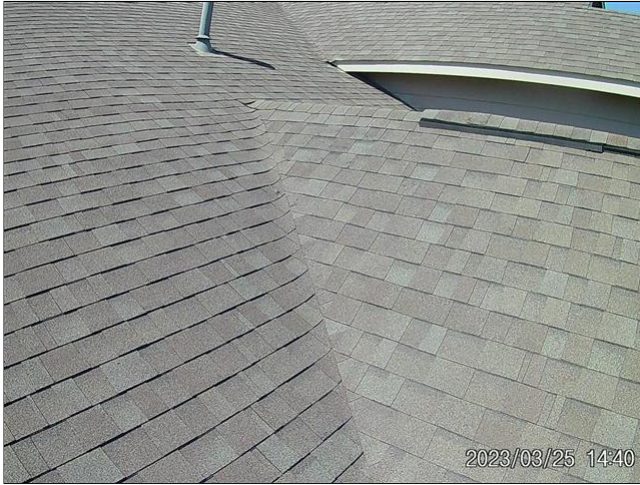
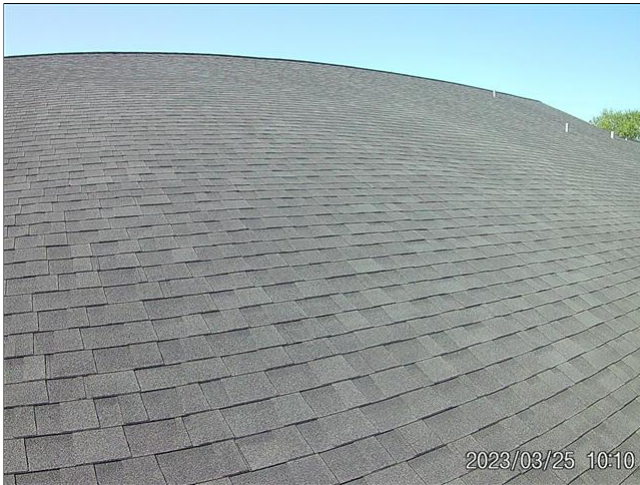
(2) 30-35 years asphalt shingles roof is in good condition at the time of inspection.

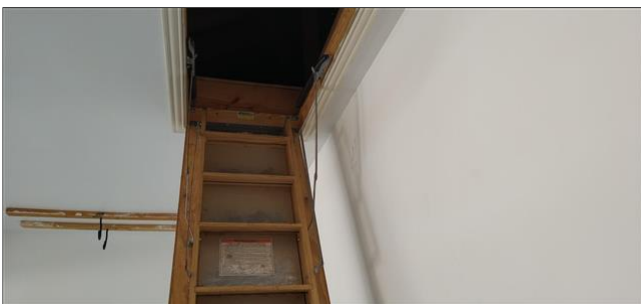
D. Item 6(Picture)

(3) Insulation appeared to be around 14.5 inches R38 value.

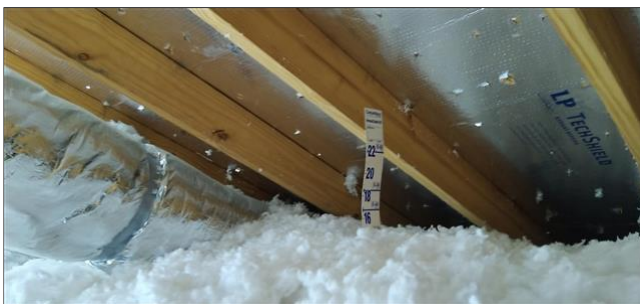
D. Item 10(Picture)

(4) Attic was installed with tech shield radiant barrier.

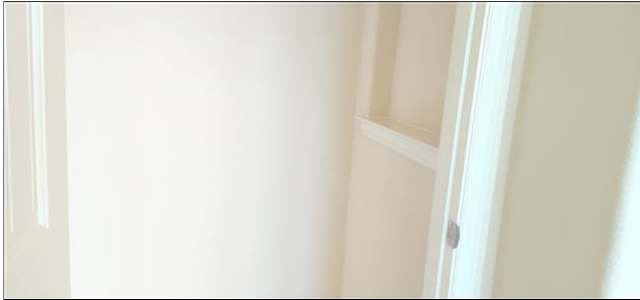
E. Item 1(Picture)

(2) The sheetrock on the wall reveals mismatch in paint touch up at the Master Bedroom. This is a cosmetic issue for your information. I recommend repair as desired.

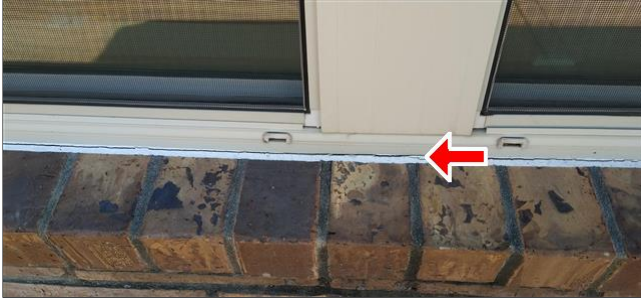
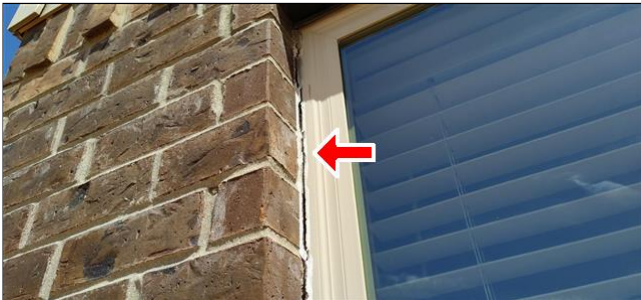
(3) Damaged and missing sealant / caulking was found at joints, transitions, and voids on the exterior veneers. This material acts as a moisture barrier to prevent water from moving to the underlying wall cavity. The re-sealing of the exterior veneers should be considered.

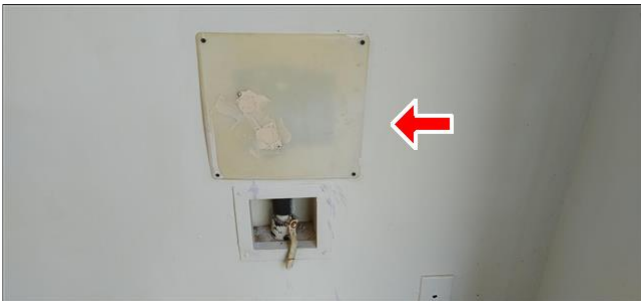
E. Item 6(Picture)

(4) Sign of previous damaged and temporary repair found in sheet rock wall in garage. I recommend to repair as needed

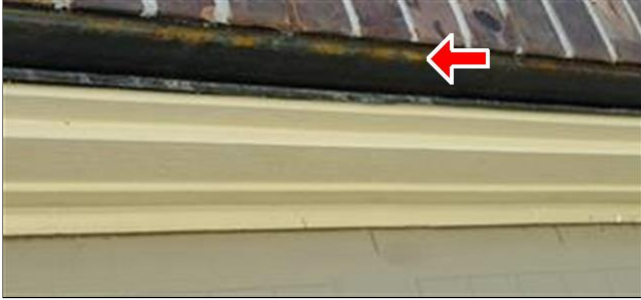
E. Item 7(Picture)

(5) Steel lintel at garage appeared to be rusted and deteriorating. I recommend to prep and repaint.

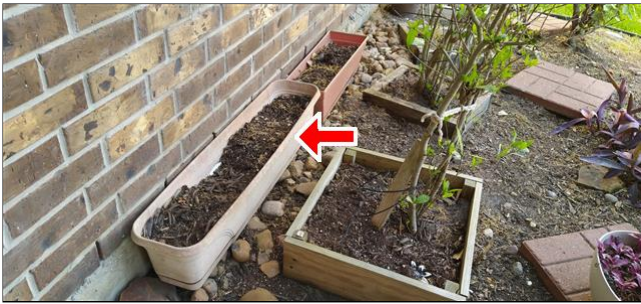
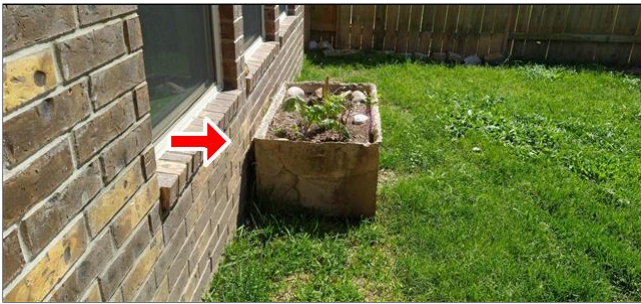
(6) I recommend to remove all items leaning against exterior walls to prevent future excessive moisture. face of foundation need to be expose to monitor for future condition.

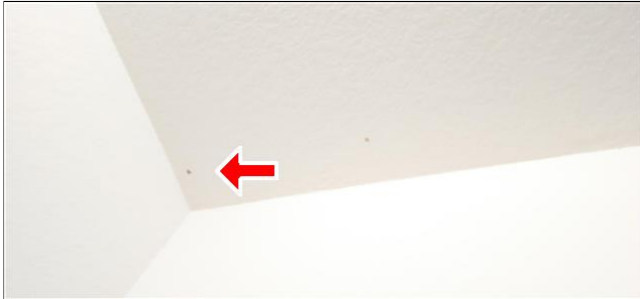
F. Item 1(Picture)

(3) Exposed nail head found in master bedroom closet ceiling. This is cosmetic and for your information only. Touch up as needed.

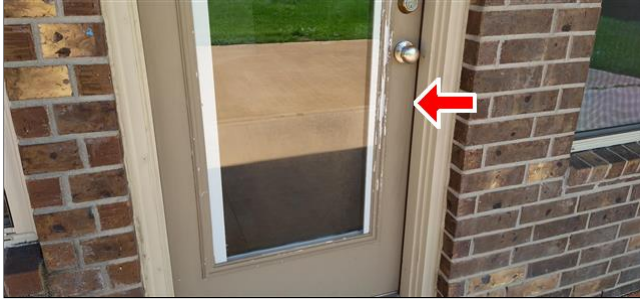
H. Item 1(Picture)

(2) The Entry door exiting to back yard shows areas of peeling paint and appeared to be damaged by pets. This is a small repair. I recommend prep prime and paint as needed.

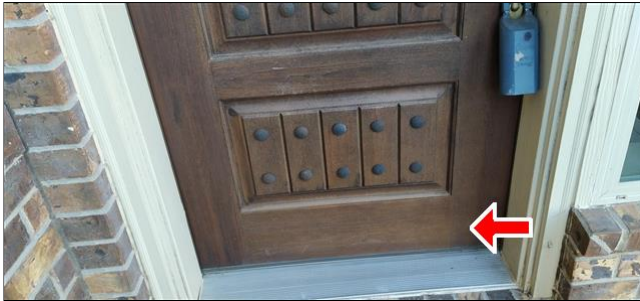
H. Item 2(Picture)

(3) Front entry door is weathered. I recommend to refinish as needed.

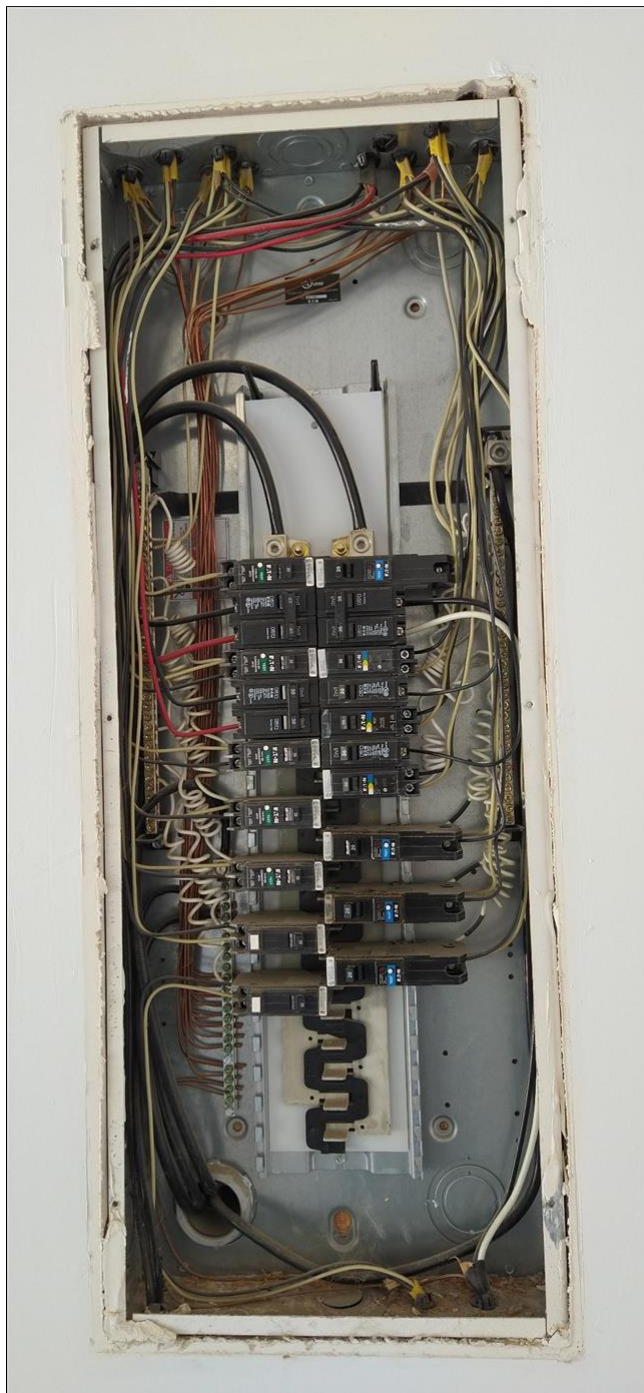
A. Item 3(Picture)

(3) Main 150 Eaton disconnect breaker located at right exterior wall facing street.

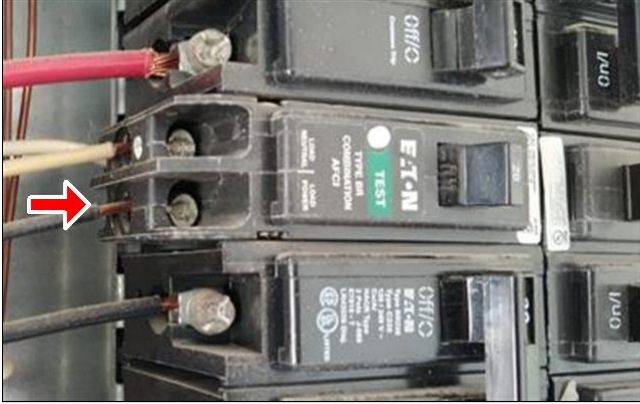
A. Item 7(Picture)

(5) Over stripped wire found at breakers at breaker need to be repair.

A wire that is stripped too long can become a hazard because it will allow the extra bare area of the conductor to be vulnerable for coming into contact with other wires such as the ground, or could become a danger to anyone who may come in contact with the wired device.

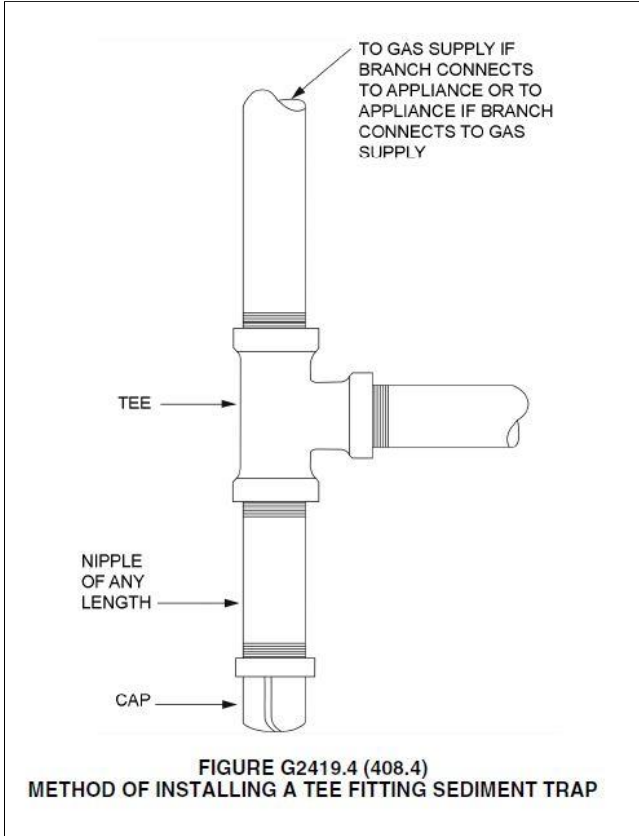
A. Item 3(Picture)

(3) Improper gas sediment trap installed at furnace gas entrance. Sediment trap prevent dust from entering and clog system. see pic for sample. see a qualified tradesman for correction.

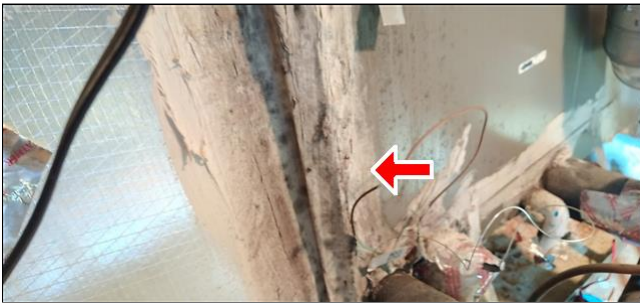
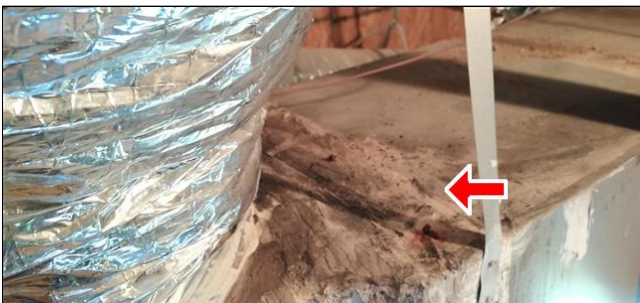
(5) Sign of excessive moisture and mold built up found at ac plenum. I recommend to see a mold inspector for further opinion and correction.

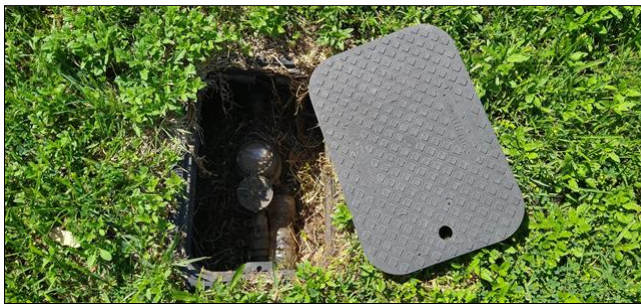
A. Item 1(Picture)

(2) water meter located at street

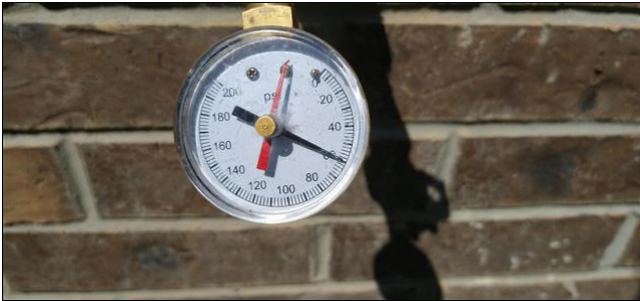
A. Item 3(Picture)

(4) Water pressure measured 60 psi

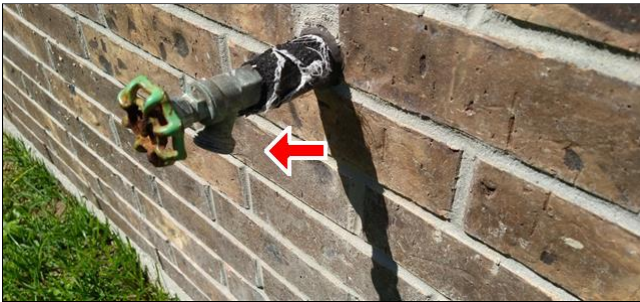
A. Item 4(Picture)

(5) No anti-siphon device installed at right exterior bib hose. Handle appeared to be rusted. Installed as needed.

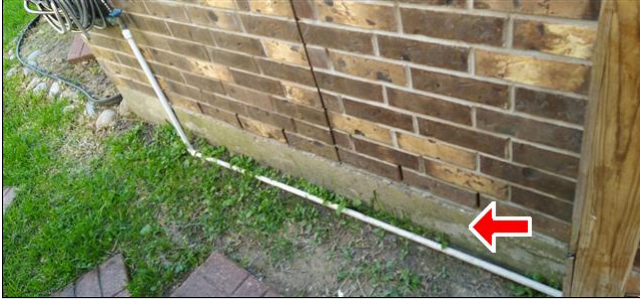
A. Item 5(Picture)

(6) Main water supply line at exterior and attic need to be insulate. Insulating pipes with an exterior approved foam can protect the pipes from harmful sun rays or below freezing temperature. See a qualified plumber for opinion and correction.

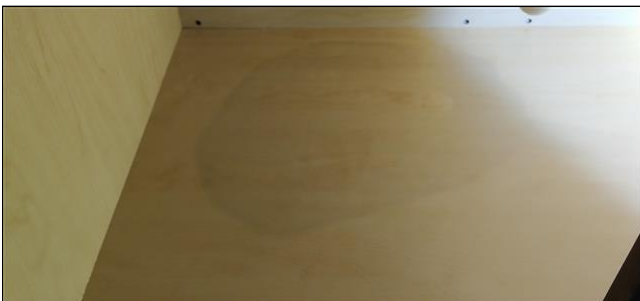
A. Item 8(Picture)

(7) sign of previous leak found under bathroom sink. Leak appeared to be old and for your information only.

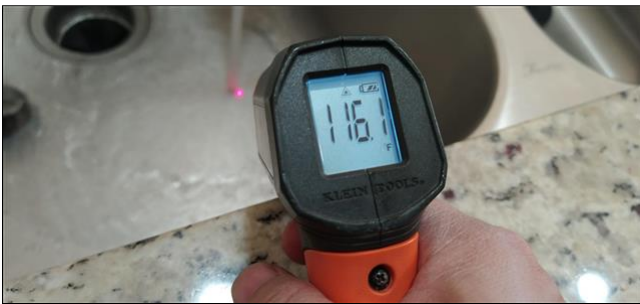
C. Item 4(Picture)

(5) Hot water measured 116F. Water heaters function as intended as the time of inspection.

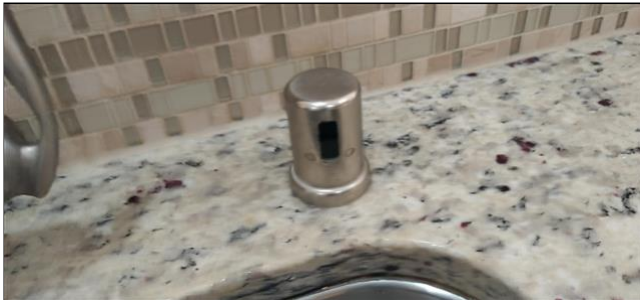
A. Item 1(Picture)

(3) Dishwasher leak at air gap when drain. When the gap leaks, it is normally due to a kink or blockage in the tube from the air gap to the tail piece (drain line) below the sink. The gap may need to be cleaned, or the drain line below the sink may be plugged. See a qualified tradesman for correction.

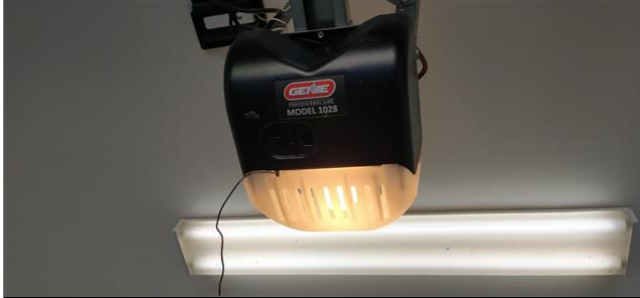
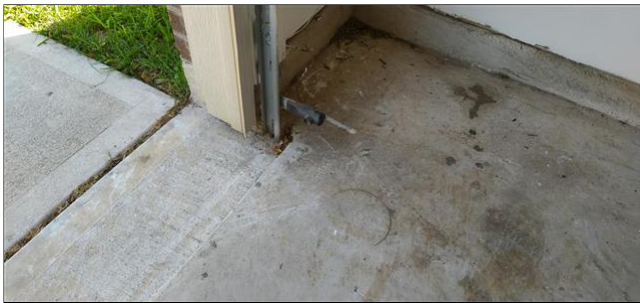
method of pressure test: hold door with hands while door was in closing motion. door automatically reversed back up.
