TPI HOME INSPECTION REPORT

3013 Wolfpack Loop
Bryan TX 77808

Mike Doyle
FEBRUARY 26, 2021

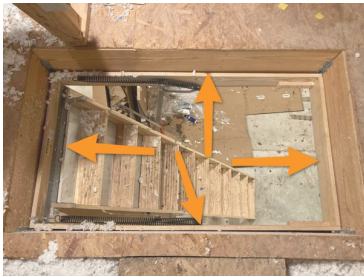
1: Improper fasteners used to install attic ladder

🔴 Deficiency

Screws or finishing nails have been used to secure the attic ladder in place. The manufacturer's instructions require 16 D nails are larger to secure the ladder.

Recommendation: Contact a handyman or DIY project

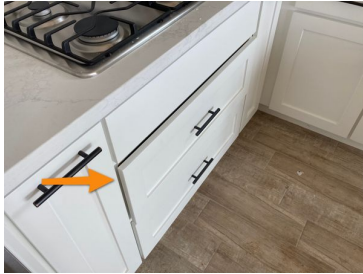
1: Drawer not closing properly

🟡 Deficiency

Kitchen below cooktop

Recommendation: Contact a qualified handyman.

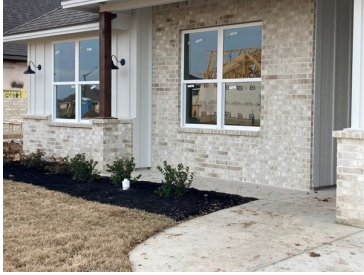
1: All window screens are missing

🟡 Deficiency

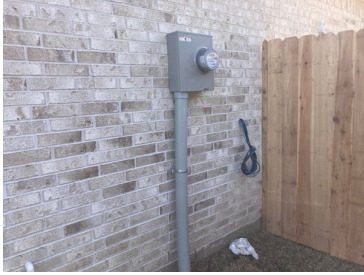
Main Panel: 200 amp, Located in garage

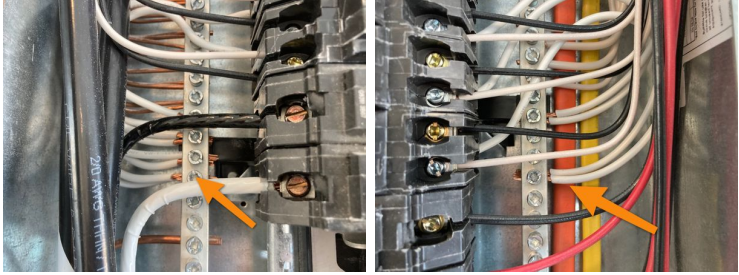
1: Multiple wires at neutral terminal in breaker panel

⊖ Deficiency

While installing neutral wires together is common practice, current building code requires each neutral wire to terminate on an individual terminal in the breaker panel. Multiple neutral wires under a single screw becomes a problem when it is necessary to isolate a circuit.

It is also unacceptable to have neutral and ground wires under the same screw since disconnecting the neutral would also disconnect the ground. The ground wire should always be solidly connected.

If inadequate terminals are present for each neutral to be singly connected then additional bus bars should be added to the panel.

Recommendation: Contact a qualified electrical contractor.

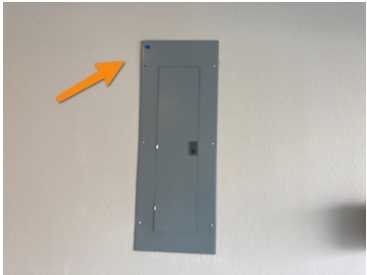
2: Missing screws at panel cover, missing knockout

➔ Deficiency

All designated fastening points should be used to secure breaker panel covers in place. Knockouts should be covered with filler plate to prevent unintended contact with components in panel.

Recommendation: Contact a qualified electrical contractor.

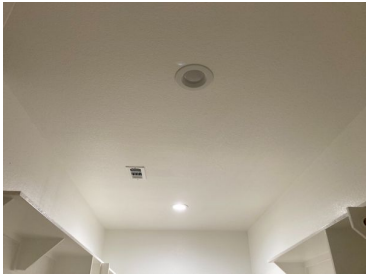
1: Light inoperable

➔ Deficiency

Master closet

One or more lights are not operating. New light bulb possibly needed.

Recommendation: Contact a qualified electrical contractor.

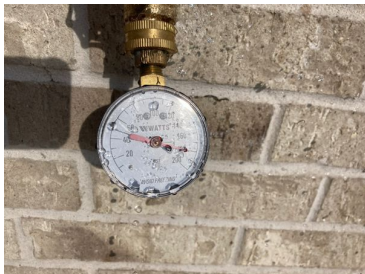
Location of Water Meter: Front Yard

Location of main water supply valve: Meter

Static water pressure reading: 40-50 psi

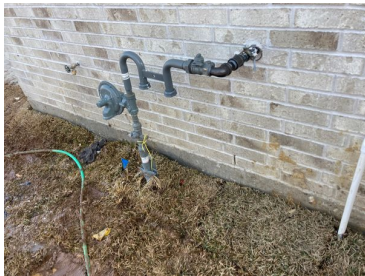
No Gas Supply:

The gas plumbing system was not functionally tested - no gas supply was available at the time of inspection.

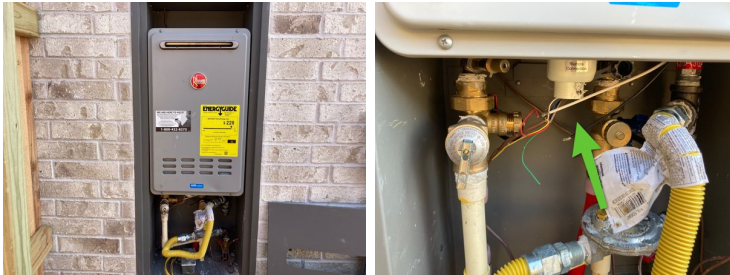
Observations: Installation incomplete -
Water heater electrical supply cord is not installed.

No Power - Not Tested:

Not functionally inspected - no electrical supply was available at the time of inspection.

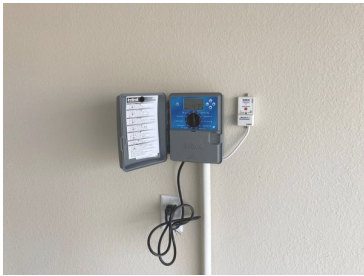
1: System inoperable

🟡 Deficiency

No response to control panel.

Recommendation: Contact a qualified landscaping contractor
