Property Inspection Report

Concerning: 123 S. Rocky Pt. Cir. Spring, Tx. 77389

By: Ruben Trevino T.R.E.C. PI #5053 10-01-19
(Name and License Number of Inspector) (Date)

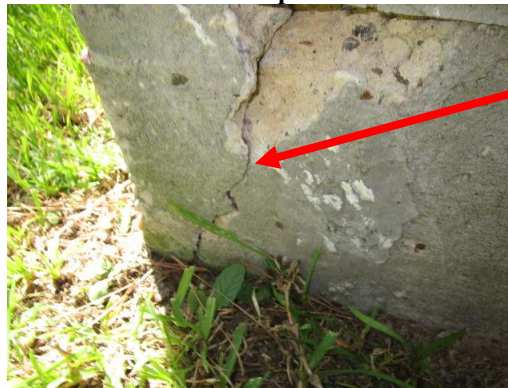
Note: Foundation has spalling (cracks) at one or more corners. Corner spalling is cosmetic; it has no effect on foundation performance. Spalling cracks allow of possible termite penetration to be undetected. Spalling crack can be sealed and or patched with a cement compound.

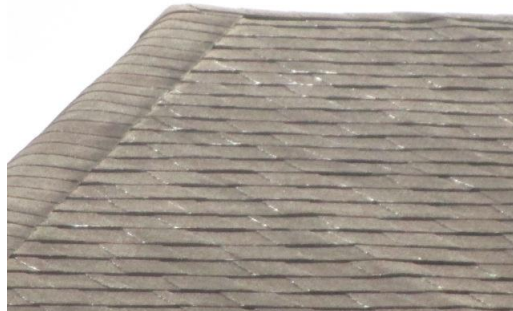
Note: Roof covering appears to be original (approx. 12 years old). Inspector observed premature wear along edges of shingles. Due to condition and wear of shingles, buyer should expect a limited life use. Total life expectancy of composition roof shingles is typically between 15 & 20 years.

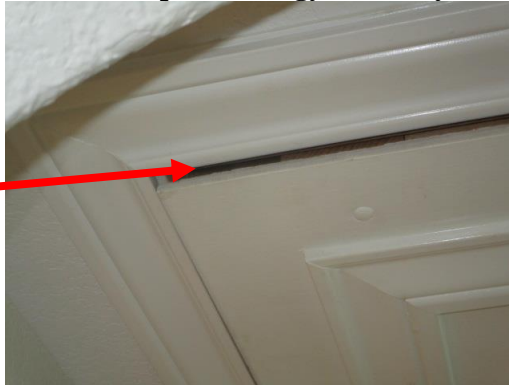
- **Recommend properly insulating attic access opening and installing weather stripping around door access to improve energy efficiency.**

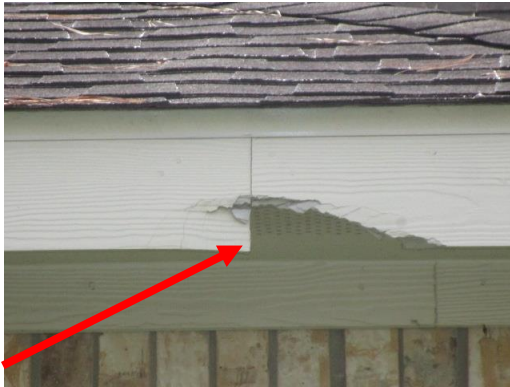
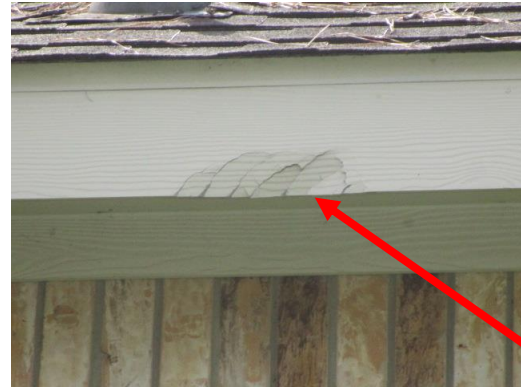
- **Fascia board at rear side of structure is damaged in one or more locations.**

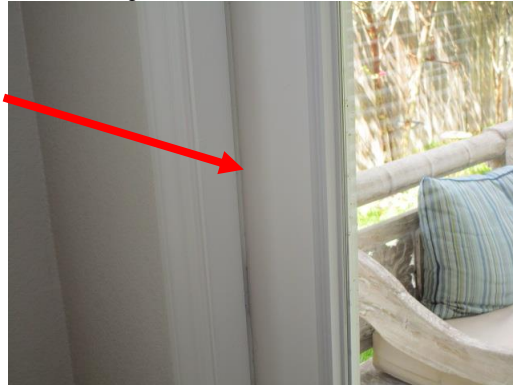
- **Automatic self-closing door between house and garage needs adjustment to operate correctly.**
- **Door sticks; hard to open or close; front door.**
- **Section of weather stripping to rear French door is missing. Gap observed along edge of door and door jam.**

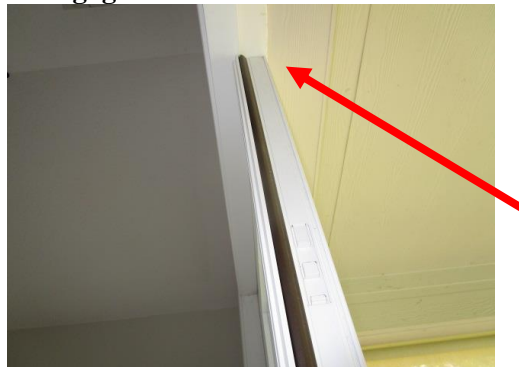
- **Top latch to French door is not properly align and or is stuck and does not function. Top latch is not engaged.**

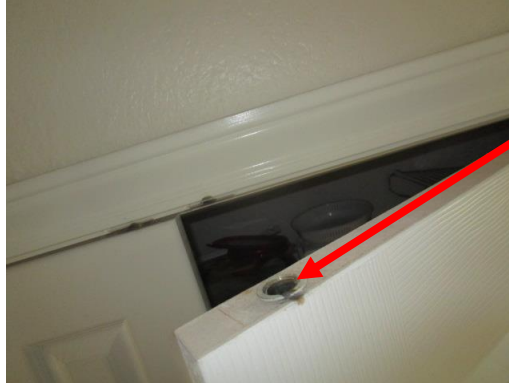
- **Top ball latch to pantry door is damaged/missing.**

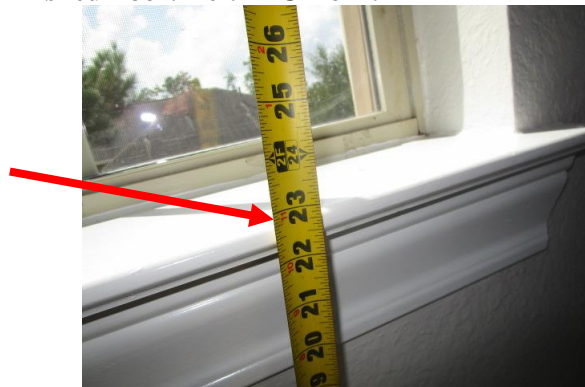
- **The window seal for the double pane window (2nd story left corner game room) appears to have a damaged vapor barrier. The window has moisture between the panes.**
- **2nd Story windows located more than 72 inches from the finished grade or surface below should be equipped with a locking device preventing window from allowing passage of a 4 inch diameter sphere where such openings are located within 24 inches of the finished floor. Ref: IRC R612.2**

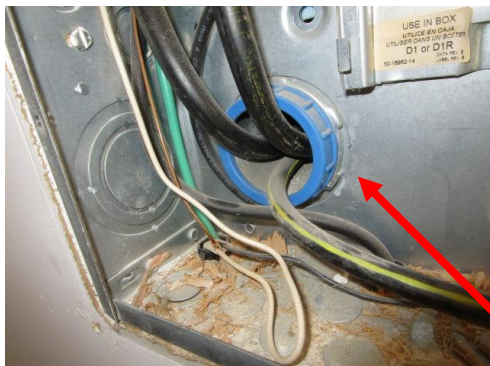
- **Bonding jumper at supply side was not present in the breaker panel. A conductor on the supply side of within a service or separately derived system to ensure the electrical conductivity between metal parts require to be electrically connected. Ref: NEC 5.250.2 (Typical for a house of this age).**

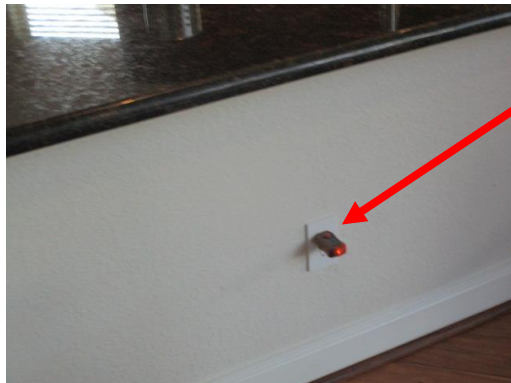
- **Outlet on pony wall serving counter/bar behind kitchen sink is not equipped with GFCI (Ground Fault Circuit Interrupter) protection. All outlets within 6 feet of sink and outlets serving kitchen counters required to be equipped with GFCI protection. Ref: IRC 3902.6 and 3902.7**

Recommend buyer consult with licensed electrician for proper repairs and corrections as required by current code.

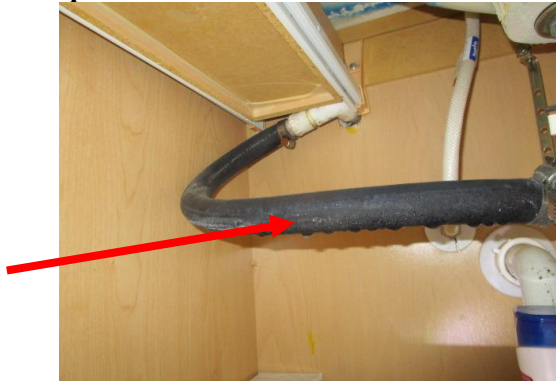
- **Temperature differential is higher than normal. (Note: Normal differential should be between 17-22 degrees). However, the differential measured at the time of the inspection can be affected by outside temperature, humidity and other factors). Excessive condensation observed dripping from drain line at P-trap under sink to 2nd story guest bathroom. Condensation is dripping onto base of cabinet. Recommend qualified/licensed HVAC technician service/repair as needed.**

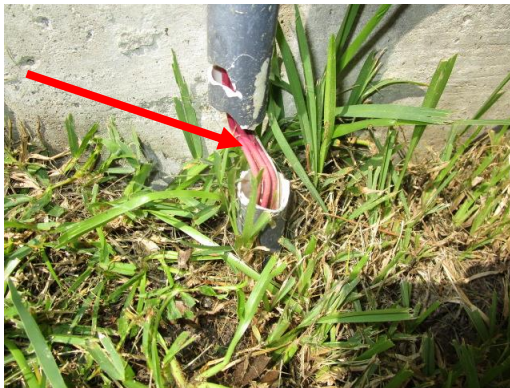
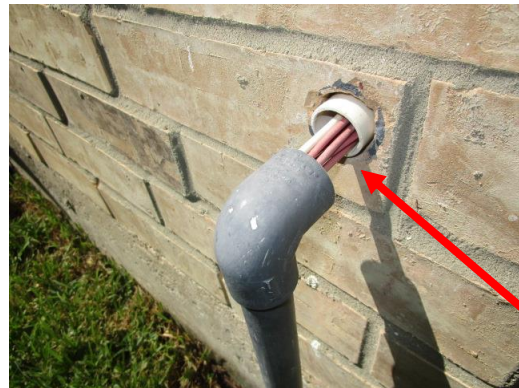
- **Conduit to electrical circuits is damaged and has pulled away from exterior wall. Recommend conduit be repaired to prevent damage from lawn equipment.**
