# TEXAS STANDARD HOME INSPECTIONS

7411 Simpson Springs Ln  
Spring, TX 77389

# PROPERTY INSPECTION REPORT FORM

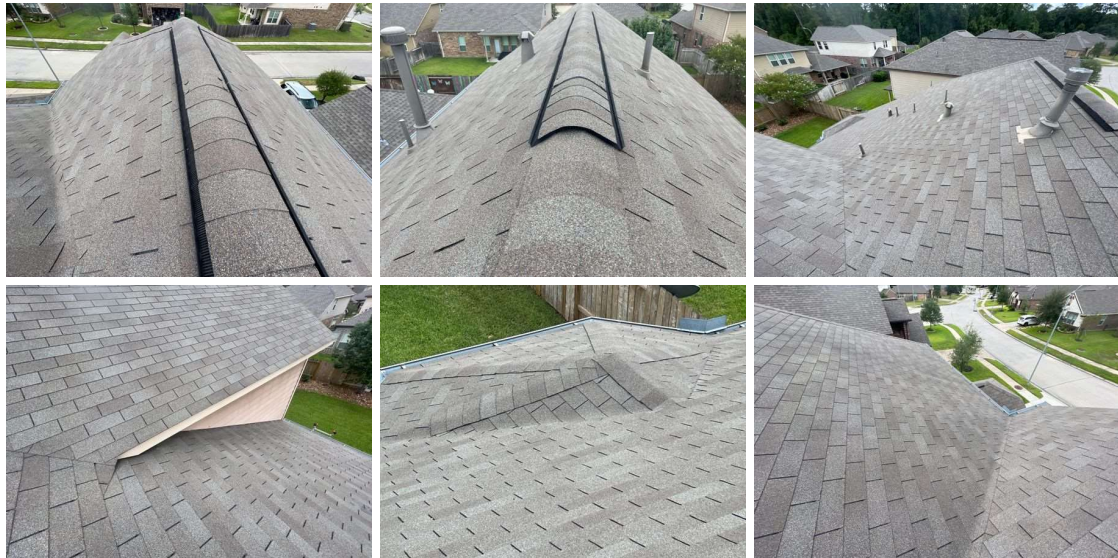
*General Roof Photos:*

Roof appeared to be aged approximately 8 years. Typical wear expected of aged roofs was observed at the time of inspection. Although these signs were observed, the roof covering appeared to be performing as intended at the time of inspection.

Please see other recommendations noted in this report for further detail and seek further evaluation by a qualified roofing professional if desired.

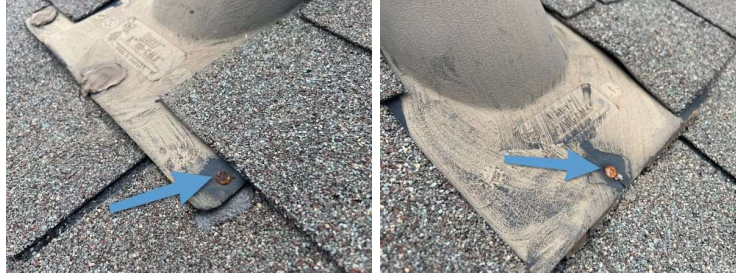
**1: Fasteners: Exposed**

Under-driven or exposed nails were found in one or more roof coverings. Nails should be driven flush and sealed. Recommend a qualified roofer evaluate and correct.

Recommendation: Contact a qualified roofing professional.

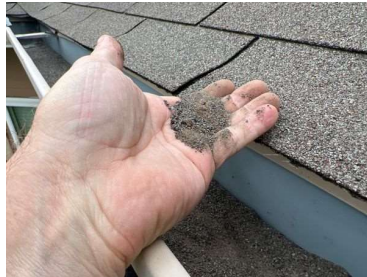
**2: Granule Loss - Minor**

Minor to moderate granule loss was noted in some areas. Common spots include ridges and valleys that see the most sunlight and/or moisture runoff.

This condition is typical for an aging roof and does not necessarily affect the performance of the roof covering at the time of inspection.

Recommend regular monitoring and inspection of this condition. Consult with a roofing contractor if you desire further evaluation of this condition.

Recommendation: Contact a qualified roofing professional.

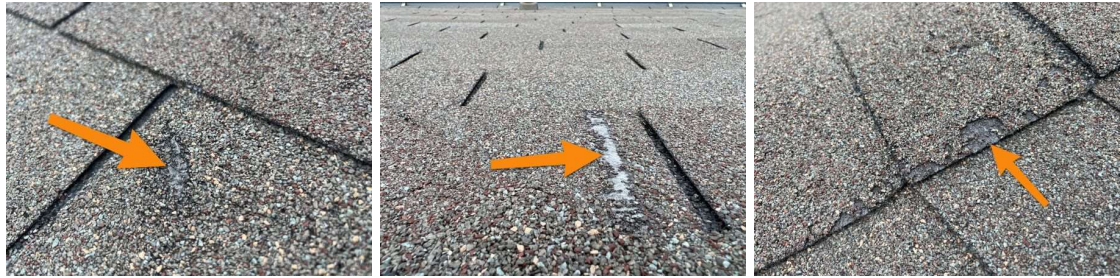
**3: Granule Loss - Mechanical Damage**

One or more areas were observed to be missing granules, possibly due to impact/ mechanical damage or manufacturer defect. This could lead to premature deterioration of the roof covering. Recommend correction.

Recommendation: Contact a qualified roofing professional.

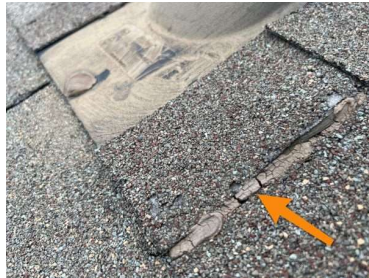
#### 4: Sealant: Improper Use

Sealant was observed to seal areas of the roof covering improperly. While sealant may be used to seal properly let flashings at mortar, it should not be used to seal shingles at ridges or valleys. This may be evident of improper repair practice. Recommend consulting with seller as to any known conditions and further evaluation/repair as needed.

Recommendation: Contact a qualified roofing professional.
