**8726 Sanders Rd  
Magnolia, TX 77354**

TEXAS OFFICIAL WOOD DESTROYING INSECT REPORT

1A. Superior Pest & Termite, LLC Name of Inspection Company 1B. 0684914 SPCB Business License Number

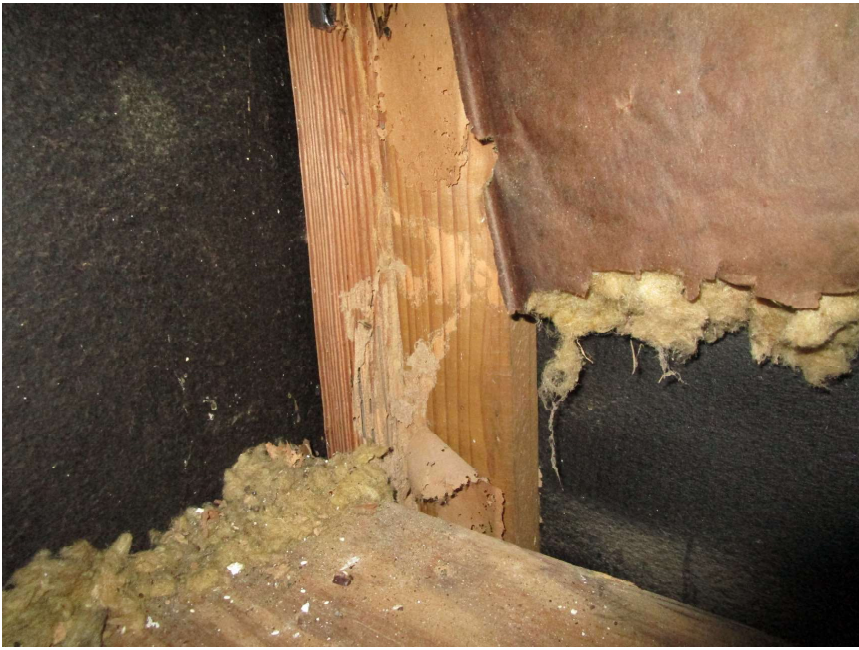
8. Inspection Reveals Visible Evidence in or on the structure:	Active Infestation	Previous Infestation	Previous Treatment
8A. Subterranean Termites	Yes <input type="checkbox"/> No <input checked="" type="checkbox"/>	Yes <input checked="" type="checkbox"/> No <input type="checkbox"/>	Yes <input checked="" type="checkbox"/> No <input type="checkbox"/>
8B. Drywood Termites	Yes <input type="checkbox"/> No <input checked="" type="checkbox"/>	Yes <input type="checkbox"/> No <input checked="" type="checkbox"/>	Yes <input type="checkbox"/> No <input checked="" type="checkbox"/>
8C. Formosan Termites	Yes <input type="checkbox"/> No <input checked="" type="checkbox"/>	Yes <input type="checkbox"/> No <input checked="" type="checkbox"/>	Yes <input type="checkbox"/> No <input checked="" type="checkbox"/>
8D. Carpenter Ants	Yes <input type="checkbox"/> No <input checked="" type="checkbox"/>	Yes <input type="checkbox"/> No <input checked="" type="checkbox"/>	Yes <input type="checkbox"/> No <input checked="" type="checkbox"/>

**Subterranean termite damage**

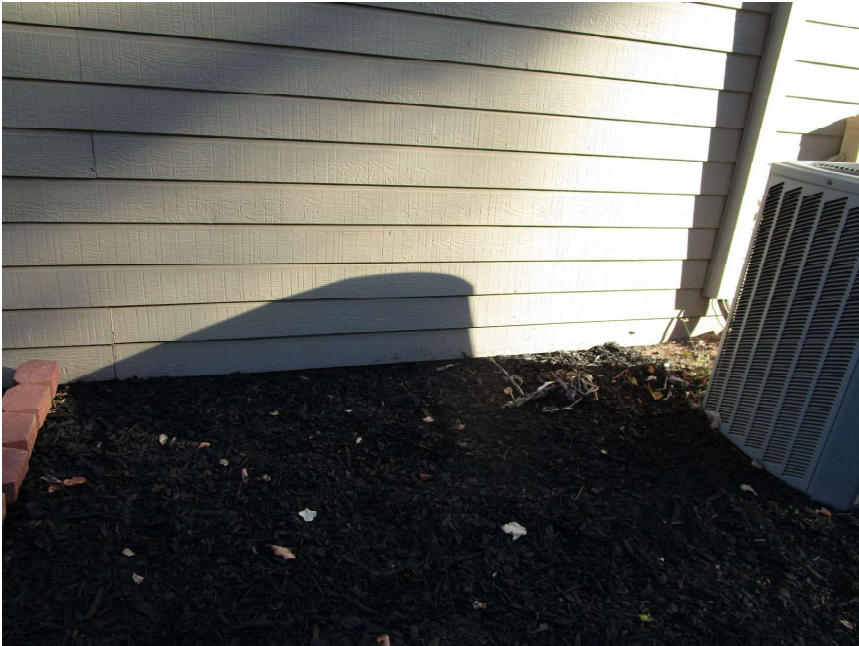
7B. Conducive Conditions include but are not limited to:  
 Debris under or around structure (K) [ ] Wood to Ground Contact (G) [ ] Formboards left in place (I) [x] Excessive Moisture (J) [x]  
 Planter box abutting structure (O) [ ] Footing too low or soil line too high (L) [x] Wood Rot (M) [ ] Heavy Foliage (N) [x]  
 Insufficient ventilation (T) [ ] Wood Pile in Contact with Structure (Q) [ ] Wooden Fence in Contact with the Structure (R) [ ]  
 Other (C) [ ] Specify: \_\_\_\_\_

**Soil line too high**

9B. A preventive treatment and/or correction of conducive conditions as identified in 7A & 7B is recommended as follows: Yes  No   
 Specify reason: recommend lowering soil line, eliminating any excessive moisture, and any wood rot in areas noted  
 Refer to Scope of Inspection Part J
