HOME INSPECTION & PEST CONTROL

**Stephen Hale**  
127 Canvasback Cove  
Livingston, TX 77351  
April 1, 2022

# PROPERTY INSPECTION REPORT FORM

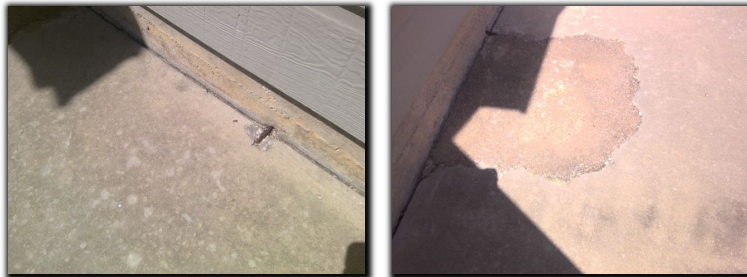
- **The foundation rebar is visible at the edge of the foundation beam and needs to be properly covered on the east side of the structure.**
- **Evidence of foundation adjustment (pier) at the east side of the structure.**

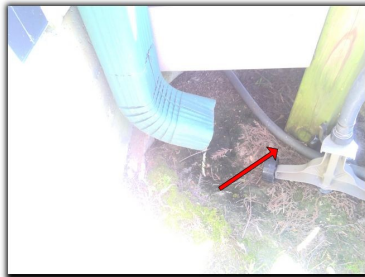
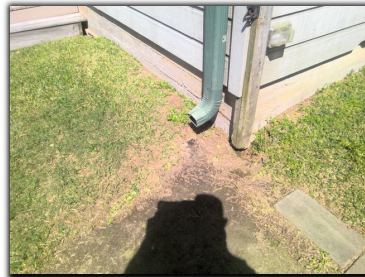
- **Note:** The gutter downspouts should discharge water at least thirty-six inches (36") away from the foundation perimeter beam. Storm water should be encouraged to flow away from the structure at the points of discharge.

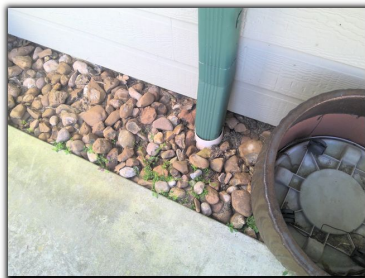
- **Buyers Notice:** There is an underground and/or surface drainage system in place. The inspector cannot and will not be able to verify the operation, sizing, efficiency or adequacy of the underground and/or surface drainage system. If there are any questions or concerns with this system or the effectiveness of the system, you should consult with the current homeowner or the appropriate specialist related to this type of system.

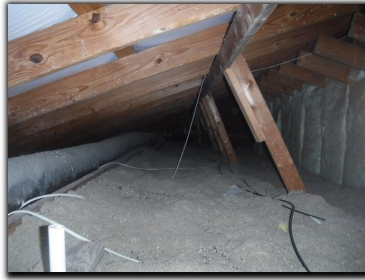
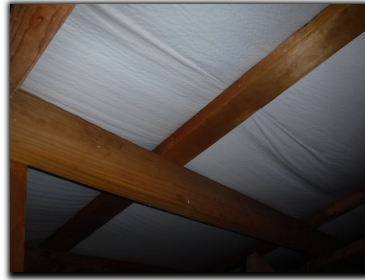
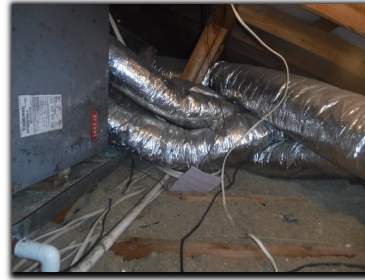
- There is no walkway installed in the attic space. There should be a walkway at least 24 inches wide in the attic to make the space available for inspection and maintenance.

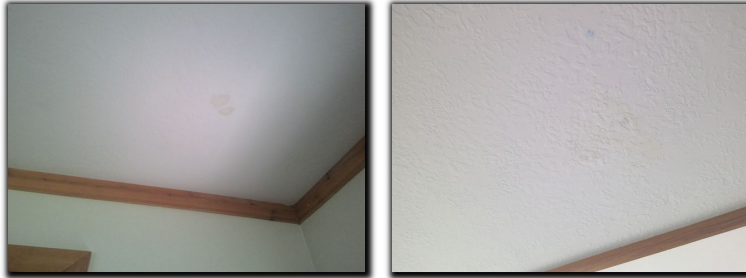
- **Small stains on the kitchen ceiling. Moisture detector did not reveal moisture**

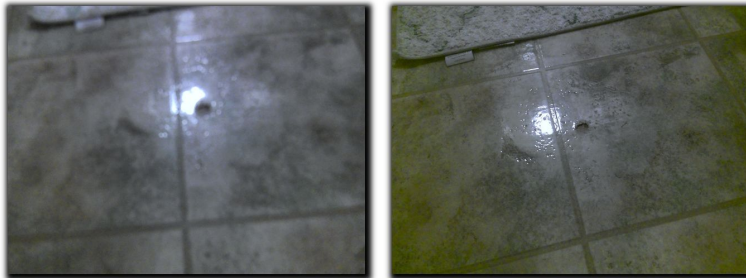
- **Small hole in a bathroom linoleum floor.**

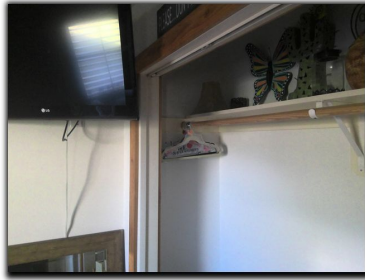
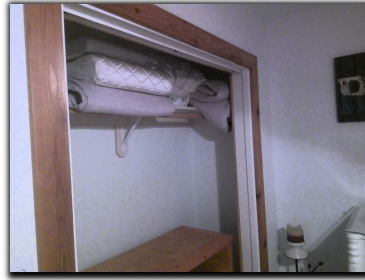
- **Folding closet doors are missing.**

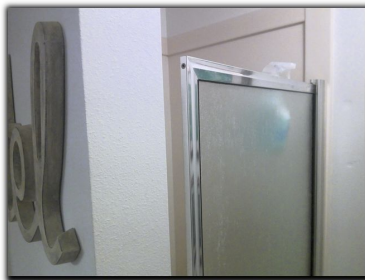
I did observe visible evidence that I would consider as being indications of movement and settlement. The areas observed to have minor visual indications of movement was one of the shower doors.

- **One shower door does not close easily. It appears that the shower door is no longer square with the door frame. Possible result of structural shifting**

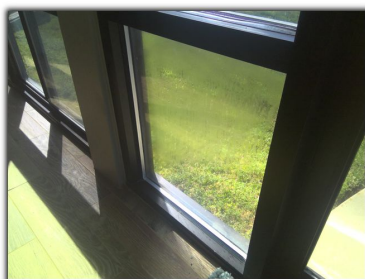
- **Windows with broken seals were noted in but may not be limited to the enclosed patio** . (the specific locations are not given because a window seal could be broken and not noticed for some time ) this allows

moisture inside between the panes of glass. This causes fogging to take place, which will eventually cause staining to the point of zero visibility.

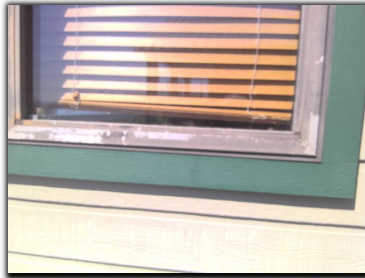
- **Window needs refinishing (painting.)**

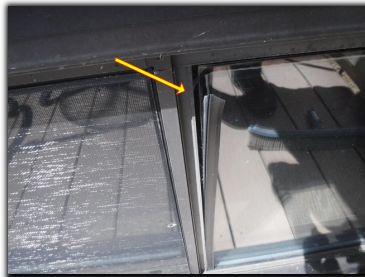
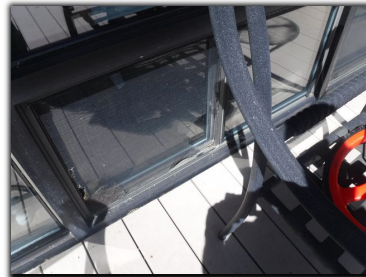
- **Window glazing has deteriorated on a closed patio window.**

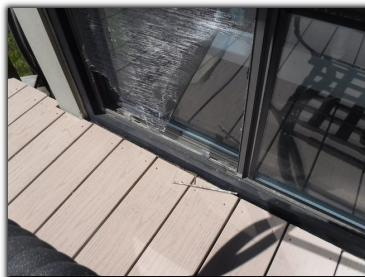
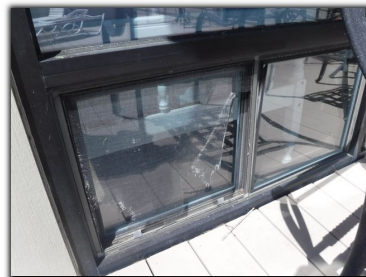
- **Damaged screens on the closed patio.**

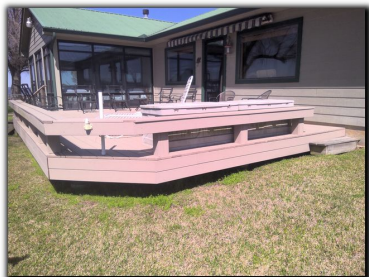
- Too close to the ground to crawl.

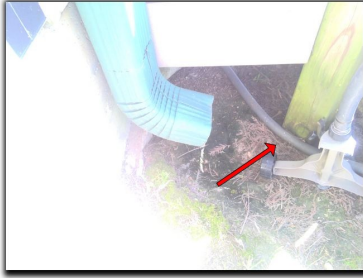
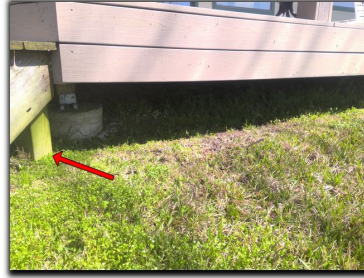
- **Wood-to-ground contact should be avoided when possible. This is a condition conducive to the infestation of wood destroying insects.**

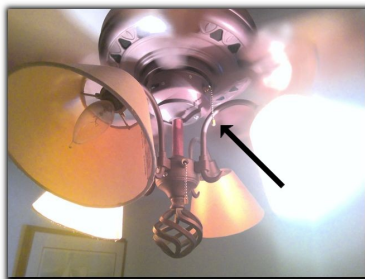
- The fan pull string switch is short in various locations throughout the house.

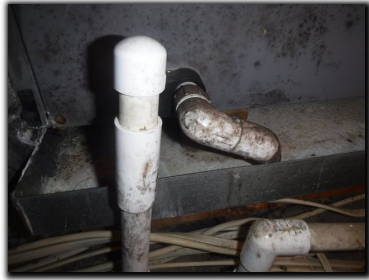
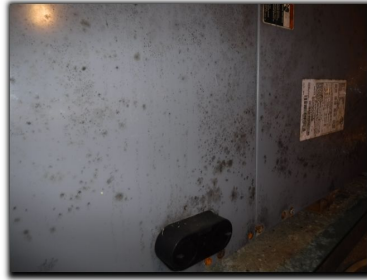
- There was an unknown dark mold like substance observed in the attic area. Evaluation of this substance is beyond the scope of this inspection. If any concerns exist on the type and/or nature of this substance, we recommend further evaluation by a professional in the Air Quality sampling field.

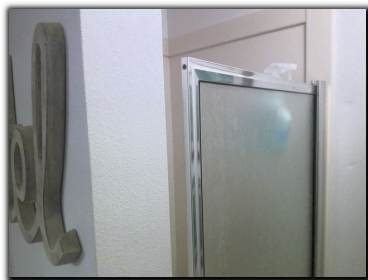
- **Shower door doesn't close easily. The door frame has shifted off square.**

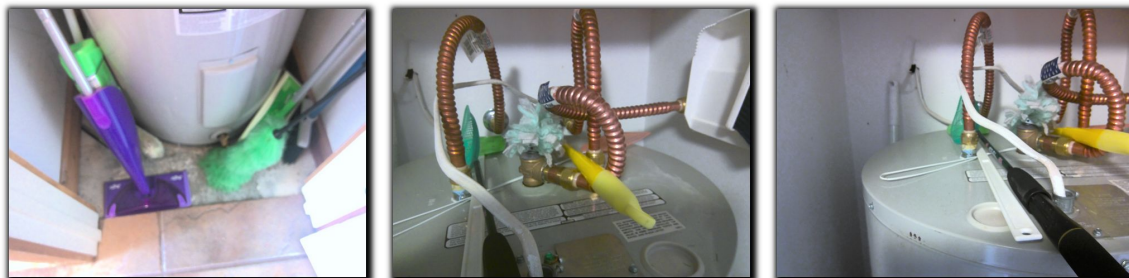
- There is no electrical disconnect located at the water heater.
- There is no pan installed under the water heater.
- The temperature and pressure relief (TPR) valve discharge pipe is running in an upwards direction in one or more locations. The TPR discharge pipe should run gravitationally downwards at all points.
