BPG Inspection, LLC

**18 Grand Bayou Place
The Woodlands TX 77382**

Client(s): Alvarado
Inspection Date: 3/10/2023
Inspector: Silviu Stanescu , TREC #24311 (TX)

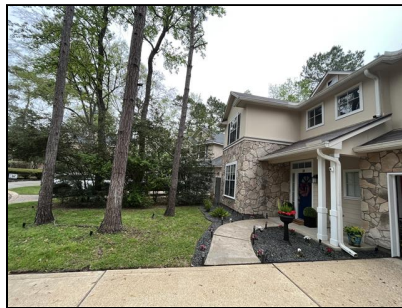
The foundation appeared to provide adequate support for the structure at time of inspection. There was no readily apparent evidence that would indicate adverse performance or significant deficiencies. No significant unlevelled conditions were observed when walking on the ground floor.

It is recommended that trees be placed no closer than 15ft from foundation structures. All tree roots that are growing beneath the slab should be severed to prevent foundation damage. (Root damming in this area will prevent future grow beneath the slab). Consult with an arborist if tree health is a concern.

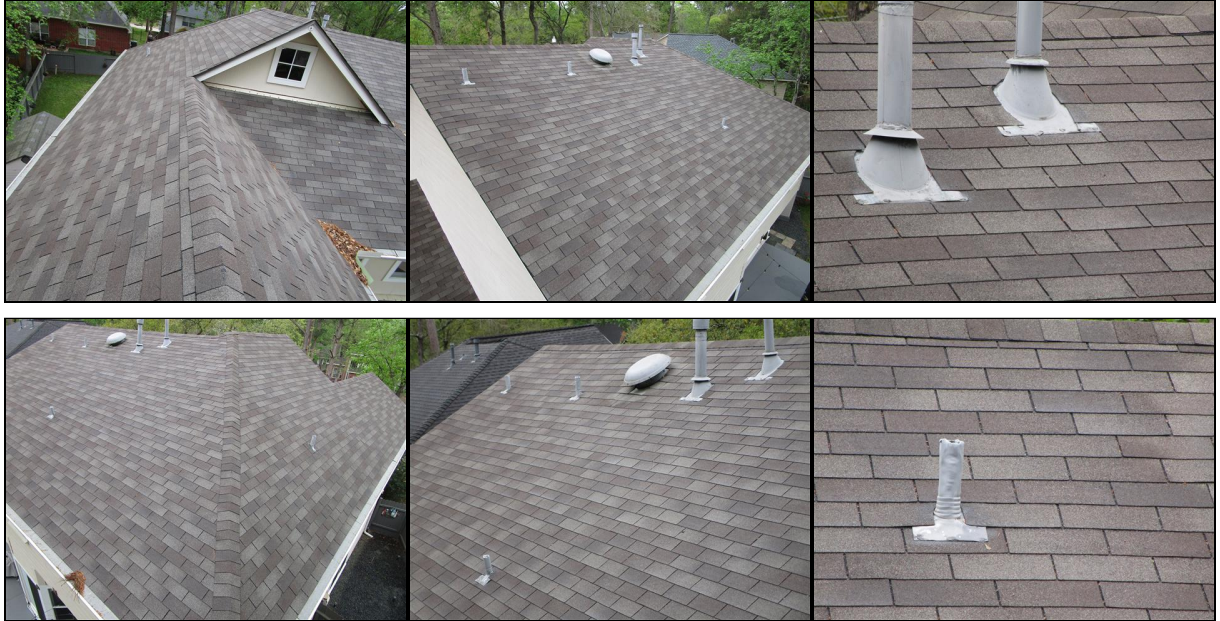
The roof covering appeared in good condition. No leaks were active at time of inspection. Shingles appeared to be properly fastened.

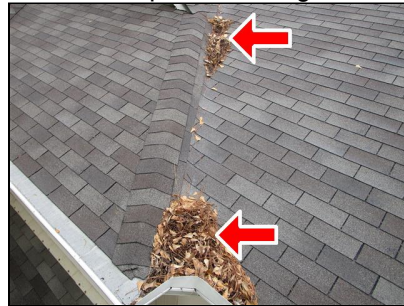
Remove all debris from roof slopes and valleys. Leaf debris may hide possible defects and damage to roofing materials. Debris may also cause water to dam up under shingle tabs.

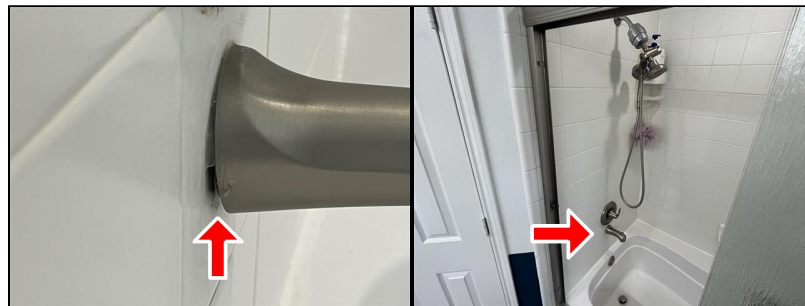
The guest bathtub fill spout needs to be re-sealed (caulked) to prevent moisture seepage into tub surround.

- 1. The guest bathtub fill spout needs to be re-sealed (caulked) to prevent moisture seepage into tub surround.

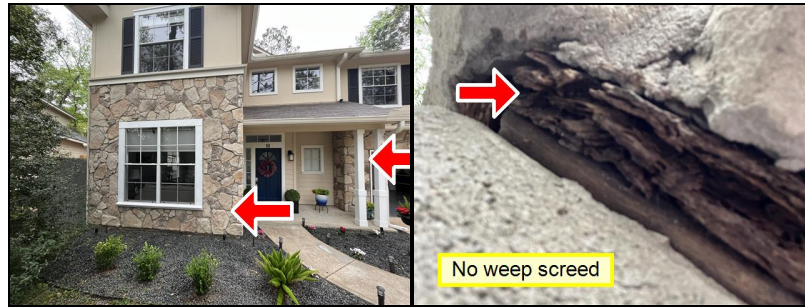
There was no weep screed installed at the bottom of the stone veneer as per current standards. These were not required at the time of construction and I did not observe any deterioration of the wall covering at time of

inspection. Monitor the area and if any concern arises, I recommend consulting a qualified contractor for corrective action.

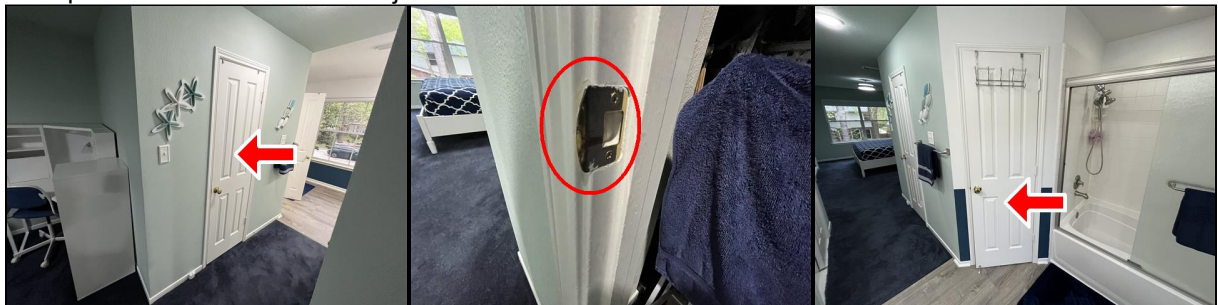
Doors do not close/latch properly into strike plate at the master bedroom closet and master toilet room. Have a qualified contractor make adjustments.

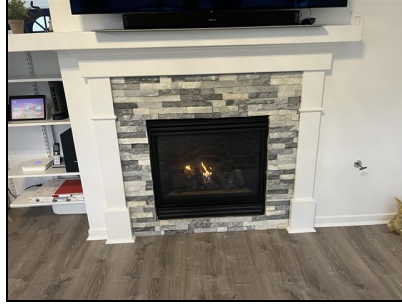
No deficiencies were observed at the time of inspection.

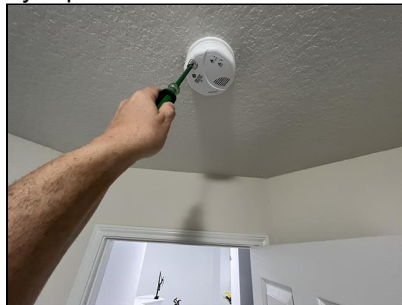
Smoke alarms: not all units functioning (guest bedroom). May be dead batteries, or need replacing. Have a qualified contractor make the necessary repairs.

- 3. Smoke alarms: not all units functioning (guest bedroom). May be dead batteries, or need replacing. Have a qualified contractor make the necessary repairs.

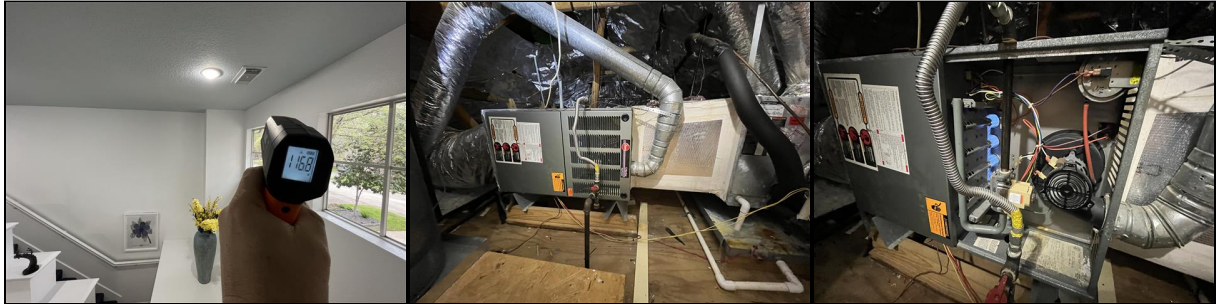
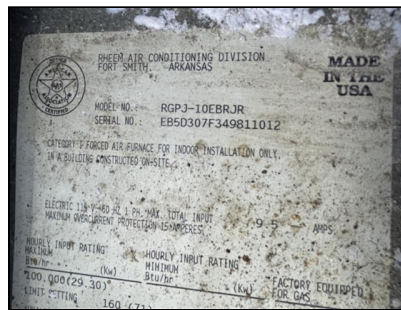
The unit functioned at the time of inspection. Proper heating operation is determined by a minimum of 100 degrees being supplied from all home supply grills.

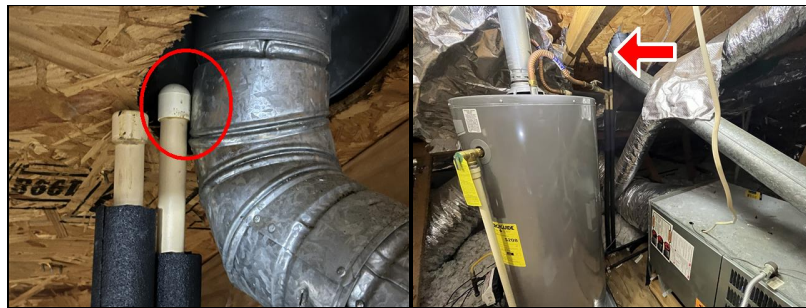
☒ CPVC venting pipe for the water heater is in contact with the exhaust flue for the furnace unit. I recommend trimming the CVPC pipe to avoid contact with hot metal flue.

- 4. CPVC venting pipe for the water heater is in contact with the exhaust flue for the furnace unit. I recommend trimming the CVPC pipe to avoid contact with hot metal flue.

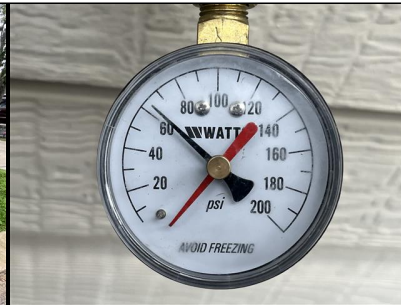
Static Water Pressure

Fixtures functional. Flow/Volume acceptable. The toilets flushed properly. Water pressure into home from city 62 PSI. Recommended maximum satisfactory pressure: 80 PSI. Meter visually inspected with no leaks or bypass concerns noted.

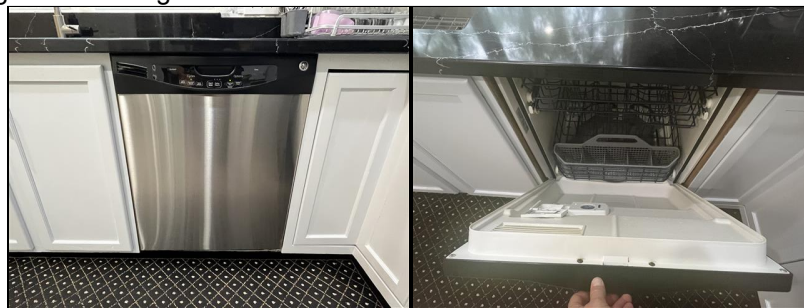
Comments:
 Unit motor is seized, and did not function. Repair as needed.

- 6. Unit motor is seized, and did not function. Repair as needed.

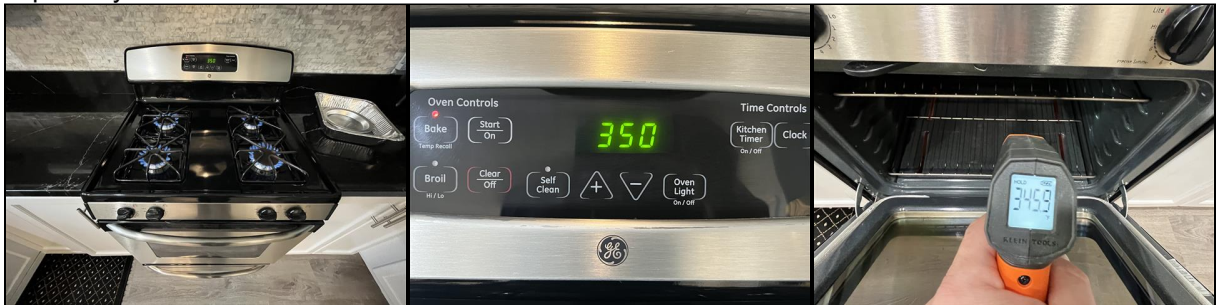
Damaged seal observed on oven door. Recommend replacement.

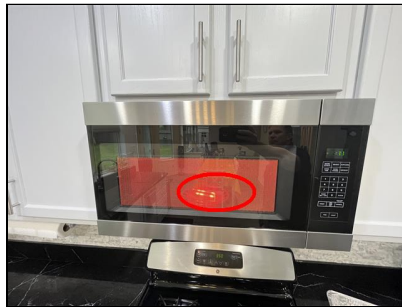
Tester Light on = OK
