SUMMARY
11120 FM 1484 Rd, Conroe, TX 77303
Linda Jemison
04/28/2023

Weston Brown
TREC# 24165/InterNachi© CPI
iHeart INSPECTIONS®
281-799-7542
iheartinspections@gmail.com

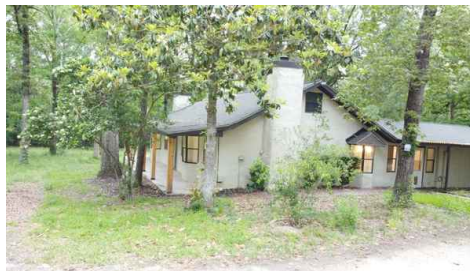
2.1.1 A. Foundations

POTENTIAL FOUNDATION DAMAGE (TREES)

- Roots from a tree located near the foundation may cause foundation damage as the tree grows and the root system expands. Monitor this area of the foundation during the growing season (usually May through September) for signs of damage. If signs of damage appear (such as cracks) the tree may need to be removed. The potential for damage from tree roots varies with tree species.

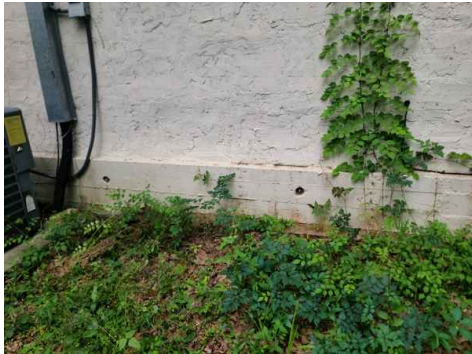
Left Exterior

POST-TENSIONED CABLES EXPOSED

- One or more exposed post-tensioned cables were observed at the time of inspection. Exposed cables are subject to water exposure which can cause the cables to rust and potentially snap. **As such, these exposed cable ends should be cleaned and patched with non-shrink concrete to prevent damage.**

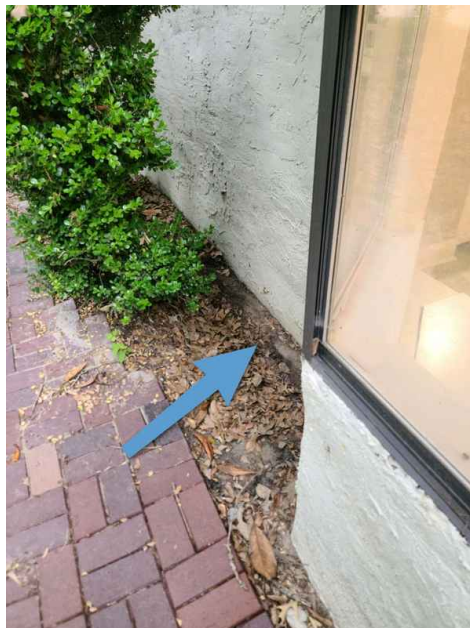
Front Right Exterior

2.2.3 B. Grading and Drainage
POOR FOUNDATION CLEARANCE (GRADE)

- The top of the foundation wall had inadequate clearance from grade. The top of the foundation wall should be a minimum of six inches above the soil. Inadequate clearance may result in moisture intrusion of the structure. Excessively high moisture levels can result in damage to the home structure or materials from decay or deterioration and may result in conditions that encourage the growth of microbes such as mold fungi. **The Inspector recommends re-grading around the home perimeter to provide increased clearance from grade.**

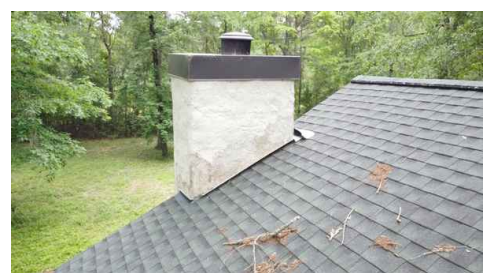
2.3.1 C. Roof Covering Materials
DEBRIS ON ROOF SURFACE

- Observed debris on the roof surface. **Recommend removal.**

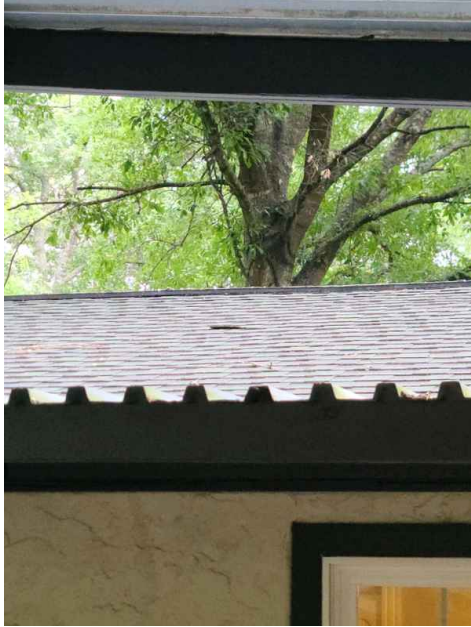
Right Exterior

LIFTED SHINGLES

- One or more shingles are bowing outward and are not flush with the roof surface. This may lead to water intrusion through this shingle. **The Inspector recommends a licensed roofing contractor to evaluate and repair.**

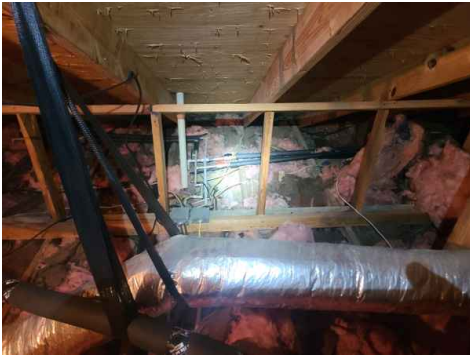
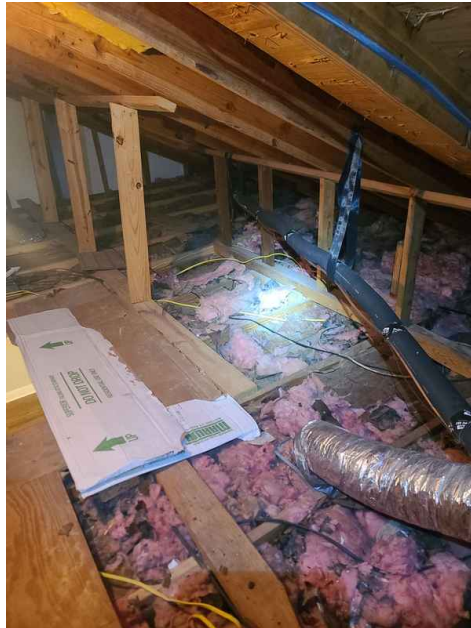
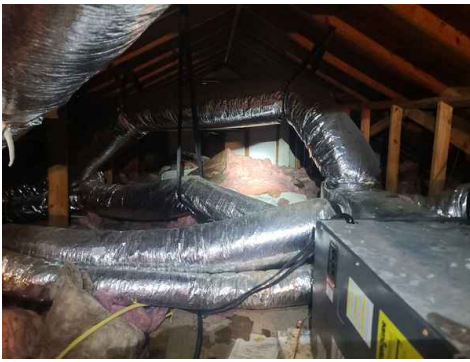
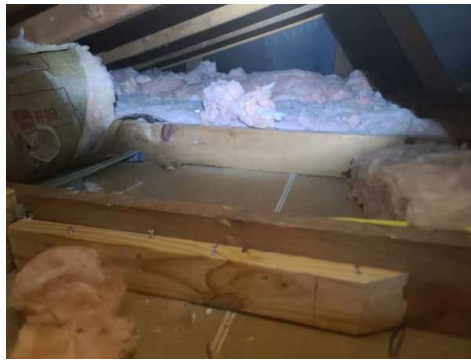
INADEQUATE INSULATION LEVELS (INSULATION)

- Thermal insulation installed to limit heat gain and loss in the living space did not appear to meet widely-accepted modern standards. To reduce energy consumption and heating/cooling costs, the inspector recommends that additional thermal insulation be added to meet modern standards. **A qualified insulation contractor should be able to advise you capably.**

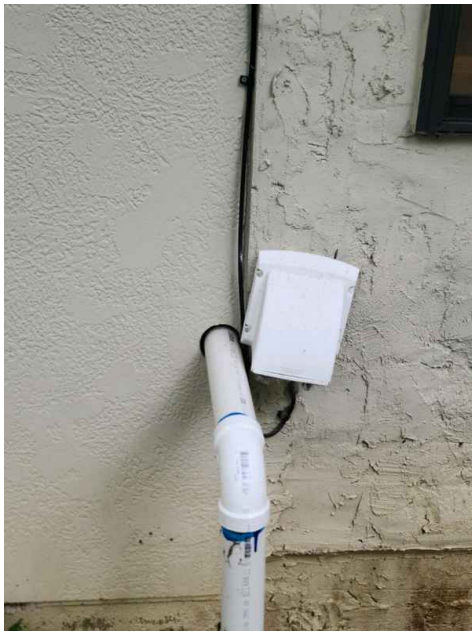
Left Exterior

SEALANT AT EXTERIOR PENETRATIONS

- All exterior penetration into the exterior veneer should have sealant installed. This condition could lead to moisture intrusion. **The Inspector recommends a licensed contractor to repair the openings.**

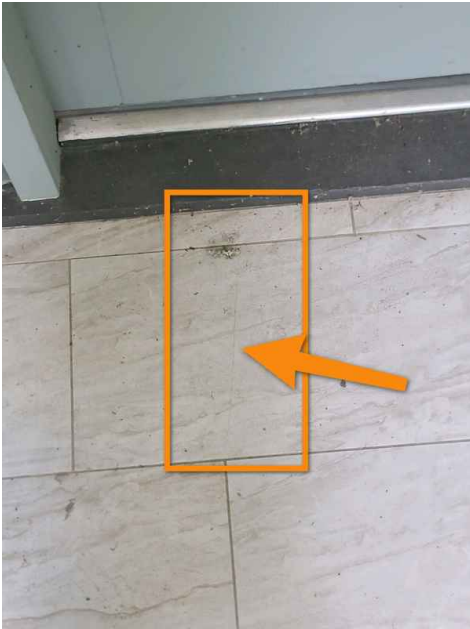
Front Porch

CRACKED TILE

- One or more tiles are cracked at the time of inspection.

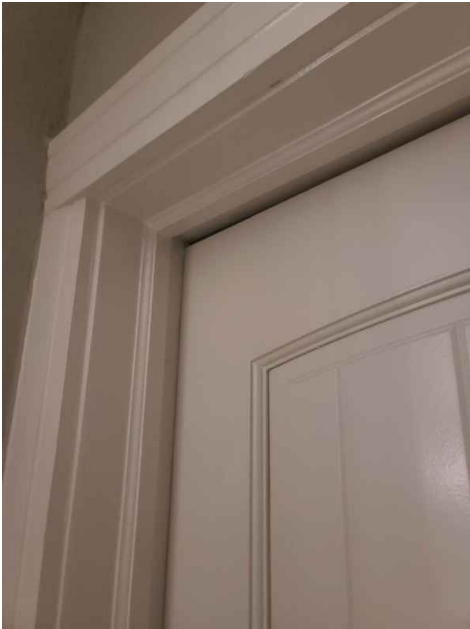
Laundry Room

DOOR STICKS

- The door sticks and is tough to open. **Recommend sanding down offending sides.**

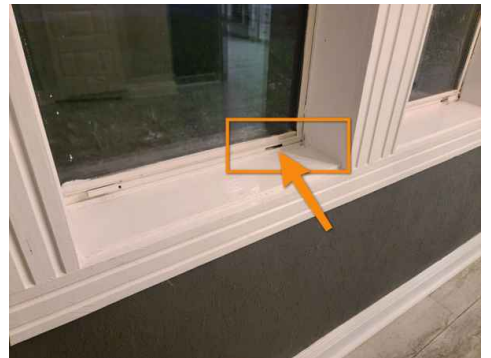
DAMAGED

- One or more windows have general damage.

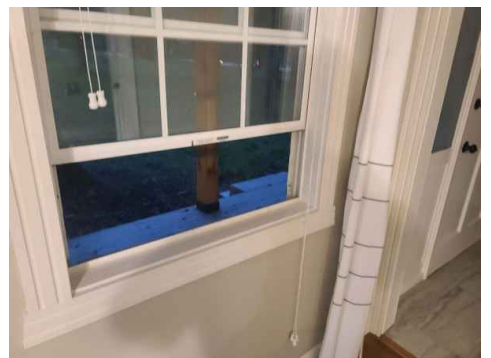
Front Living Room

MISSING SCREEN(S)

- One or more windows are missing a screen. **Recommend replacement.**

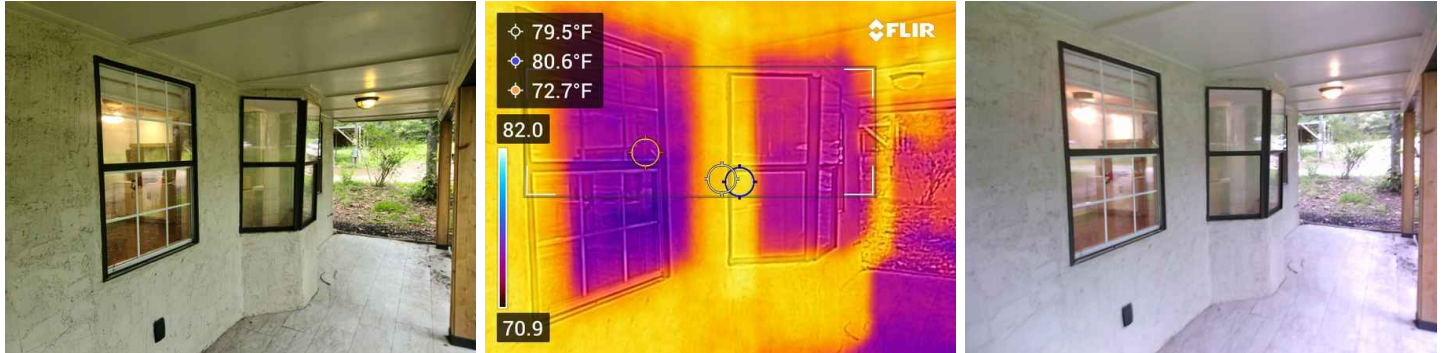
2.8.4 H. Windows
OLD WINDOWS

- The windows appear to be original and are passed their useful time. **The Inspector recommends considering changing out the window for a more energy efficient home.**

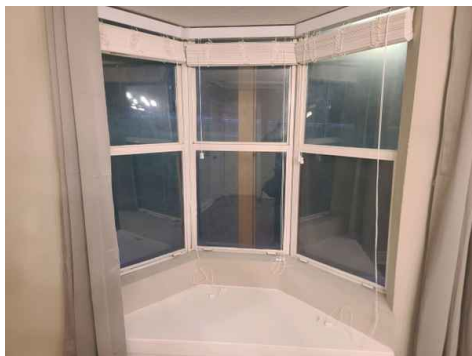
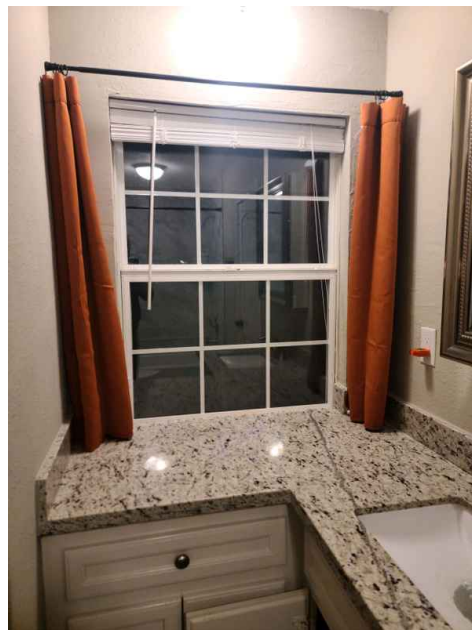
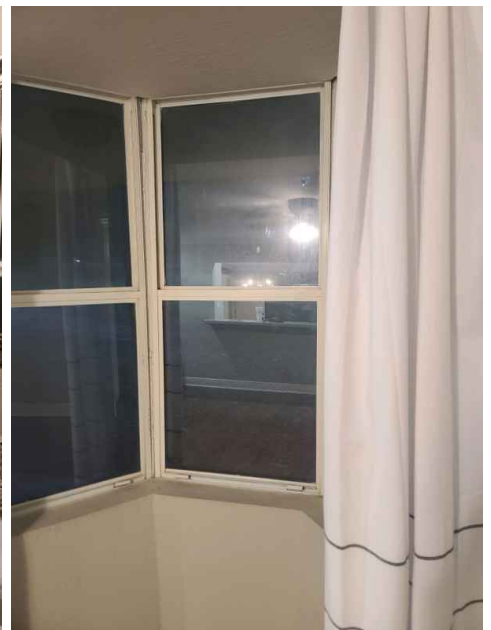
Front Primary Bedroom

2.8.5 H. Windows
WINDOW DIFFICULT TO OPEN

- Many windows were difficult to open. **The Inspector recommends a licensed window repair company to evaluate the issue or replace the aging window.**

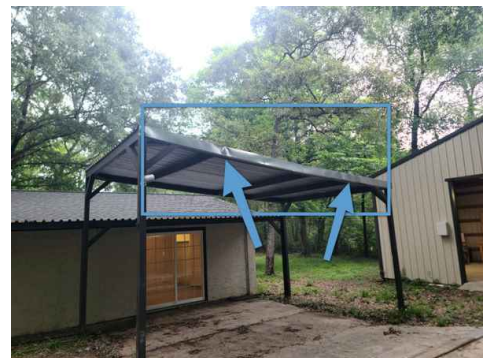
2.11.1 K. Porches, Balconies,
Decks, and Carports**DAMAGED CARPORT**

- General damage to the carport was observed at the time of inspection.

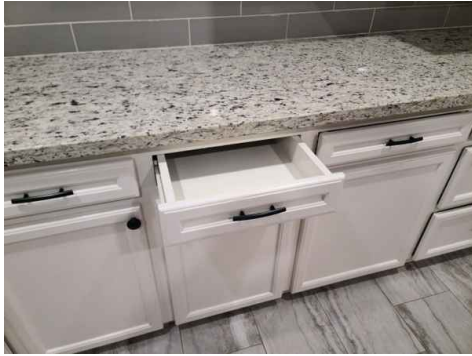
Kitchen

DRAWER STICKS

- One or more drawers are sticking when operated.

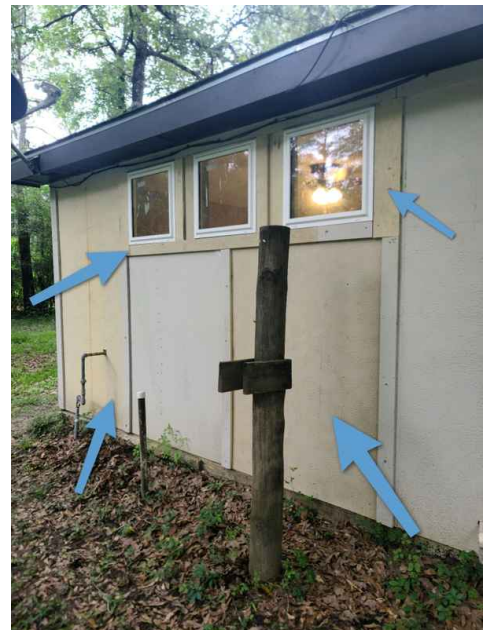
Left Rear Exterior

PAINT EXTERIOR VENEER

- Finish painting the exterior veneer in one or more locations.

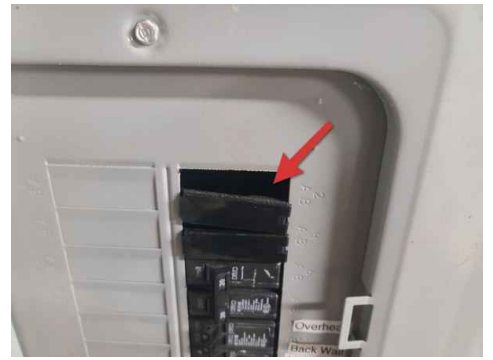
Garage

UNFILLED OPENINGS

- Unfilled holes or knockouts in the electrical service panel may allow persons to come into contact with energized electrical components, may allow insect or rodent entry, or may allow moisture intrusion that can cause corrosion of interior components that can degrade electrical connections. **This condition is a potential fire/shock/electrocution hazard and should be corrected by a qualified electrical contractor.**

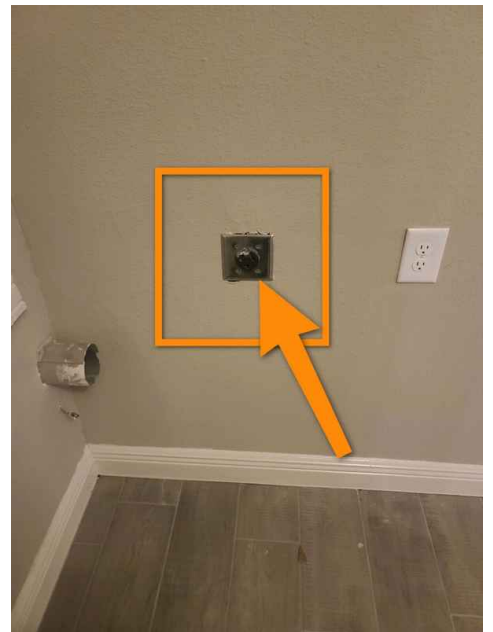
Laundry Room

INOPERABLE RECEPTACLES

- An electrical receptacle was inoperable at the time of the inspection. **The Inspector recommends service by a qualified electrical contractor.**

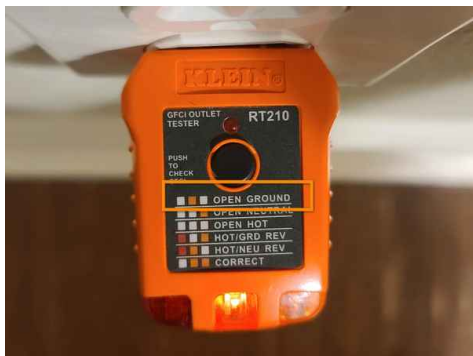
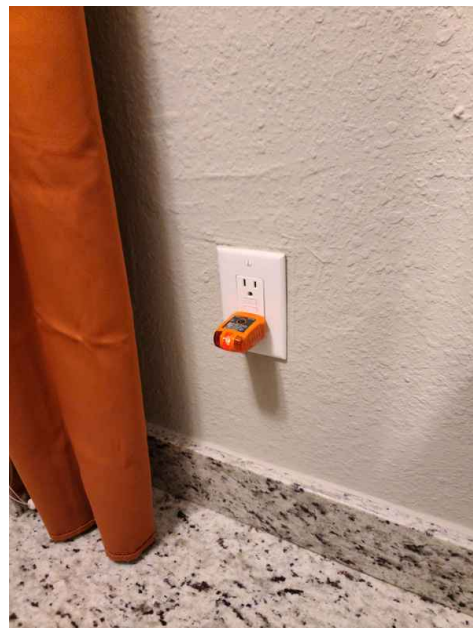
Rear Primary Bedroom

OPEN GROUND - RECEPTACLES (INTERIOR)

- An electrical receptacle had an open ground. Other receptacles in the home were grounded. **This receptacle should have a functional equipment grounding conductor installed by qualified electrical contractor.**

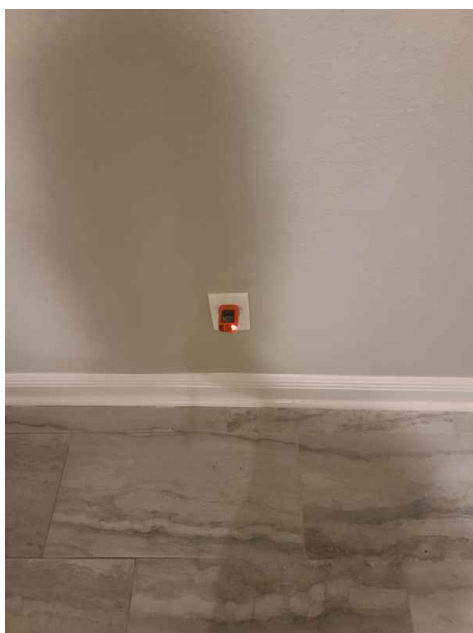
Front Right Bedroom

3.2.5 B. Branch Circuits, Connected Devices, and Fixtures
OPEN NEUTRAL RECEPTACLES (INTERIOR)

- An electrical receptacle had an open neutral which should be corrected by a qualified electrical contractor.

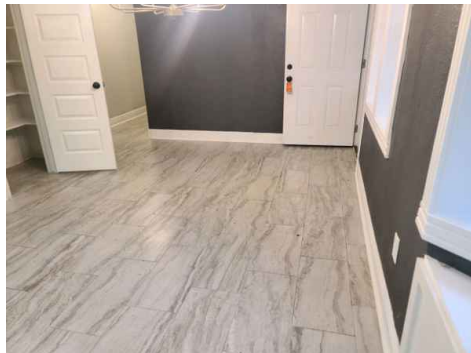
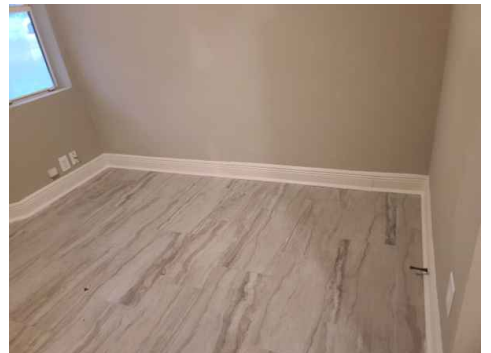
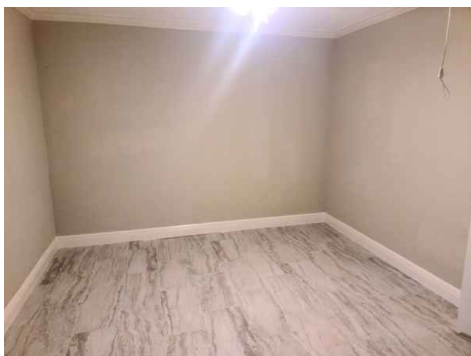
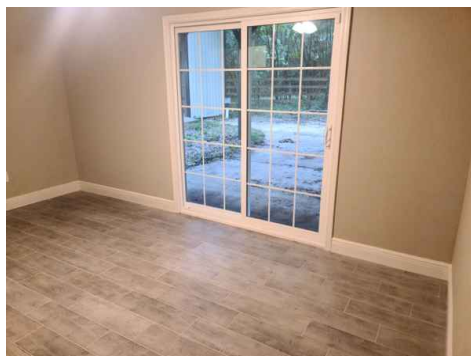
NEED MORE RECEPTACLES

- In general living areas, there should be an outlet on the wall every 6 feet (horizontally). Living areas refer to all large areas in your home, including the bedrooms, study, dining room, and hallways. Hallways over 10 feet long require at least one outlet. Walls less than 2 feet long do not require an outlet. **Discuss additional receptacles with a licensed electrician.**

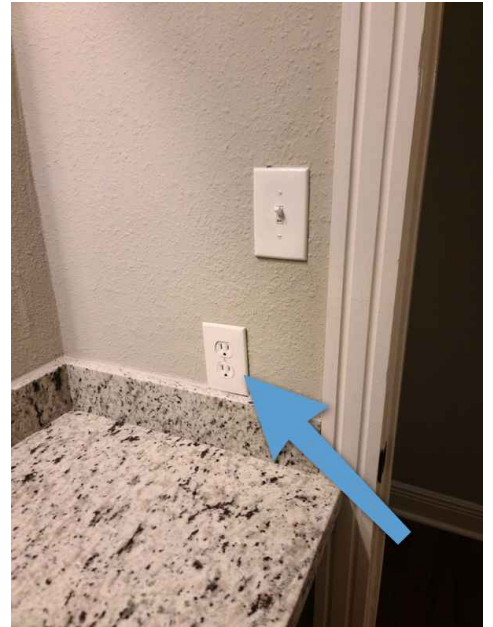
Front Hall Bathroom

RECEPTACLE PLATE LOOSE

- One or more receptacle plates are loose at the time of inspection.

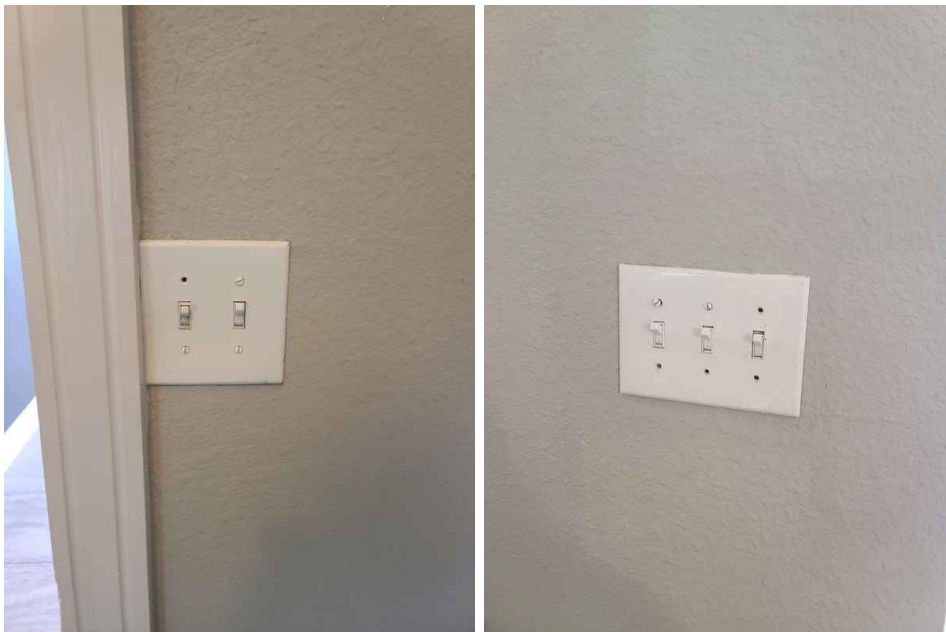
SWITCH SCREWS MISSING

- One or more switch screws are missing in the plate. **Replace screws.**

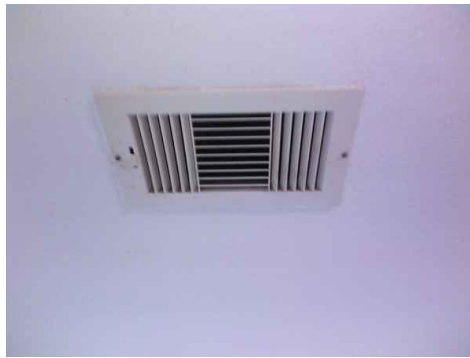
LOW SUPPLY TEMP

- A lower-than-normal temperature was recorded from the supply registers while the furnace was operating. **Recommend a licensed HVAC professional be contacted to evaluate the system.**

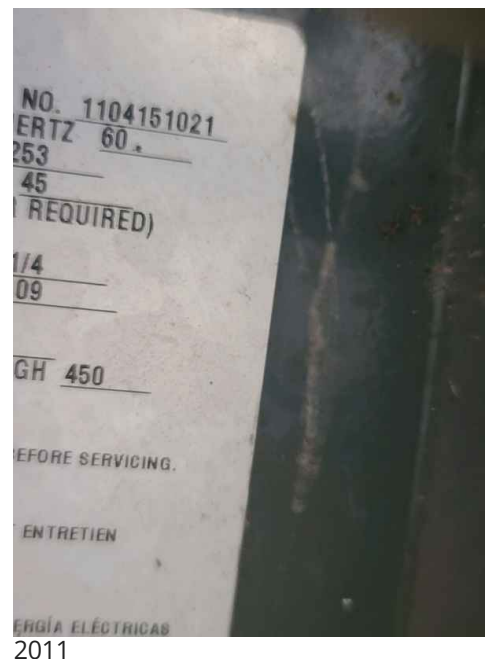
4.2.1 B. Cooling Equipment
AGING A/C

- The A/C is approximately 12 years old. Most condensers or air handlers need replacement between 15-20 years. **Although no obvious deficiencies with the furnace were observed at the time of inspection, the Inspector recommends the client budget in the case of furnace failure.**

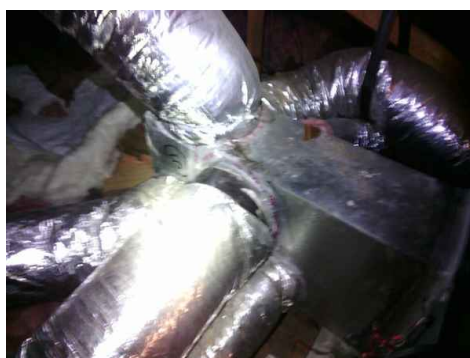
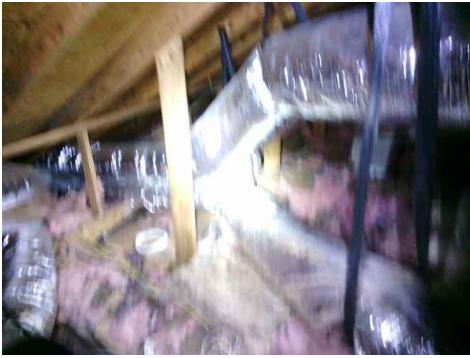
4.3.1 C. Duct Systems, Chases, and Vents
DUCT LEAKING

- The air supply duct was leaking air. **Recommend a qualified HVAC technician or vents & ducts contractor repair.**

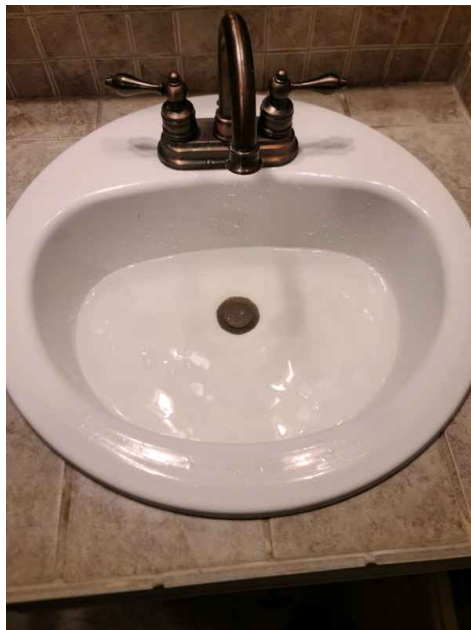
Rear Left Bathroom

5.1.1 A. Plumbing Supply, Distribution Systems, and Fixtures
DISCOLORED HOT WATER

- Discolored hot water visible at the time of the inspection is seldom caused by tank failure, but may be caused by several non-toxic, iron-reducing bacteria; Crenothrix, Leptothrix, and Gallionella. Bacterial action can lead to early failure of anode rods. Well water, water softeners, and dormant water heaters are conditions that encourage bacterial proliferation. Treatment is possible. **The Inspector recommends service by a qualified water treatment specialist.**

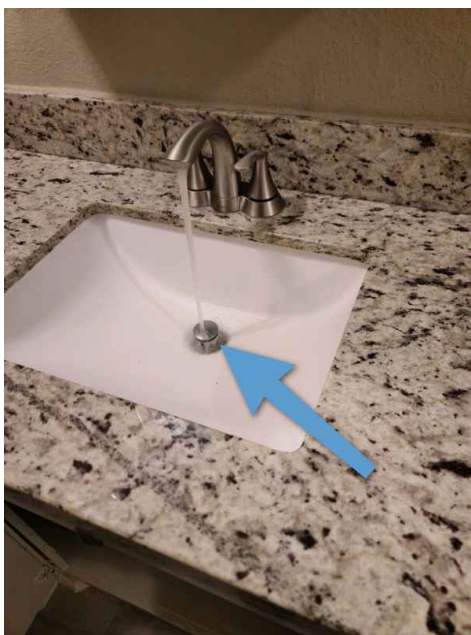
Primary Bathroom

5.1.3 A. Plumbing Supply, Distribution Systems, and Fixtures FAUCET STOPPERS INOPERABLE

- The water stoppers for the faucet are inoperable. **The Inspector recommends a licensed contractor to repair.**

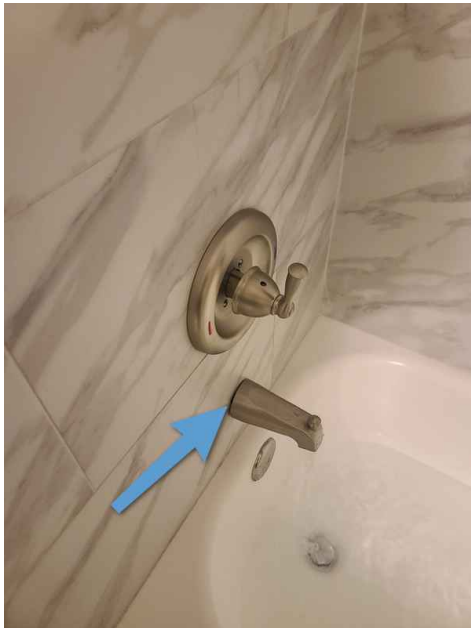
Front Hall Bathroom

SEALANT NEEDED ON FIXTURE

- The sealant on the tub faucet needs to be added, and resecured to the tile veneer. ***The Inspector recommends a licensed contractor be contacted to make repairs.***

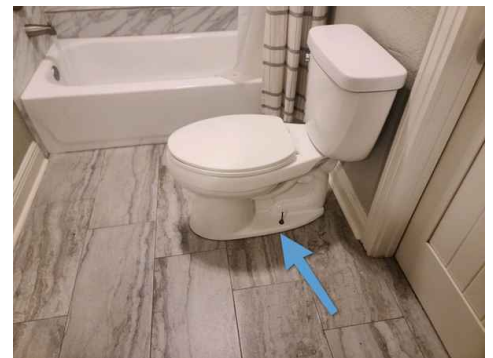
Primary Bathroom

TOILET LOOSE

- The toilet was loose and should be repaired.

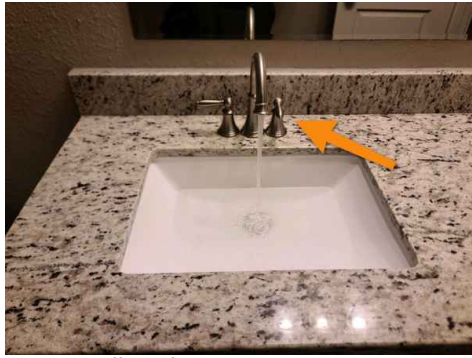
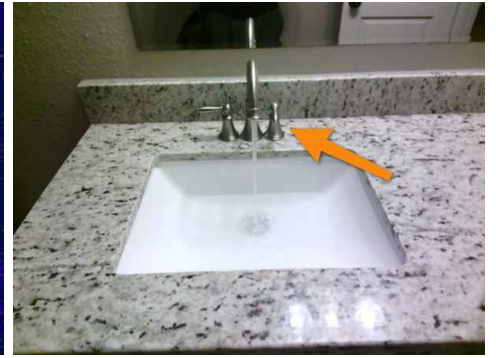
Front Hall Bathroom

HOT AND COLD REVERSED

- The hot and cold water is reversed on the fixture.

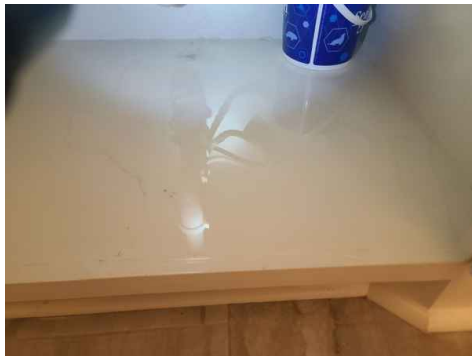
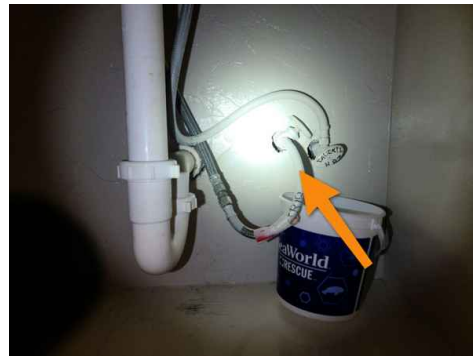
Front Hall Bathroom

5.1.7 A. Plumbing Supply, Distribution Systems, and Fixtures
COLD WATER SUPPLY LEAK

- The cold water supply line was leaking at the time of inspection. ***Recommend a licensed plumbing contractor be contacted to evaluate and repair the issue.***

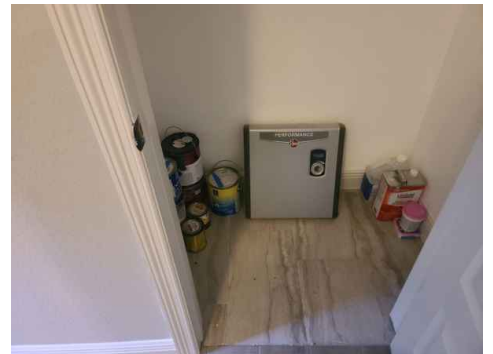
FRONT COVER ISSUE

- The front cover for the water heater came off and should be repaired.

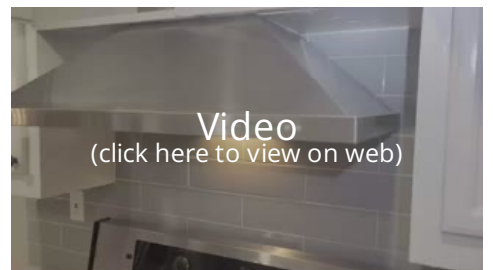
LOUD NOISE

- Loud noises were observed from the range hood when operated on "High" mode. **Contact an appliance repair specialist to evaluate the issue.**
