RESIDENTIAL INSPECTION REPORT

2835 Trevino Ct
Friendswood, TX 77546

PROPERTY INSPECTION REPORT FORM

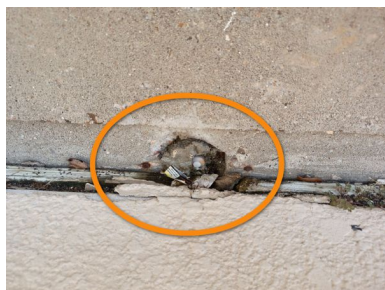
Garage Right Exterior

1: Slab: Exposed Post Tension Cables or Nails

Multiple Locations

Post tension cables or nails were exposed along the perimeter of the foundation. Evaluation and remediation is recommended.

Recommendation: Contact a qualified professional.

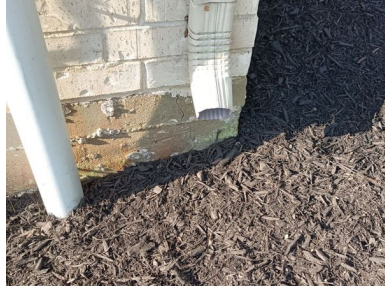
1: Gutters & Downspouts: Defects Present

Gutters and/or downspouts had one or more defects at the time of the inspection. Examples include, but are not limited to:

- Poor slope
- Loose
- Damaged
- Clogged
- Corroded
- Missing components
- Leaking

Evaluation and remediation is recommended.

Recommendation: Contact a qualified professional.

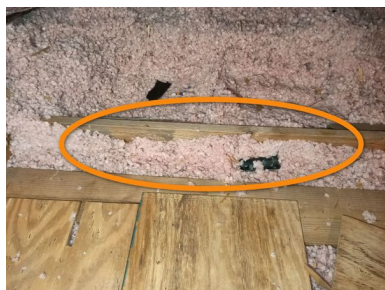
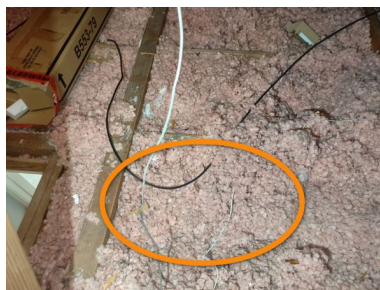
1: Insulation: Voids/Fallen

Gaps or areas of poor insulation coverage were observed in one or more locations of the attic. This may reduce the R value of the insulation system. Evaluation and remediation is recommended.

Recommendation: Contact a qualified insulation contractor.

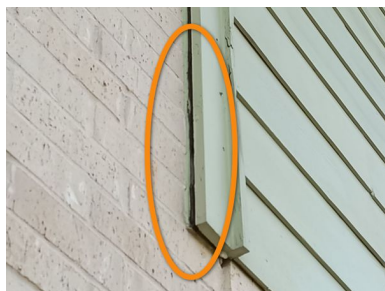
Trim Boards

1: Exterior: Seal Wall Fixtures

Trim Boards, All Exterior Wall Penetrations -

One or more areas were not properly sealed/caulked. Most exterior sealants have a lifespan of 5 to 8 years and should be regularly maintained with that lifespan in mind. Evaluation and remediation is recommended.

Recommendation: Contact a qualified professional.

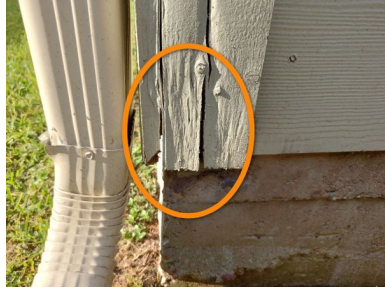
Garage Rear Left Exterior

2: Exterior: Evidence of Wood Rot

Wood rot/deterioration was observed. Evaluation and remediation is recommended.

Recommendation: Contact a qualified professional.

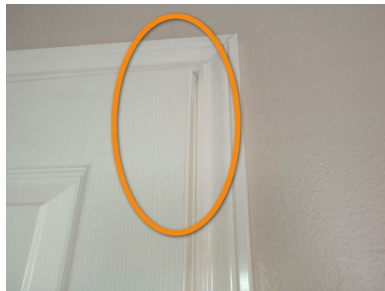
2nd Floor Middle Left Bedroom

1: Doors: Sticks/Difficult to Operate

The doors were sticking and/or were difficult to operate. Evaluation and remediation is recommended.

Recommendation: Contact a handyman or DIY project

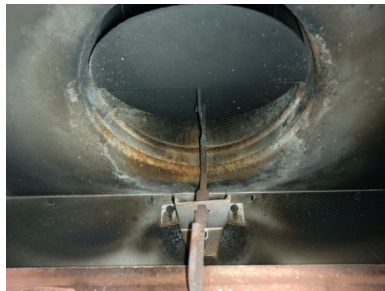
1: Damper: No Clip

No apparent safety clip on the damper. Typically when gas logs are present, a safety clip must be installed on the damper to keep it from closing fully. Evaluation and remediation is recommended.

Recommendation: Contact a qualified professional.

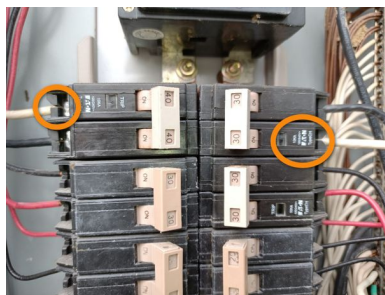
2: White Wires Not Marked

White wires connected to breakers were not marked with black or red electrical tape to indicate that they are "hot". Evaluation and remediation is recommended.

Recommendation: Contact a qualified electrical contractor.

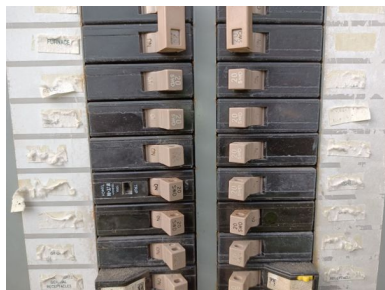
3: Circuits Not Labeled

Circuits in the distribution panel were not properly labeled. Evaluation and remediation is recommended.

Recommendation: Contact a qualified electrical contractor.

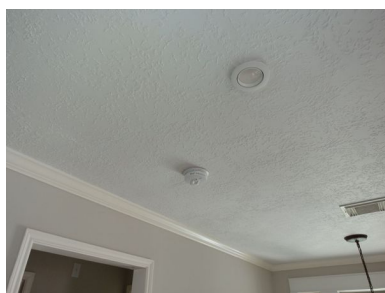
1: Smoke/Carbon Monoxide Detectors Defective

Not Present in Required Location -

Smoke detectors are required in all bedrooms, hallways to bedrooms, and living areas on every level of the home. These devices should be changed every 10 years for safety. Evaluate the units in the home and remedy as needed.

As gas appliance(s) were installed in the living portion of the home, installation of carbon monoxide detectors is recommended for safety. Evaluation and remediation is recommended.

No Carbon Monoxide Detector on 2nd Floor

Recommendation: Contact a qualified professional.

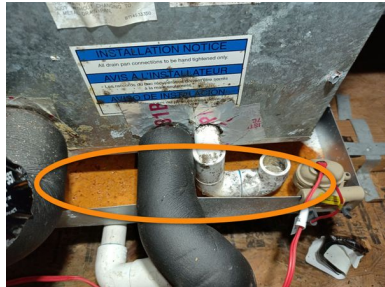
1: Condensate System: Emergency Pan Defects

The emergency overflow pans had one or more defects at the time of the inspection. Examples include, but are not limited to:

- Standing water
- Debris
- Corrosion
- Poor sloping

Evaluation and remediation is recommended.

Recommendation: Contact a qualified HVAC professional.

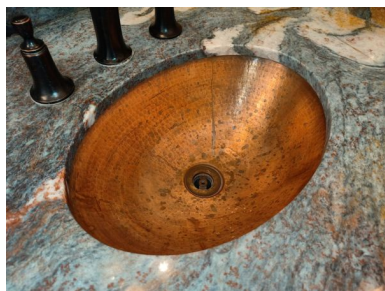
Primary Bathroom

1: Fixtures: Drain Stops Missing, Damaged or Ineffective

Drain stops had issues that prevented them from working properly. Evaluation and remediation is recommended.

Recommendation: Contact a qualified plumbing contractor.

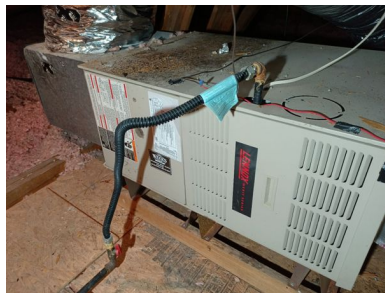
1: Missing/Improper Sediment Traps (Drip Legs)

Sediment traps are installed to help prevent sediment in the gas piping from getting into the gas valve or burner area of an appliance and causing problems. Evaluation and remediation is recommended.

Recommendation: Contact a qualified plumbing contractor.

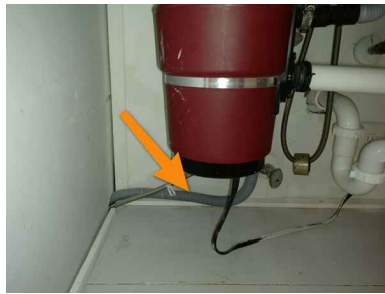
An anti-siphon loop was not installed at the drain hose under the sink. Most manufacturers specifications suggest that in the absence of an air gap, the drain be looped to prevent back washing from the sink. Evaluation and remediation is recommended.

Recommendation: Contact a qualified professional.

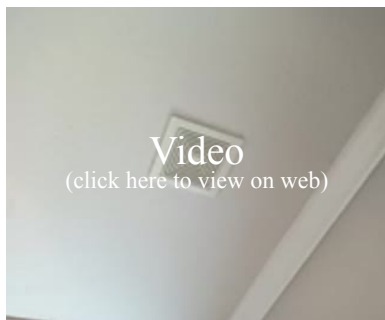
Vent fans were noisy during operation. Evaluation and remediation is recommended.

Recommendation: Contact a qualified professional.

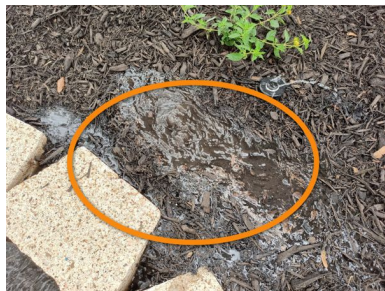
Zone 3

1: Leaks

Components of the irrigation system leaked. Evaluation and remediation is recommended.

Recommendation: Contact a qualified professional.
