RESIDENTIAL INSPECTION

703 Excalibur Ct
Friendswood TX 77546

PROPERTY INSPECTION REPORT

Concerning: 703 Excalibur Ct, Friendswood TX 77546
(Address or Other Identification of Inspected Property)

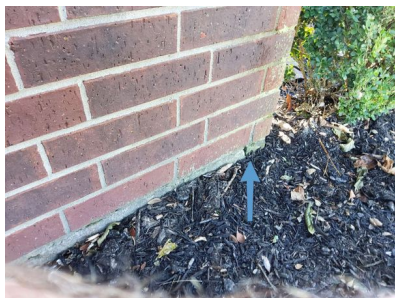
Front of house

1: Foundation Cracks - Minor

Minor cracking was noted at the foundation. This is common as concrete ages and shrinkage surface cracks are normal. Recommend monitoring for more serious shifting/displacement.

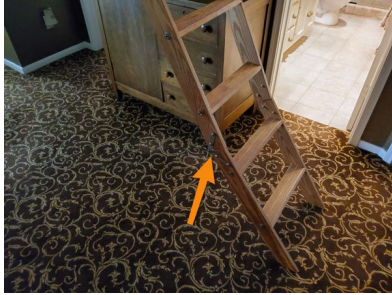
1: Pulldown stairs damaged

Pulldown stairs were damaged.

Recommendation: Contact a handyman or DIY project

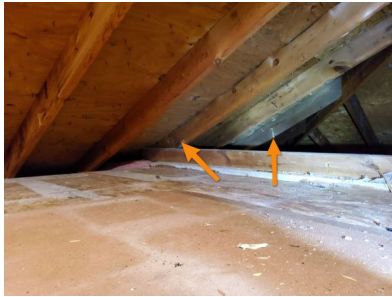
Garage attic

2: Damaged rafter

Damaged rafter was observed.

Recommendation: Contact a qualified professional.

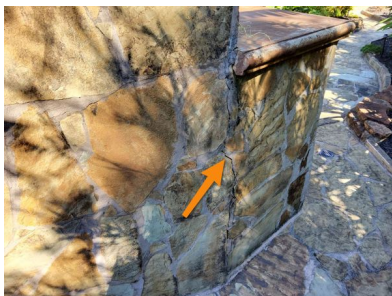
Outside kitchen

1: Cracks - Major

Major cracking observed in wall structure. This could be from moisture intrusion at the structure and/or soil movement. Recommend a qualified structural engineer evaluate and advise on course of action.

Recommendation: Contact a qualified structural engineer.

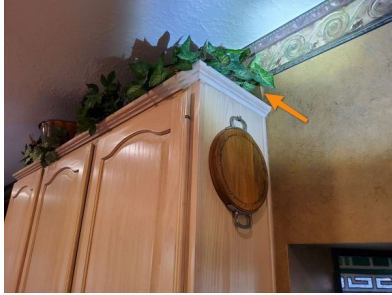
Kitchen

2: Cracks - Minor

Minor cracking was observed in wall structure. This is common in homes this age. Recommend monitoring.

Recommendation: Contact a handyman or DIY project

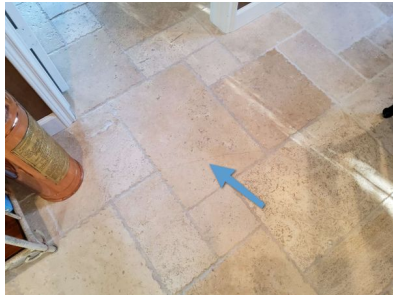
Breakfast room

2: Cracked flooring tiles

Minor cracking of floor tiles was observed during the inspection.

Recommendation: Contact a handyman or DIY project

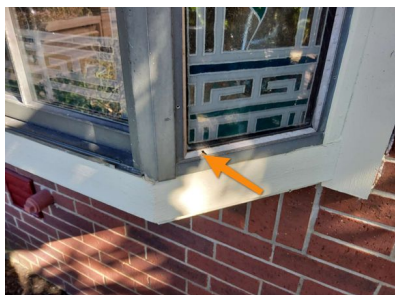
Right side of house

2: Trim damaged

Trim around the windows was either damaged or missing.

Recommendation: Contact a qualified professional.

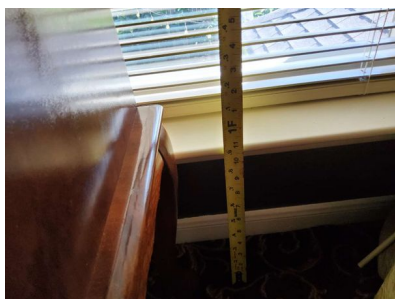
Gameroom

3: Sill height too low

Current building standards require any window with an exterior sill height of 72" or greater to have a minimum interior sill height of 24".

Recommendation: Contact a qualified professional.

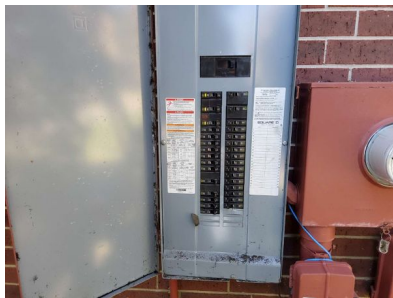
1: Panel Missing Labels

Electrical panel does not have labels. Recommend a licensed electrician test and properly label all switches.

Recommendation: Contact a qualified electrical contractor.

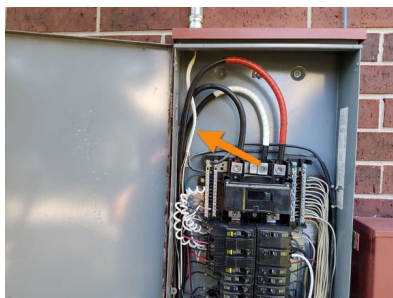
2: Wire sheathing not removed

No more than 2' of wire sheathing should extend into panel. Recommend a licensed electrician evaluate and repair.

Recommendation: Contact a qualified electrical contractor.

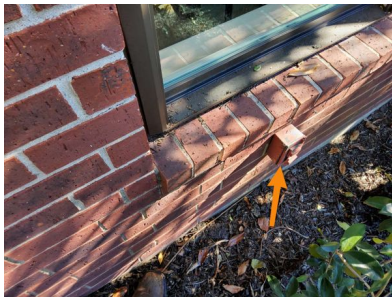
Right side of house

1: Cover Plates Damaged

One or more receptacles have a damaged cover plate. Recommend replacement.

Recommendation: Contact a handyman or DIY project

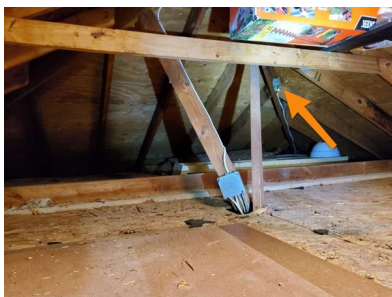
Garage attic

2: Open Junction Box

Open junction box observed. Recommend concealing or replacing.

Recommendation: Recommended DIY Project

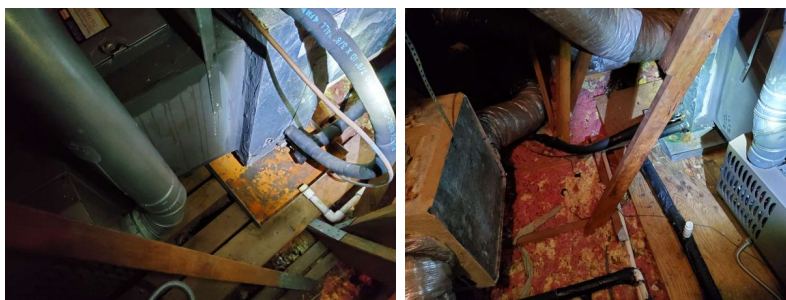
2: Drain pan rusted

The drain pan was rusted.

Recommendation: Contact a handyman or DIY project

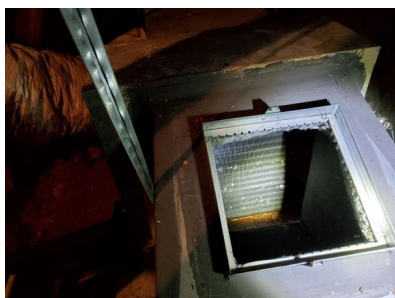
3: Evaporator coils dirty

The evaporator coils were dirty. Recommend licensed HVAC contractor evaluate.

Recommendation: Contact a qualified HVAC professional.
