## REDSTAR RESIDENTIAL INSPECTION REI 7-6

26118 Katy Prairie Dr  
Katy, TX 77493

# PROPERTY INSPECTION REPORT FORM

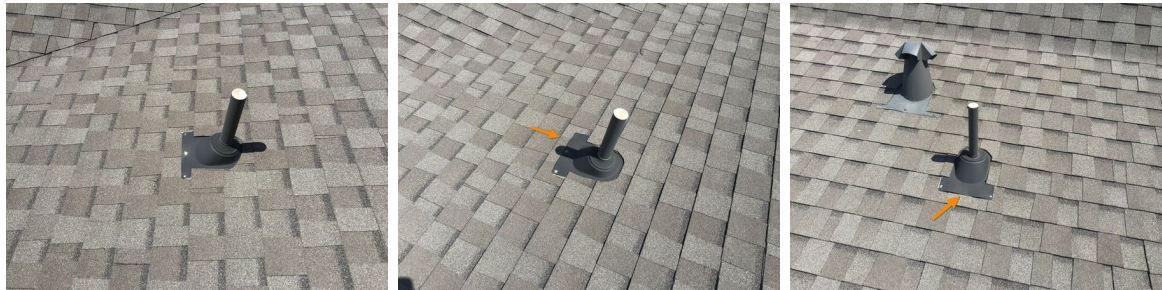
One or more locations where the nail heads are exposed and need sealed. These locations include around vent jacks, flashings, and hip and ridge caps. Recommend correction by a qualified contractor as needed to prevent moisture penetration over time.

Recommendation: Contact a qualified roofing professional.

All roof repairs have been completed.

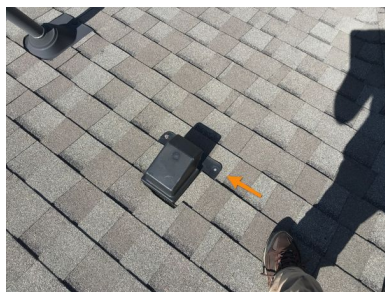
**2: Shingles: Lifted/Cupped**

Observed buckled/lifted shingles on the roof covering. This condition is where the shingles are lifted or are not laying flat due to wrinkling of the underlayment or a shingle issue. High humidity and moisture issues at decking can also contribute to this condition. Recommend further evaluation by a roofing contractor to determine the extent of necessary repair.

Recommendation: Contact a qualified roofing professional.

All roof repairs have been completed.

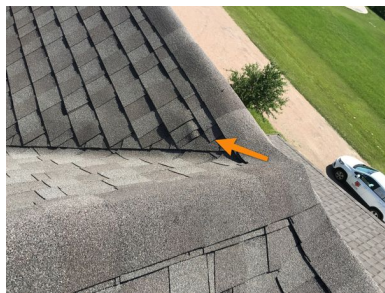
**3: Flashing: Deteriorated Sealant**

Deteriorated sealant was observed around plumbing and other flashing components. It is vital to maintain these locations to ensure performance of the covering. Recommend correction to avoid further deterioration or potential moisture intrusion issues.

Recommendation: Contact a qualified roofing professional.

All roof repairs have been completed.

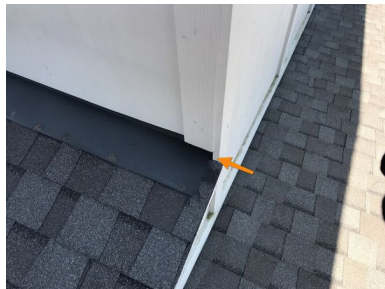
4: Flashing: Loose/Raised Flashing

Raised or loose flashing areas were observed around the roof covering. This condition leaves the covering exposed to potential moisture or pest intrusion. Recommend all areas be evaluated and secured/sealed as needed.

Recommendation: Contact a qualified roofing professional.

All roof repairs have been completed.

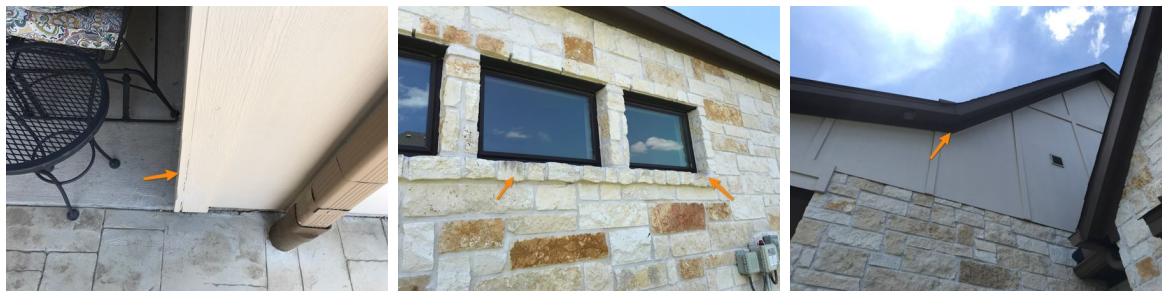
The above stated locations were identified as areas in need of proper caulking and sealing, or maintenance to the existing sealant. Examples of locations needing sealing are pictured for your reference. Recommend further evaluation of these areas and all others to determine the extent of needed repairs.

Recommendation: Contact a qualified handyman.

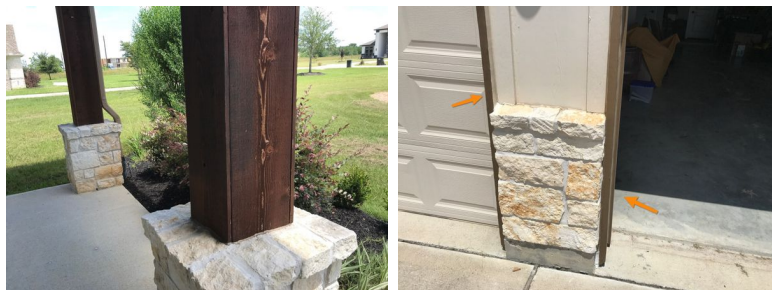
**2: Masonry: Minor cracks/Maintenance Recommended**

Minor cracks were observed in the masonry walls and/or mortar lines around the home. These conditions appear related to typical or normal settlement. Recommend you consider correction to avoid further deterioration and for cosmetic reasons.

Recommendation: Contact a qualified masonry professional.

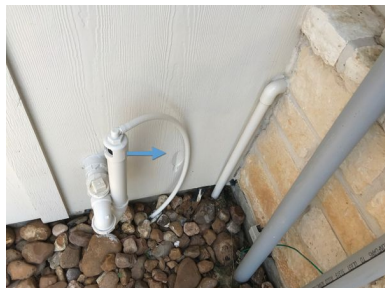
**3: Siding: Minor Damage/Maintenance Recommended**

The siding displayed sections with minor damage or maintenance issues. Common maintenance items include: minor damage, separation at joints and trim, finishes that are worn, etc. While these conditions do not appear to be contributing to any larger issues, recommend you consider correction to avoid further deterioration and as apart of normal maintenance.

Recommendation: Contact a qualified handyman.

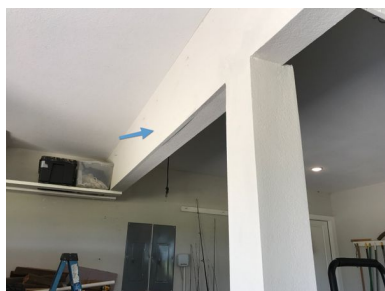
**1: Ceiling: Cracked Tape Joints**

Cracked taped joints and other cosmetic issues were observed on the ceiling finish at multiple locations. These cracks and cosmetic issues may be due to typical settlement of the foundation. Recommend repair as needed to prevent further deterioration and monitoring for additional movement.

Recommendation: Contact a qualified painting contractor.

Cracked tape joints and painting to be completed.

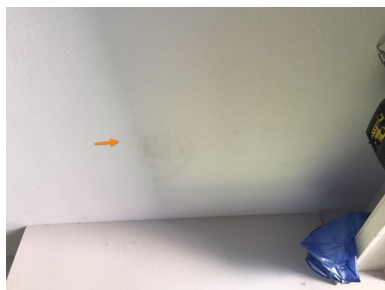
**2: Ceiling: Water Mark**

Water mark/staining observed at the interior of the home at the ceiling. Thermal imaging revealed no signs of active moisture at these locations, and it appears these stains are related to a previous issue. Recommend consulting with the seller to determine any previous issues at these locations, and recommend cosmetic repair and further monitoring to help ensure no leaking is present.

Recommendation: Contact a qualified professional.

Cracked tape joints and painting to be completed.

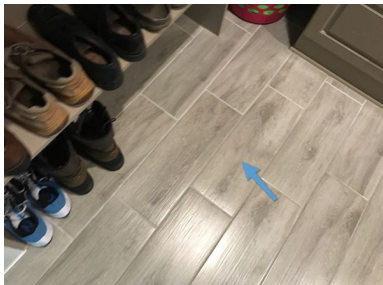
Floor tiles were observed to be cracked or hollow at the above stated locations. Repair as needed.

Recommendation: Contact a qualified flooring contractor

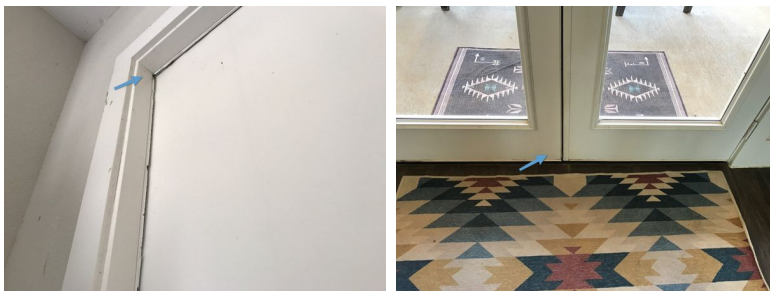
Gaps were observed in the weather seal around the exterior doors. Repair as needed to prevent moisture, pest, and air intrusion.

Recommendation: Contact a qualified professional.

All doors are sealed correctly and lock securely.

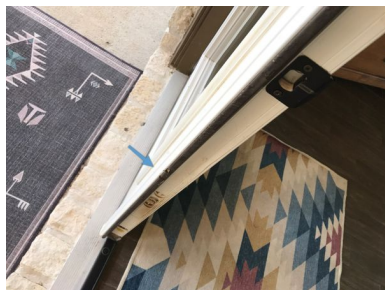
**2: Exterior Door: Weatherstripping Missing or Damaged**

Multiple exterior doors showed damage or were missing its weatherstripping. Recommend installation or repair of standard weatherstripping to prevent energy loss and/or moisture intrusion.

Recommendation: Contact your builder.

All doors are sealed correctly and lock securely.

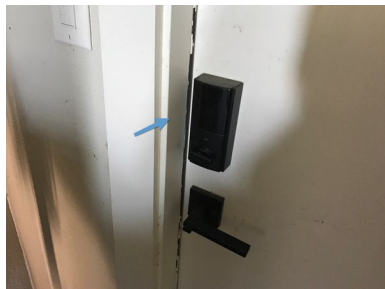
**7: Interior Door: Loose Hardware**

The door knob hardware at multiple doors around the home was observed to be loose. Recommend tightening to allow for easier operation of the doors.

Recommendation: Contact a qualified professional.

Hardware tightened and door closes securely.

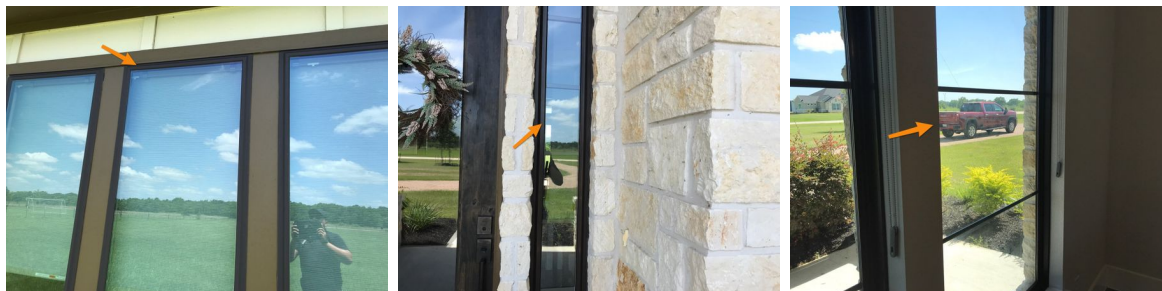
**1: Failed Seal or Low E-Coating Defects**

The seal appears compromised or a low E-Coating defect appear to be present on the double pane window glass at the above stated locations. This condition is indicated by build-up observed between the panes of glass and will potentially require replacement of the glass. Recommend further evaluation and correction as needed. Consult with a qualified window contractor to evaluate above stated locations as well as thoroughly inspect all other units to identify any other seals that are compromised.

Recommendation: Contact a qualified window repair/installation contractor.

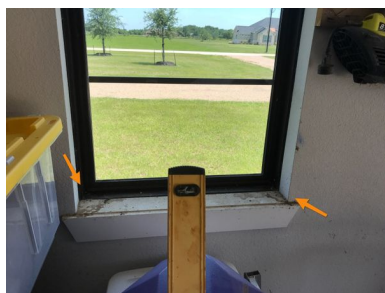
3: Moisture Damage

Moisture damage was observed at the jambs and sills around the interior of windows at the above stated locations. This can indicate a potential moisture intrusion issue, recommend further evaluation and repair as needed.

Recommendation: Contact a qualified professional.

Contacted Contractor to be repaired week of 6/29/2023.

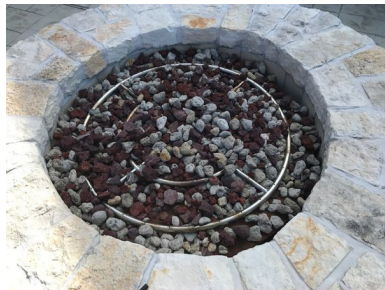
The outdoor fireplace unit was observed to not ignite when tested, recommend further evaluation and repair to allow it to function properly.

Recommendation: Contact a qualified professional.

Outdoor firepit fully funtional. The gas key is located under the BBQ Pit.

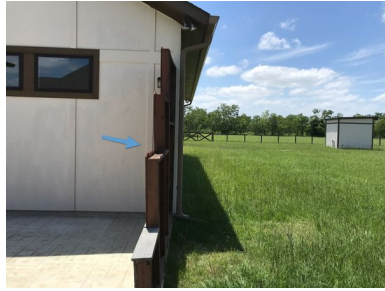
**1: Fence: Loose, Damaged and Missing Boards**

Loose, damaged and/or missing fence boards were observed at multiple locations around the property. Repair as needed for security and privacy purposes.

Recommendation: Contact a qualified professional.

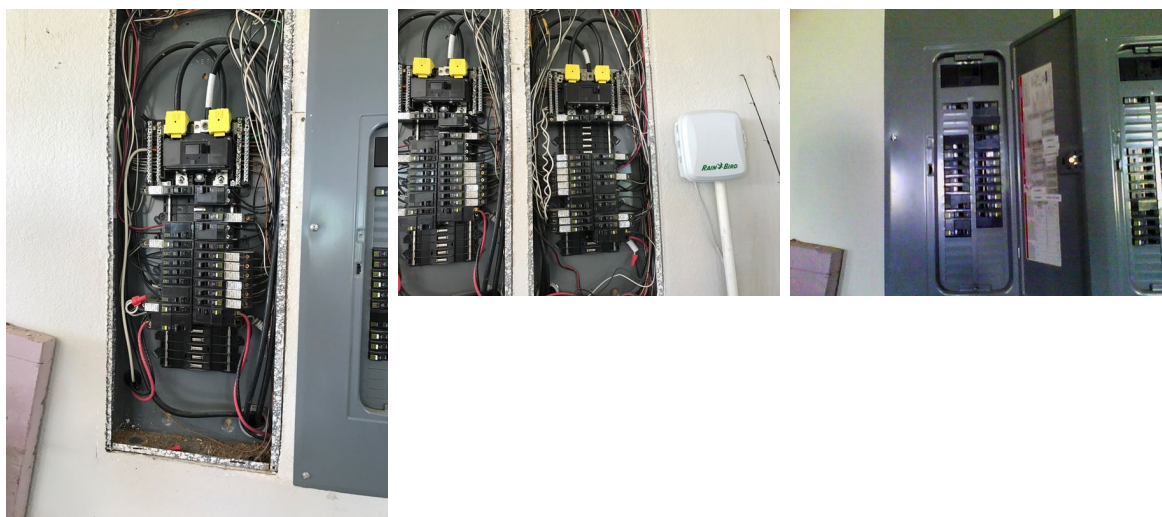
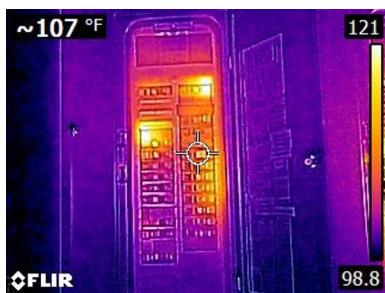
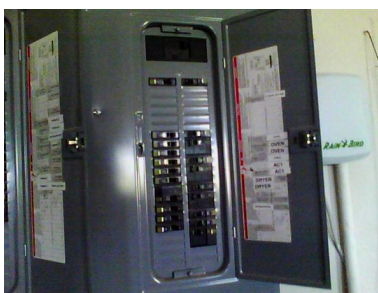
*Photo of Panel:*

**Contractor scheduled for further evaluation to determine if any repairs are needed.**

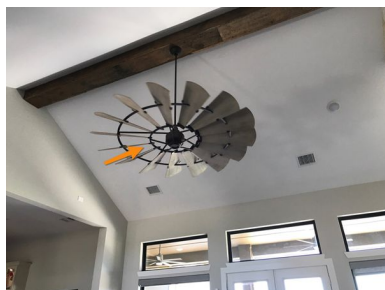
Ceiling fans at above stated locations were observed to be out of balance when in operation. Further evaluation to correct this issue is recommended.

Recommendation: Contact a qualified electrical contractor.

Ceiling Fan balanced and working as intended.

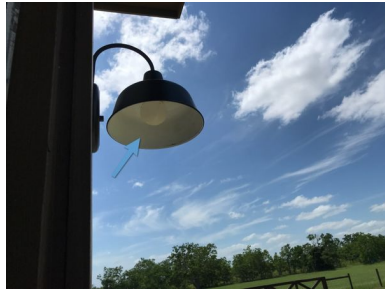
One or more light fixtures around the home did not function, possibly bulb related. Correct as needed.

Recommendation: Contact a qualified electrical contractor.

Light bulb replaced.

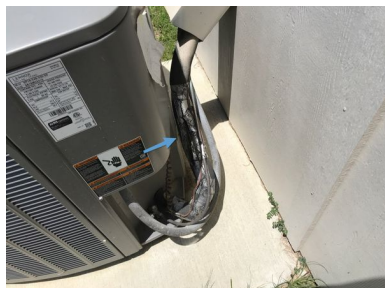
**1: Refrigerant Line: Insulation Missing or Damaged**

Missing or damaged insulation on refrigerant line can cause energy loss and condensation. Recommend correction.

Recommendation: Contact a qualified HVAC professional.

Cleaned

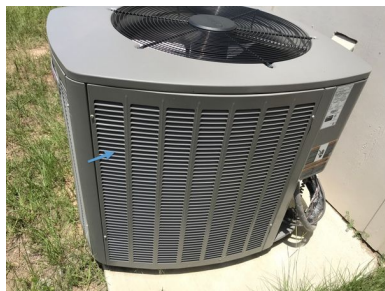
2: Condenser: Dirty Fins

Recommend cleaning fins around the condenser unit to allow it to operate efficiently.

Recommendation: Contact a qualified professional.

Cleaned

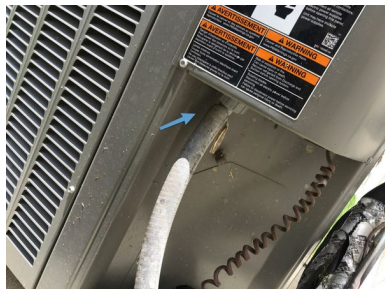
3: Condenser Unit: Loose Conduit

Conduit for the electrical supply wires at the condenser unit was loose. Repair as needed to prevent damage to the wires.

Recommendation: Contact a qualified professional.

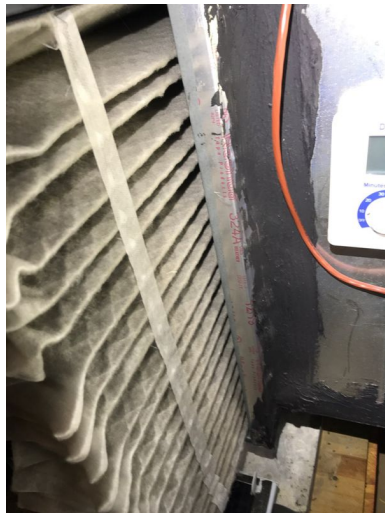
The media air filter at the air handler was observed to be dirty. Correct as needed to allow the equipment to operate properly.

Recommendation: Contact a qualified professional.

Filter replaced.

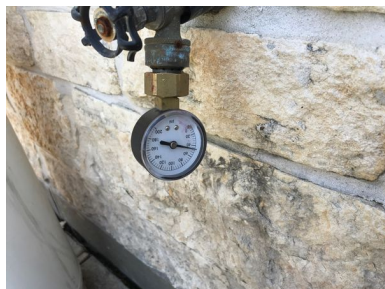
*Static Water Pressure Reading: 40-45 PSI -*

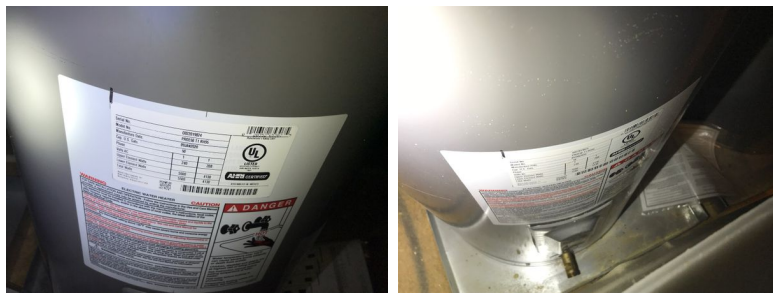
Data label:

All portions of the water heating equipment were observed to be performing as intended at the time of inspection.

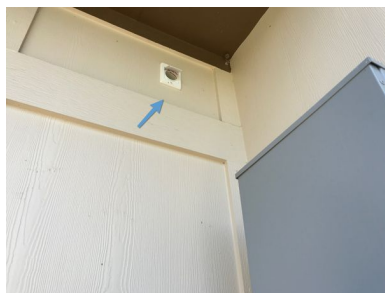
One or more vent covers were observed to be damage/missing. Remedy as needed.

Recommendation: Contact a qualified professional.

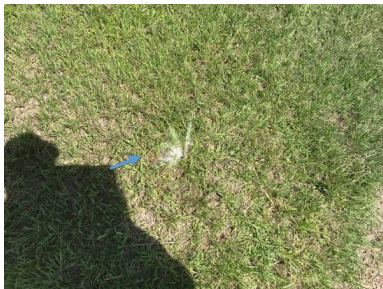
**1: Sprinkler Heads: Need Adjustment**

Sprinkler heads at multiple zones need adjustment due to them leaning, spraying the home/fence or were buried under the grade. Correct as needed for an efficient spray pattern.

Recommendation: Contact a qualified professional.

All sprinkler head zones adjusted.

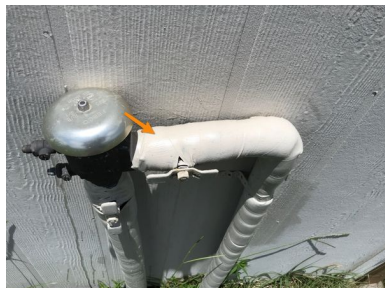
The anti-backflow device was observed to be damaged and as a result the valves would leak when operated. Repair as needed.

Recommendation: Contact a qualified professional.

**Fixed and repaired.**

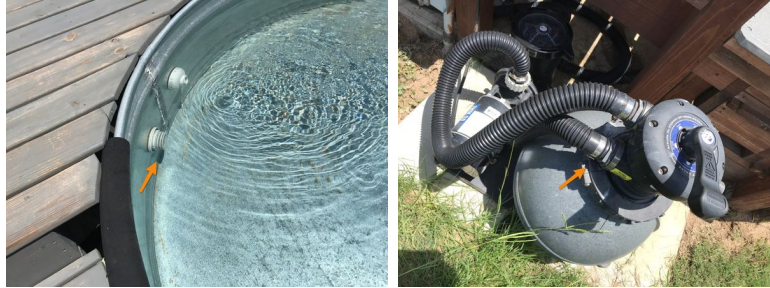
**1: Pool/Water Feature**

Recommend further evaluation and repair to allow the equipment to operate properly.

Recommendation: Contact a qualified professional.
