## Inspection Report

**Property Address:**  
7331 Northleaf Dr.  
Houston TX 77086

# PROPERTY INSPECTION REPORT FORM

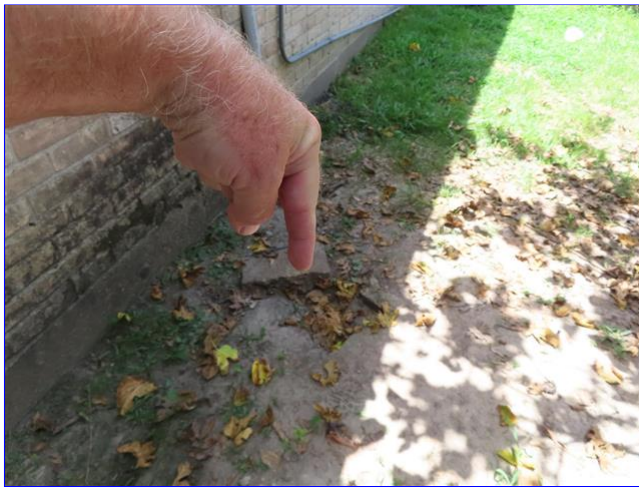
B. Item 2(Picture)

(2) Yards have low spots in several areas at time of inspection. This is conducive to ponding. Should have a professional correct for proper drainage.

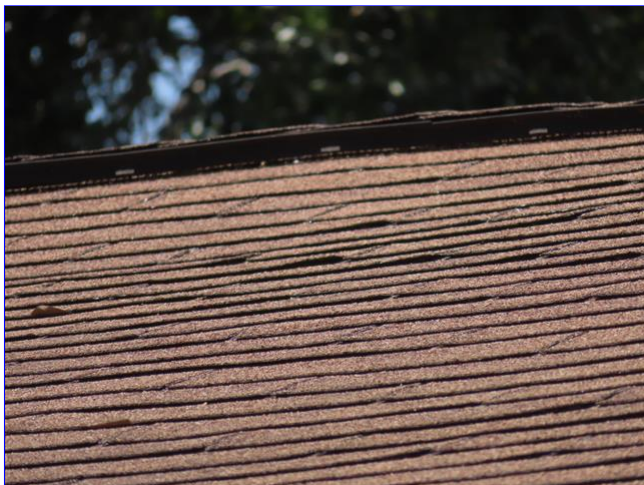
C. Item 3(Picture)

(2) Roofing has wear and tear at time of inspection. Should have a professional roofer evaluate. Roof may need to be replaced.

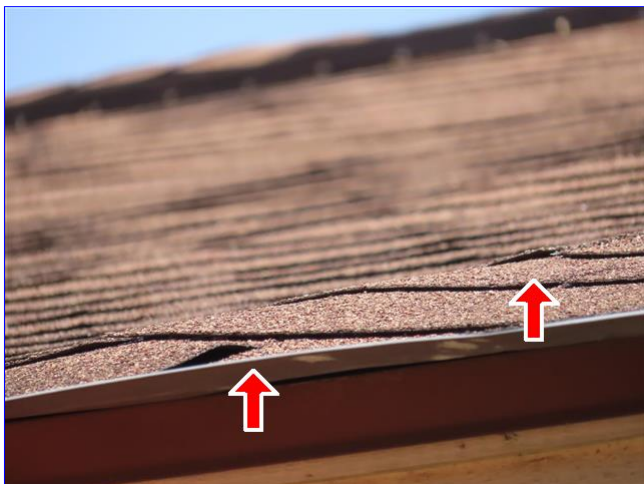
C. Item 4(Picture)

(3) Roofing is buckled in several areas at time of inspection. Should have a professional roofer correct properly.

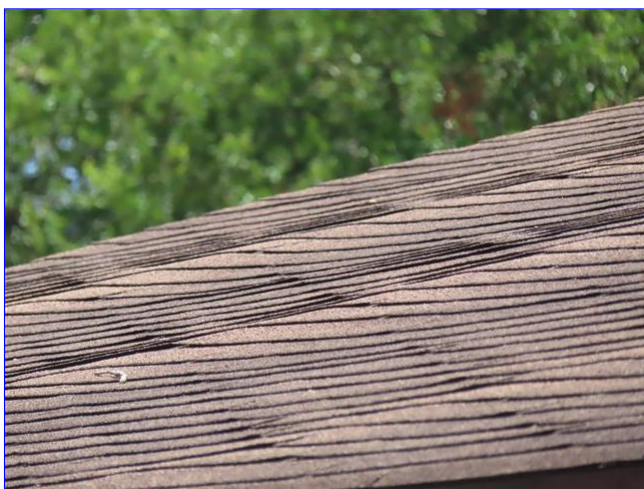
C. Item 6(Picture)

(4) Roofing is sagging in several areas at time of inspection. This is a possible structural issue. Should have a professional inspect and correct properly.

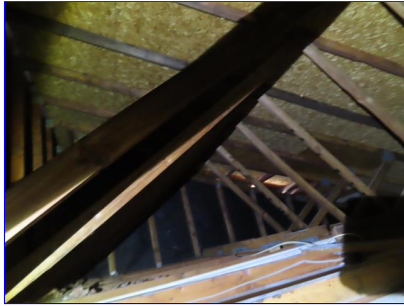
D. Item 4(Picture)

(3) Attic was missing and lacking insulation in several areas at time of inspection. Should have a professional add more insulation in these areas of the attic for proper energy efficiency. This is creating hot areas.

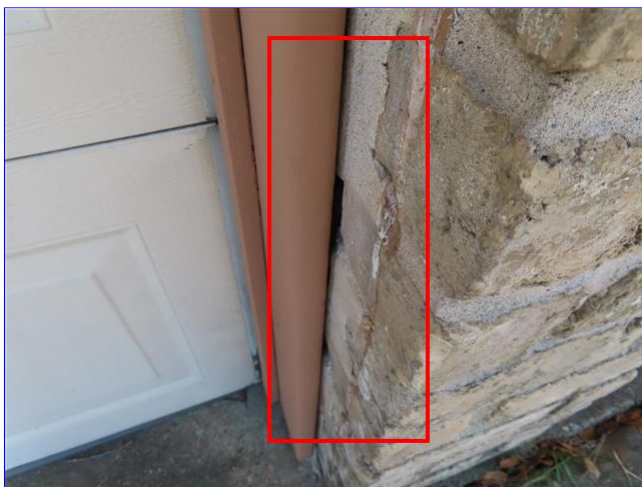
E. Item 1(Picture)

(1) Large exterior gaps from brick wall to garage door trim should be sealed properly. Conducive to moisture intrusion and causing possible damage.

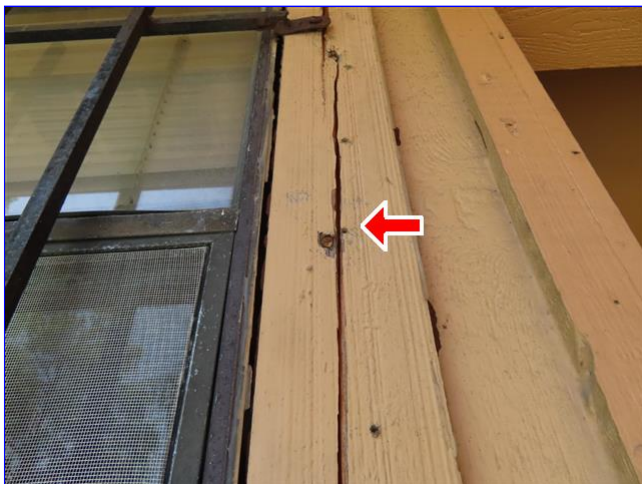
E. Item 2(Picture)

(2) Exterior rear window trim is damaged and should be replaced properly. Conducive to moisture intrusion and causing possible damage.

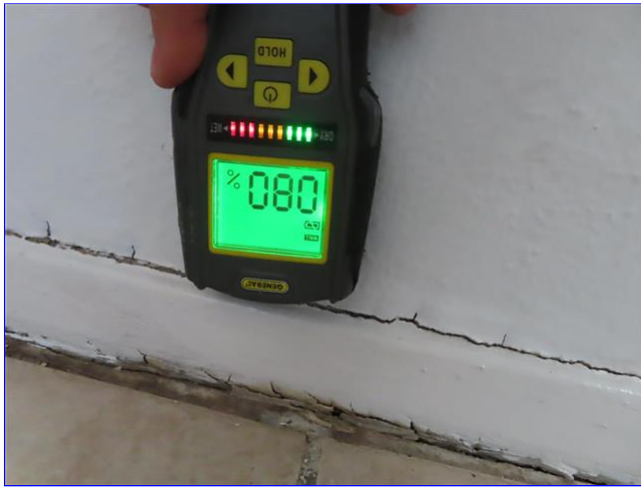
E. Item 6(Picture)

(6) Middle bathroom wall has moisture damage with high levels of moisture at time of inspection. Should have a professional inspect and correct properly.

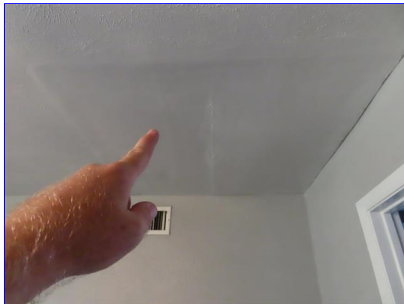
F. Item 1(Picture)

(2) Bathroom ceiling is sagging at time of inspection. Should have a professional correct properly.

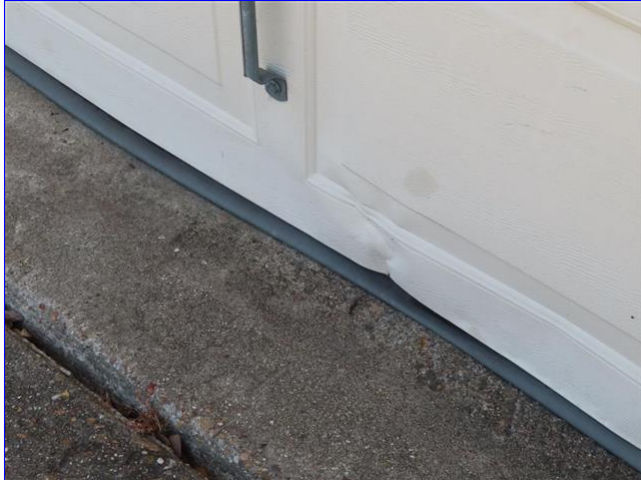
G. Item 1(Picture)

(1) Garage door is damaged in several areas and both doors were not operating properly or level in door frames at time of inspection. Should have a professional Door Tech inspect and correct properly.

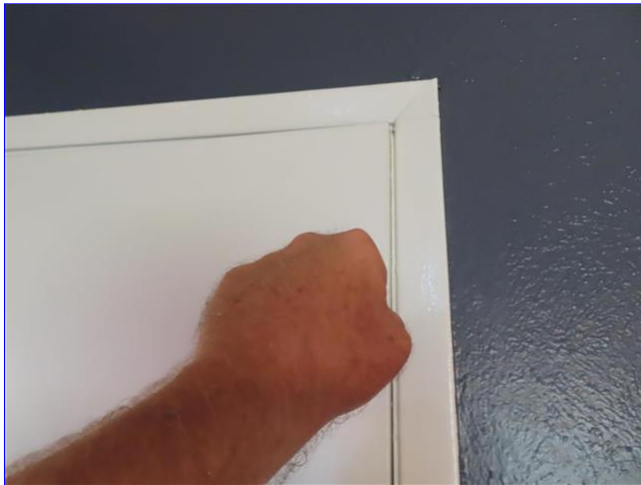
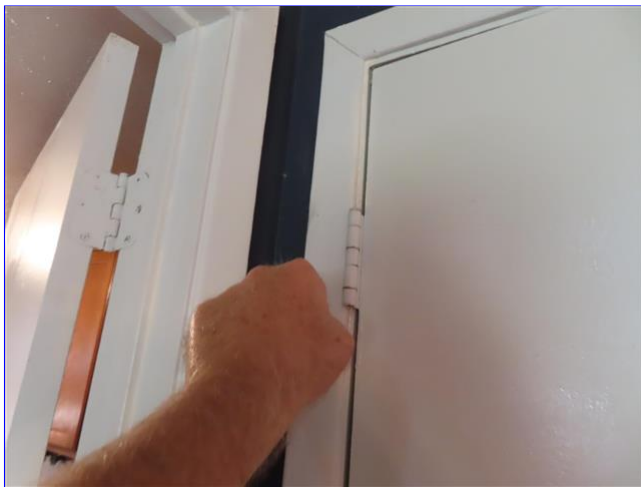
G. Item 11(Picture)

(6) Interior garage door was missing self closing hinges and door was catching door frame at time of inspection. Should have a professional correct properly.

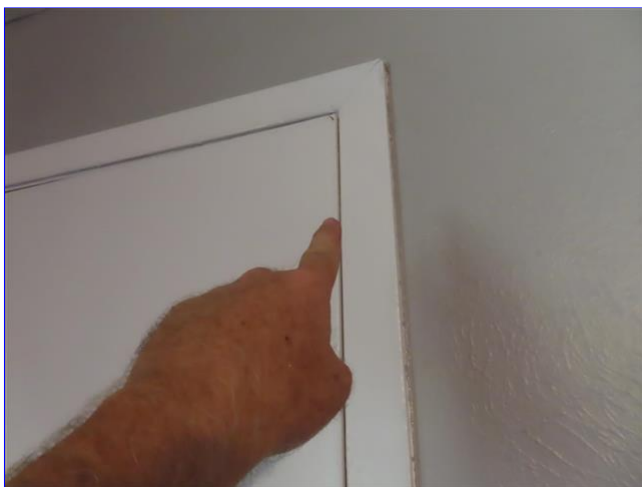
G. Item 14(Picture)

(9) Bathroom linen closet door was not latching properly at time of inspection. Should correct properly.

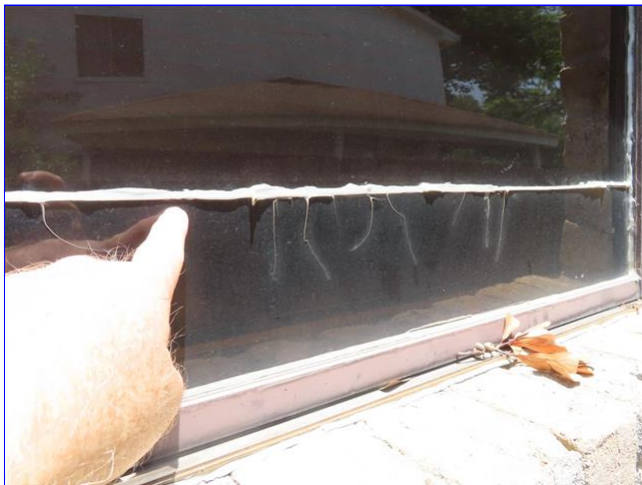
H. Item 1(Picture)

(1) Window glass was replaced with improper plastic at time of inspection. Should have a professional correct properly.

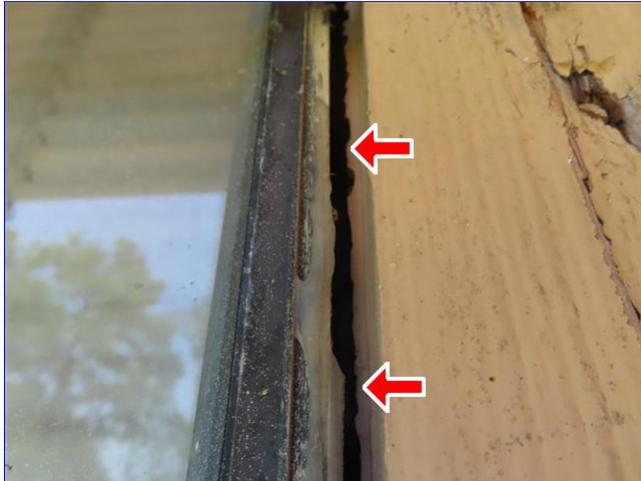
H. Item 3(Picture)

(4) Exterior window gaskets were damaged and loose in several areas at time of inspection. Should have a professional correct properly. Conducive to moisture intrusion and causing possible damage.

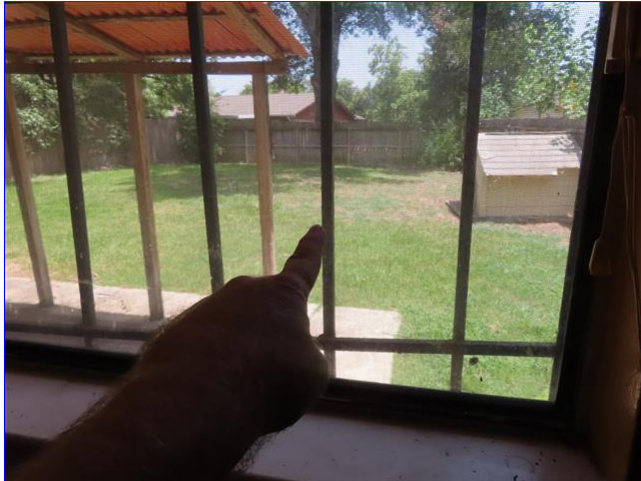
H. Item 5(Picture)

(6) All windows are original and not energy efficient. Several windows are hard to operate and are leaking moisture at time of inspection. Recommend replacing with energy efficient Low E windows.

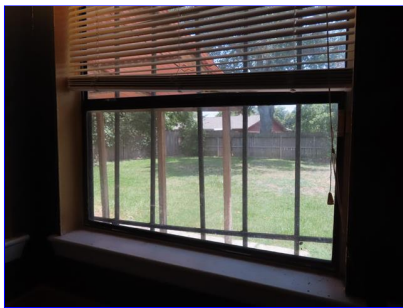
H. Item 6(Picture)

(7) Bedroom sliding window was not opening at time of inspection. Should have a professional correct for proper egress. This is a possible safety hazard.

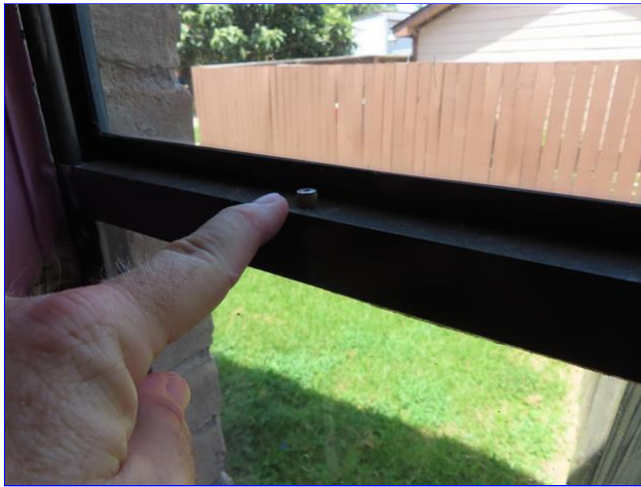
H. Item 8(Picture)

(8) Bedroom window was not operating properly and was missing latches at time of inspection. Should have a professional correct properly.

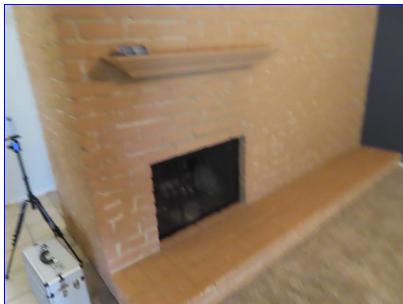
J. Item 1(Picture)

Fireplace was only visually inspected for defects or deficiencies at time of inspection. Did not inspect operation of fireplace at time of inspection. Fireplace did not have any visible defects at time of inspection. Inspection of fireplace is not part of home inspection per TREC Standards of Practice. Recommend having a professional Fireplace Tech further evaluate unit.

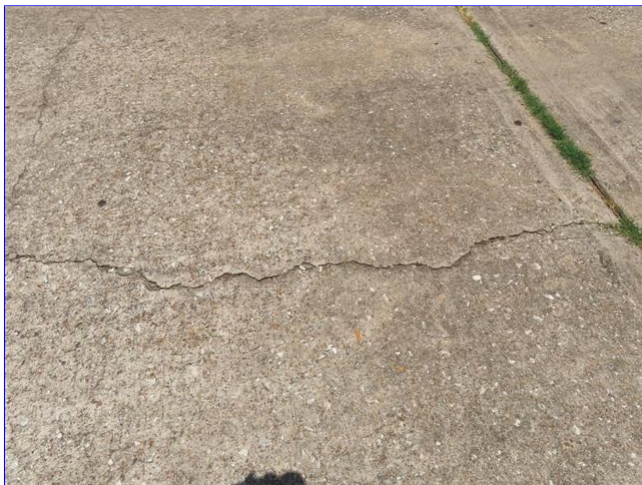
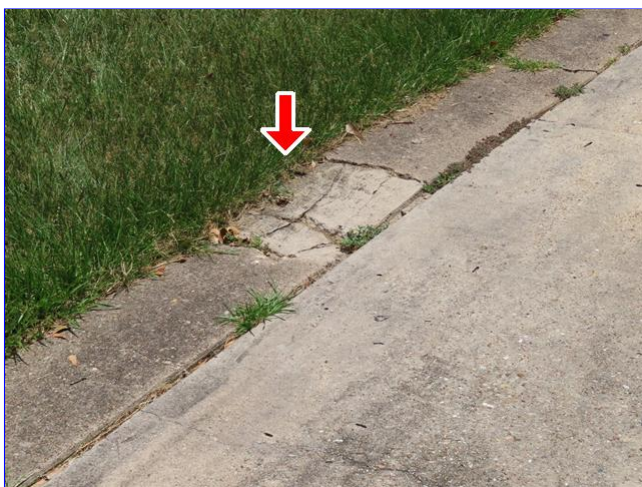
K. Item 1(Picture)

(1) Driveway has large cracks and damaged area at time of inspection. Should have a professional correct properly.

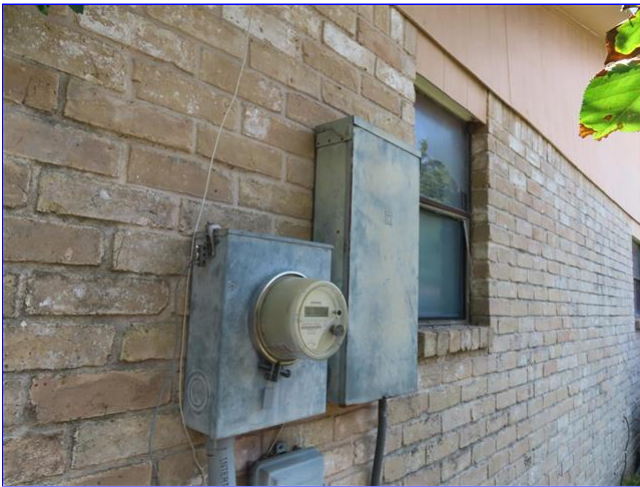
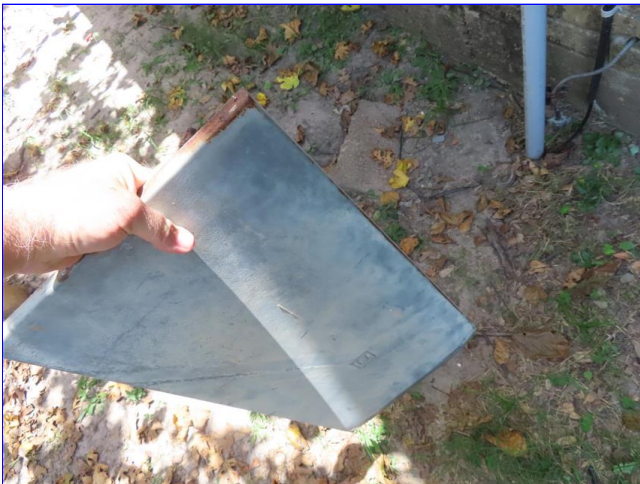
A. Item 1(Picture)

(1) Square D breaker box and electric meter. Breaker box door was loose from unit and was not operating properly, breakers were missing labels and box was missing AFCI breakers for all livable rooms, dead front cover was missing several blanks creating large gaps into the box and was installed with improper pointed fasteners at time of inspection. Should have a professional electrician correct properly.

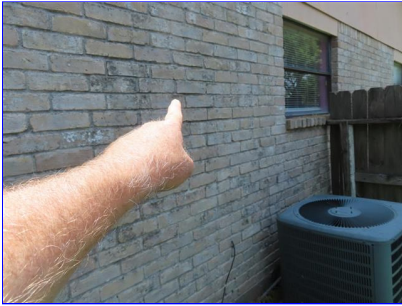
A. Item 8(Picture)

(3) AC unit was missing electrical disconnect box at time of inspection. Should have a professional electrician correct properly.

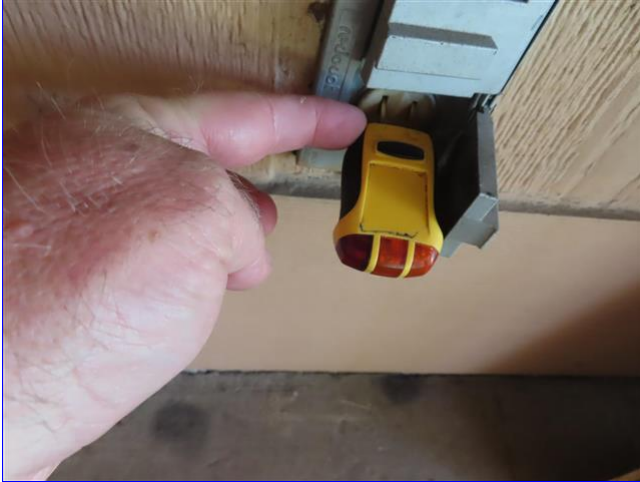
B. Item 5(Picture)

(2) Rear exterior electrical outlet could not be plugged into at time of inspection. All exterior electrical outlets should be GFCI protected and sealed to the structure properly. Outlets should be installed in exterior boxes with covers. Should have a professional electrician inspect and correct properly.

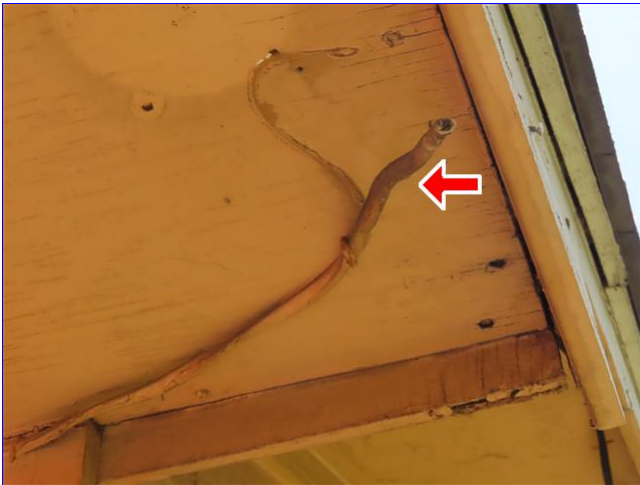
B. Item 6(Picture)

(3) Rear open electrical should be sealed and covered properly by a professional electrician.

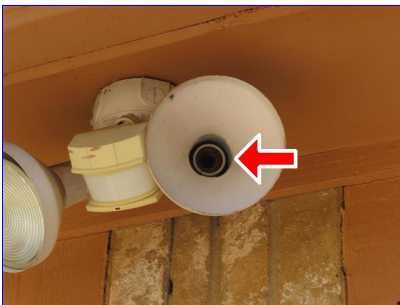
B. Item 7(Picture)

(4) Rear light was missing bulb at time of inspection. Should correct properly.

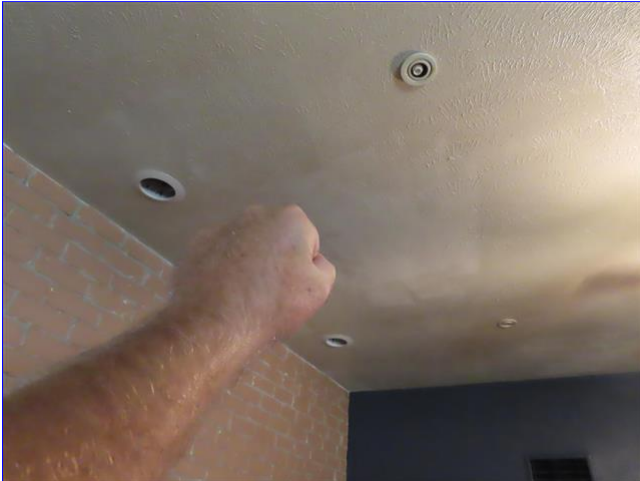
B. Item 8(Picture)

(5) Living room lights were not operating at time of inspection. Should have a professional electrician correct properly.

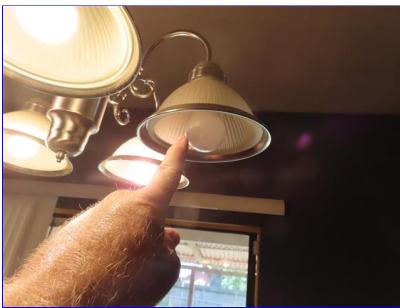
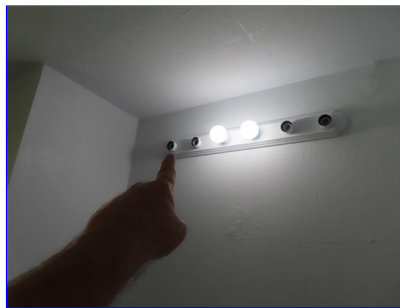
(6) Several lights were not operating at time of inspection. Possible burnt or missing bulbs. Should correct properly.

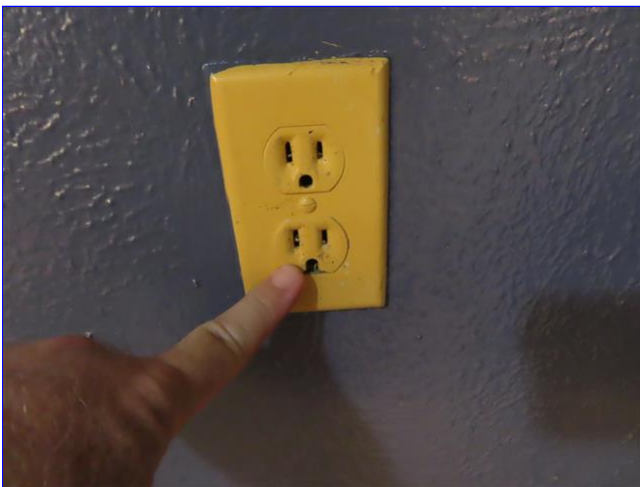
B. Item 11(Picture)

(7) Several electrical outlets were damaged at time of inspection. Should have a professional electrician correct properly.

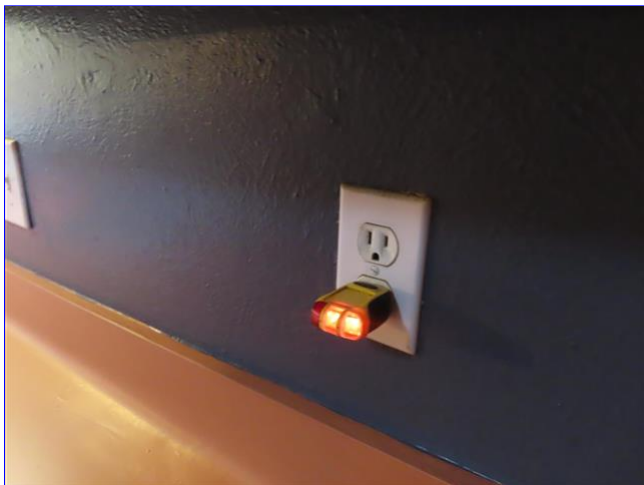
B. Item 12(Picture)

(8) All kitchen electrical outlets should be at least 3' from sink and GFCI protected. Should have a professional electrician inspect and correct. Covers should be labeled GFCI protected.

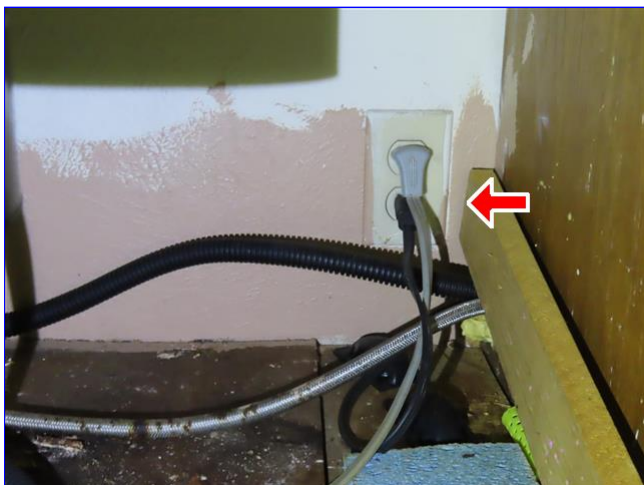
B. Item 13(Picture)

(9) Electrical outlet under kitchen sink should be GFCI protected outlet. Should have a professional electrician correct properly.

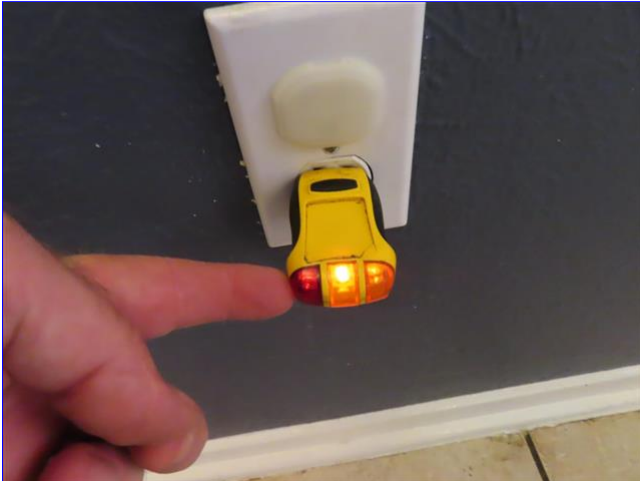
B. Item 14(Picture)

(10) Several electrical outlets were not operating properly at time of inspection. Should have a professional electrician inspect and correct properly.

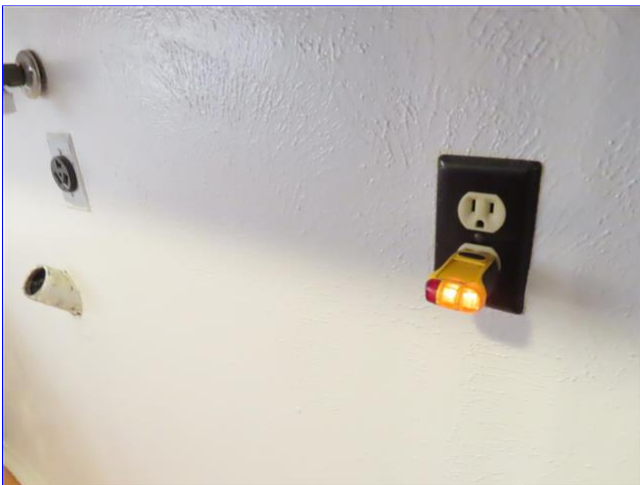
B. Item 15(Picture)

(11) All utility room electrical outlets should be GFCI protected. Electrical covers were missing GFCI protected label at time of inspection. Should have a professional inspect and correct.

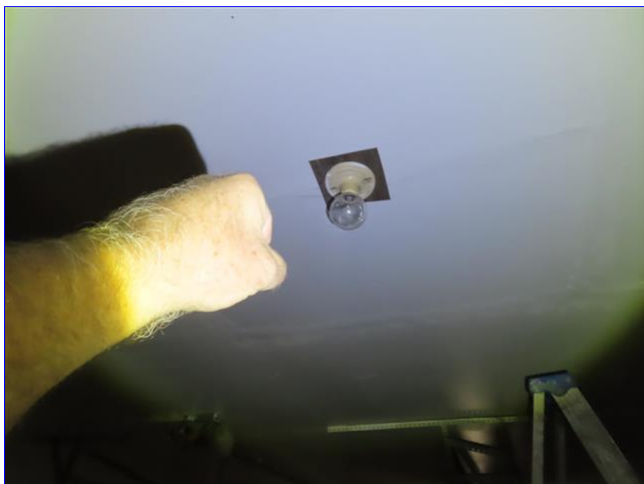
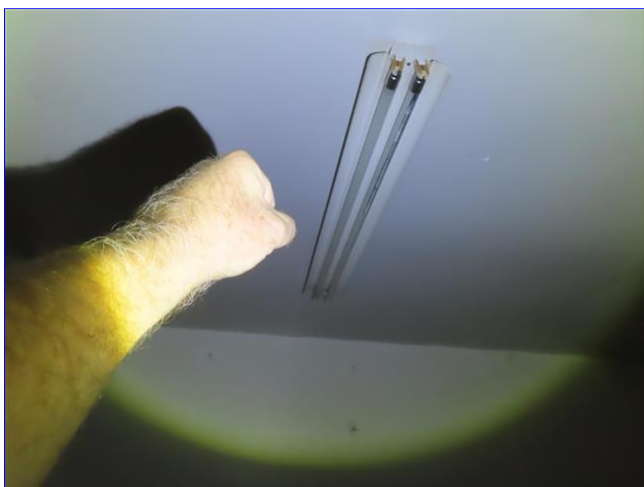
B. Item 16(Picture)

(12) Garage lights were not operating at time of inspection. Should have a professional electrician inspect and correct properly.

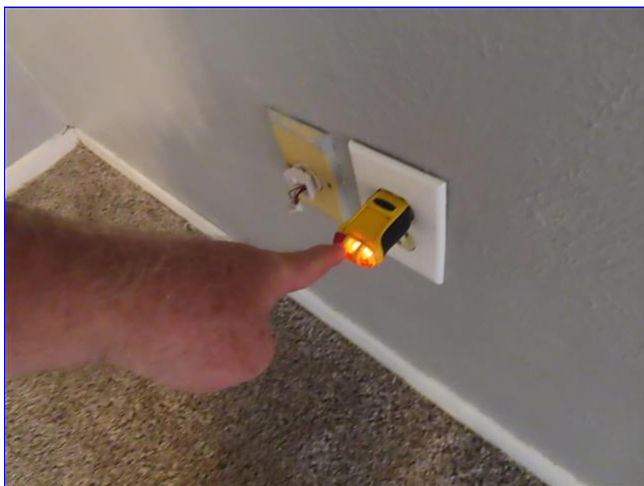
B. Item 18(Picture)

(13) Several interior electrical outlets were loose to the wall at time of inspection. Should a professional electrician secure properly.

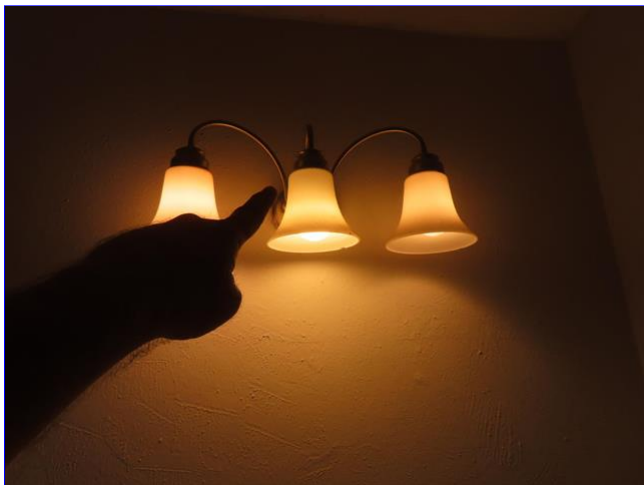
B. Item 19(Picture)

(14) Bathroom lights were loose from wall at time of inspection. Should have a professional electrician correct properly.

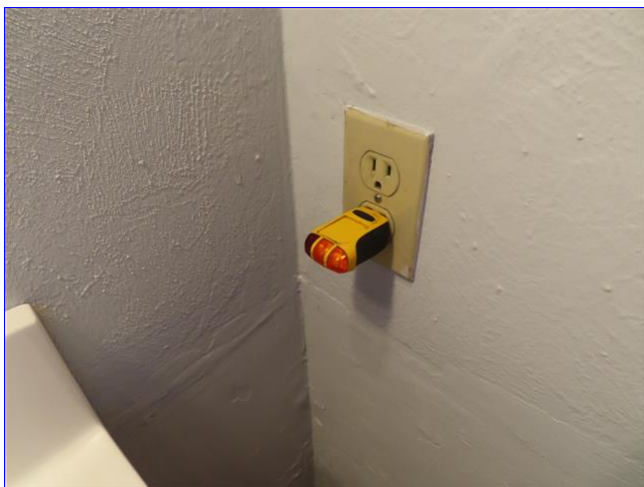
B. Item 20(Picture)

(15) All bathroom electrical outlets should be at least 3' from the sinks and GFCI protected. Electrical covers were missing GFCI protected label at time of inspection. Should have a professional inspect and correct.

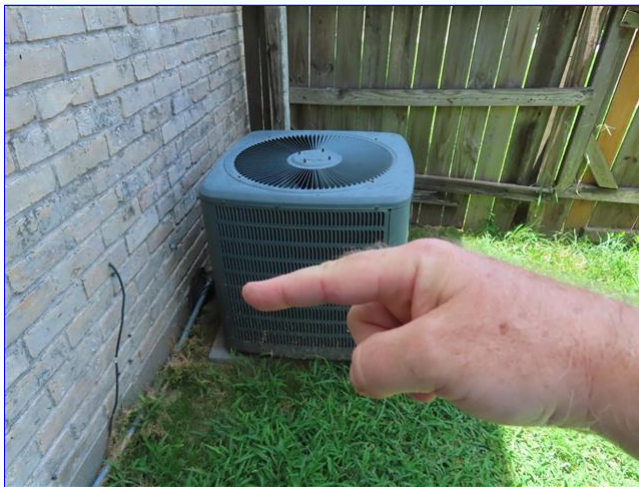
A. Item 1(Picture)

2012 Goodman 3 ton AC unit was not balanced and was leaning, unit was not cooling at time of inspection. Should have a professional AC Tech inspect and correct properly.

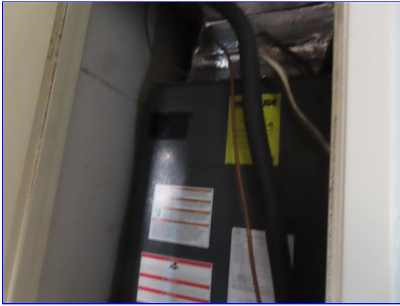
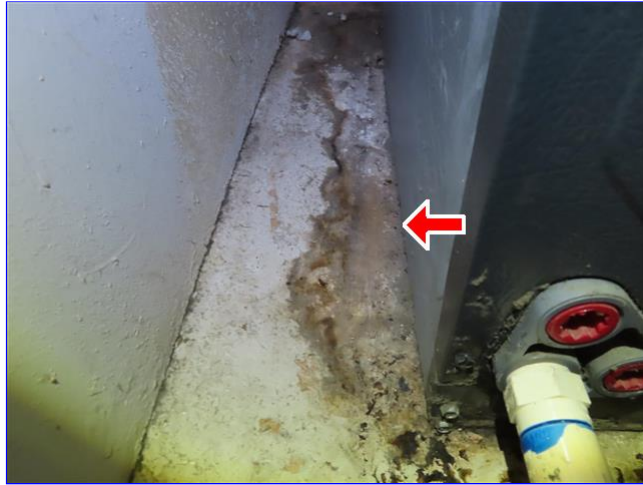
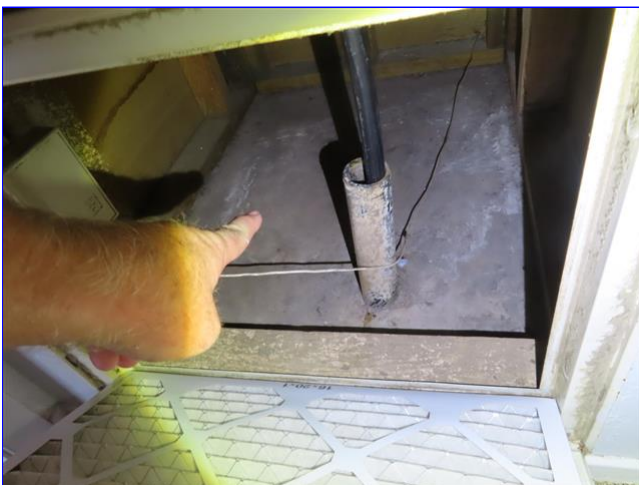
unit has moisture staining from possible condensation, unit was missing drip pan and drain, electrical from unit was missing main disconnect box at time of inspection. Should have a professional AC Tech inspect and correct properly.

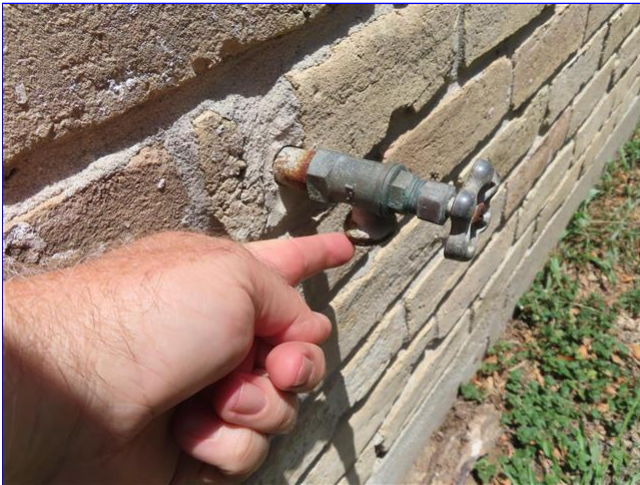
A. Item 1(Picture)

(1) Exterior faucet threads were damaged at time of inspection. Should have a professional plumber correct properly.

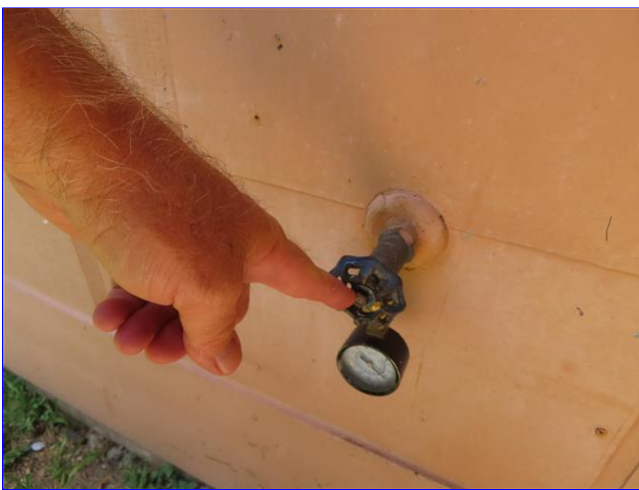
A. Item 4(Picture)

(4) Exterior faucet valve was leaking at time of inspection. Should have a professional plumber correct properly.

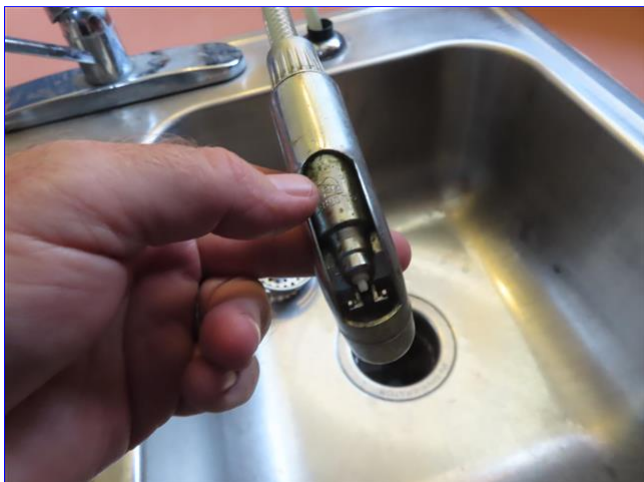
A. Item 6(Picture)

(6) Kitchen sprayer was damaged and should be replaced by a professional plumber.

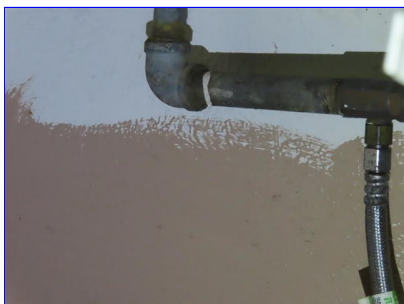
A. Item 7(Picture)

**(7) Structure has galvanized plumbing that will rust, corrode, leak and have calcium build up that reduces water pressure. These issues could of been hidden at time of inspection. Recommend replacing all galvanized plumbing by a professional plumber.**

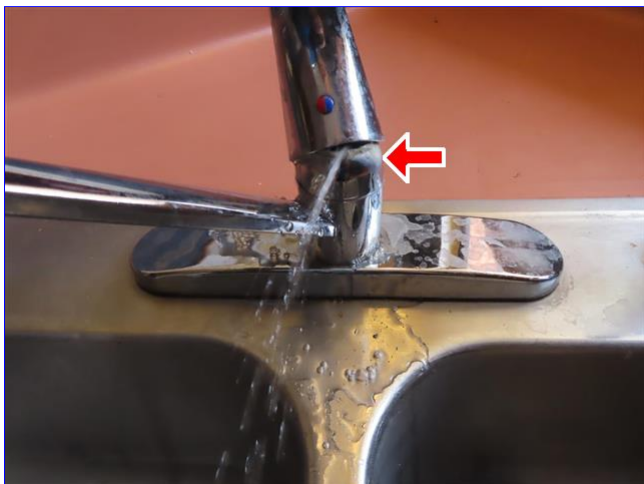
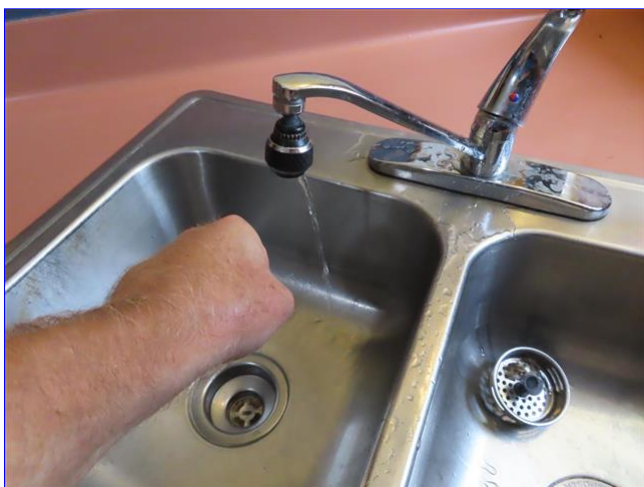
(8) Kitchen faucet control valve was leaking at time of inspection. Could side would not produce water at time of inspection. Should have a professional plumber replace properly.

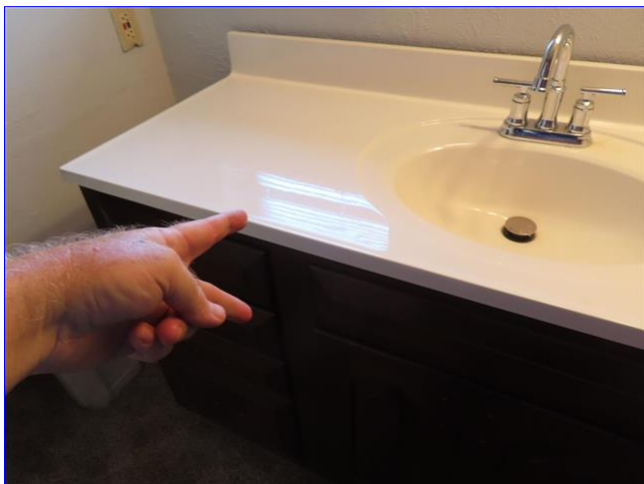
A. Item 11(Picture)

(9) Bathroom cabinets and countertops were loose from wall in both bathrooms at time of inspection. Should have a professional correct and secure properly.

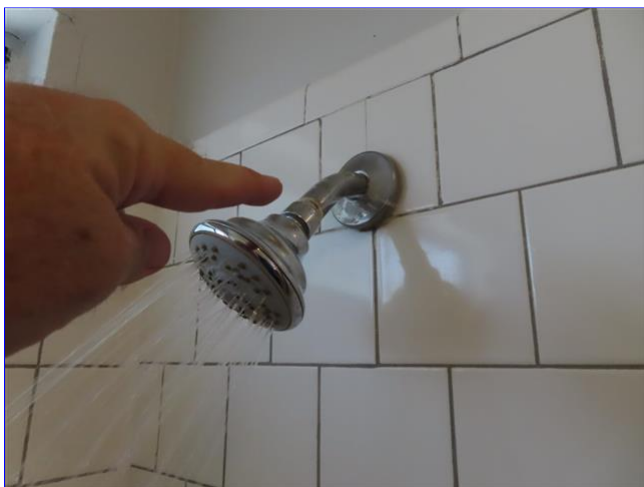
A. Item 12(Picture)

(10) Both showerheads were leaking at plumbing connection at time of inspection. Should have a professional plumber correct properly.

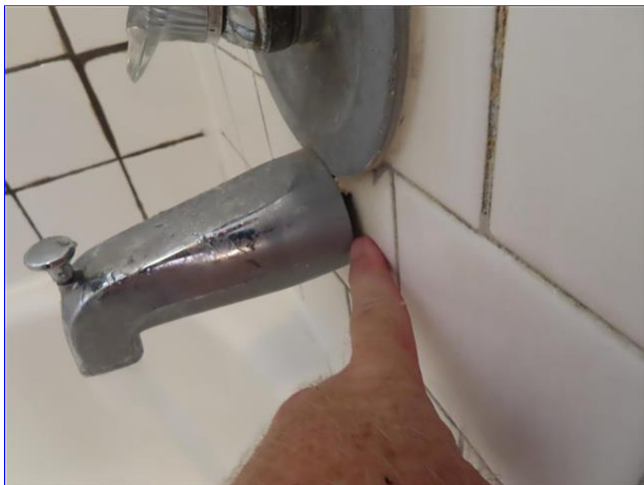
A. Item 14(Picture)

(11) All bathtub faucet gaps from tile walls should be sealed properly. Conducive to moisture intrusion and causing possible damage.

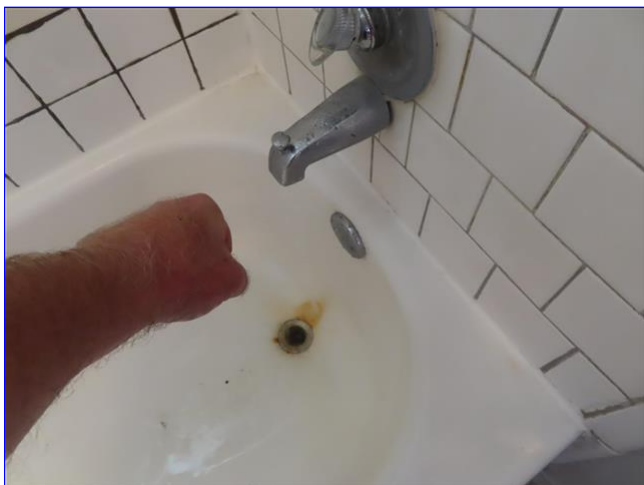
A. Item 15(Picture)

(12) Bathtub on hot side was not producing water at time of inspection. Should have a professional plumber inspect and correct properly.

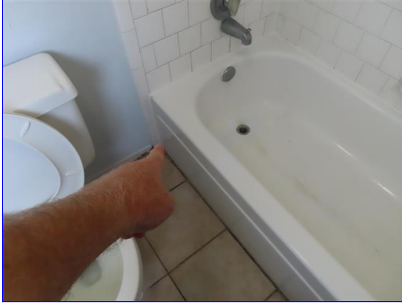
A. Item 16(Picture)

(13) Bathtubs and showers were missing plumbing access panel at time of inspection. Should have a professional plumber correct properly.

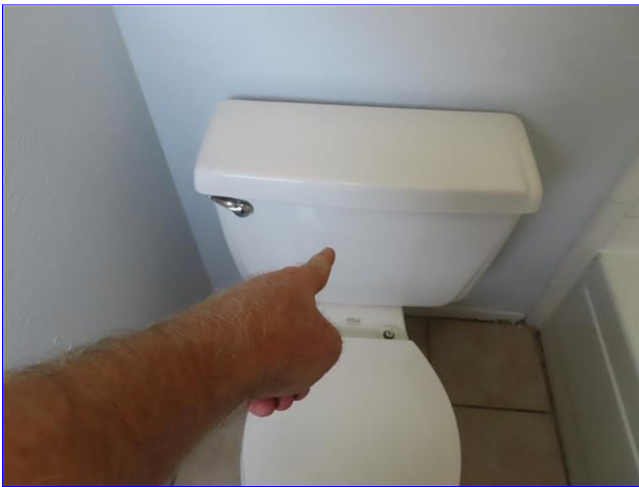
A. Item 17(Picture)

(14) Middle bathroom toilet bowl was loose at time of inspection. Should have a professional plumber correct properly. Conducive to leaking and causing possible damage.

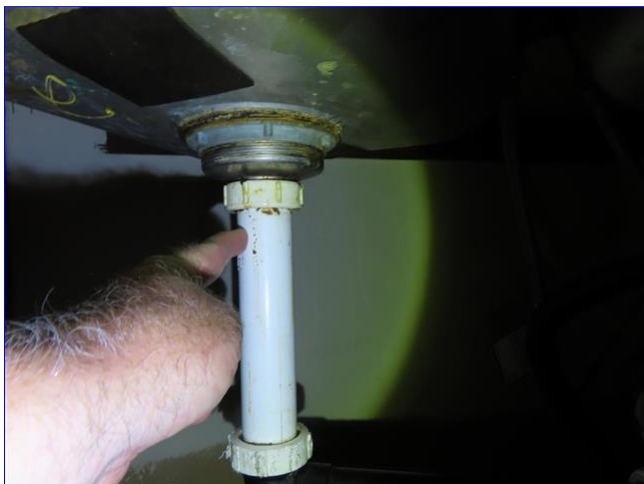
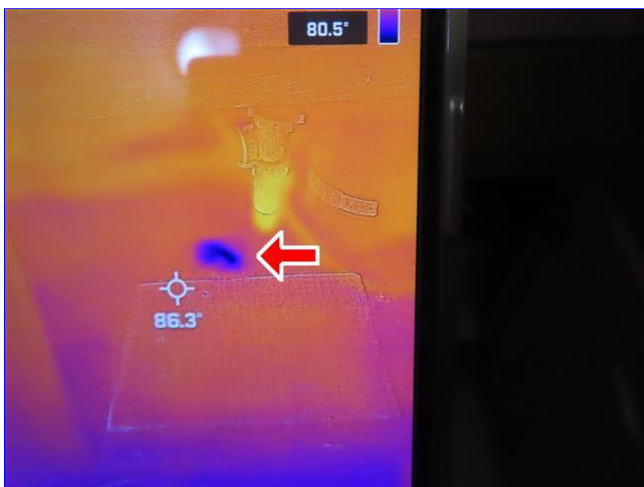
(1) Kitchen sink drain has signs of possibly leaking at time of inspection. Should have a professional plumber inspect and correct properly.

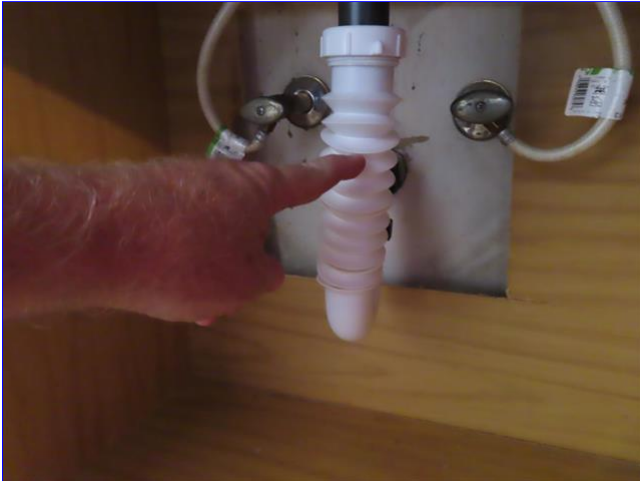
B. Item 3(Picture)

(2) Several bathrooms sink drain plumbing were loose and installed with improper flex piping at time of inspection. Conducive to leaking and causing possible damage. Should have a professional plumber correct.

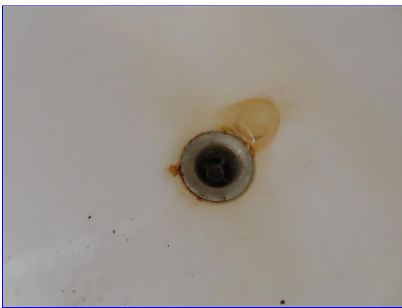
B. Item 4(Picture)

(3) Bathtub were missing drain stoppers at time of inspection. Should have a professional plumber inspect and correct properly.

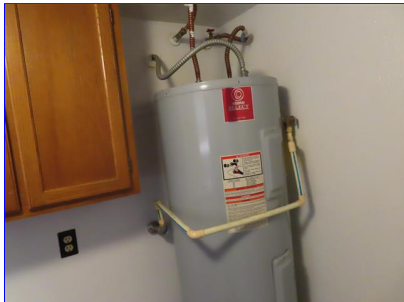
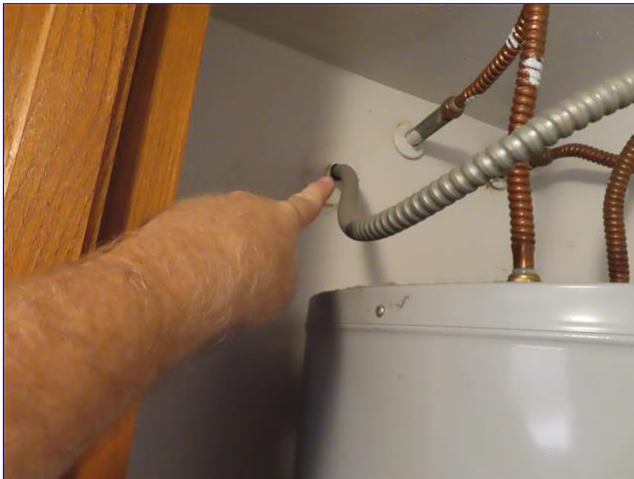
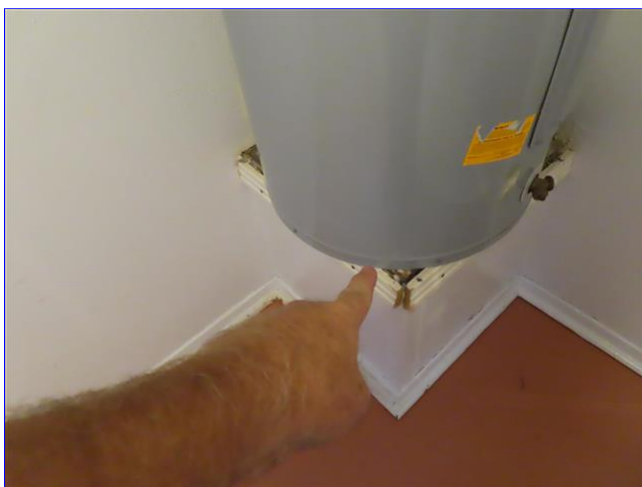
Aged 2007 State electric 50 gallon hot water heater in the utility room was operating properly at time of inspection. Unit was missing drip pan and drain to exterior, unit electrical was missing proper disconnect box at time of inspection. Should have a professional correct properly.

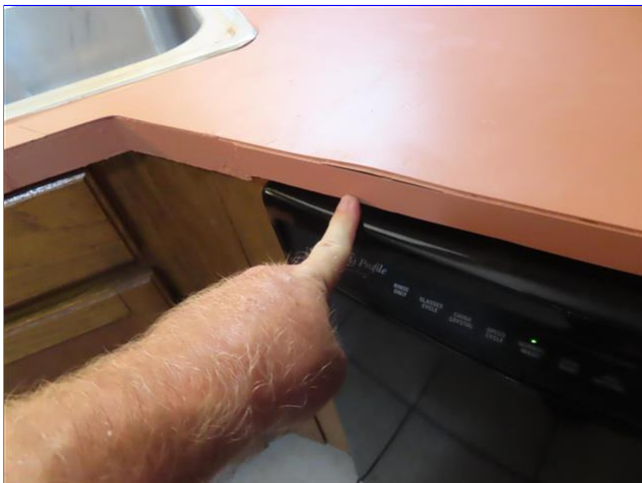
A. Item 1(Picture)

GE dishwasher was not operating properly at time of inspection. Unit door was catching countertop and door was not operating properly at time of inspection. Should have a professional inspect and correct properly.

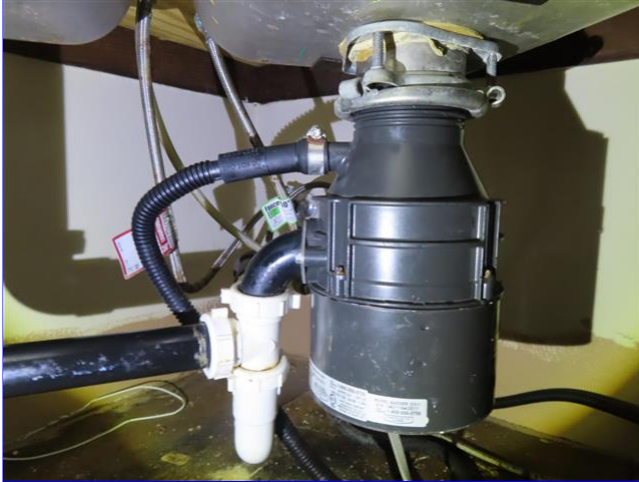
B. Item 1(Picture)

Badger disposal was not operating properly at time of inspection. Electrical to unit was missing proper electrical connector at time of inspection. Should have a professional plumber inspect and correct properly.

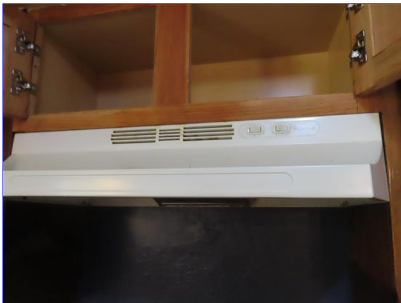
C. Item 1(Picture)

Nutone exhaust fan and light was working properly at time of inspection.

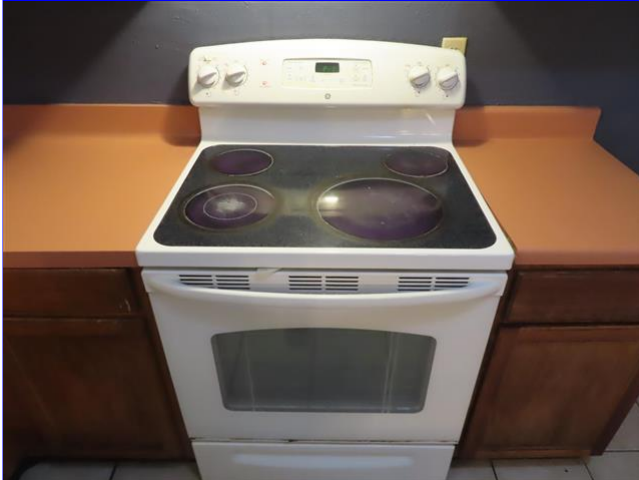
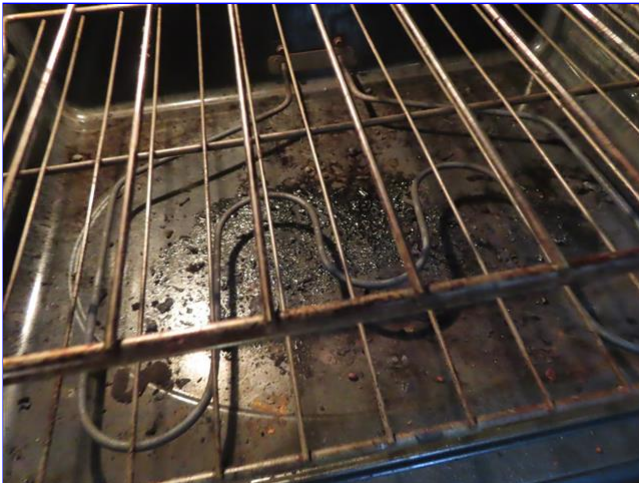
D. Item 1(Picture)

GE electric cooktop and oven was working properly at time of inspection. Unit was loose in compartment and may be missing Anti Tip Device. Unit should be secured properly. Possible safety hazard. Interior of oven is dirty and should be cleaned properly.

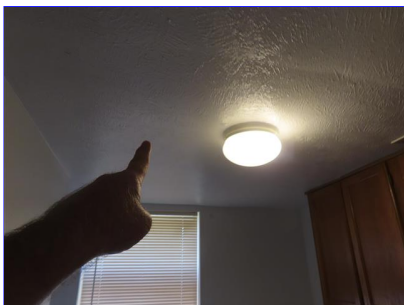
F. Item 1(Picture)

(1) Utility room was missing exhaust fan at time of inspection.

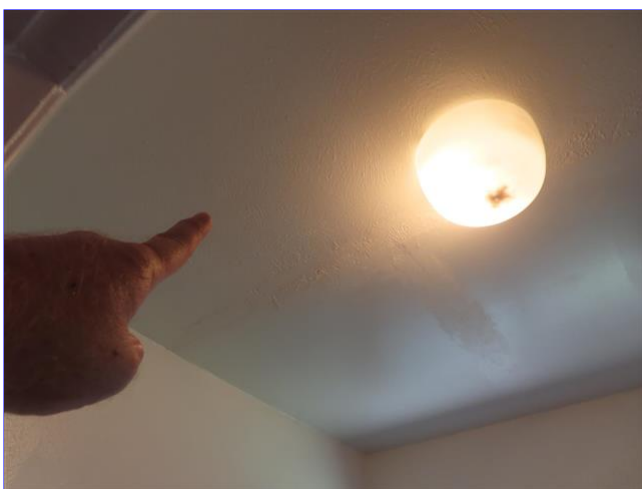
F. Item 2(Picture)

(2) Several bathrooms were missing exhaust fans at time of inspection. Should have a professional correct properly.

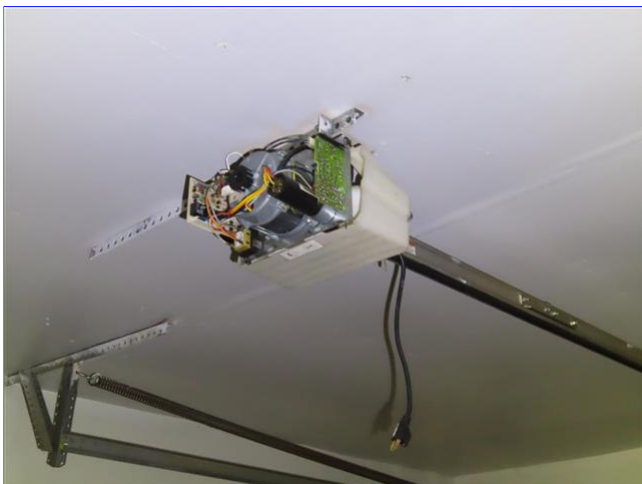
G. Item 1(Picture)

Garage door opener was damaged and not operating at time of inspection. Should have a professional Door Tech replace unit properly.

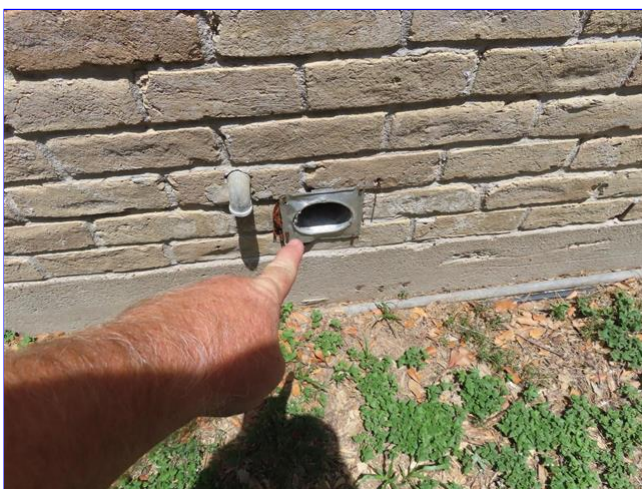
H. Item 1(Picture)

Exterior dryer vent was missing at time of inspection. Should have a professional plumber replace properly.
