Inspection Report

Property Address:
18407 Autumn Park Dr
Houston TX 77084

PROPERTY INSPECTION REPORT

By: Matt Smith - 23130 / HG Home Inspections 4/2/2021

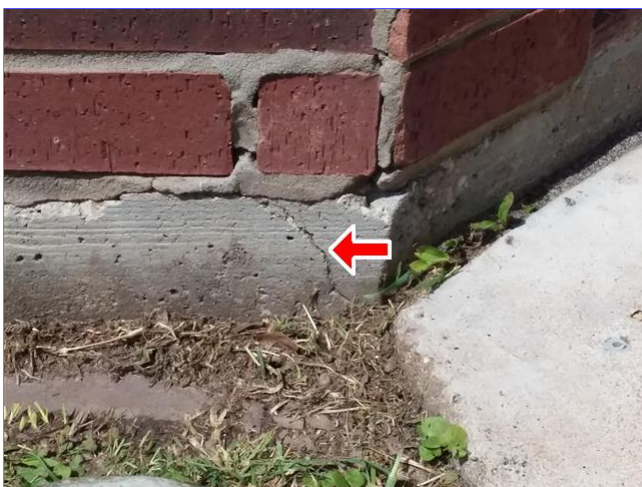
A. Item 3(Picture) minor corner pop back side

- (1) This is not an engineering report, but is only an opinion based on observation of conditions known to be related to foundation performance, using the knowledge and experience of the inspector.
- (2) The foundation is poured on grade with post tension cables and appears to be performing as designed.
- (3) The foundation has large corner pop(s) that are larger than 4 inches. Further deterioration will occur if not corrected. I recommend having a qualified person make repairs as needed.

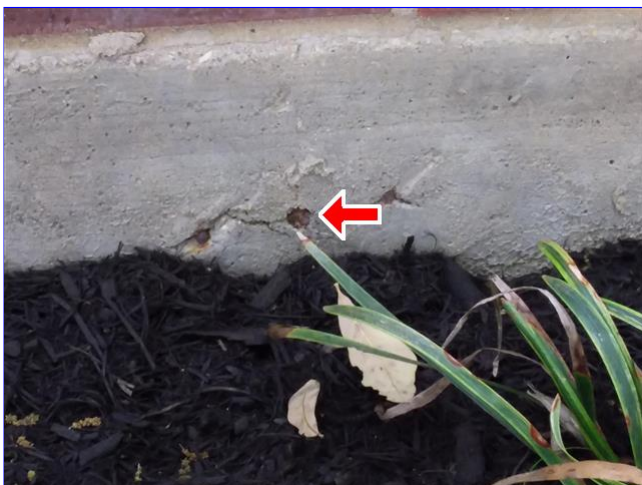
A. Item 4(Picture) exposed to cable front of home

(4) The post tension foundation has exposed cable ends that are starting to show signs of deterioration.

This is a maintenance issue. Further deterioration will occur if not corrected. I recommend having a qualified person make repairs as needed.

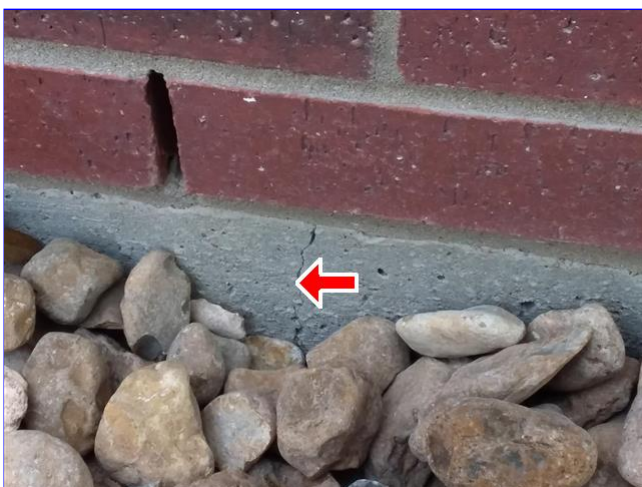
A. Item 5(Picture) slight crack left side

(5) The foundation wall has slight visible cracking. I recommend monitoring the crack at this time. If they crack increases in size, I recommend having a foundation company or Structural Engineer further evaluate.

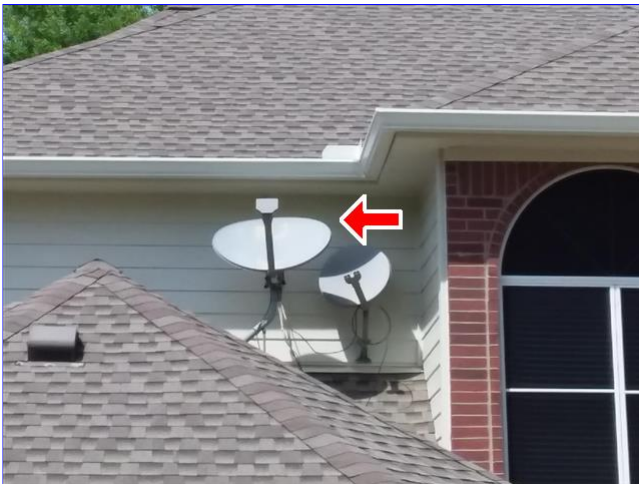
C. Item 1(Picture) dish on roof

(2) There is a satellite dish bracket mounted on roof that is screwed directly through roofing surface. This is not considered to be today's standard. I recommend having a qualified person remove and patch roofing as needed. (The area will need periodic maintenance) **Dish (2) removed. Mounts left intact since not leaking.**

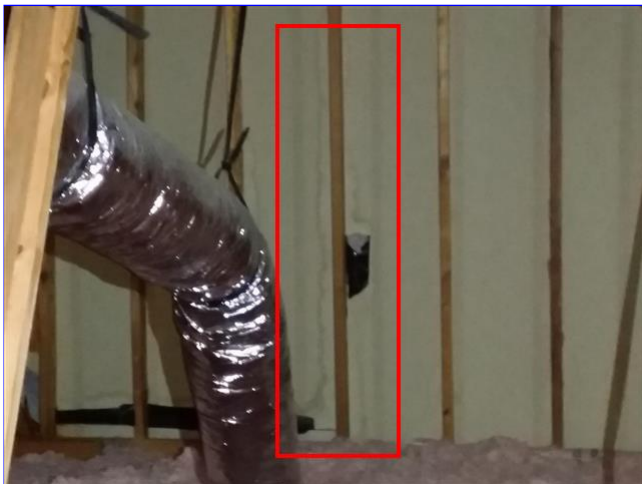
D. Item 1(Picture) evidence of previous leak in attic

(1) The roof structure in the attic has water stain indicating a leak did or still exists in areas. The moisture meter was used and it did not indicate an active moisture at the time of the inspection. A qualified contractor should inspect and repair as needed. **New Roof installed 2016, per previous owner.**

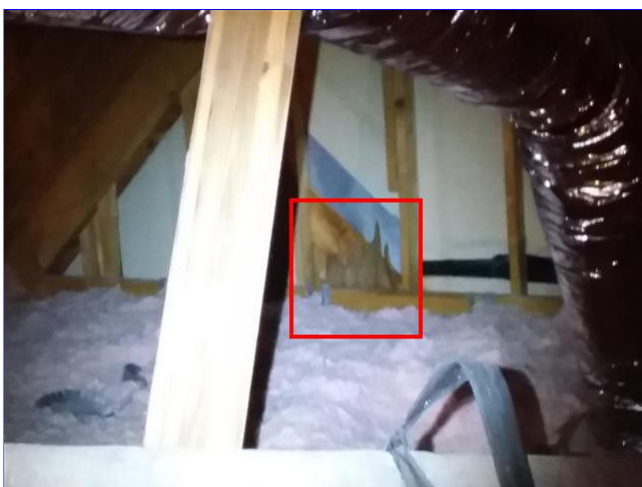
D. Item 2(Picture) evidence of former beehive in attic

(2) Evidence of a former beehive was observed in the attic. Homeowner and formed the inspector that the bee colony has been professionally removed. **Prior owner indicated professional pest control company removed**

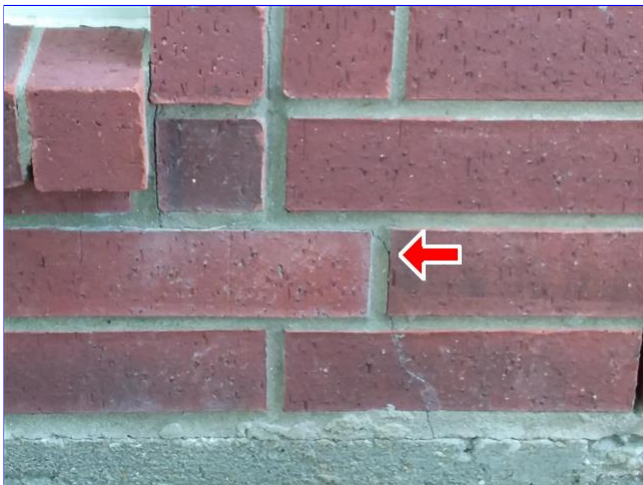
E. Item 1(Picture) Step crack front right window

(1) The Brick siding at the exterior has step cracks caused from settlement. Deterioration can eventually occur if not corrected. A qualified contractor should inspect and repair as needed.

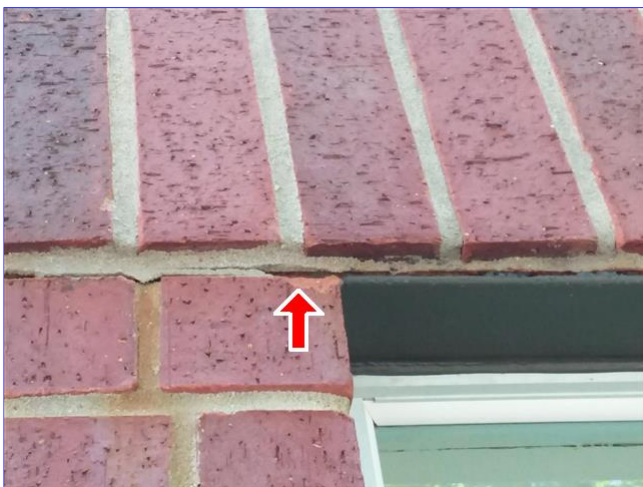
E. Item 2(Picture) window lintel rust

(2) Lintels above windows are showing signs of deterioration in area's. Further deterioration may occur if lintels are not primed and painted. A qualified person should repair as needed.

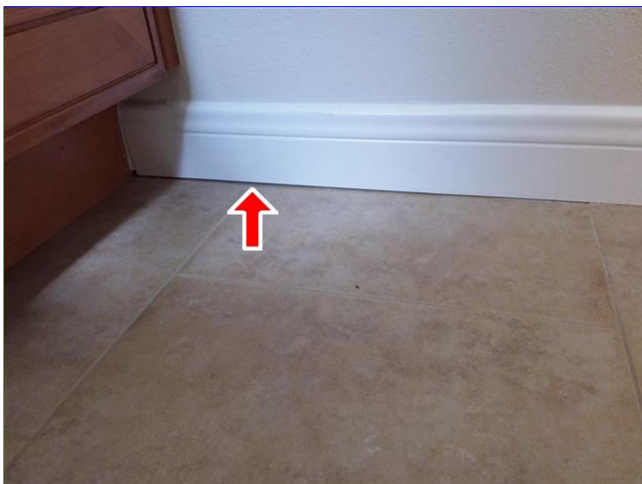
E. Item 3(Picture) baseboard separation and master bathroom

(3) Baseboards have some separation and deterioration of caulking. I recommend having a qualified person make repairs of needed

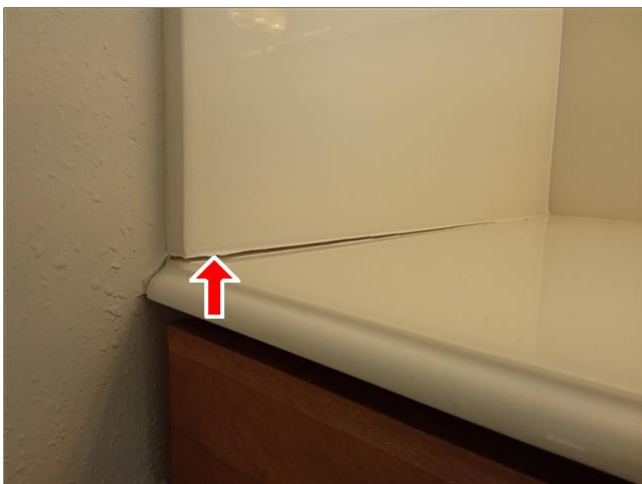
E. Item 4(Picture) missing sealant master bathroom counter

(4) The master bathroom counter is loose and missing sealant at the counter top. I recommend repairs as needed. **Repaired**

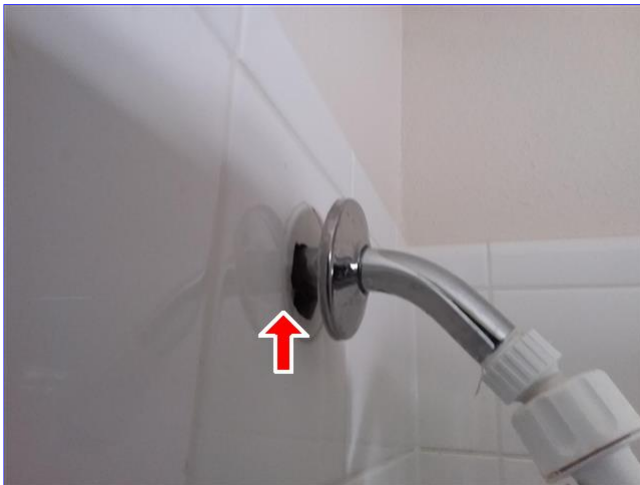
E. Item 6(Picture) guest bathroom one shower had not sealed

(5) Areas where wiring or piping passes through walls should be sealed. I recommend having a qualified person seal as needed.

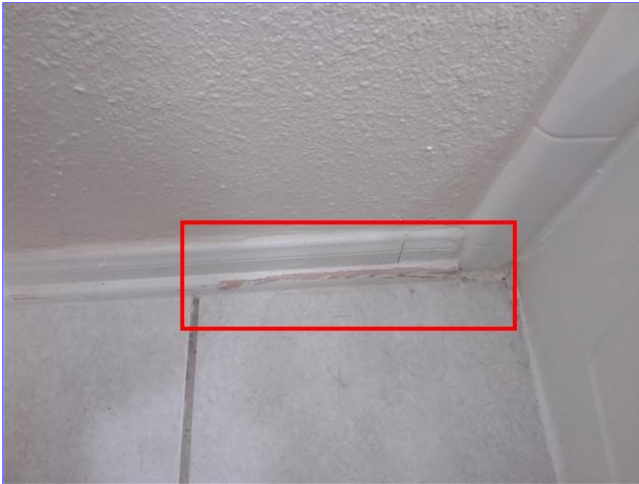
E. Item 8(Picture) guest bathroom baseboard trim peeling

(7) Interior trim is damaged or peeling paint in areas. This is a cosmetic issue. I recommend repair as desired. Painted

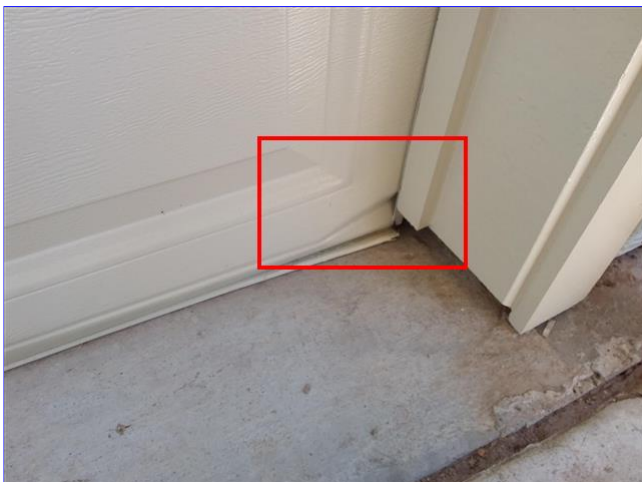
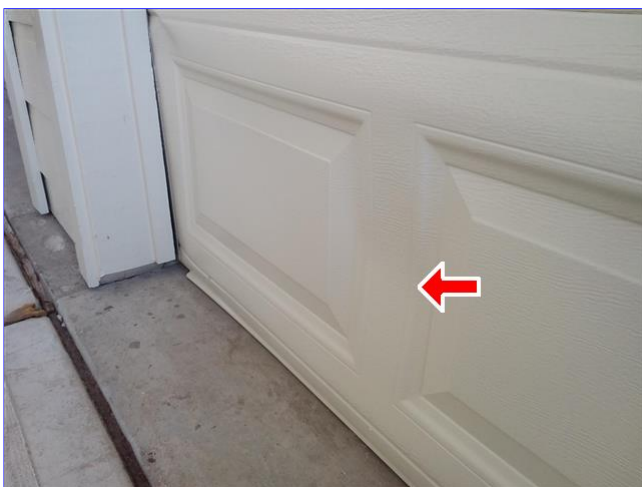
G. Item 1(Picture) right garage door warped

(1) The garage door at the rear of home is damaged at panel. Warped doors usually cannot be easily corrected. A qualified person should repair or replace as needed.

G. Item 2(Picture) right garage door warped

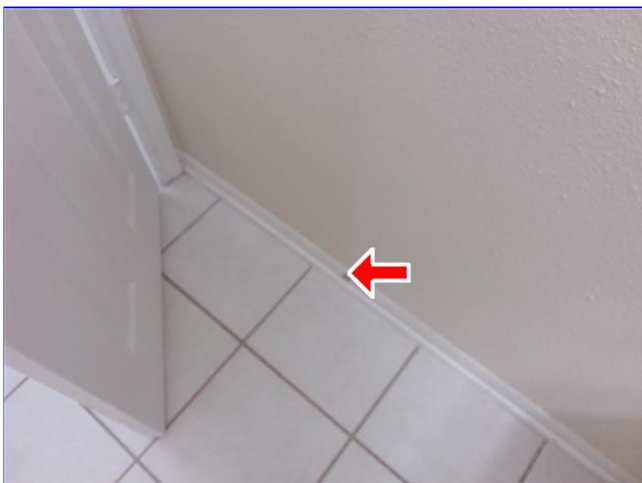
G. Item 3(Picture) doorstops missing in areas

(2) There are door stops missing in the home. This is not considered to be today's standard I recommend having a qualified person make repairs as needed. **Repaired/Replaced all**

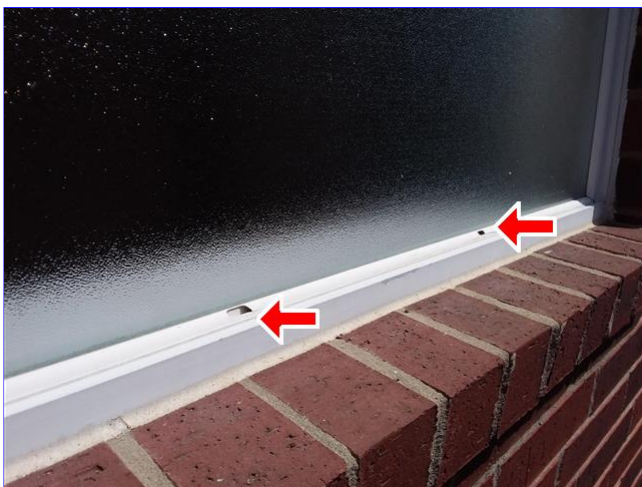
H. Item 1(Picture) cracked glazing strip master bathroom exterior

(1) There are window frames that are not properly sealed. This can cause energy loss. I recommend having a qualified person seal and repair as needed,

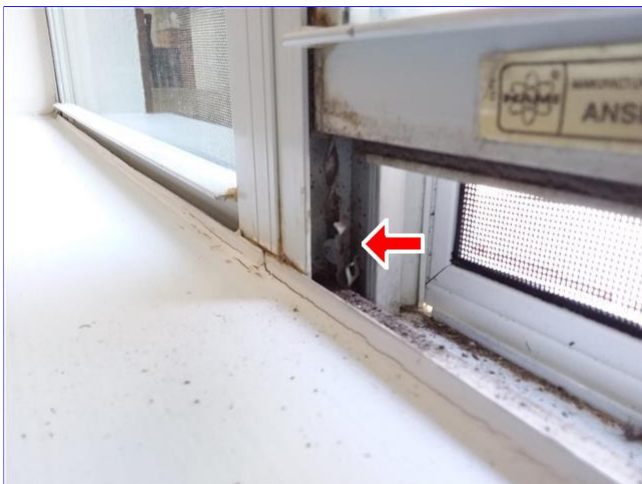
H. Item 3(Picture) spring loose in living room window

(2) Windows the jamb spring is weak or no longer works properly in areas. A repair may be needed. A qualified person should repair or replace as needed.

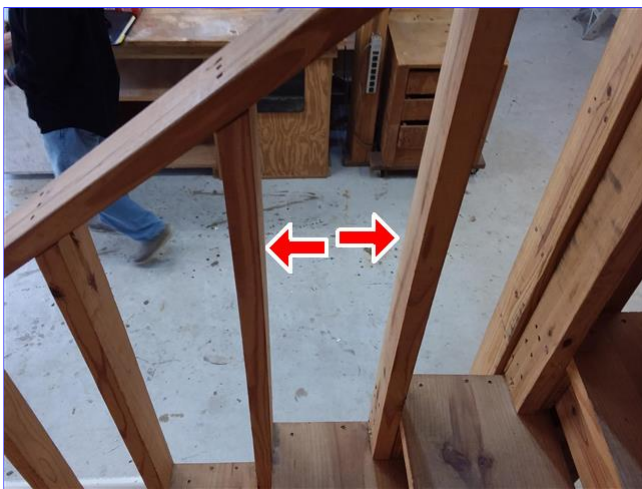
I. Item 1(Picture) pickets greater than 4 inches

(1) The pickets on the guard rail at the upstairs are spaced to far apart for safety. Spacing more than 4 inches apart could allow an adult, child or pet to fall through.

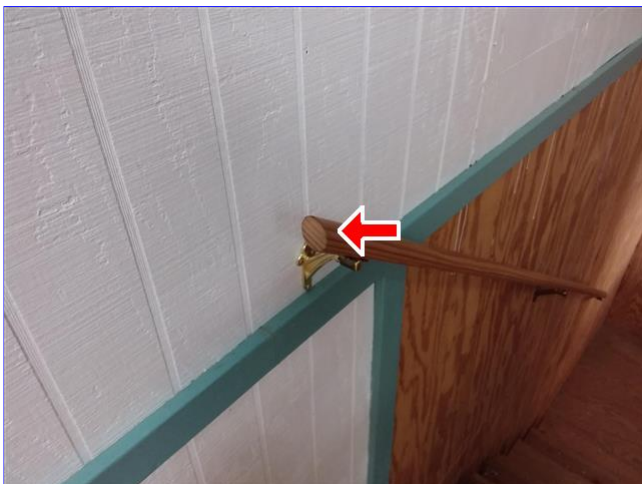
I. Item 2(Picture) corner piece missing

(2) The hand/guard rail for the upstairs missing corner piece. A fall or injury could occur if not corrected. I recommend repair as needed.

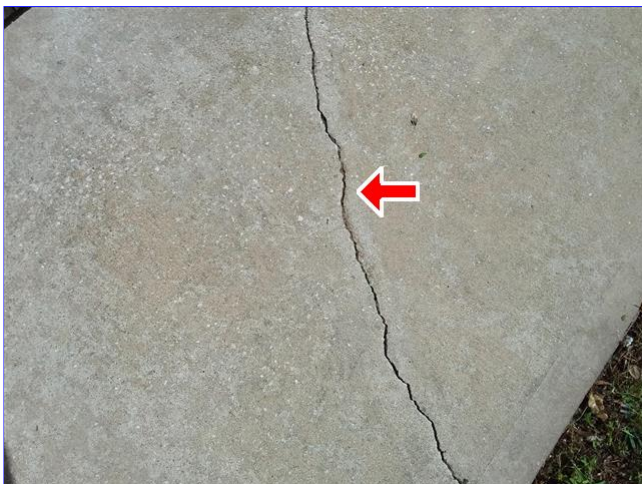
K. Item 1(Picture) cracked back patio

- (1) The weight load capabilities are not part of this inspection.
- (2) The concrete floor on the patio at the rear of home has cracked in some areas (which are cosmetic). Further deterioration can occur if not repaired. I recommend repair as desired. Filled/Sealed larger cracks

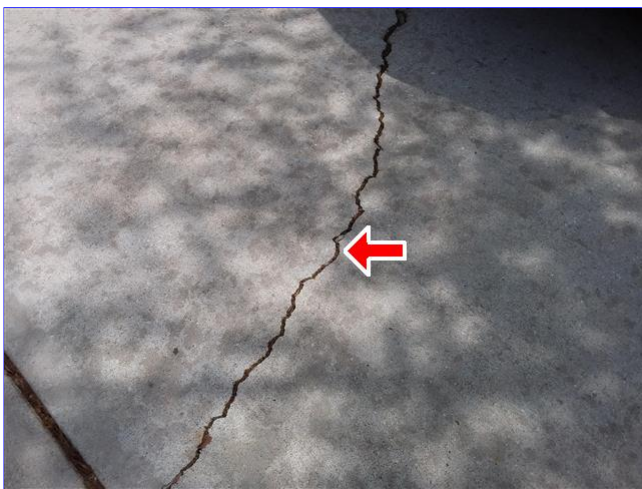
L. Item 1(Picture) settlement cracks in driveway

(1) The concrete drive at the front of home has settlement cracks. Further deterioration can occur if not repaired. I recommend repair as desired. Filled/Sealed larger cracks

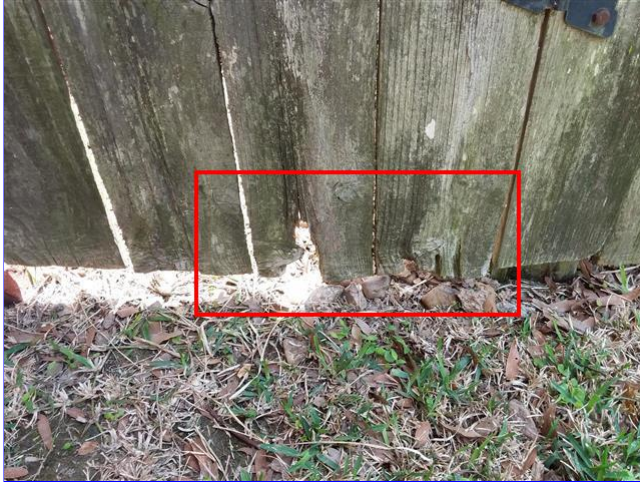
L. Item 2(Picture) fence deterioration in areas

(2) Fence is deteriorated/damaged in area's. Recommend repair or replace by a qualified contractor.

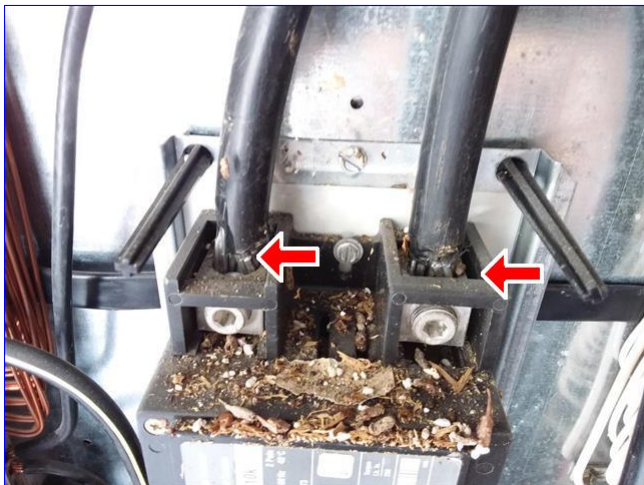
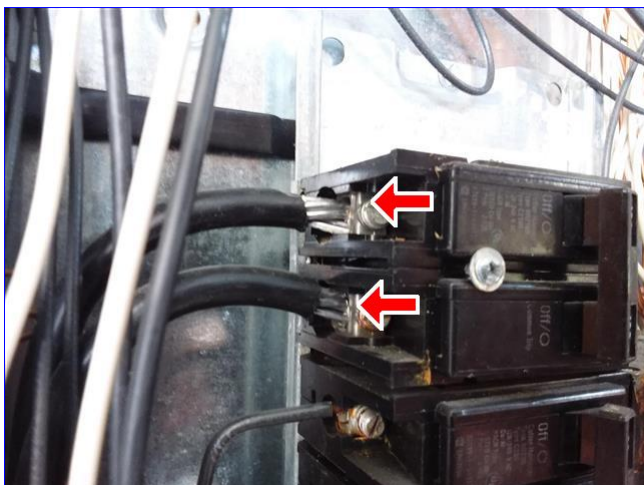
A. Item 1(Picture) missing antioxidant

(1) There is no antioxidant on aluminum conductors feeding panel. This is not considered to be today's standard. I recommend having a qualified electrician evaluate make repairs as needed. **Repaired**

A. Item 2(Picture) missing antioxidant sub panel

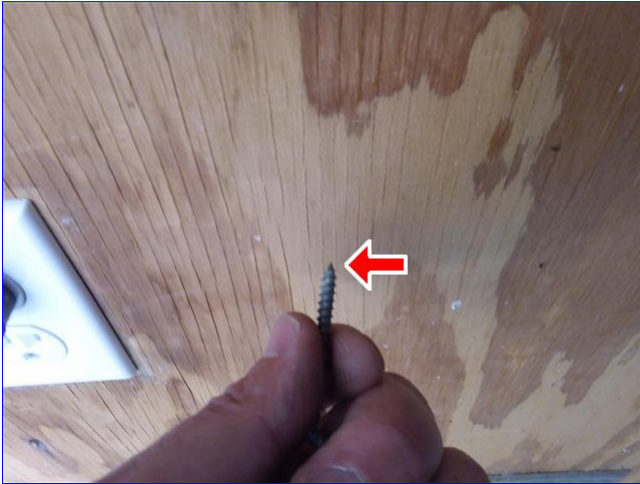
A. Item 3(Picture) improper panel screw

(2) The panel cover is using (sharp) improper screws. This is a safety hazard until corrected. I recommend having a qualified person make repairs as needed, **Replaced with proper, blunt-end screws**

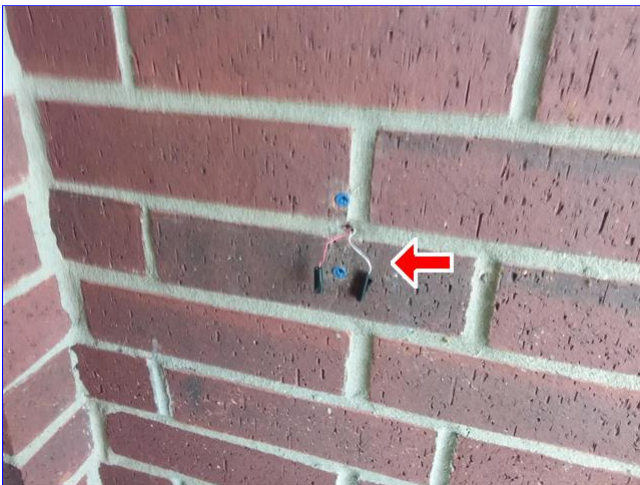
B. Item 1(Picture) doorbell missing

(2) The alternate Doorbell was not installed at the time of inspection. I recommend having a qualified person repair. **Repaired. New BLINK doorebll/camera installed**

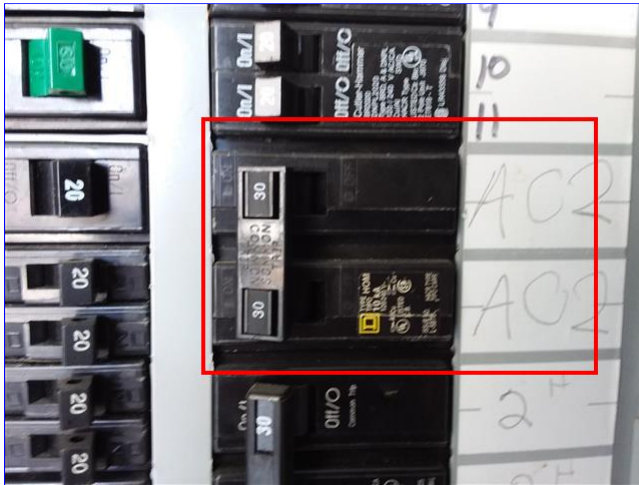
B. Item 3(Picture) Square D breaker in cutler hammer box

This statement is incorrect. Square D brand and Eaton brand breakers are compatible with Cutler-Hammer panels, per Cutler-Hammer.

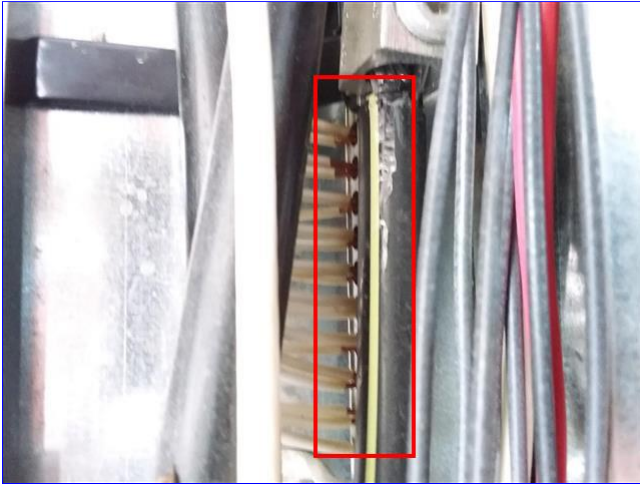
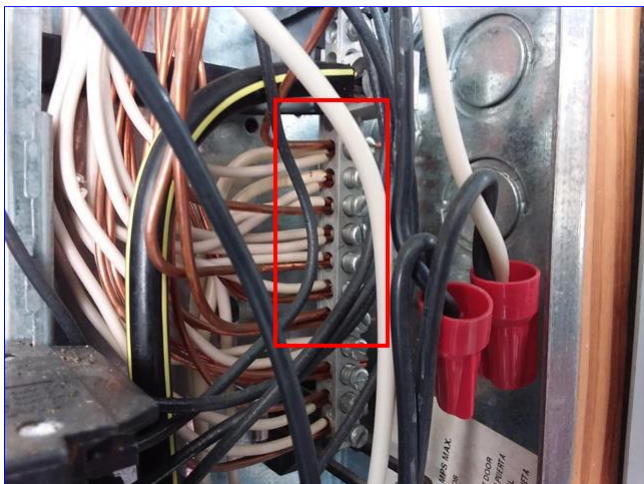
B. Item 4(Picture) double lugged neutrals in main panel

(5) Problem(s) discovered with Branch Circuits such as amateur wiring installation, doubled wiring at neutral/grounding bar, and any other problems that an electrical contractor may discover while performing repairs need correcting. I recommend a licensed electrical contractor inspect further and correct as needed.

B. Item 6(Picture) double lugged neutrals in sub panel

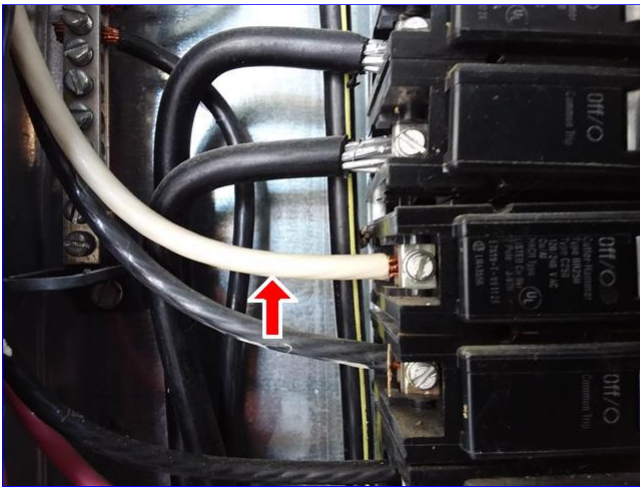
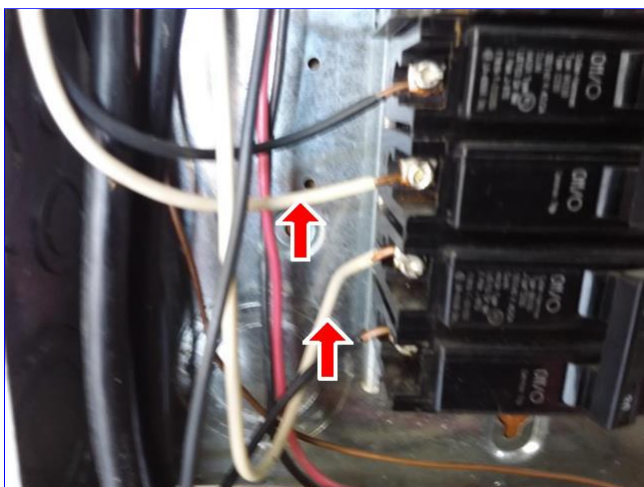
B. Item 5(Picture) wire not marked

B. Item 7(Picture) wires not marked

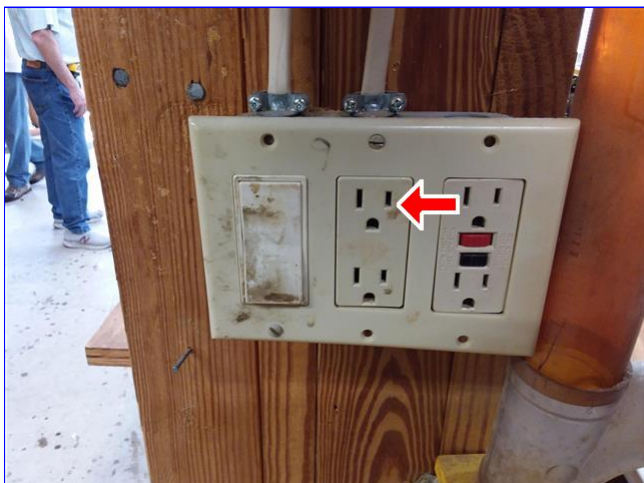
B. Item 8(Picture) missing GFCI in garage

(6) There are no GFCI protected circuits in required area's. This is not considered to be today's standard. I recommend having a qualified electrician make repairs as needed.

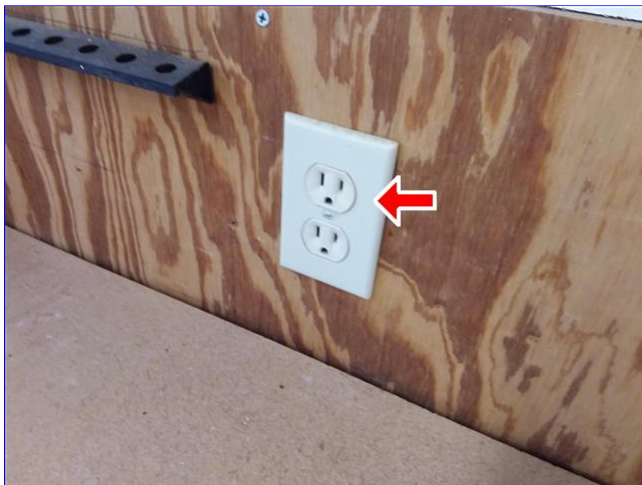
B. Item 9(Picture) loose outlets in areae

(7) Outlets are loose in wall in areas. Electrical issues are considered a hazard until repaired. A qualified licensed electrical contractor should perform repairs that involve wiring.

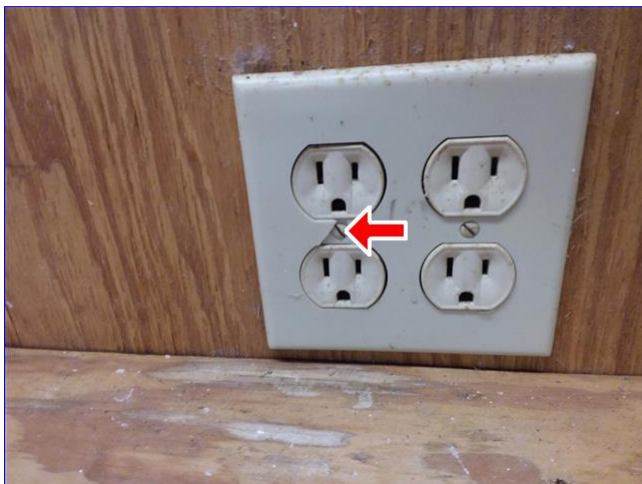
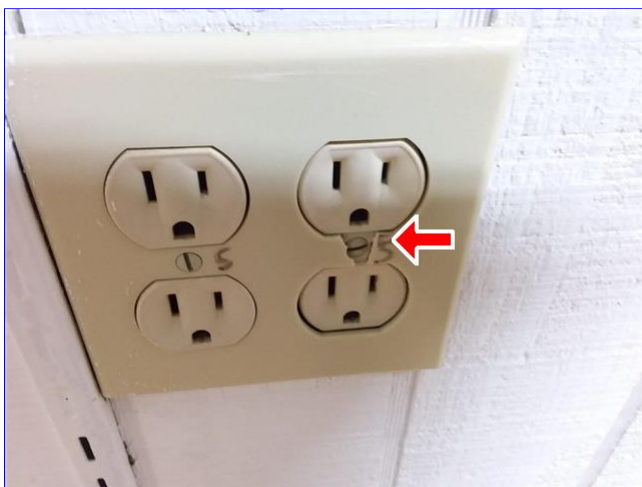
B. Item 10(Picture) damaged cover in garage

(8) The outlet cover is damaged and needs repair or replace. I recommend having a qualified person make repairs as needed.

B. Item 11(Picture) damaged cover second floor garage outlet

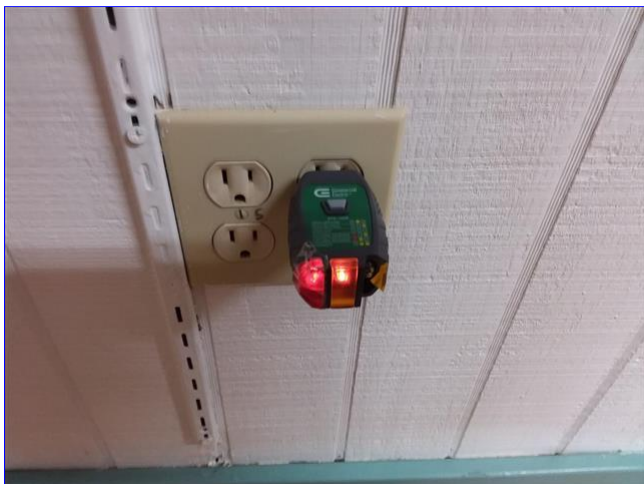
B. Item 12(Picture) reversed polarity second floor garage outlet

(9) Outlets are incorrect "reverse polarity" in areas. Electrical issues are considered a hazard until repaired. A qualified licensed electrical contractor should perform repairs that involve wiring.

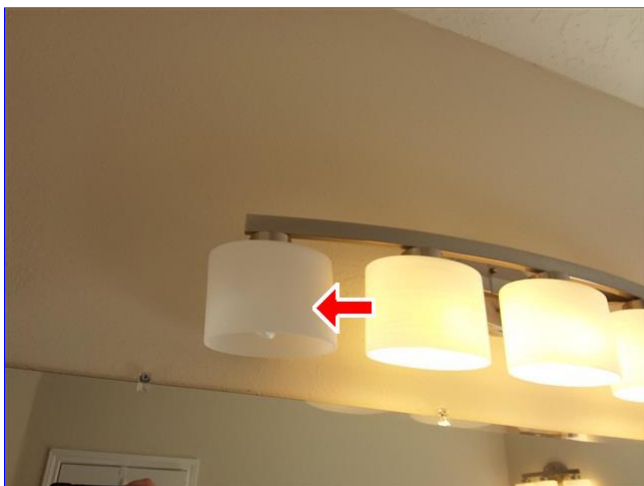
B. Item 13(Picture) master bathroom light out

(10) The light fixture does not work (try bulb first). Electrical issues are considered a hazard until repaired. A qualified licensed electrical contractor should perform repairs that involve wiring. **Repaired**

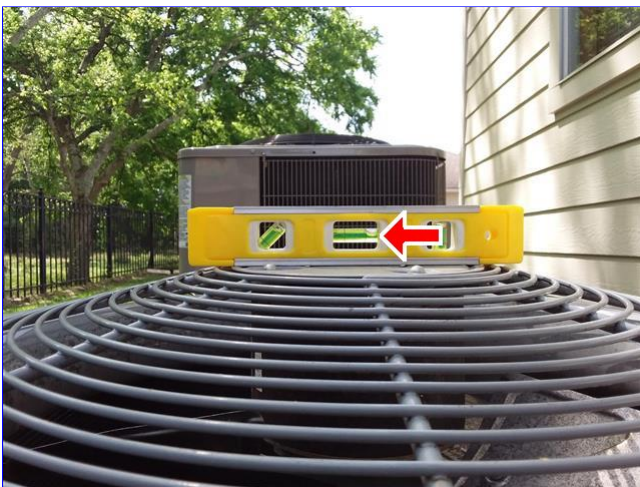
B. Item 11(Picture) garage unit 2 not level Has been leveled

(4) The condenser is not level. This can cause damage to the unit or shorten its life span. I recommend service or repair as needed. **Has been leveled.**

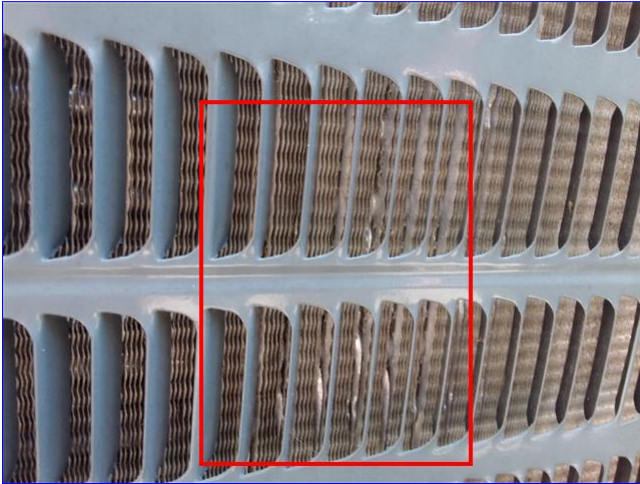
B. Item 12(Picture) unit 2 coil damage

(5) Condenser coil at exterior of home is damaged in areas. This damage can shorten the life expectancy of the unit. I recommend having a qualified HVAC company inspect and make repairs as needed.

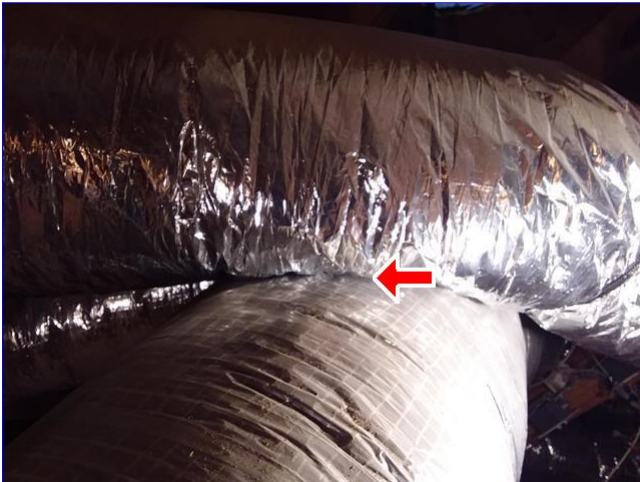
C. Item 1(Picture) duct contact in attic

(2) Duct piping appears to be in contact with one another in the attic space. Condensation could occur if not corrected. I recommend having a qualified HVAC contractor further evaluate and make repairs as needed.

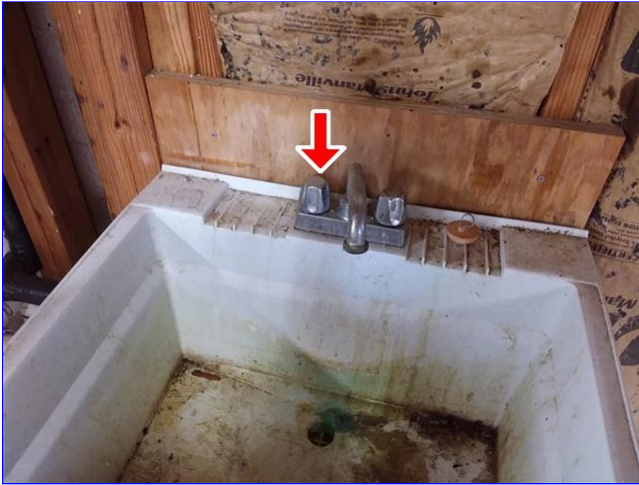
A. Item 1(Picture) no hot water supply and continuous drip in garage

The garage sink has no hot water supply and has a **slow continuous drip**. Repair may be needed. **Repaired**

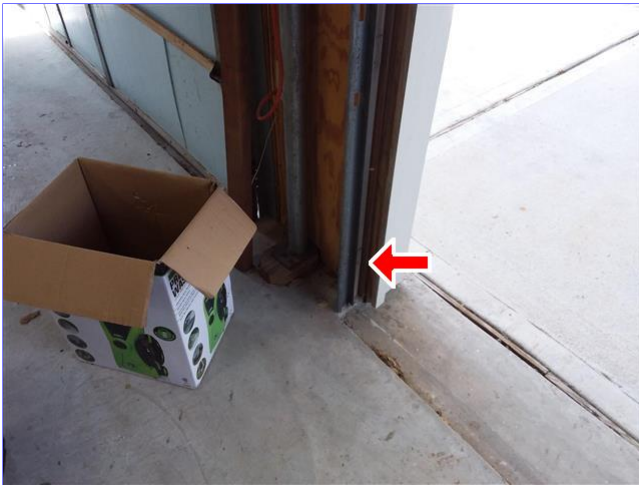
G. Item 2(Picture) door sensors missing

(2) The sensors are not in place for the left garage door. This is a potential safety hazard. The installation of sensors is recommended.
