## RESIDENTIAL INSPECTION REPORT

1519 Lake Buchanan Ct  
Richmond, TX 77406

# PROPERTY INSPECTION REPORT FORM

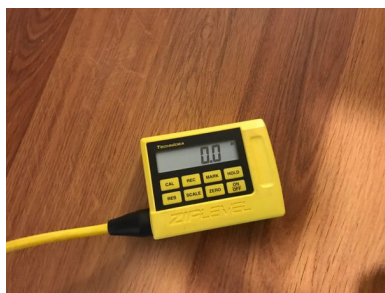
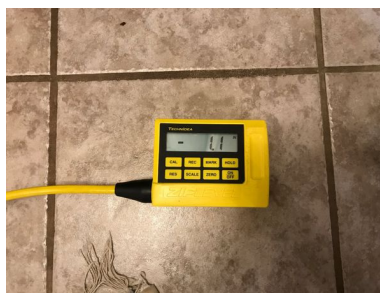
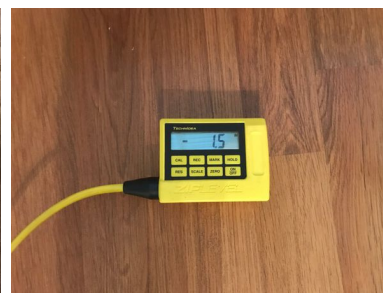
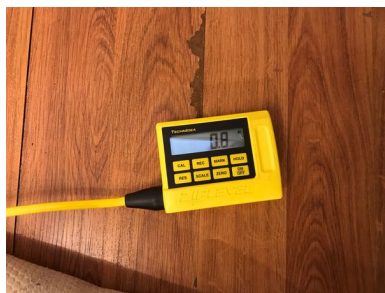
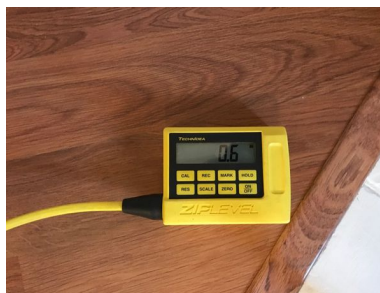
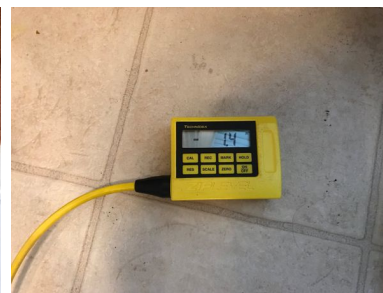
*Foundation Inspected with Digital Level:*

This foundation was measured with the use of an electronic digital measurement tool. Multiple elevation points were registered on the foundation throughout the property to determine if there were elevation variations that indicated excessive movement of the foundation. At the time of this inspection the measured areas did not indicate any variations that, in this inspector's OPINION, indicated any need for invasive repairs to the foundation.

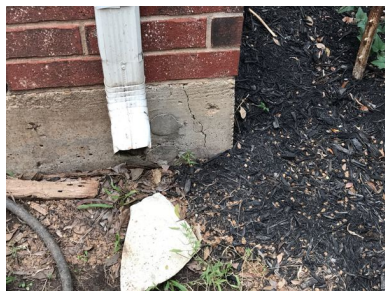
**1: Slab: Shear Cracks**

**Note:** Shear cracking ("corner pops") observed at foundation corners is not normally associated with structural movement or deficiencies.

Recommendation: Contact a handyman or DIY project

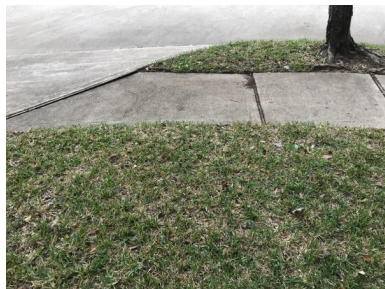
**1: Grading & Drainage: Uneven/Cracked Flatwork**

Uneven or Cracked flatwork can be a trip hazard. Evaluation and remediation recommended.

Recommendation: Contact a qualified concrete contractor.

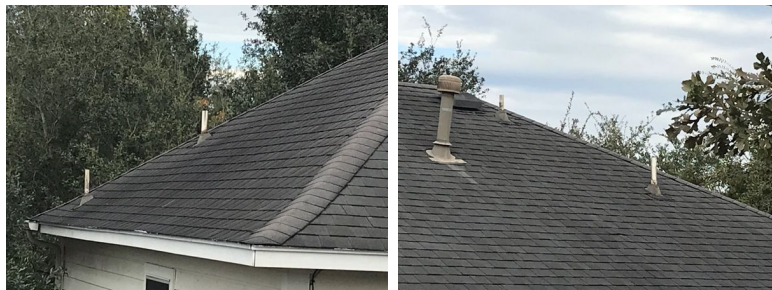
**1: Flashing Deficiencies**

PVC Roof Vents not Painted -

Deficiencies with the flashings were present at the time of inspection. Evaluation and remediation is recommended.

Recommendation: Contact your builder.

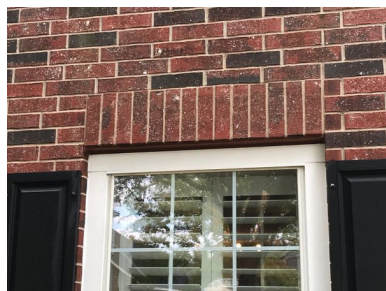
**1: Exterior Masonry: Weep holes not present over openings**

Weep holes were not installed in brick above steel lintels over windows and/or doors. Modern practices often utilize weep holes to prevent rusting of steel lintels supporting brick. If there is visible moisture damage to steel lintels or other building materials around these openings then this condition should be evaluated by a brick mason for possible correction. Otherwise the area should be monitored periodically.

Recommendation: Contact a qualified professional.

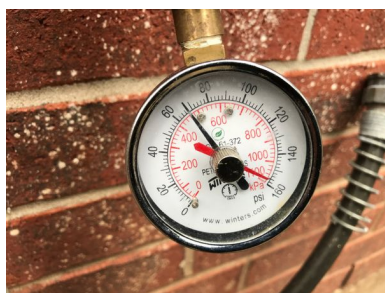
*Static water pressure reading:* 70 psi
