LAND TITLE SURVEY

JOB NO.:	2204033689	NO.	REVISION	DATE
DATE:	04/23/22			
DRAWN BY:	NK/FR			
APPROVED BY:	RRR

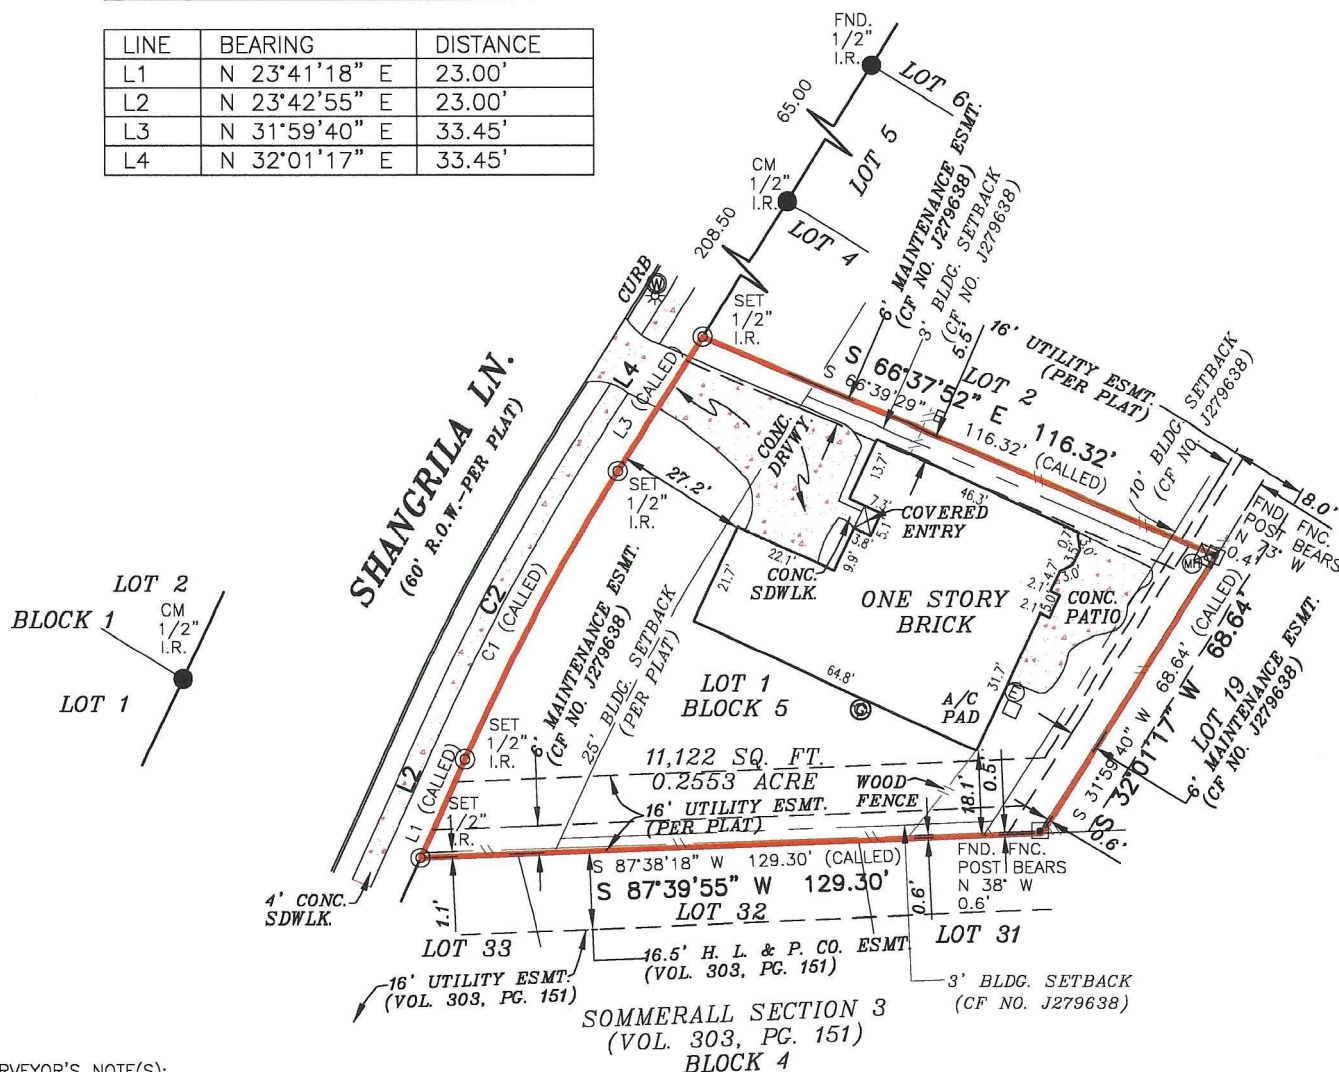
CURVE	RADIUS	ARC LENGTH	CHORD LENGTH	CHORD BEARING	DELTA ANGLE
C1	470.00'	68.14'	---	---	---
C2	470.00'	68.14'	68.08'	N 27°52'06" E	08°18'22"

LINE	BEARING	DISTANCE
L1	N 23°41'18" E	23.00'
L2	N 23°42'55" E	23.00'
L3	N 31°59'40" E	33.45'
L4	N 32°01'17" E	33.45'

THE ORIGINAL PLAT RECORD IS ILLEGIBLE. THIS REPRESENTATION IS SURVEYOR'S BEST INTERPRETATION OF RECORD INFORMATION.

THE SETBACKS AND EASEMENTS SHOWN ON THIS DRAWING ARE THE BEST INTERPRETATION OF THE SURVEYORS BASED ON THE INFORMATION AVAILABLE TO US AT THE TIME OF THE DRAWING.
