# PROPERTY INSPECTION REPORT FORM

| Jovanni Bradley<br><i>Name of Client</i> | 07/01/2023 10:00 am<br><i>Date of Inspection</i> |
| 3 Robinhood Dr, Conroe, TX 77301<br><i>Address of Inspected Property</i> | |

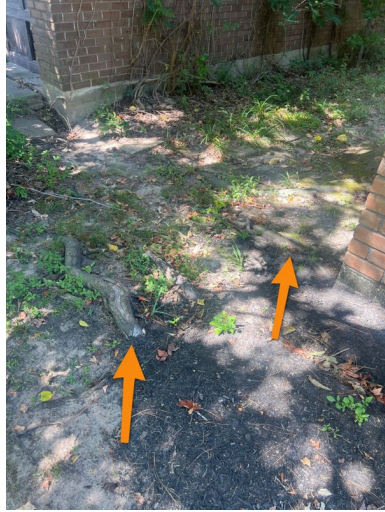
**2: Vegetation**

Large rooted vegetation near the foundation may effect the performance of the foundation

Recommendation: Contact a qualified professional.

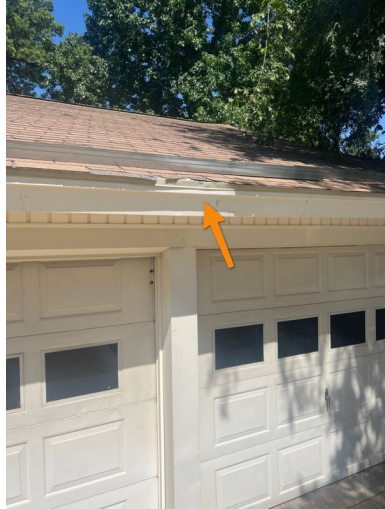
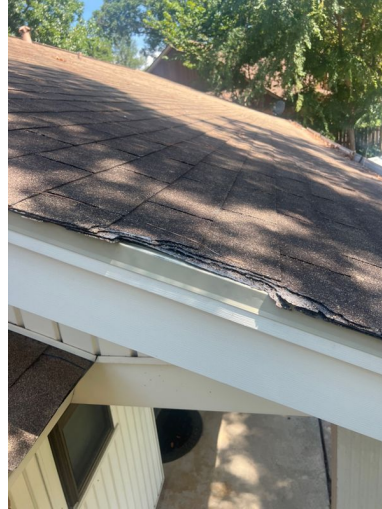
**1: Damaged Coverings**

Roof coverings exhibited general damage that could affect performance. Recommend a qualified roofer evaluate and repair.

Recommendation: Contact a qualified roofing professional.

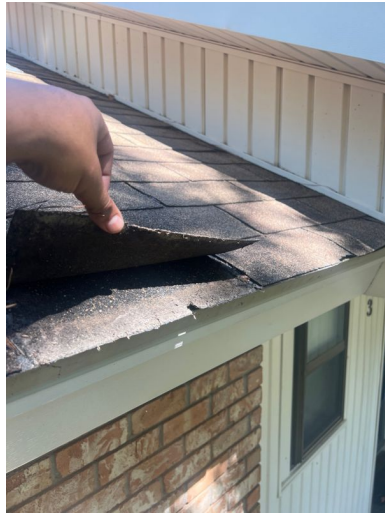
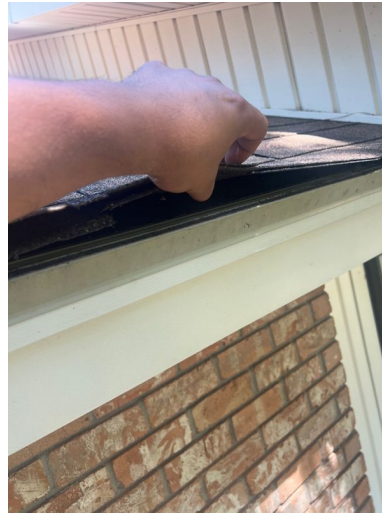
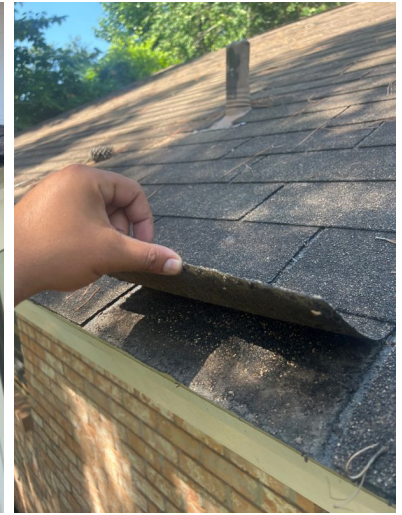
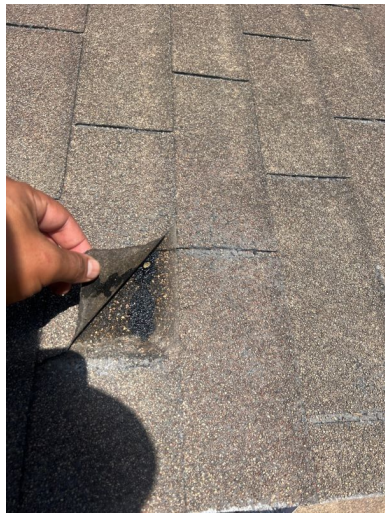
**2: Loose/unsealed**

Loose/unsealed shingles observed, I recommend a qualified professional evaluate and repair.

Recommendation: Contact a qualified professional.

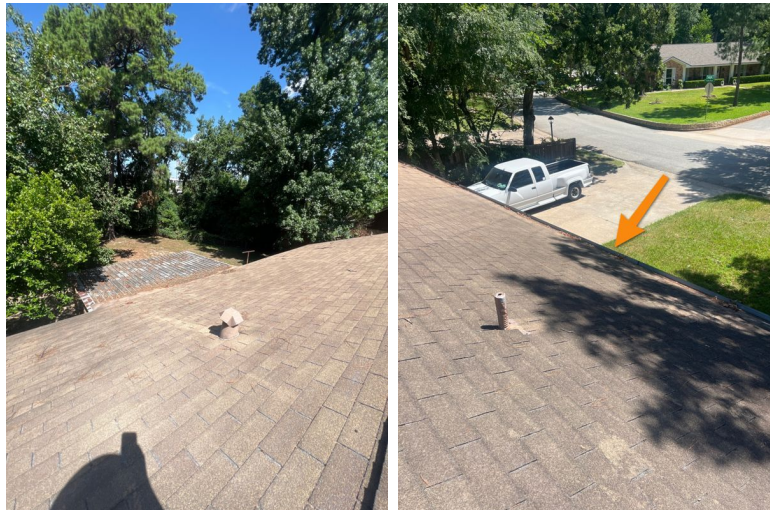
#### 4: Debris

Debris can hold moisture against the roof covering, I recommend removal of all debris.

Recommendation: Contact a qualified professional.

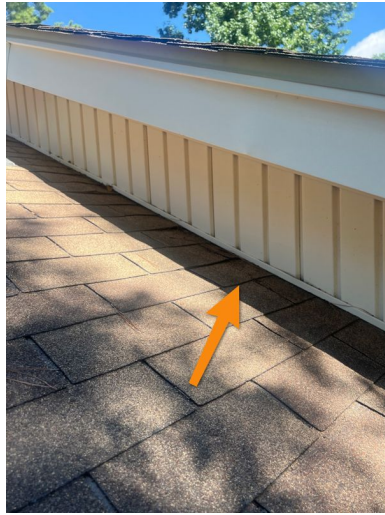
#### 5: Clearance

1" clearance from wall covering to roof covering is required

Recommendation: Contact a qualified professional.

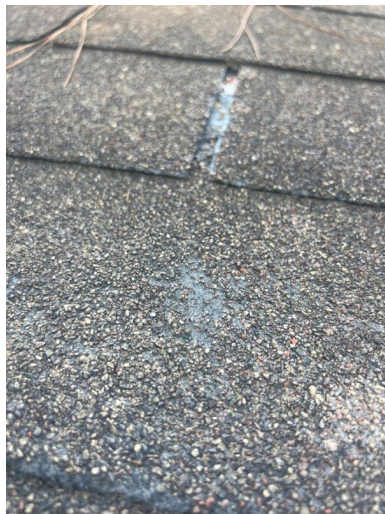
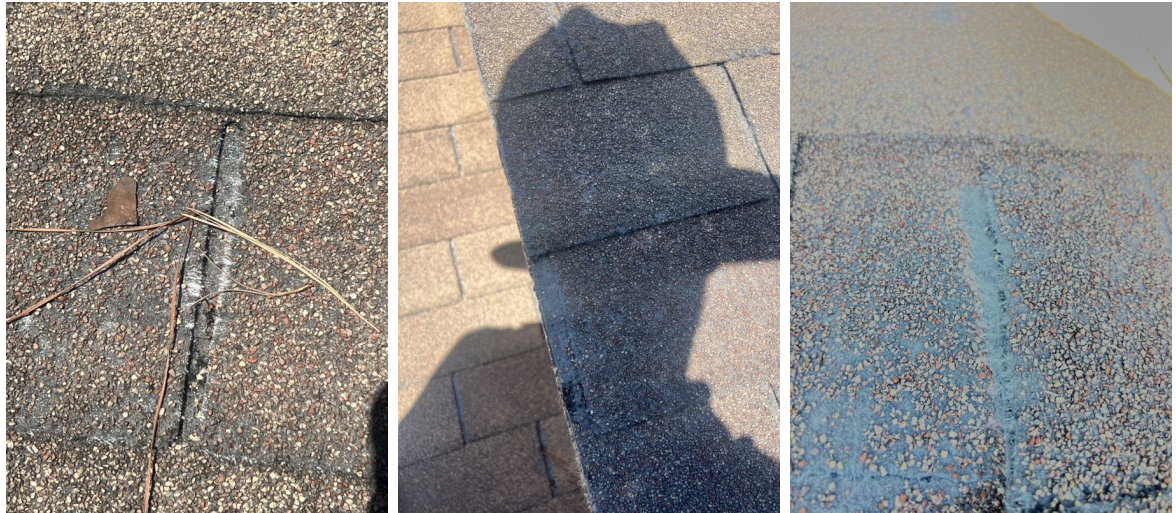
**6: Granule loss**

Visible fibers, this is due to granule loss. I recommend a qualified professional evaluate further

Recommendation: Contact a qualified professional.

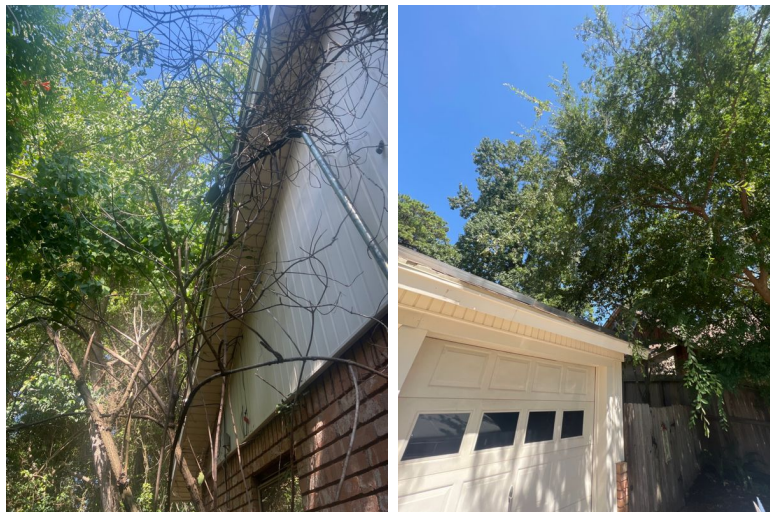
**7: Vegetation**

Trim vegetation away from the roof covering as it will damage the roof covering

Recommendation: Contact a qualified professional.

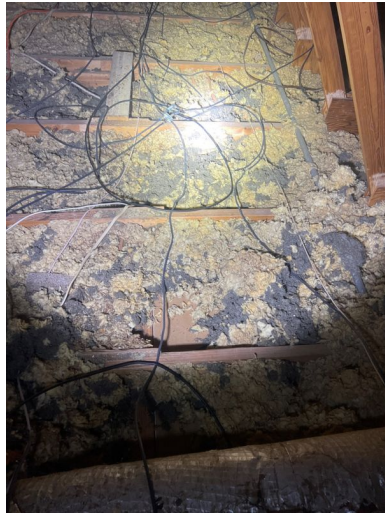
**1: Insufficient Insulation**

Insulation depth was inadequate. Recommend a qualified attic insulation contractor install additional insulation.

Recommendation: Contact a qualified insulation contractor.

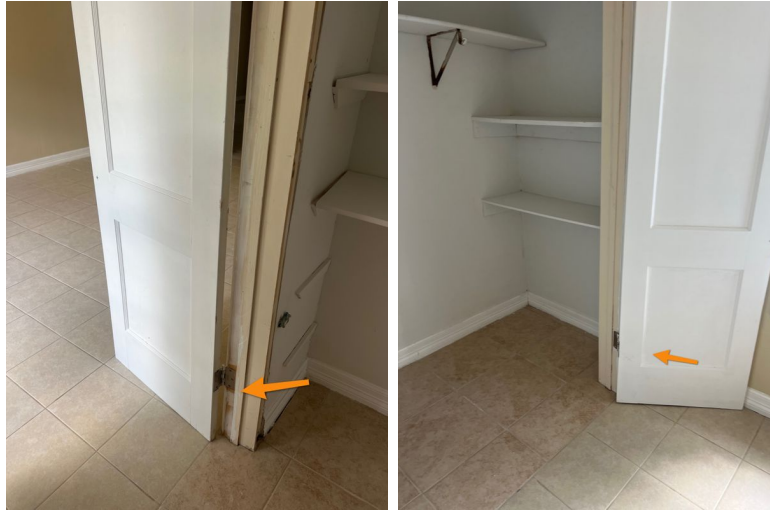
**1: Hinges Loose**

Loose hinges can cause door to stick or eventually fall out of place. Recommend handyman tighten hinges.

Recommendation: Recommended DIY Project

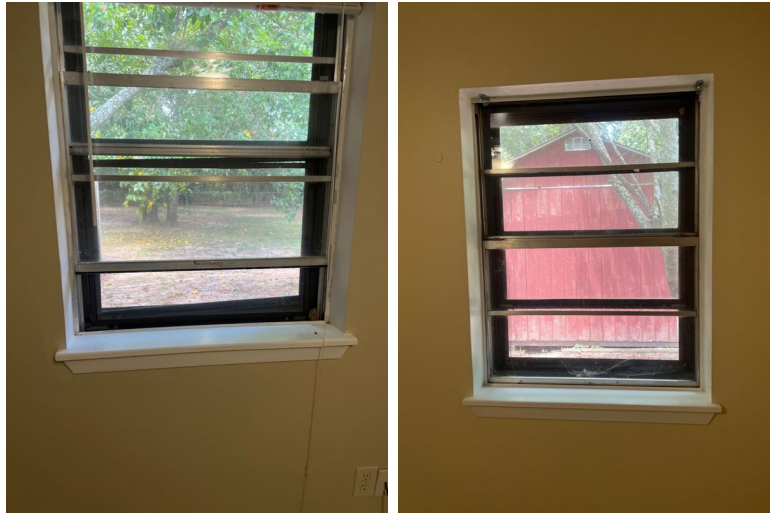
**2: Double windows**

Double windows have been installed this may pose a safety hazard in the event of an emergency evacuation.

Recommendation: Contact a qualified professional.

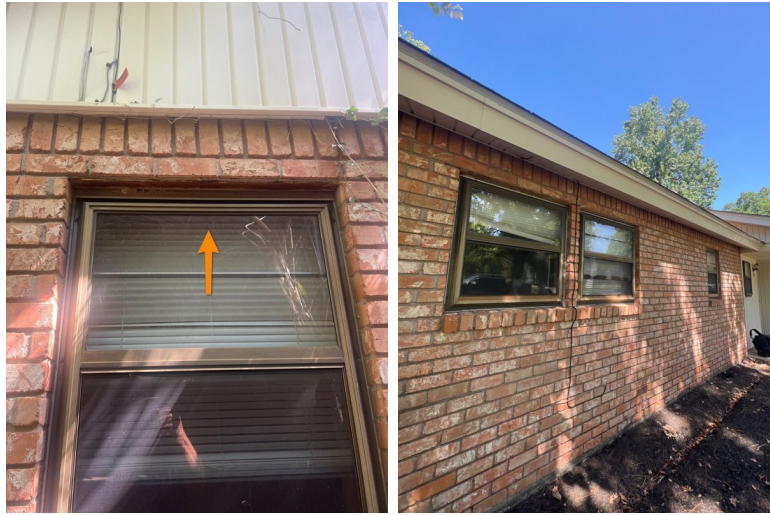
### 4: Corroded lintels

If corroded lintels are observed it is recommended to clean and coat with an anti corrosive coating. They usually will require maintenance yearly to keep from corroding. Severe cases (over a long period of time) will cause diagonal cracks radiating from the top corners of the windows. The metal expands as it corrodes.

Recommendation: Contact a qualified professional.

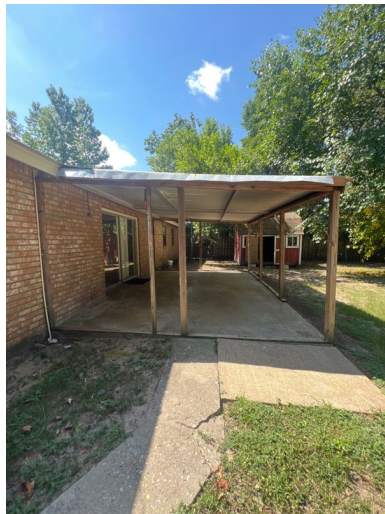
**1: In need of further evaluation**

Upon inspection I observed non standard building practices. I recommend further evaluation and repair as needed

Recommendation: Contact a qualified professional.

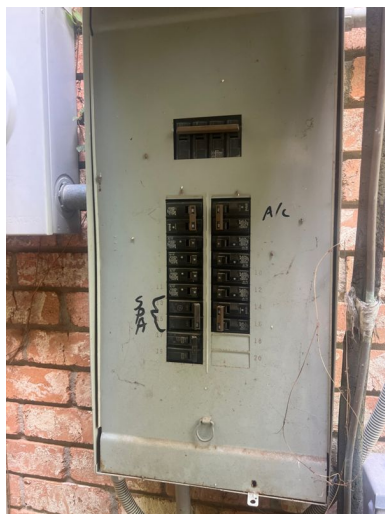
**1: Panel Missing Labels**

Electrical panel does not have labels. Recommend a qualified electrician test and properly label all switches. I was unable to verify breaker sizing per application

Recommendation: Contact a qualified electrical contractor.

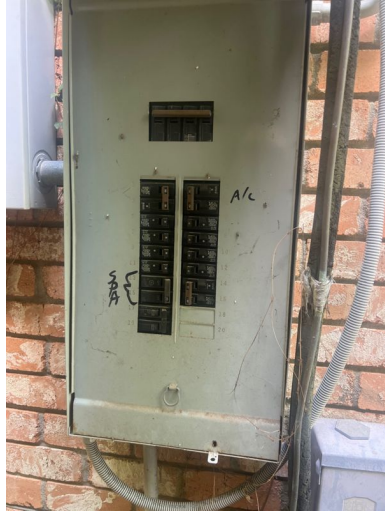
**2: Panel/system Upgrade Recommended**

The electrical panel/system is outdated and lacks modern safety features such as a surge protector, GFCI, AFCI breakers. Recommend a qualified electrician evaluate and upgrade to meet current building standards.

Recommendation: Contact a qualified electrical contractor.

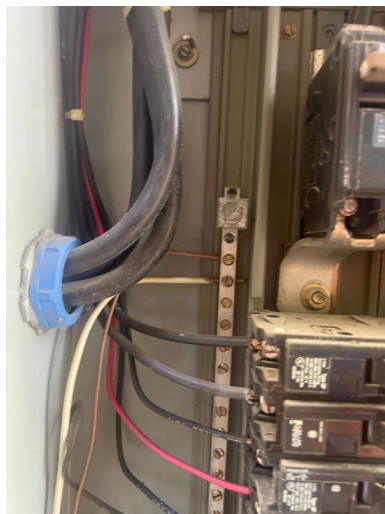
Upon inspection I observed neutrals (white) and grounding conductors (bare) on the same bus bar. Neutrals and grounds are required to have separate bus bars. I recommend a licensed electrician evaluate for repair.

Recommendation: Contact a qualified electrical contractor.

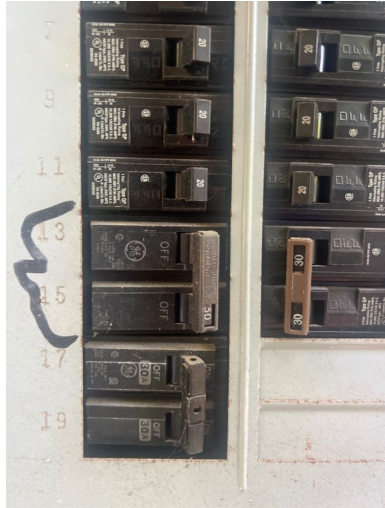
I observed different brand breakers inside the electrical panel. I recommend a licensed electrician evaluate for compatibility.

Recommendation: Contact a qualified professional.

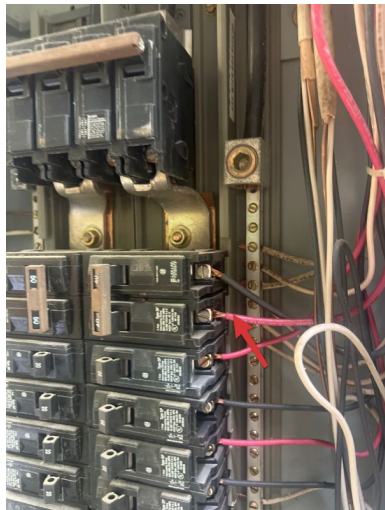
Undersized conductors observed based on the breaker size. I recommend a licensed electrician evaluate and repair

Recommendation: Contact a qualified professional.

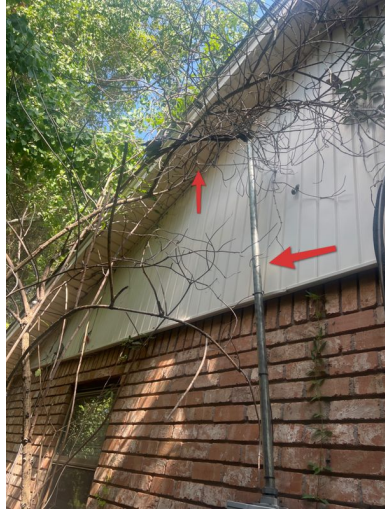
I recommend a licensed electrician evaluate and repair as needed (remove vegetation and secure to walk with proper drip loop)

Recommendation: Contact a qualified professional.

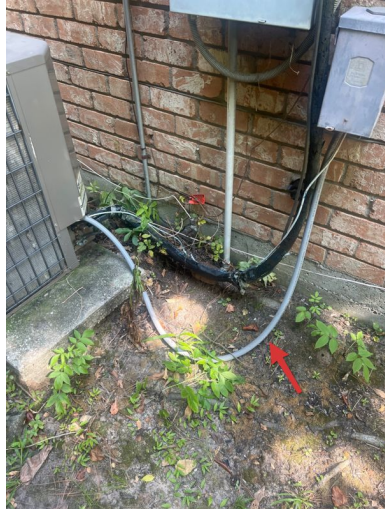
Secure conduit to the wall to prevent damage

Recommendation: Contact a qualified professional.

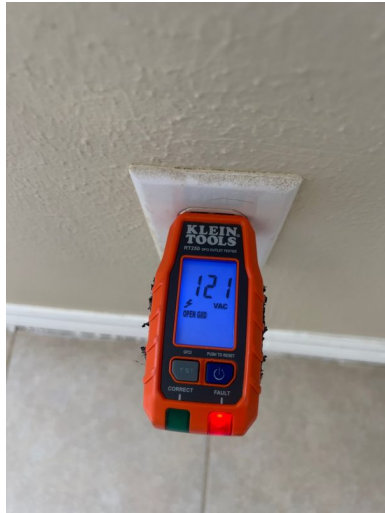
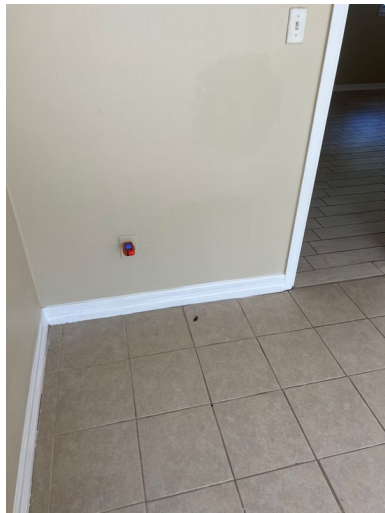
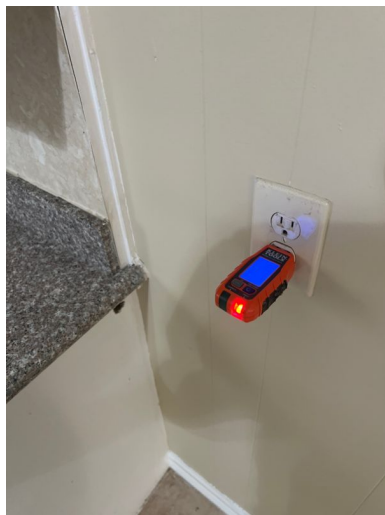
Multiple receptacles tested to be wired incorrectly upon inspection (based on my tester). I recommend a licensed electrician evaluate and repair as needed

Recommendation: Contact a qualified professional.

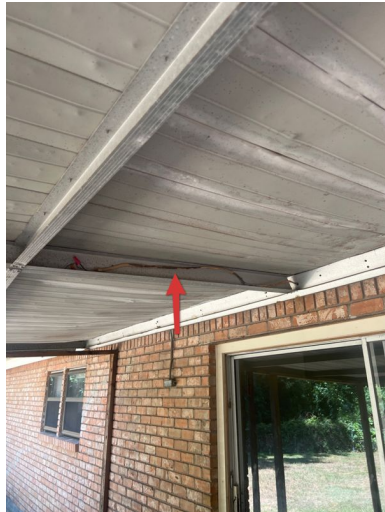
**6: Conduit in need of repair**

Exposed romex is a safety hazard

Recommendation: Contact a qualified professional.

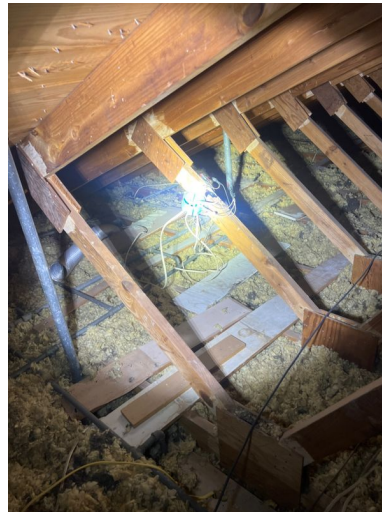
**8: Missing junction box**

I recommend a licensed electrician add a junction box

Recommendation: Contact a qualified professional.

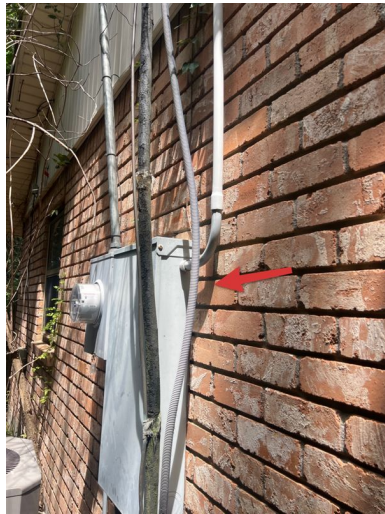
**10: Conduit in need of repair**

flexible conduit is not recommended to be installed on the exterior of the home. I recommend a licensed electrician evaluate and repair as needed

Recommendation: Contact a qualified professional.

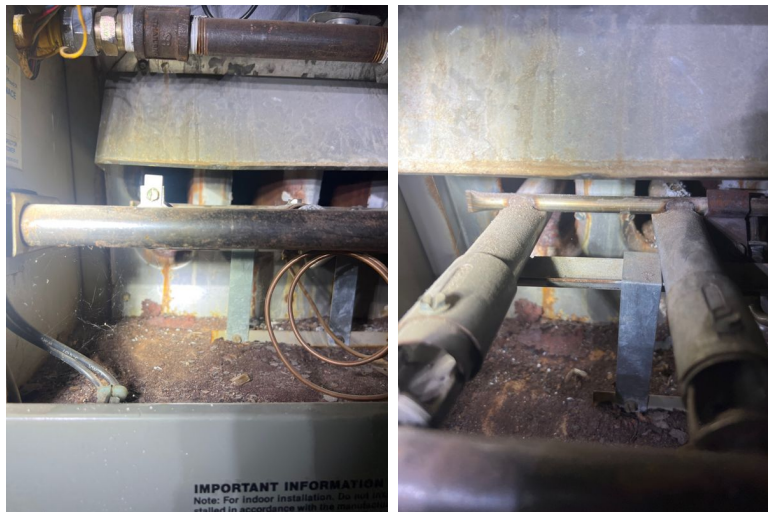
**1: Corrosion**

Furnace was corroded in one or more areas. Recommend a HVAC contractor evaluate and repair.

Recommendation: Contact a qualified HVAC professional.

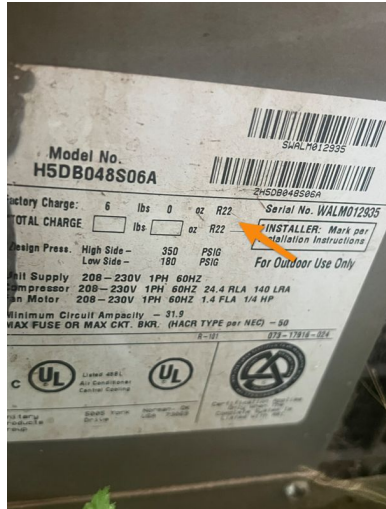
**3: R22**

Based on labeling r-22 is in use, this is older refrigerant and has been phased out. I recommend contacting a licensed HVAC specialist

Recommendation: Contact a qualified professional.

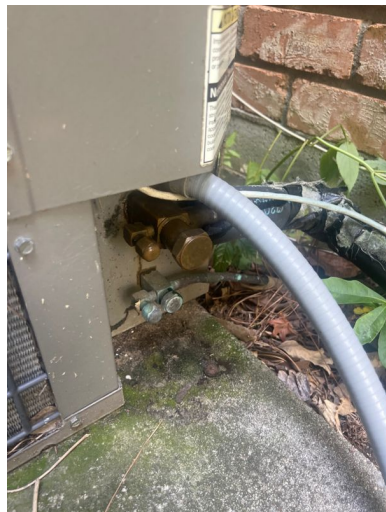
#### 4: Anti tamper locks

Anti tamper locks required on all AC refrigerant line valves

Recommendation: Contact a qualified professional.

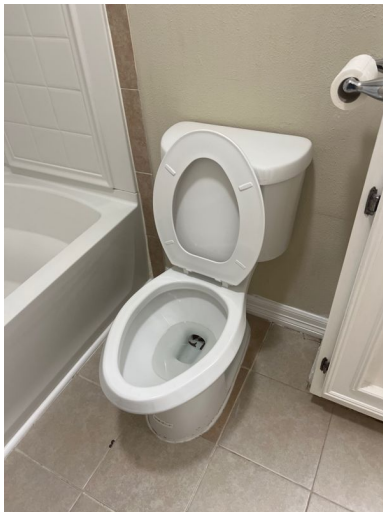
Upon inspection I observed a lazy flush, a licensed plumber should evaluate and repair as needed

Recommendation: Contact a qualified professional.

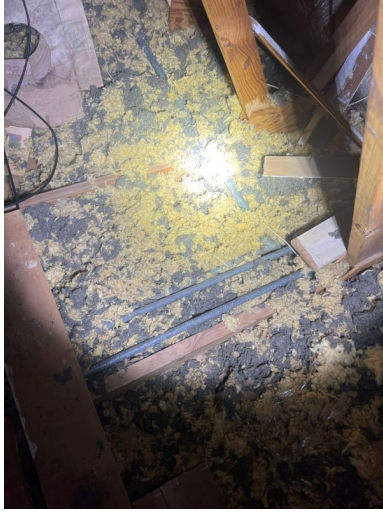
**2: Galvanized**

Apparent galvanized pipes in use in various areas. I recommend a plumber evaluate for replacement  
Recommendation: Contact a qualified professional.

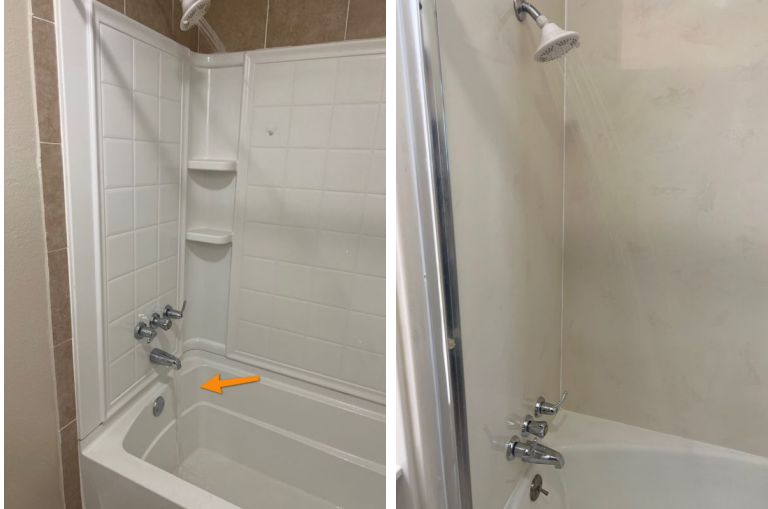
**3: Leak at lower fixture**

The lower fixture leaked when the shower was “on”

Recommendation: Contact a qualified professional.

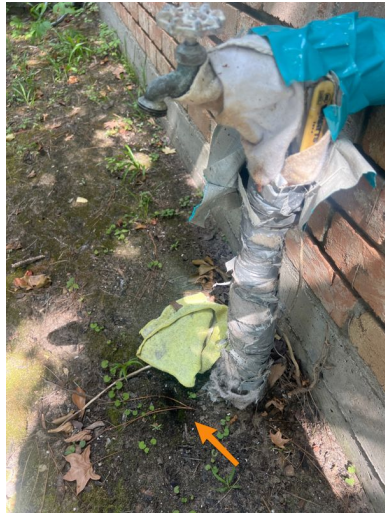
**6: Leak observed**

Leak observed upon inspection, I recommend a licensed plumber repair

Recommendation: Contact a qualified professional.

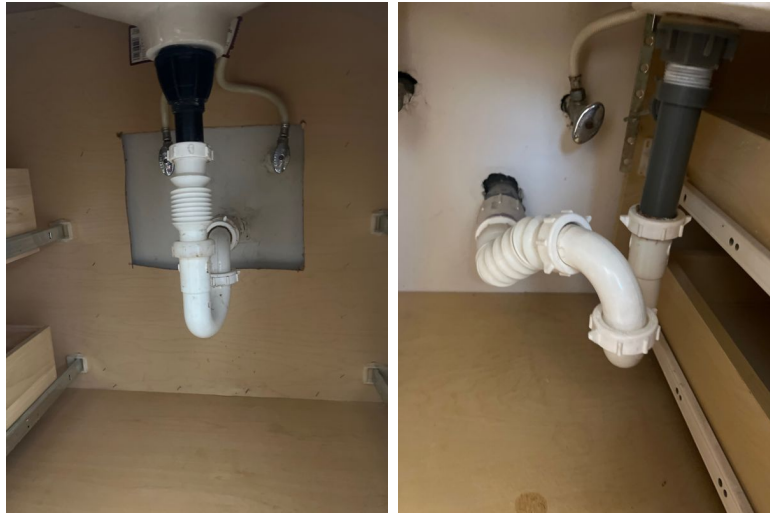
Corrugated pipe is not intended for permanent use only temporary. A licensed plumber should evaluate for repair

Recommendation: Contact a qualified professional.

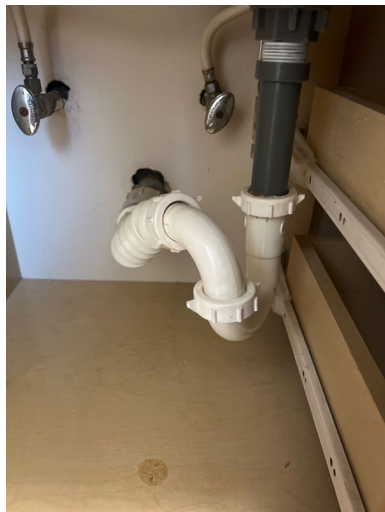
**2: Improper trap**

The change of direction after the trap will hinder the flow of draining water

Recommendation: Contact a qualified professional.

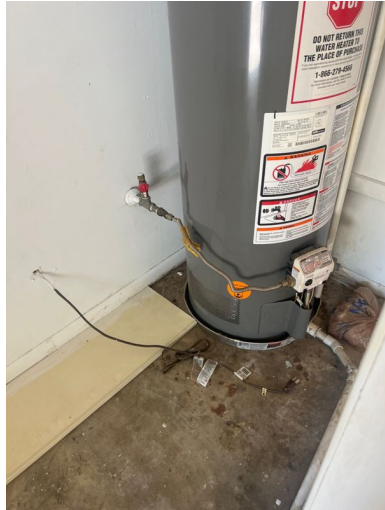
A sediment trap is recommended on the gas supply line.

Recommendation: Contact a qualified professional.

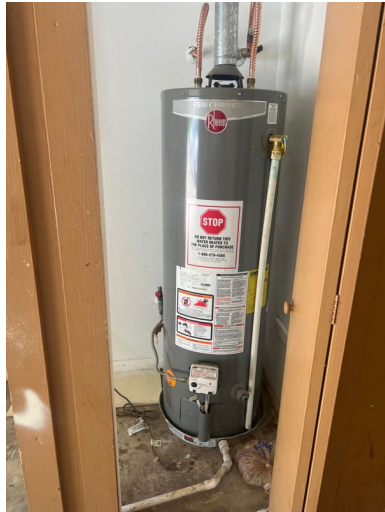
**2: In need of repair**

The water heater rest in the drain pan that may hold water. This may cause damage to the water heater

Recommendation: Contact a qualified professional.

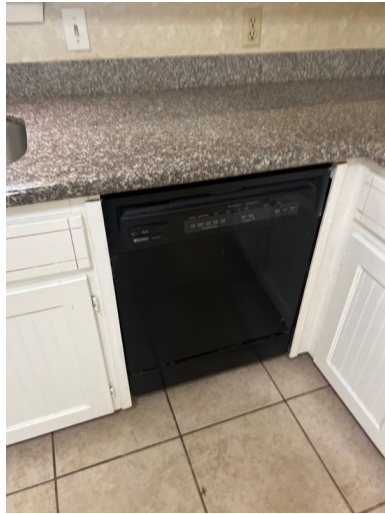
inoperable upon inspection

Recommendation: Contact a qualified professional.

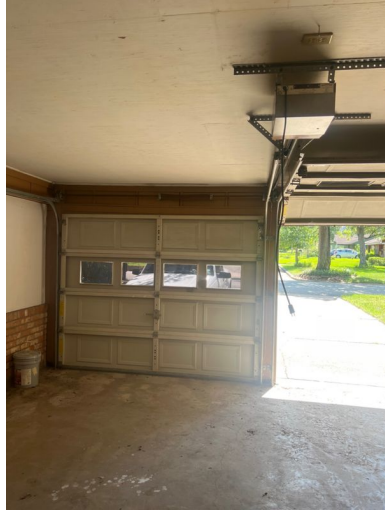
- G. Garage Door Operators**  
*Comments:*  
*Brand:* Touch N GO  
**1: Inoperable**  
**🚫Recommendation**  
The door was not connected to the unit upon inspection  
Recommendation: Contact a qualified professional.

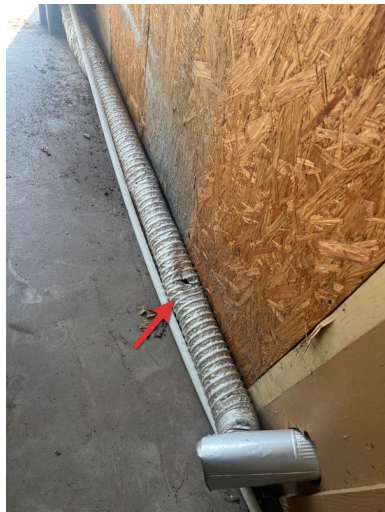
**1: Damaged**

Upon inspection I observed damage to the dryer exhaust vent. I recommend further evaluation and repair

Recommendation: Contact a qualified professional.
