## RESIDENTIAL INSPECTION REPORT

5305 Caprock Dr  
Pearland, TX 77584

# PROPERTY INSPECTION REPORT FORM

Cassandra Worrel <i>Name of Client</i>	06/16/2023 2:00 pm <i>Date of Inspection</i>
5305 Caprock Dr, Pearland, TX 77584 <i>Address of Inspected Property</i>	
Colin Cecil <i>Name of Inspector</i>	TREC #21956 <i>TREC License #</i>
<i>Name of Sponsor (if applicable)</i>	<i>TREC License #</i>

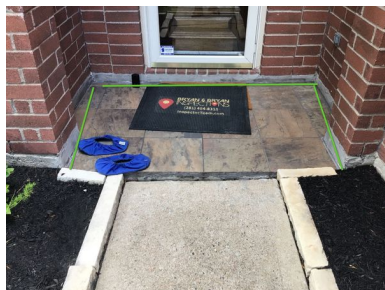
Front, concrete dressing

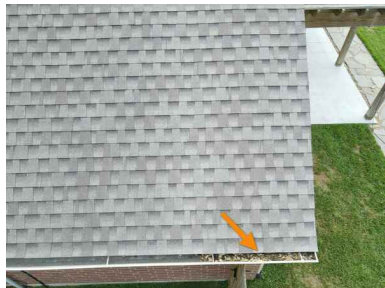
**1: Gutters & Downspouts: Defects Present**

Gutters and/or downspouts had one or more defects at the time of the inspection. Examples include, but are not limited to:

Clogged

Evaluation and remediation is recommended.

Recommendation: Contact a qualified professional.

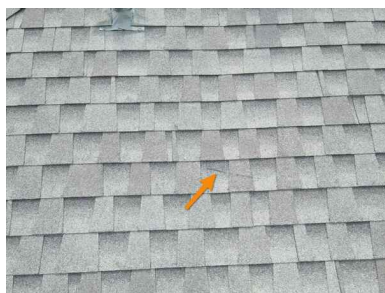
**1: Shingles: Damaged/Torn/Missing**

Roof shingle material was missing, damaged, or torn in areas. Evaluation and/or repair by a qualified roofing professional is recommended.

Recommendation: Contact a qualified roofing professional.

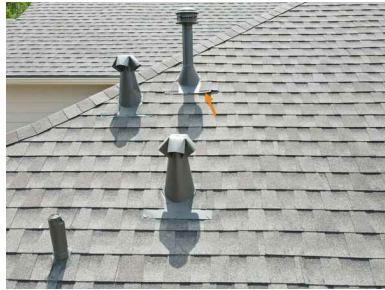
**2: Flashing Deficiencies**

Deficiencies with the flashings were present at the time of inspection. Evaluation and remediation is recommended.

Lifted

Recommendation: Contact a qualified roofing professional.

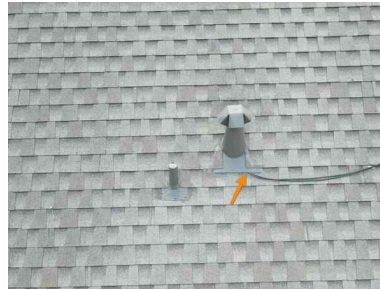
Cable Through Flashing

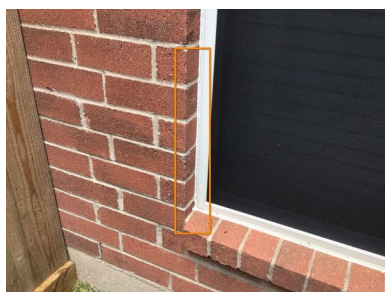
Left Side

### 1: Exterior: Seal Wall Fixtures

One or more areas were not properly sealed/caulked. Most exterior sealants have a lifespan of 5 to 8 years and should be regularly maintained with that lifespan in mind. Evaluation and remediation is recommended.

Recommendation: Contact a qualified professional.

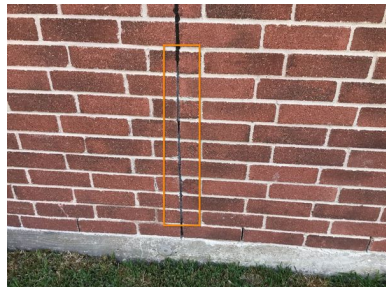
Right Side

Sealant in the expansion joints is missing or has deteriorated. Evaluation and remediation is recommended.

Recommendation: Contact a qualified masonry professional.

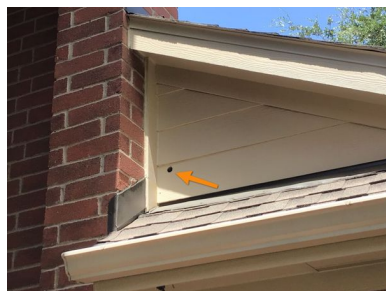
Front

### 4: Exterior Walls: Surface Defects

The exterior wall coverings, such as siding, trim fascia, soffit or eave had defects. Examples include, but are not limited to:

Damaged, rear

Evaluation and remediation is recommended.

Recommendation: Contact a qualified professional.

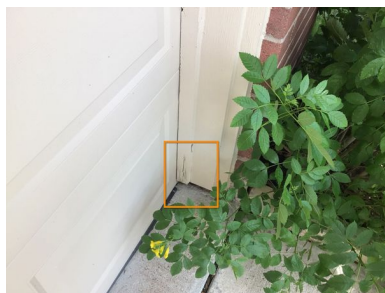
Garage

**1: Doors: Wood Rot at Base of Frame/Door**

Wood rot was observed at the base of a door frame/door. Evaluation and remediation is recommended.

Recommendation: Contact a qualified professional.

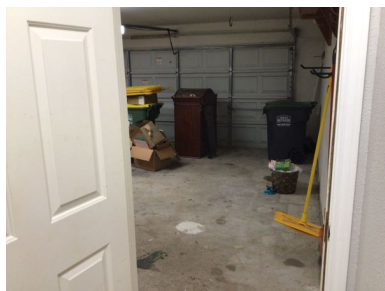
Entry door between the garage and living space should have a functioning self-closing mechanism. Evaluation and remediation is recommended.

Recommendation: Contact a qualified professional.

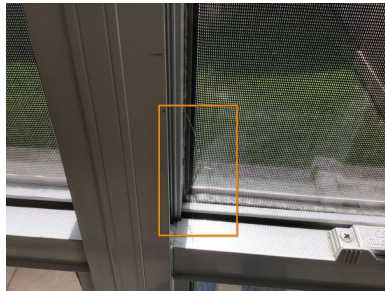
Breakfast Area

### 2: Windows: Cracked/Broken Glass Panes

Cracked or broken glass panes were present. Evaluation and remediation is recommended.

Loose from frame, 2nd Floor

Recommendation: Contact a qualified window repair/installation contractor.

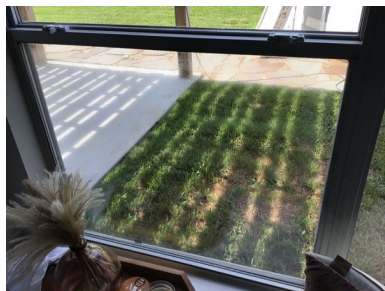
Primary Bedroom

### 3: Windows: Failed Seals or Low-E Coatings

There was evidence of failed seals or the Low-E coating on the panes was deteriorated. Evaluation and remediation by a window professional is recommended.

Recommendation: Contact a qualified window repair/installation contractor.

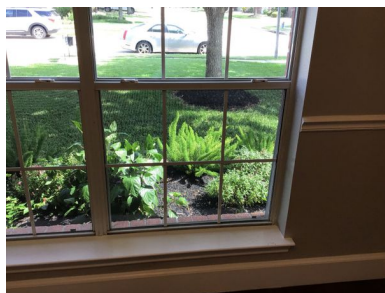
Will not stay open

Evaluation and remediation by a window professional is recommended.

Recommendation: Contact a qualified window repair/installation contractor.

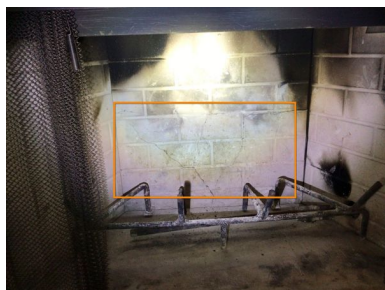
**1: Firebox: Firewall Cracked/Deteriorated**

The brick lining of the fireplace was cracked or deteriorated in one or more places. This could lead to chimney damage or toxic fumes entering the home. Evaluation and/or repair by a qualified fireplace contractor is recommended.

Recommendation: Contact a qualified fireplace contractor.

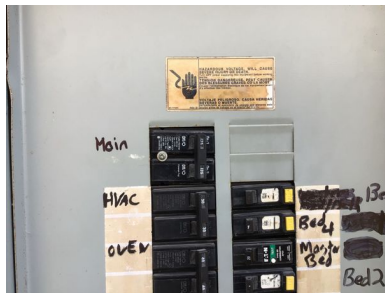
**1: Double Lugged Neutral Wires**

Double lugged neutral wires were on the neutral bus bar inside the distribution panel. One neutral wire per lug is recommended. Evaluation and remediation is recommended.

Recommendation: Contact a qualified electrical contractor.

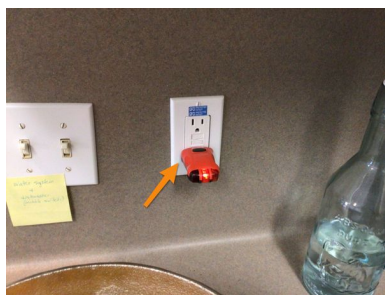
## 1: Receptacles: Improper Wiring

Receptacles are not wired correctly. Evaluation and remediation is recommended.

Recommendation: Contact a qualified electrical contractor.

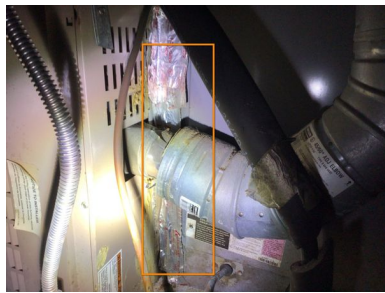
**1: Plenum: Damaged/Leaking**

The plenums were damaged and/or leaking. Evaluation and remediation by a licensed HVAC contractor is recommended.

Leaking

Recommendation: Contact a qualified HVAC professional.

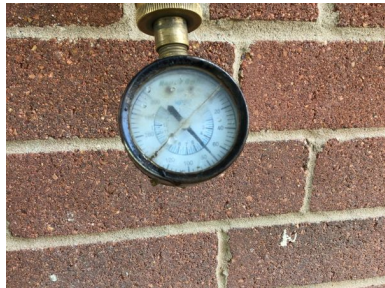
*Static Water Pressure Reading: 75 PSI*

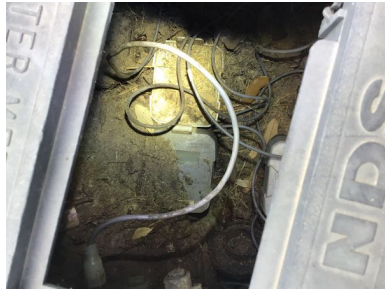
*Standing Water/Mud in Meter Box:*

Standing water or mud was observed in the water meter box. Source could not be determined.

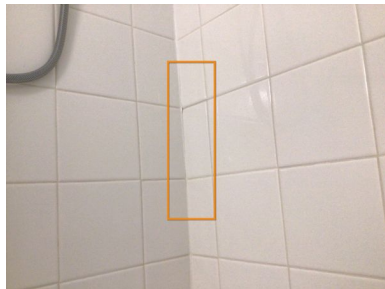
2nd Floor Bathroom

**1: Shower/Tub: Missing/Deteriorated Caulking or Grout**

Evaluation and remediation is recommended.

Recommendation: Contact a qualified professional.

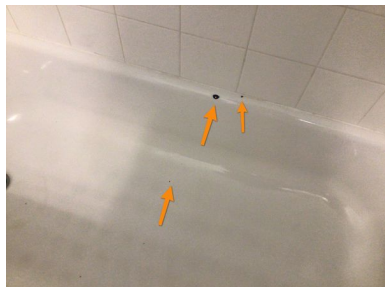
**2: Shower/Tub: Surface Defects**

Defects were observed on the shower/tub surface. Evaluation and remediation is recommended.

Recommendation: Contact a qualified professional.

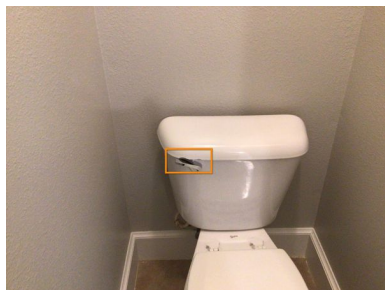
Primary Bathroom

**3: Toilet tank lig damaged**

Evaluate and remedy as needed.

Recommendation: Contact a qualified professional.

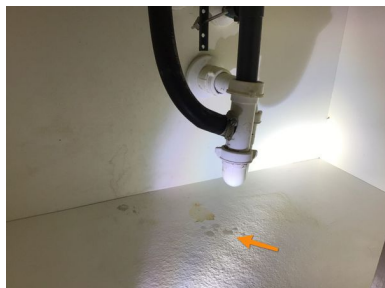
Primary Bathroom

**1: Drain Piping: Leaks**

Leaking was observed at time of inspection. Evaluation and/or remediation by a licensed plumber is recommended.

Recommendation: Contact a qualified plumbing contractor.

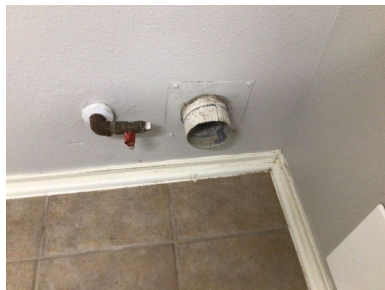
General Photos of Dryer Exhaust System:

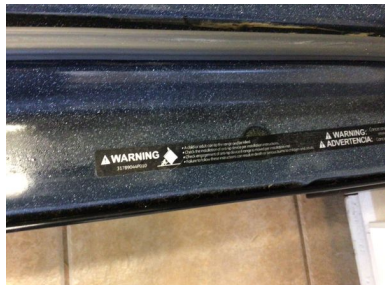
**1: Missing Anti-Tip Device**

There was no anti-tipping device installed on the oven/range to prevent tipping if the door is climbed on while opened. This is a possible safety hazard. Evaluation and remediation is recommended.

Recommendation: Contact a qualified professional.

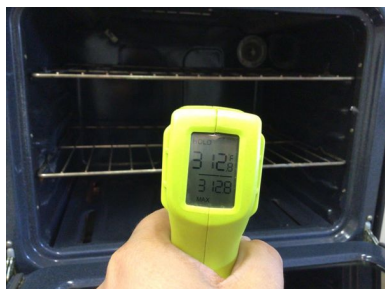
**2: Oven Temperature Inaccurate**

The oven thermostat was inaccurate. A variance of more than 25 degrees F was noted when set at 350F. Evaluation and remediation is recommended.

Recommendation: Contact a qualified professional.

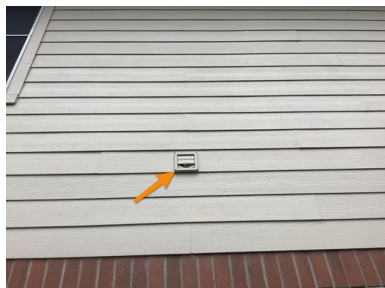
**1: Missing/Damaged Vent Lines or Covers**

The vent lines or covers for the exhaust fan were either missing or damaged. Evaluation and remediation is recommended.

Recommendation: Contact a qualified professional.
