**National Register of Historic Places
Inventory—Nomination Form**

NAME: William S. Rogers House

Historic Resources of Chappell Hill
Chappell Hill, Washington County, Texas

#46 William S. Rogers House
Cedar Street

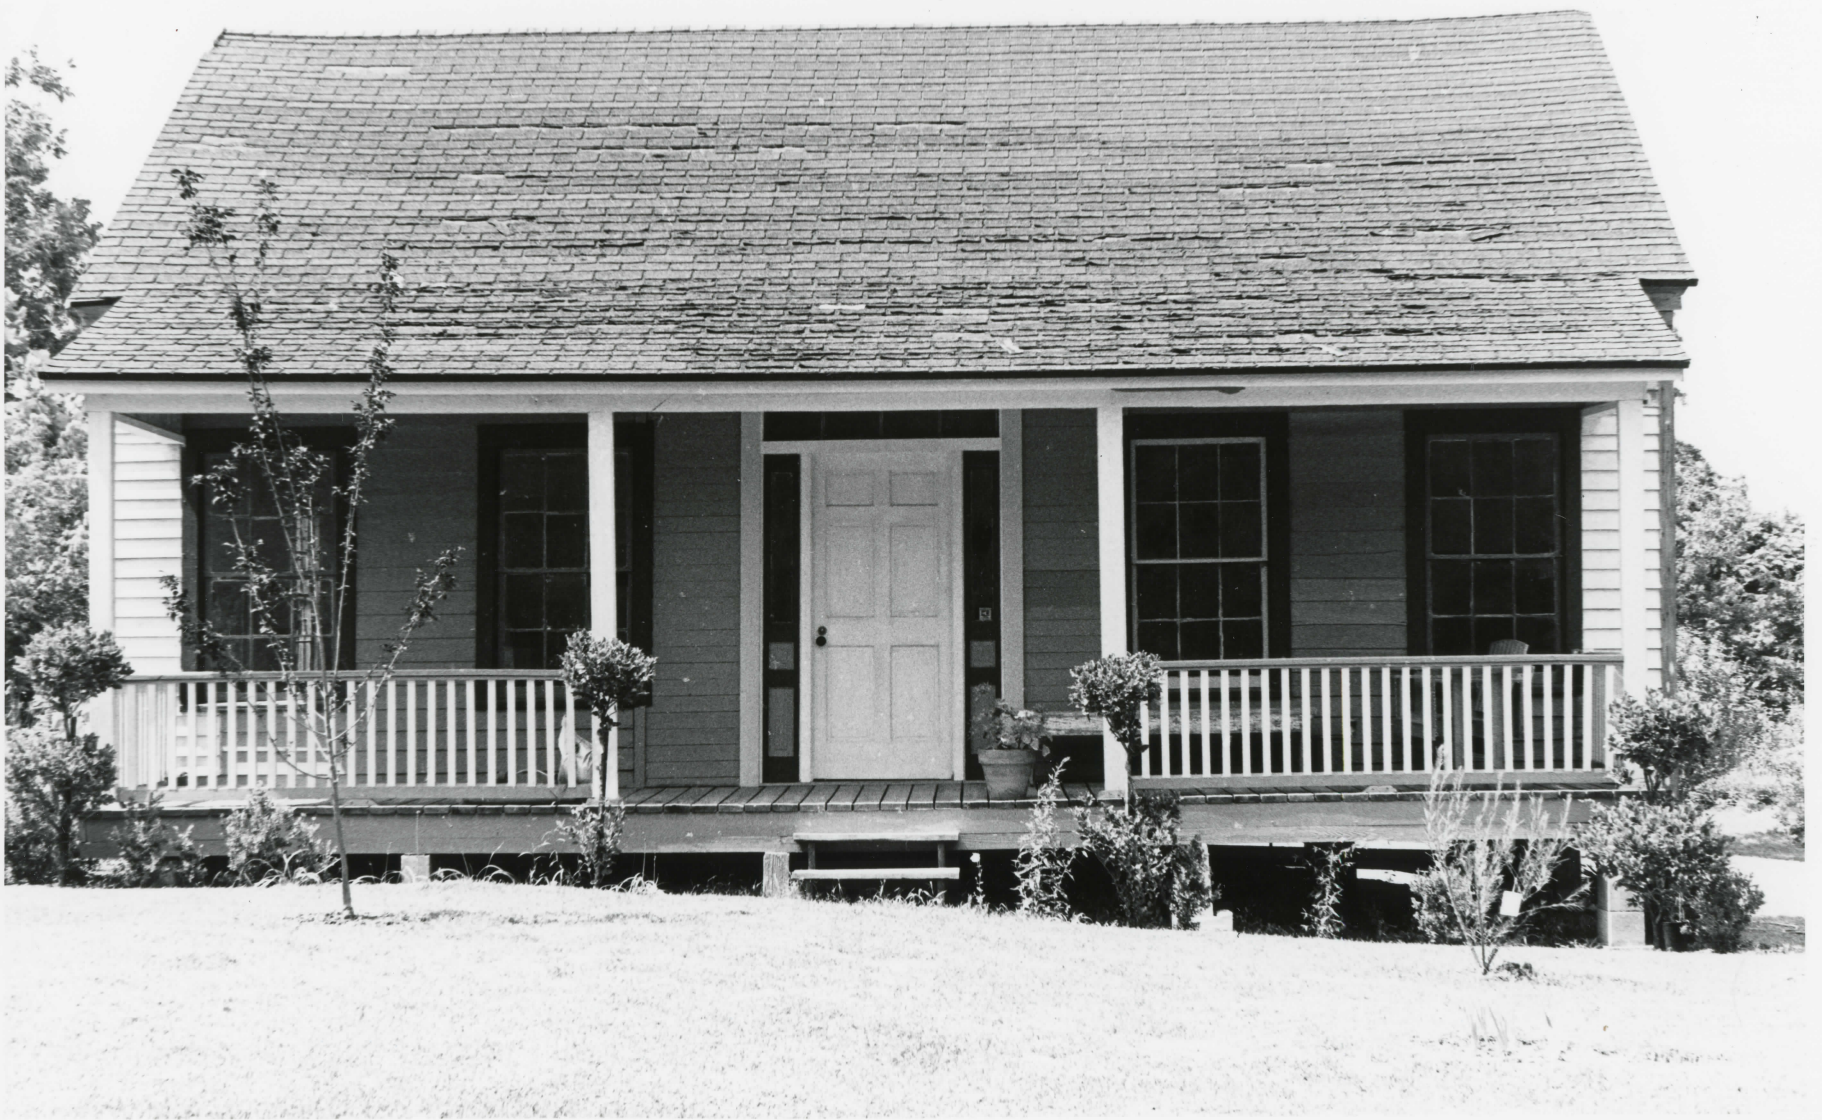
photo 17 of 58

South facade, camera facing north

The William S. Rogers House is a pioneer, wood-frame, vernacular building constructed in the 1860s; it consists of five bays with a central entrance surrounded by sidelights and a transom. The broad sweep of the gabled roof is broken only by a one-room ell addition on the rear which once contained a screened porch on the east side. The roof of the gallery extends across the entire south facade and is supported by four chamfered, square cedar posts. A simple cypress railing, which may not have been original to the house, surrounds the porch. A composition roof covers the original cedar shingles.

The structure contains 6/6 double-hung sash-type windows with original single panes of blown glass. A brick chimney on the west end of the house was added ca. 1900-1910, as was a partition in the end room of the interior. The interior plan originally contained two rooms on each side of a central hall. There is evidence that a side door on the east end of the main structure had previously been enclosed.

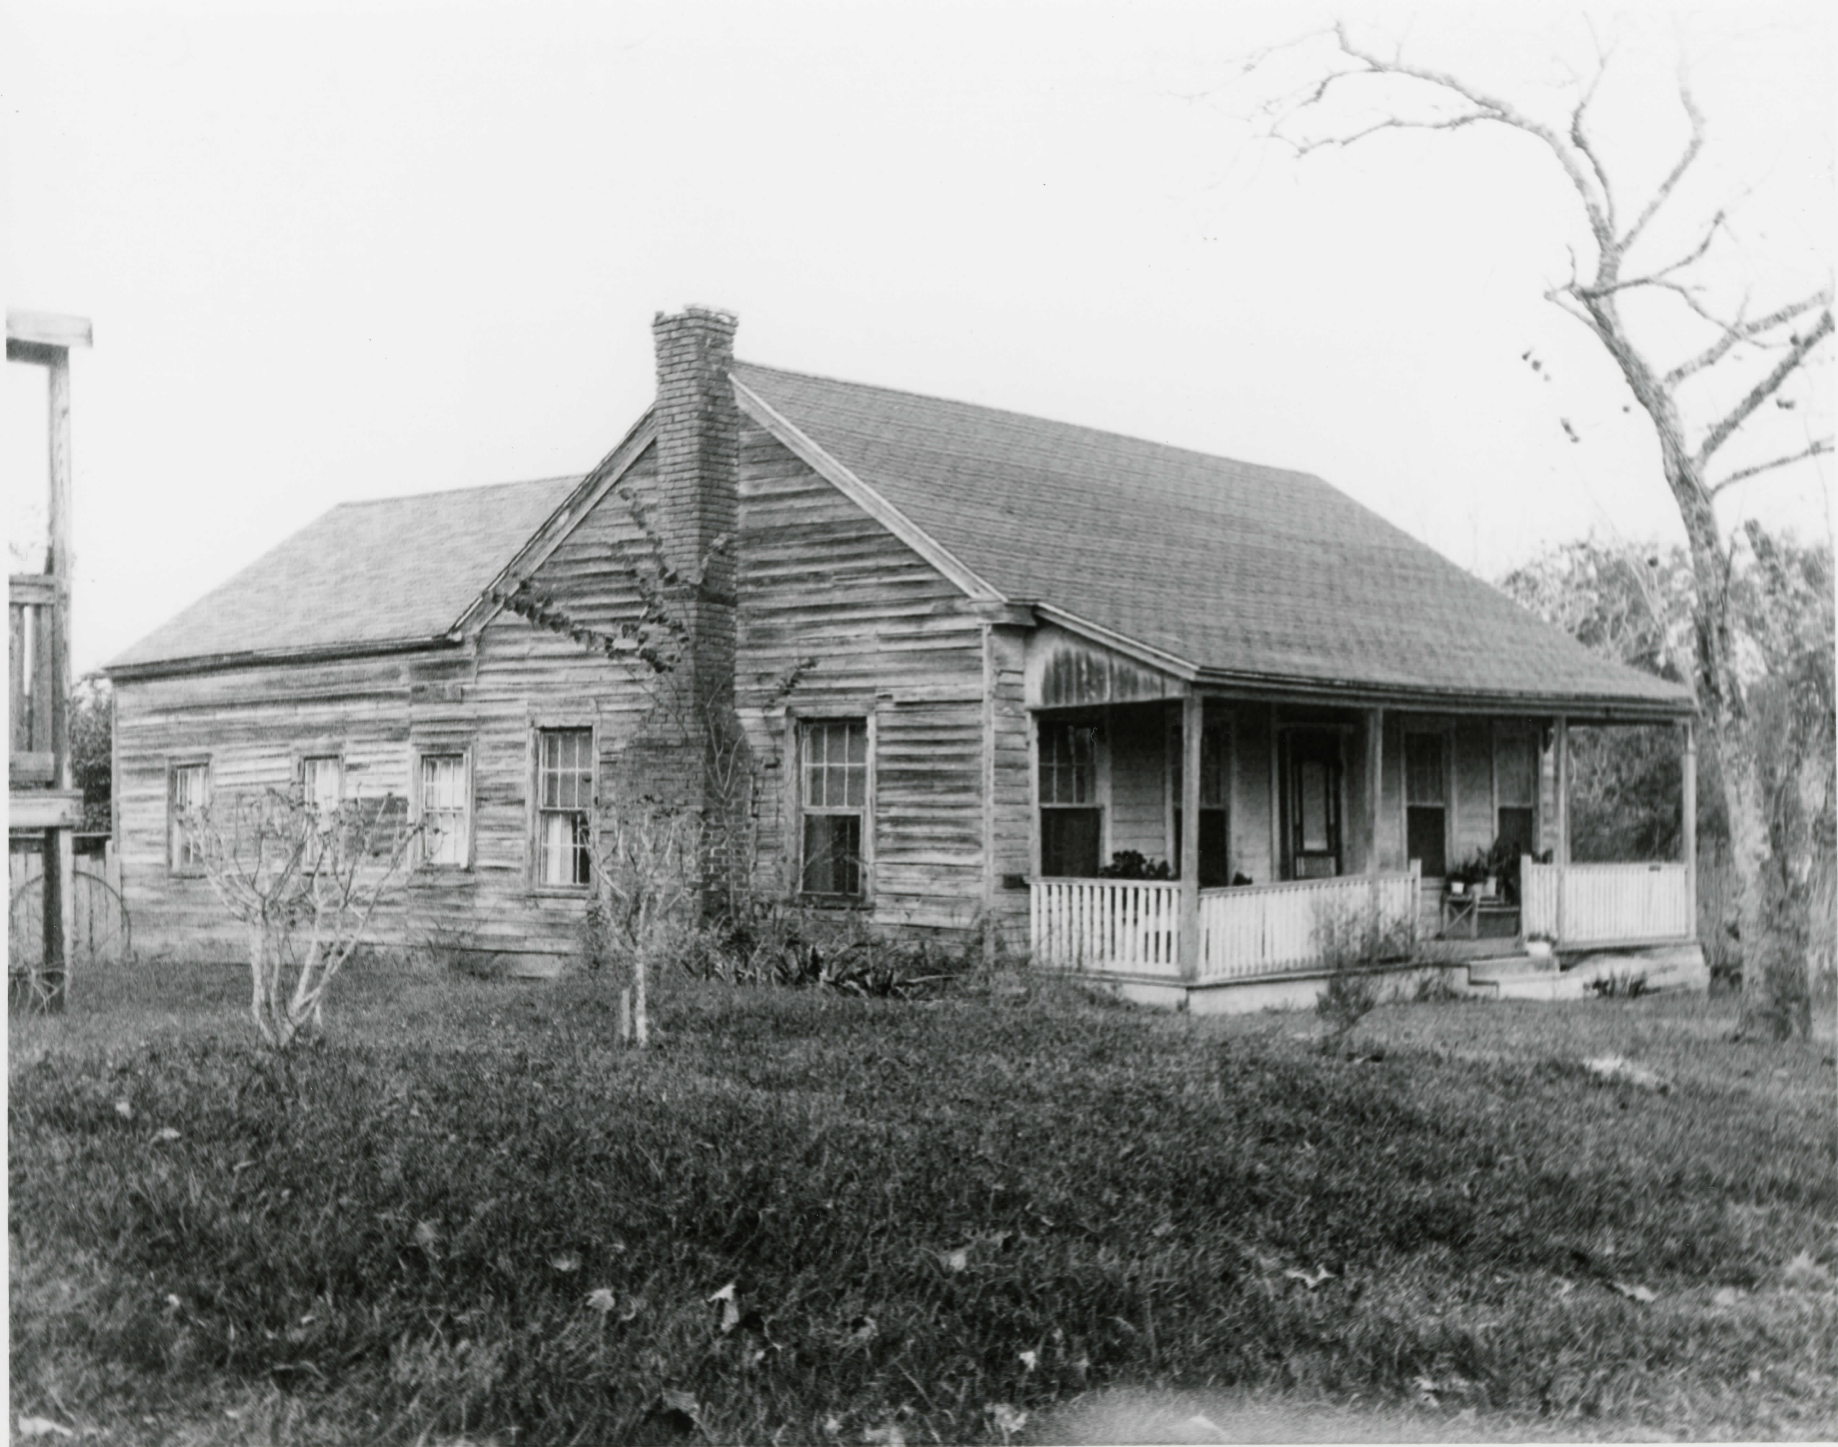
Photo by Ed Smith, November 1981
Negative on file at the Texas Historical Commission
Photo # 18 of 58

VIEW: NORTH ELEVATION; camera facing south
(Prior to restoration)

In 1983 the current owners, Jim Lather and John Shaw, initiated the restoration of the house and are now in the process of completing interior work. The rear screened-in porch was enclosed and deteriorated interior flooring replaced. With the exception of the front (south) facade, deteriorated exterior cedar boards were replaced with new ones. It was also necessary to replace the front porch flooring. During the course of the restoration project, the west chimney crumbled but may be rebuilt by the owners. The house will soon be painted with its historic colors, a light yellow with a blue porch ceiling.

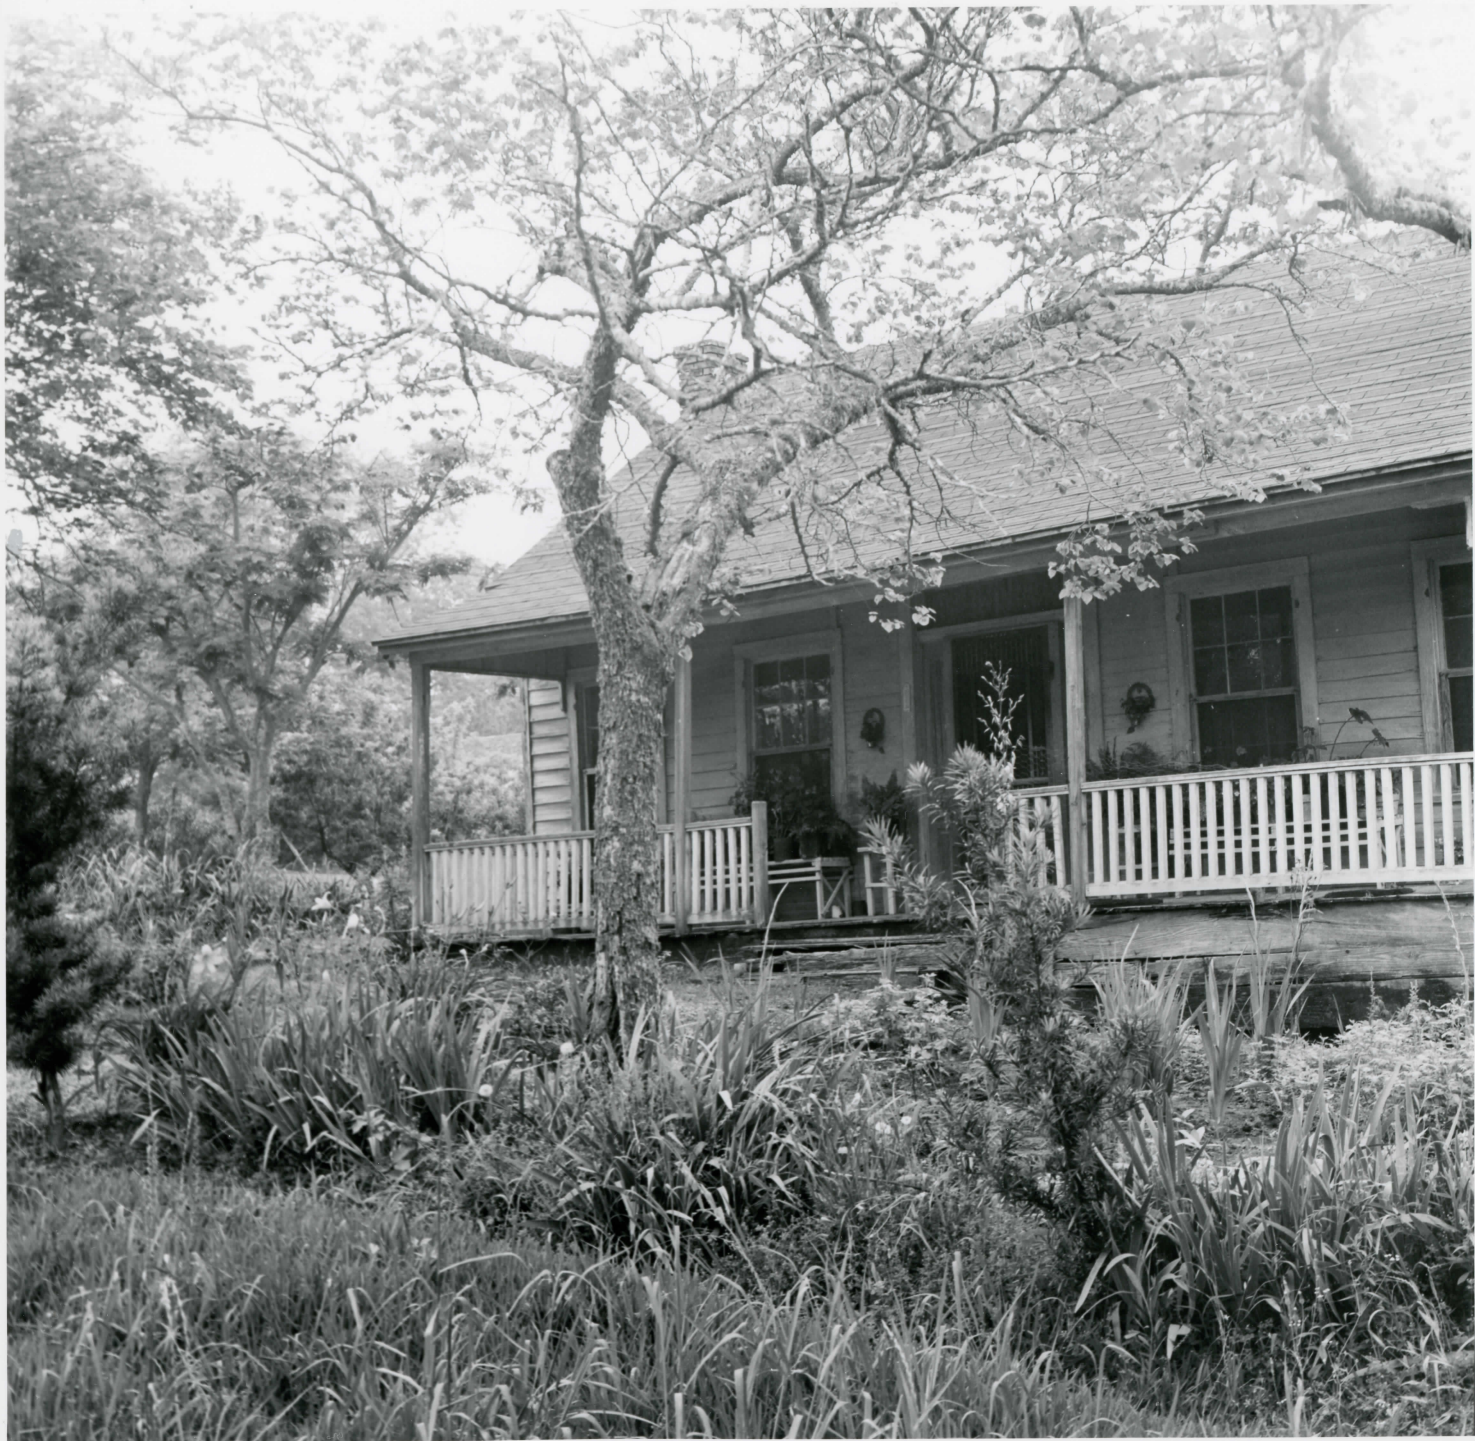
Photographer, date unknown, neg. with owners,
Jim Lather & John Shaw, Chappell Hill
Photo # 18A of 58

South elevation; camera facing north
