## NOBLE PROPERTY INSPECTION REPORT

4634 Galesburg St  
Houston, TX 77051

# PROPERTY INSPECTION REPORT FORM

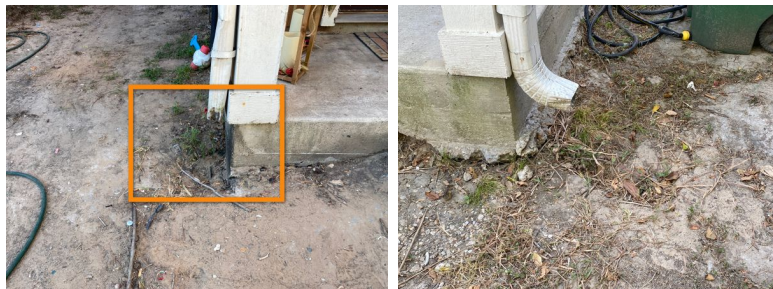
Improper grading and drainage. One or more areas around the perimeter of the home had low spots or was not sloped properly to drain water away from the house. This restricts drainage and will cause water to pool next to the foundation, which, over time, can cause foundation and structural damage to the home. It is recommended to seek further advice and solutions from a landscaping professional.

Hole in yard, missing downspout extension

Recommendation: Contact a qualified landscaping contractor

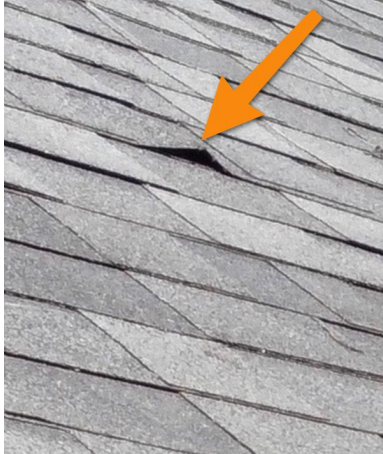
🟡 Recommendation

Areas of the roof show lifted shingles. This is typically caused by high gusts of wind. Lifted shingles will not seal with the lower shingles and allow for water intrusion. Recommend a roofing contractor to replace.

Recommendation: Contact a qualified roofing professional.

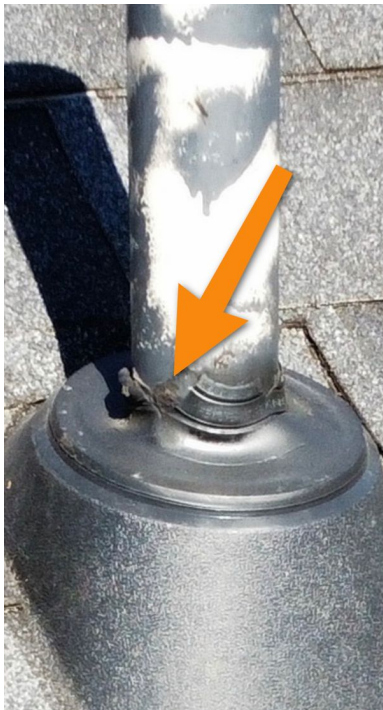
### 3: Vent boot missing, damaged, or not installed correctly

A pipe venting boot is missing, damaged, or was not installed correctly. Pipe boots are installed correctly when:

Any other installation will lead to an eventual leaking around the outside of the pipe material and water intrusion into the structure. Vents that depend on sealant alone to prevent moisture intrusion are considered incorrect installations. Recommend replacing the boot or having a roofing professional resolve this issue.

Recommendation: Contact a qualified roofing professional.

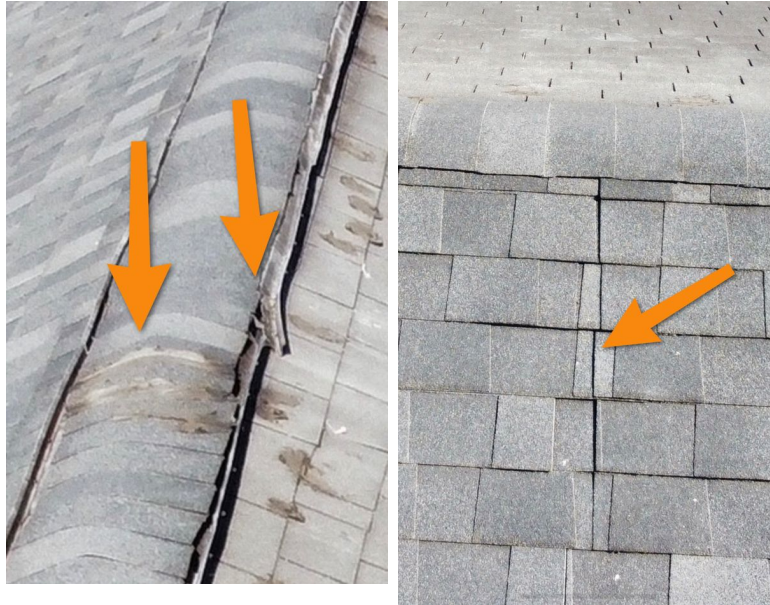
Shingles were damaged at one or more locations on the roof. Further evaluation and correction as necessary by a roofing professional is recommended.

Recommendation: Contact a qualified roofing professional.

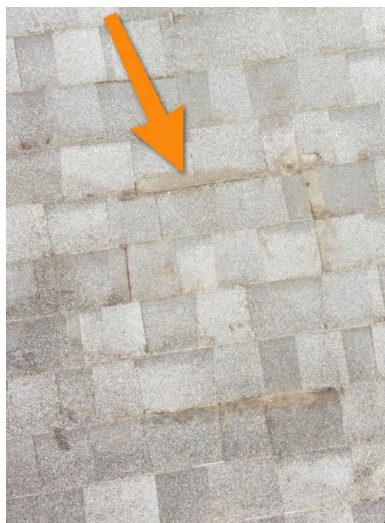
Previous roof repairs have been performed. These areas present a high risk of future leakage and can result in property damage. Further evaluation by a roofing professional is recommended.

Recommendation: Contact a qualified roofing professional.

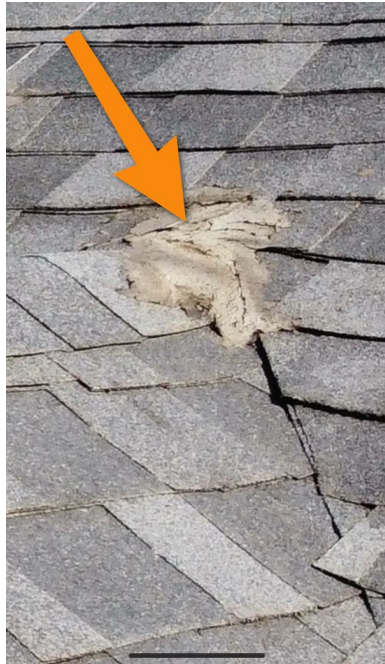
#### 4: Damaged shingles

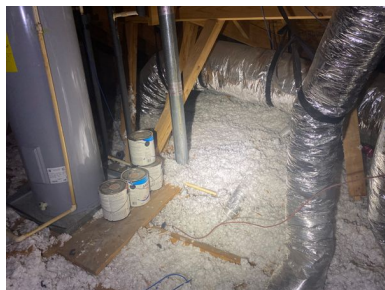
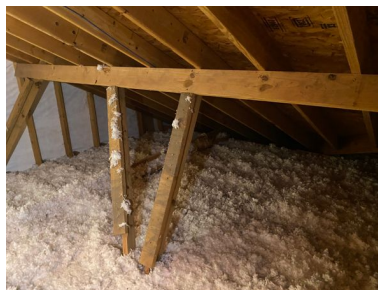
*Type of insulation (w/ photos):* Blown-In / Loose Fill

*Depth of insulation:* 11.5 Inches (R-38) (2x12) -

This is considered to represent the approximate average depth and type of insulation discovered during this inspection.

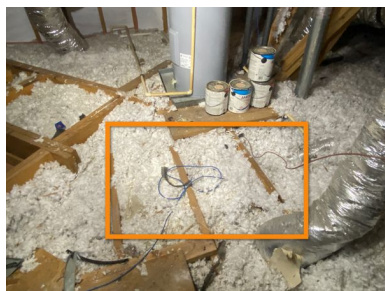
There is missing decking to safely access and service attic equipment. Address as needed.

Missing attic decking to equipment

Recommendation: Contact a qualified general contractor.

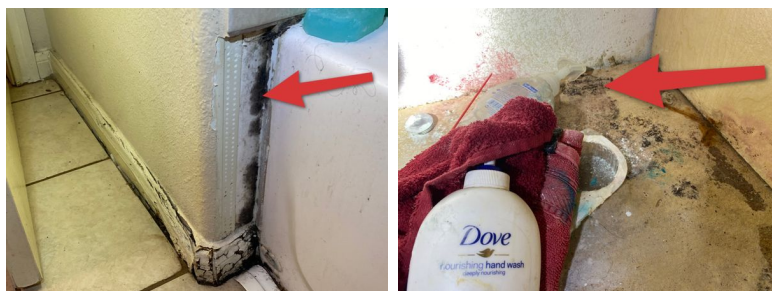
Observed signs of suspected mold (discoloration, mold odor, mold spots, etc.) in one or more areas of the wall. Recommend mold inspector identifying source of moisture intrusion and possibly sending samples to a lab for testing.

Recommendation: Contact a qualified mold inspection professional.

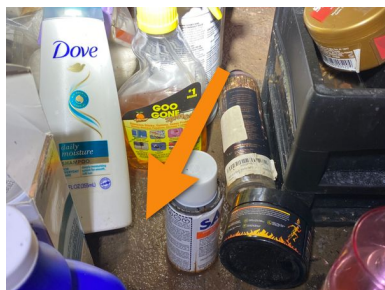
Unit B Primary Bathroom

One or more areas of the cabinet show signs of water damage. This may be caused by rain water inundation or leaking of the plumbing fixtures from above. Particularly in older structures, signs of water damage under the sink cabinets including stains, warping, and sagging flooring could be from previous leaks and are common discoveries. An active leak could mean the presence of mold. Recommend monitoring for future leaking, mold testing, and replacement depending on clients opinion.

Recommendation: Recommend monitoring.

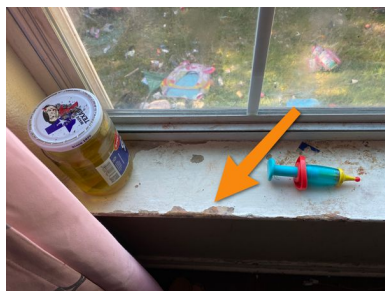
There was interior wall or trim damage at various locations in both units.

Windowsills damaged

Recommendation: Contact a qualified general contractor.

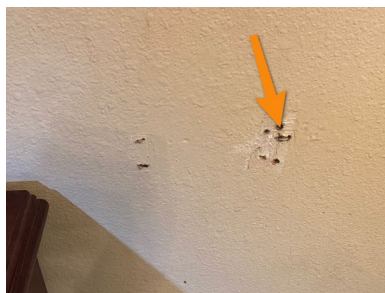
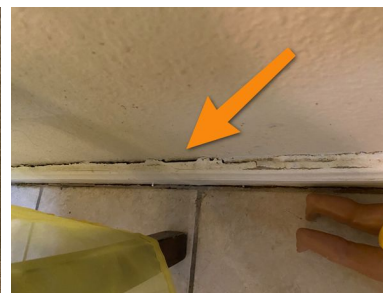
Damaged baseboard

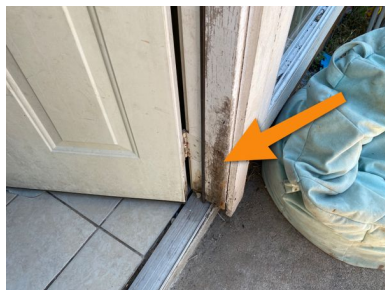
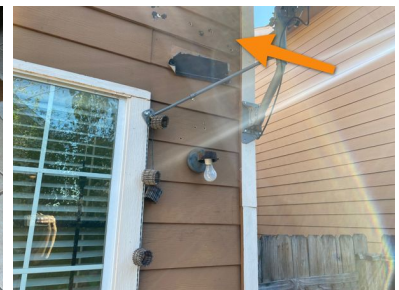
Exterior siding/trim damage. There was damage to the exterior siding and trim at several locations around the house.

Recommendation: Contact a qualified general contractor.

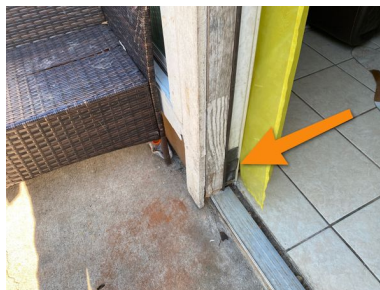
#### 4: Exterior wall or trim damage

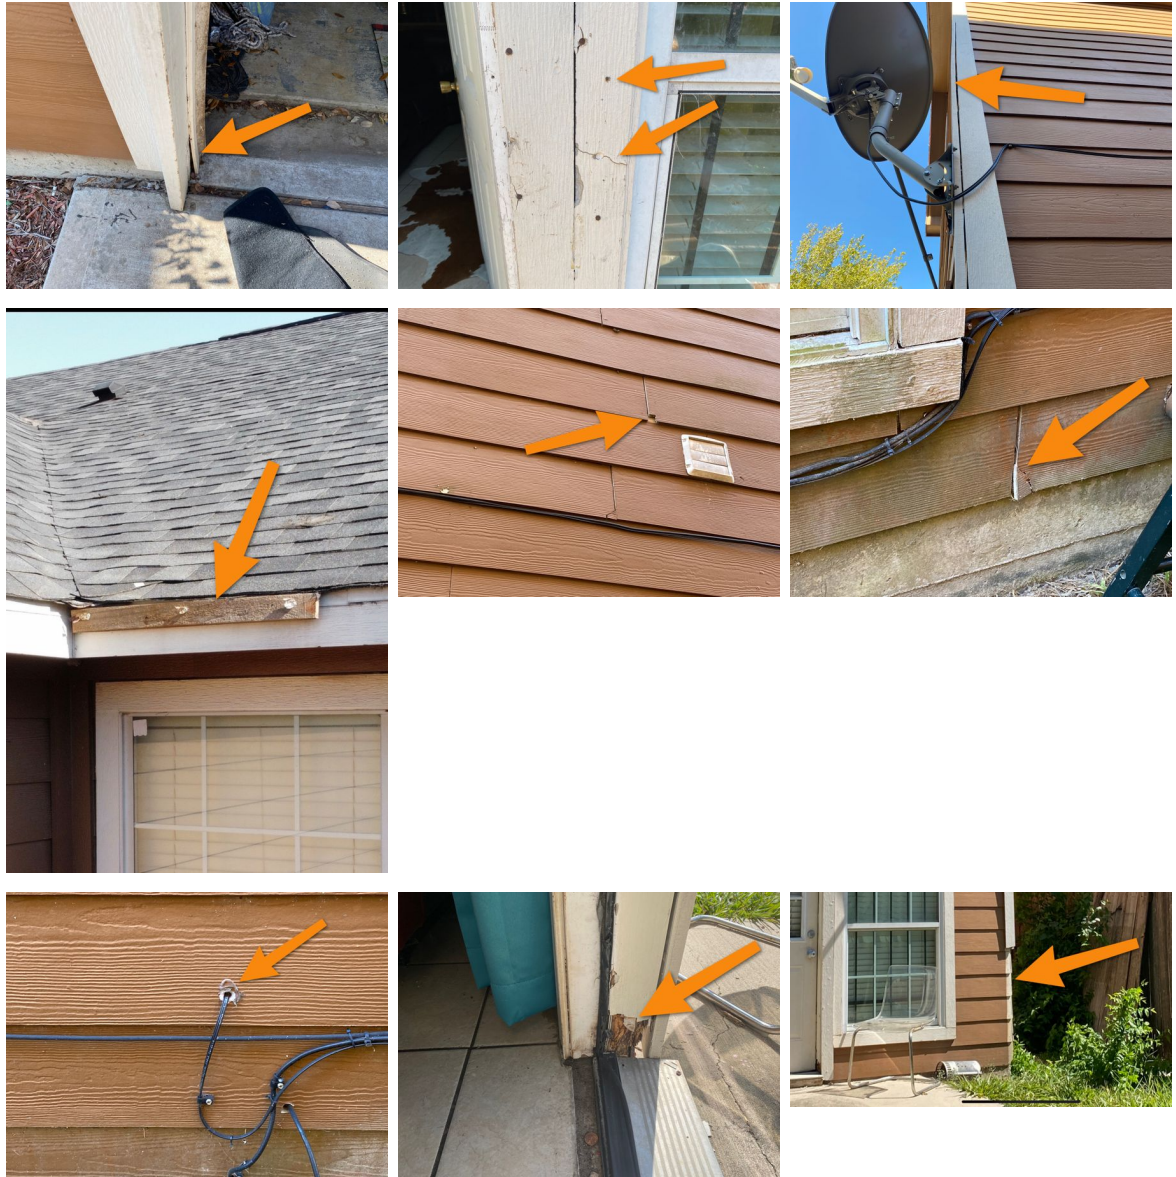
Unit a back door

**5: Missing sealant**

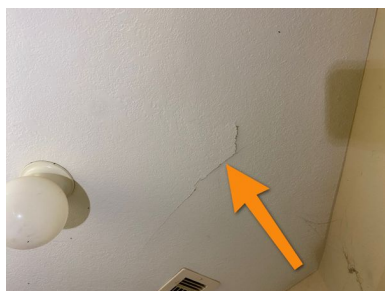
Unit b Laundry

Minor sheetrock cracking was observed on the ceiling. This is common in structures this age and is often determined to be cosmetic, most often the separation of drywall tape joints. Recommend monitoring these locations for further cracking.

Recommendation: Contact a qualified Do It Yourself

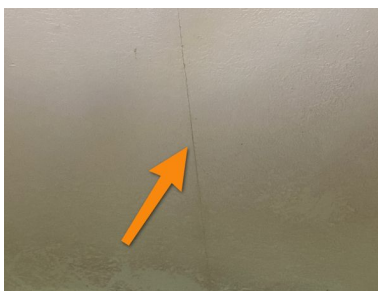
Unit b Living

**1: Ceiling - sheetrock cracks minor**

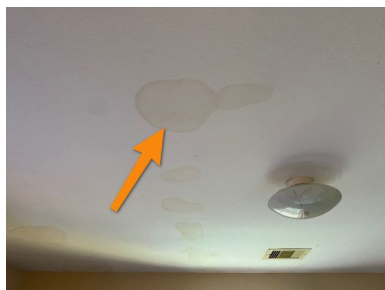
A stain on the ceiling is present. This stain did not visually appear damp and could be from a previously resolved water leak. Inspector is not always able to perform a spot moisture test on ceiling water stains because of the location and height. Recommend monitoring and addressing as necessary.

Ceiling stains at multiple locations in both units

Recommendation: Contact a qualified general contractor.

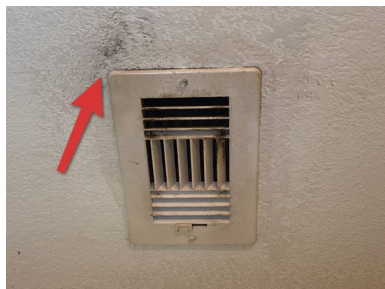
Unit b 1st Floor Bathroom

Observed signs of mold (discoloration, mold odor, mold spots, etc.) in one or more areas in the Ceiling. Recommend mold inspector identifying source or moisture intrusion and sending samples to a lab for testing.

Recommendation: Contact a qualified mold inspection professional.

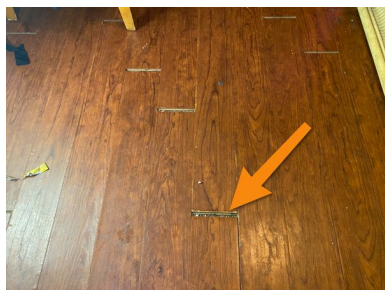
Wood flooring was damaged at various areas in both units.

Recommendation: Contact a qualified flooring contractor

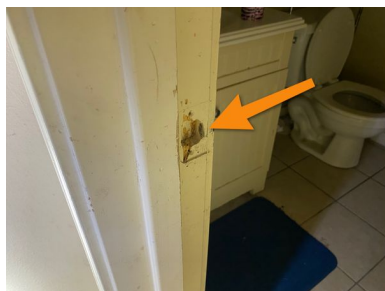
Unit b 1st Floor Bathroom

The door is missing metal hardware that is installed on the door frame where the door will latch. The missing hardware is used to support the doorknob in the frame and can be ripped from the wood frame without the support. Recommend installation of the missing hardware by a door repair contractor or do-it-yourself.

Recommendation: Contact a qualified door repair/installation contractor.

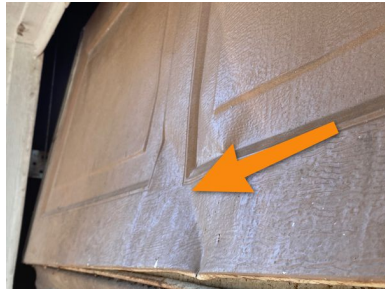
Garage door

Doors were damaged at one or more locations.

Recommendation: Contact a qualified general contractor.

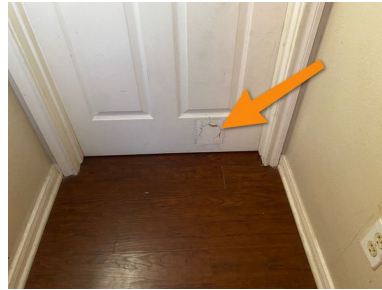
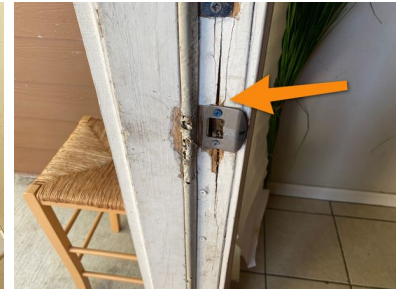
Front door unit A

### 4: Door damage

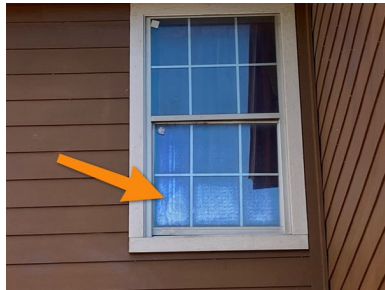
Unit B, rear window

Double pane windows appear to have broken seals between the glass panes. This is indicated by moisture present between the panes or the seal being visibly ruptured (cracked, torn, or squeezed out). If windows were argon gas-filled, the gas is likely gone. The efficiency of the window is compromised.

Recommendation: Contact a qualified window repair/installation contractor.

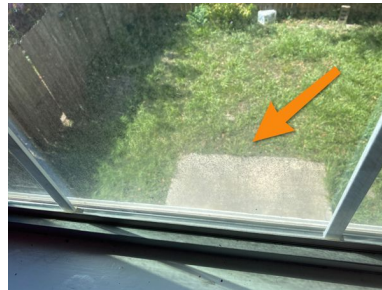
Unit A rear window

**3: Window won't stay open**

One or more windows won't stay open and fall closed. This could be caused by a number of reasons including failed railing mechanism, deficient springs, broken latches, or frames that are misaligned. Recommend windows be restored to functional use by an window repair and installation contractor.

Recommendation: Contact a qualified window repair/installation contractor.

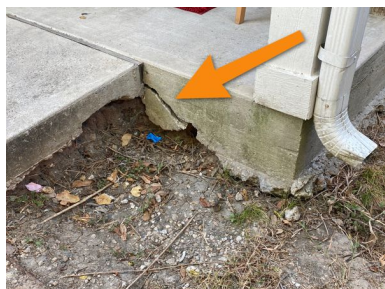
Front porch, unit A

**1: Old concrete - porch cracks, separation, or heaving**

The porch show signs of aged cracking, separation, heaving, and/or deterioration. This is common in areas of the state that have clay-based soils. Compromised concrete will continue to exhibit decay, failure, collapse, and uplift if not remediated. Cracking can also be a safety tripping hazard for pedestrians.

Recommendation: Recommend monitoring.

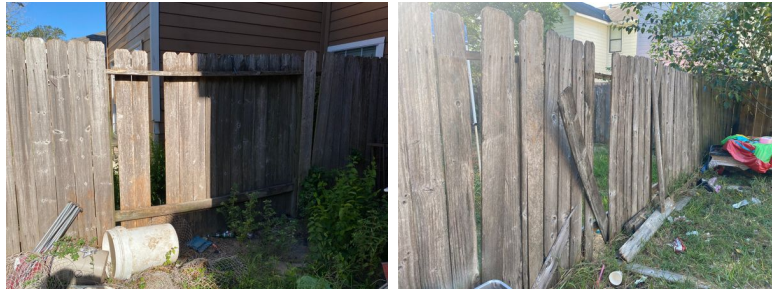
**1: Major fence deficiencies - rot and/or structural issues**

Fence appears to have significant rot damage and/or structural issues. Recommend contract a fencing contractor for repair and/or replacement of the elements that are exhibiting rot or structural issues.

Recommendation: Contact a qualified fencing contractor

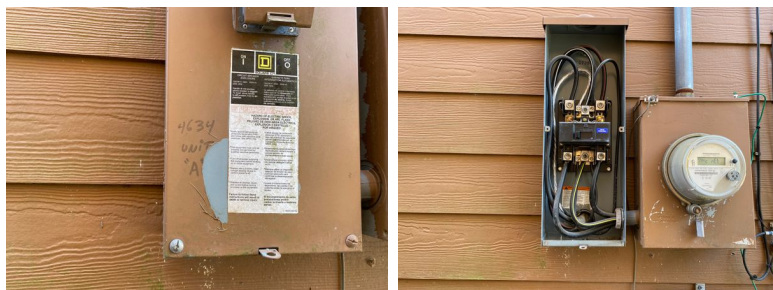
*Photo(s) of electric sub-panel: Capacity Undetermined*

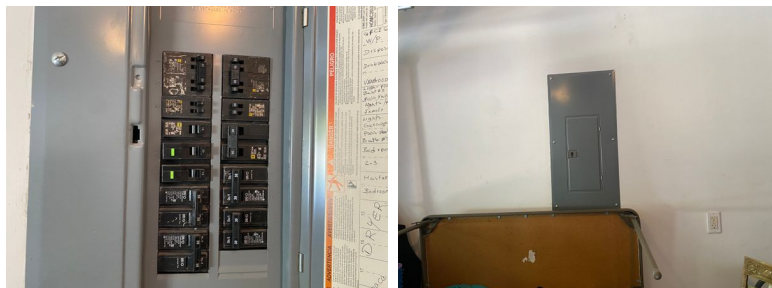
*Branch circuit wiring: Copper -*

Branch wiring (wiring throughout the structure) should be copper for all circuits within structure. Aluminum wire is considered a fire hazard and is caused by oxidation and other factors that lead to overheating where the wire is connected at splices, outlets and light fixtures. Aluminum wire is OK and very common for the main electrical service from the meter.

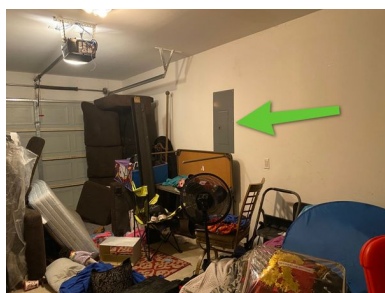
Unit A

The panel is obstructed and cannot be accessed for further evaluation. Recommend owner remove obstruction and allow for the panel to be properly inspected.

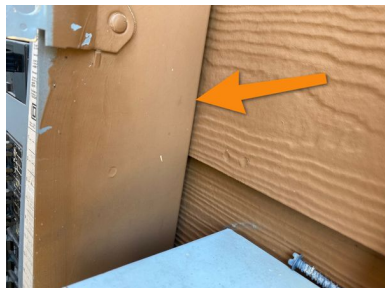
The electrical panel is not sealed at the wall. This can result in water intrusion down the back of the electrical panel and into the wall or panel itself. This should be resolved by sealing the panel against the wall to prevent water intrusion, electrical issues, and structural rot. Recommend an electrical or siding contractor to resolve the issue.

Recommendation: Contact a qualified electrical contractor.

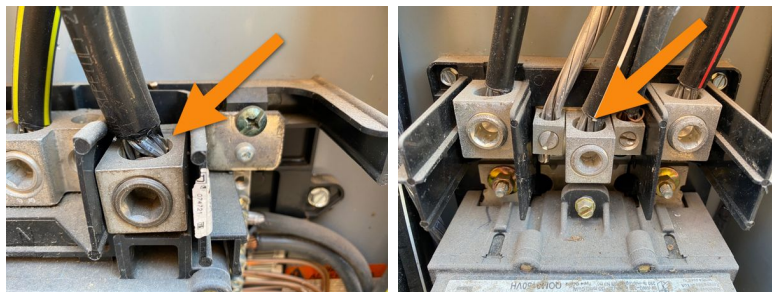
Conductor antioxidant termination paste/gel/compound is used on termination connections of aluminum wires to an electrical breaker panel. The substance gets used to retard oxidation at the conductor/connector interface and protect the aluminum from lowered conductivity. Primary service wires into the lugs of a electrical panel should have antioxidant the substance applied to the wires. Recommend an electrician remove the conductors and add.

Recommendation: Contact a qualified electrical contractor.

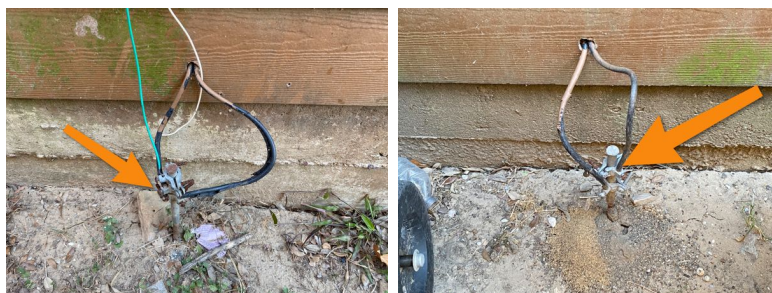
The ground clamps were loose on the ground rods.

Recommendation: Contact a qualified electrical contractor.

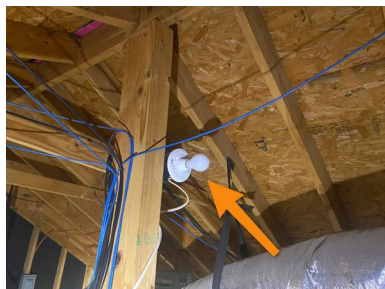
**1: Fixture - light inoperable / bulb needs replacement**

One or more light fixtures were inoperable (didn't turn on when nearby switches were operated). Recommend further evaluation by replacing bulbs and/or consulting with the property owner. If replacing bulbs doesn't work and/or no other switch(es) can be found, then recommend that a qualified electrician evaluate and repair or replace light fixtures as necessary.

Lights were not working at several locations in both units

Recommendation: Contact a qualified electrical contractor.

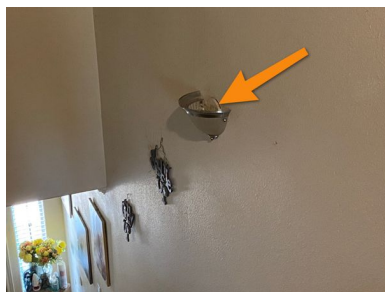
Stairway lights

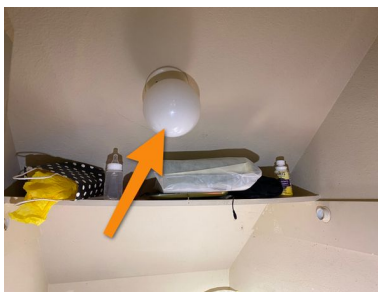
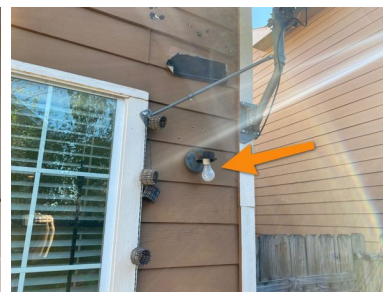
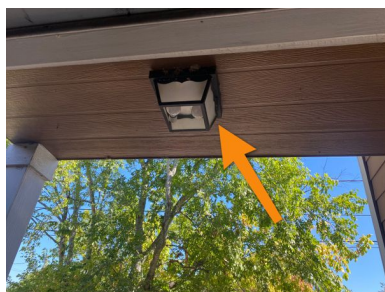
Stairway light, unit a

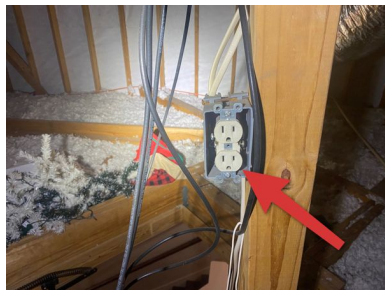
One or more electrical receptacles are missing a cover plates, or the plate is damaged. This causes short and shock risk. Recommend replacement of the damaged or missing cover plate.

Cover plates were missing at various locations within both units

Recommendation: Contact a qualified electrical contractor.

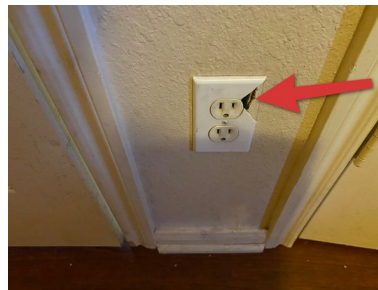
### 3: Cover plates missing or damaged

Cover plates were damaged in various areas in both units

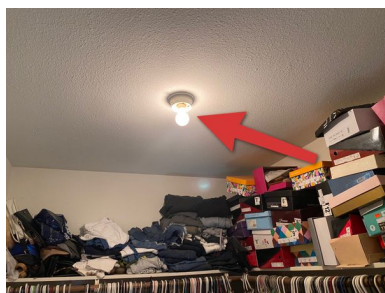
Closets used to store clothing and/or all attic areas must have light fixtures that cover the bulb (with a pendant shade) or a cage. This will prevent the possibility of fire or physical harm from a bulb burst.

Recommendation: Contact a qualified Do It Yourself

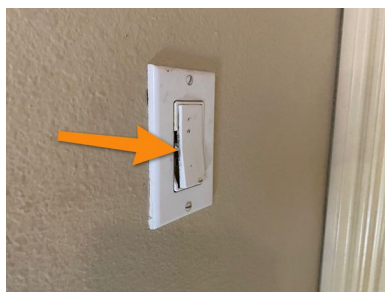
Electrical switches were damaged at various locations in both units.

Recommendation: Contact a qualified electrical contractor.

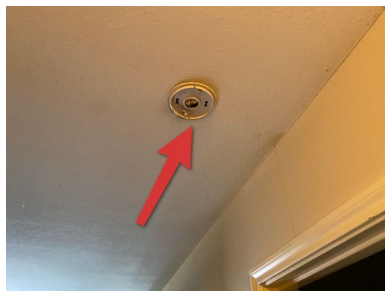
**1: Smoke alarms - missing or not working**

Smoke alarms/detectors were missing or not working in the structure in multiple locations. It is recommended that smoke alarms be installed inside each bedroom, outside each sleeping area and on every level of the structure. On levels without bedrooms, it is recommended that alarms be installed in the living room (or den

Missing

or family room) or near the stairway to the upper level, or in both locations. Recommend installation of smoke alarms/detectors in all areas of the structure, throughout the property, in all areas that require them.

Recommendation: Contact a qualified Do It Yourself

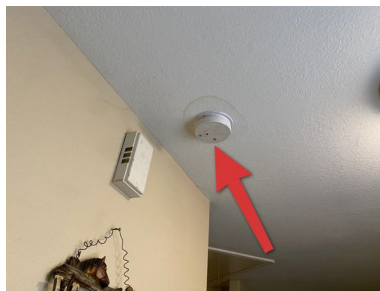
Not working

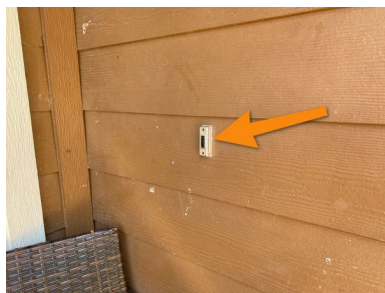
Unit B

The doorbell is inoperable and not producing an audible sound when pressed.

Recommendation: Contact a qualified electrical contractor.

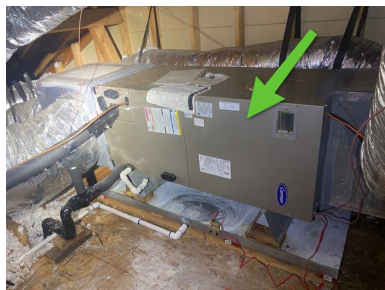
Unit B furnace

*Photo(s) of unit B heating system:* Electric Central Heat - Unit B

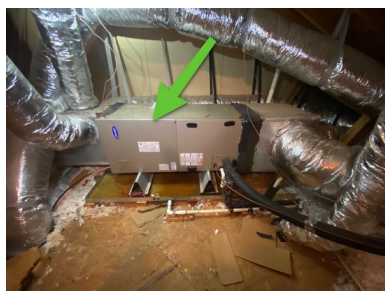
Unit A furnace

*Photo(s) of unit A heating system:* Electric Central Heat

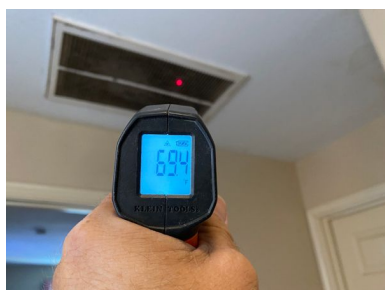
Return

Unit B - measured temperature differential: Operable (15°F to 20°F)

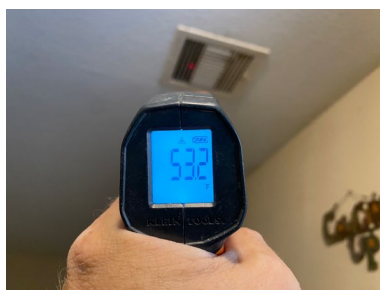
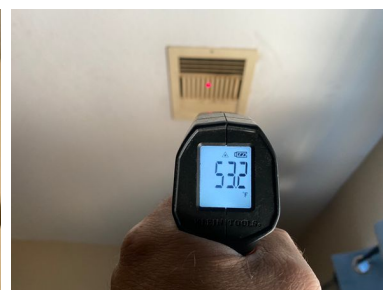
Supply, 16° differential

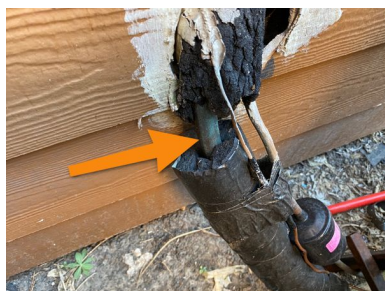
Unit b

**1: Condenser - freon insulation missing or damaged**

Missing or damaged insulation on the refrigerant line can cause energy loss and condensation. Recommend contacting an HVAC professional to replace the missing or damaged insulation.

Recommendation: Contact a qualified HVAC professional.

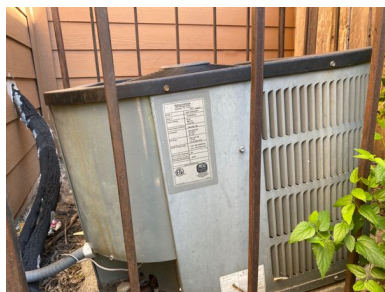
Unit a

The pad for the HVAC condenser is uneven and not level. An uneven pad can cause the fan motor in the condenser to work harder and the fan bearings to malfunction sooner. Recommend releveling the pad or hiring an HVAC professional to replace it.

Recommendation: Contact a qualified HVAC professional.

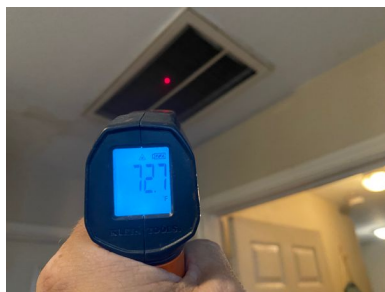
Return, unit A

Cooling system was not producing cold enough air at time of inspection. The differential between the return intake and the supply vents was less than the recommended 15°F of minimum difference. A system that is adequately sized and working properly should produce a 15°F to 20°F difference passing through the evaporator coil. Some reasons for a lower differential measurement include:

- Filter needing replacement (clogged filter)
- Inadequate insulation on supply and/or return duct-work
- Low on freon (freon leak)
- Inoperable component of the AC
- Undersized system

Recommend qualified HVAC professional evaluate & ensure functionality.

Recommendation: Contact a qualified HVAC professional.

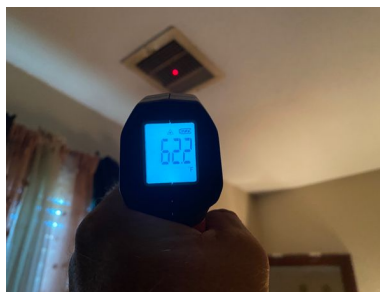
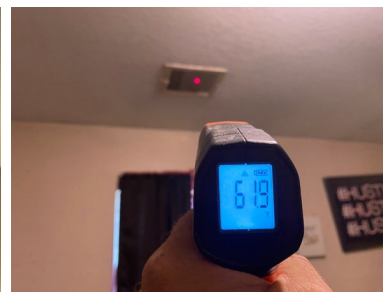
Supply, 10° differential

Supply, 11° differential

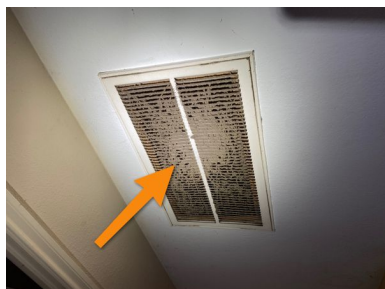
**1: Filter requires replacement**

The furnace filter appears to be beyond its expected lifespan. Recommend replacement.

Recommendation: Contact a qualified HVAC professional.

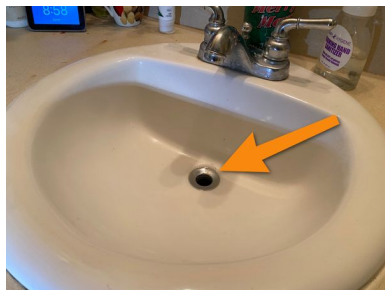
Drain stops missing at sinks at various areas in both locations

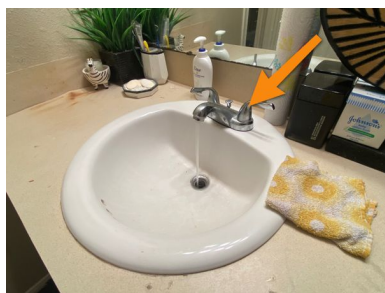
Unit A Primary Bathroom

Plumbing fixture is loose. Recommend hiring a plumber to tighten fixture.

Recommendation: Contact a qualified plumbing contractor.

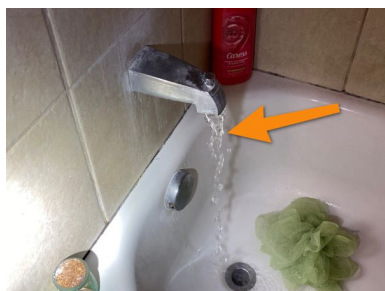
Low water pressure, both units

Recommendation: Contact a qualified plumbing contractor.

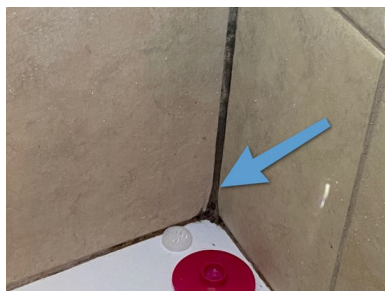
Bathroom

The tub and/or shower requires re-caulking. Re-caulking is necessary where caulking is missing or mold/mildew stains are present and have permanently set (i.e. they are no longer removable). Re-caulking can

be completed DIY, or most general contractors and plumbers can re-caulk a bathroom. Confirm the use of silicon-based sealants that will prevent the penetration of water into the seams and cracks.

Recommendation: Contact a qualified Do It Yourself

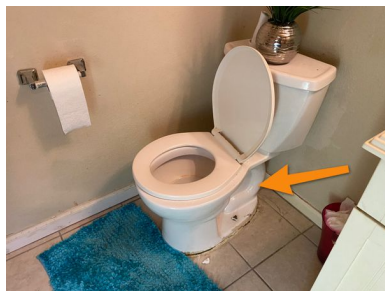
Unit A 1st Floor Hall Bathroom

The toilet is loose and not stable. This could be at the connection with the ground or at the bowl connection with the tank. Recommend tightening the toilet bolts or hiring a qualified plumbing contractor to tighten and further investigate.

Recommendation: Contact a qualified plumbing contractor.

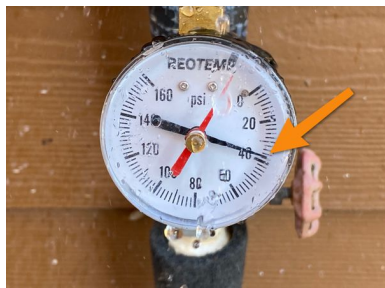
The water distribution pressure was measured below the lowest recommended pressure of 40 pounds per square inch (psi). Low water pressure could be isolated to a single fixture (indicating a line clog or a small pipe) or could be much more extensive, coming from the City water source. In some cases, low water pressure cannot be fixed easily and would require infrastructure changes to the municipal's delivery supply. Recommend further evaluating why the water pressure at the property is low.

Less than 40 psi, both units

Recommendation: Contact a qualified plumbing contractor.

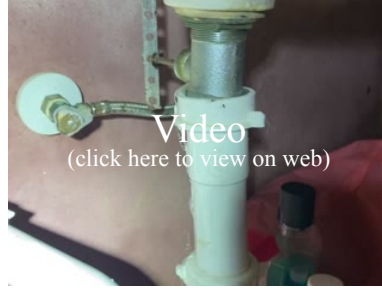
Unit B Primary Bathroom

There is an active drain leak underneath the sink. Recommend plumbing contractor to remediate.

Recommendation: Contact a qualified plumbing contractor.

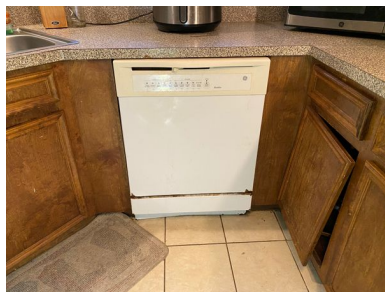
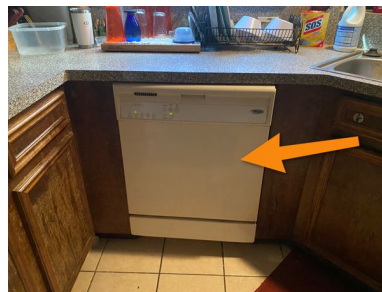
Dishwasher appliance was inoperable at the time of inspection. Recommend qualified appliance professional to repair.

Recommendation: Contact a qualified appliance repair professional.

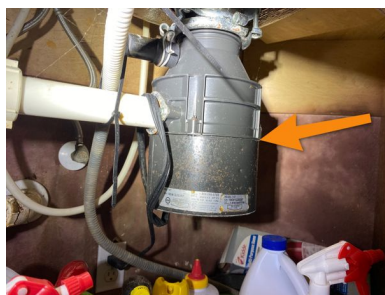
Garbage disposal was inoperable at the time of inspection. Recommend qualified handyman repair.

Recommendation: Contact a qualified handyman.

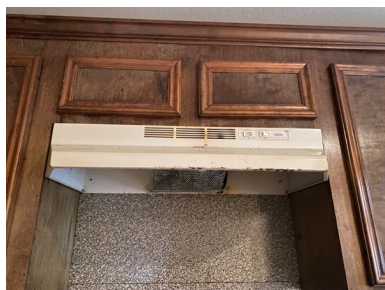
Unit A

Exhaust fan was inoperable. Recommend a qualified contractor repair.

Recommendation: Contact a qualified plumbing contractor.

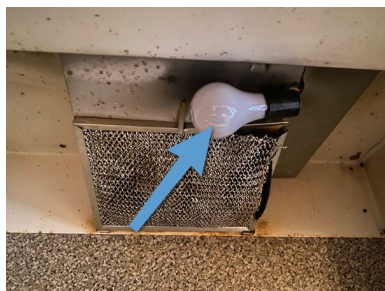
Unit a

The exhaust fan light was inoperable. This is likely caused by a burnt out lightbulb. Recommend replacement of bulb and/or further investigation for possible exhaust deficiency.

Recommendation: Contact a qualified professional.

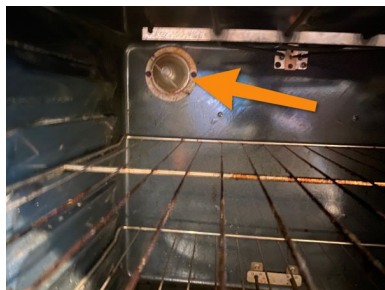
Unit a

The oven light was inoperable. This light bulb is more difficult to replace than a typical appliance bulb and may require the assistance of an appliance repair technician. Recommend further evaluation for self DIY repair, and if too complicated discuss with an appliance repair company.

Recommendation: Contact a qualified appliance repair professional.

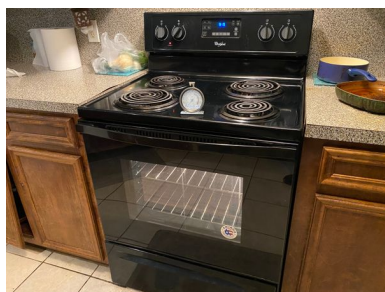
Both units missing anti-tip bracket

Recommendation: Contact a qualified handyman.

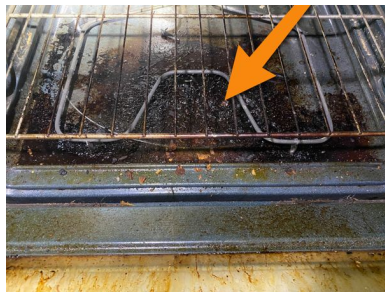
There was a heavy grease buildup in the oven in unit A. This is a fire hazard, and for this reason the oven in this range was not tested.

Recommendation: Contact a qualified appliance repair professional.

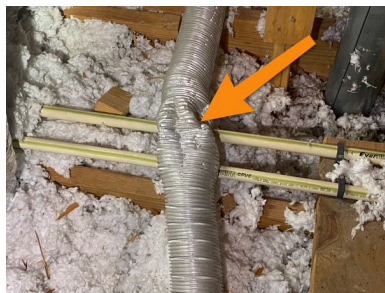
Bathroom fan vent duct was crushed in the attic of unit A.

Recommendation: Contact a qualified general contractor.

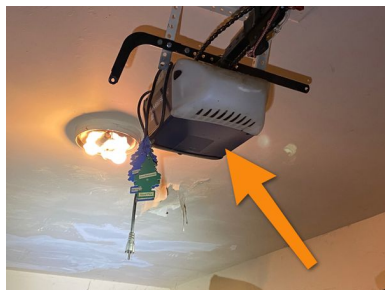
Unit B

The automatic garage door opener is not operable and will not move the garage door up and down into place. Recommend further evaluation and possibly replacement of the garage door opener.

Recommendation: Contact a qualified garage door contractor.

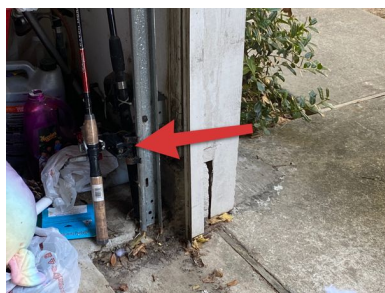
Sensors inoperable, unit a

Recommendation: Contact a qualified garage door contractor.
