NOBLE PROPERTY INSPECTION REPORT

6824 St Augustine St
Houston, TX 77021

PROPERTY INSPECTION REPORT FORM

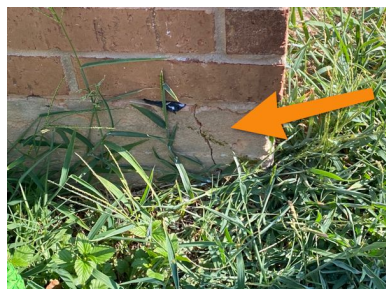
Front Left

1: Slab - foundation cracks - corners

Corner cracks are visible in the foundation slab but are of minimal structural concern. Shrinkage is a natural part of the curing process of concrete and cracks located in corners of structures are common. Recommend monitoring to confirm the cracking does not worsen.

Recommendation: Recommend monitoring.

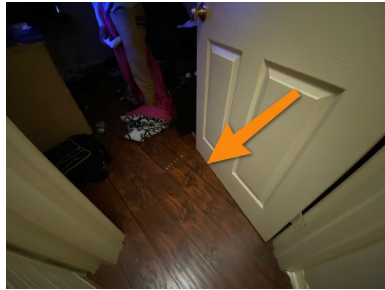
Doors binding at various locations

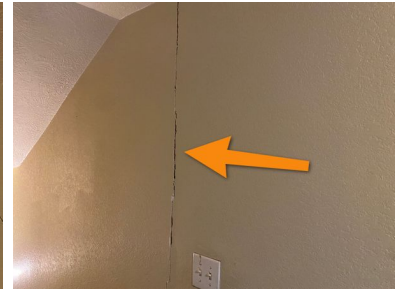
Wall cracks

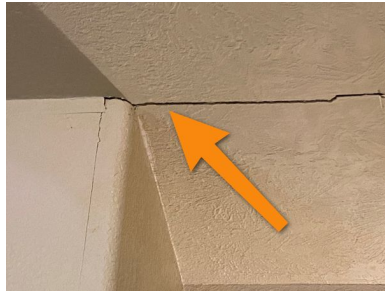
Ceiling cracks

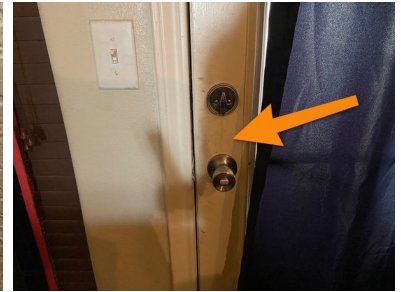
Doors did not latch

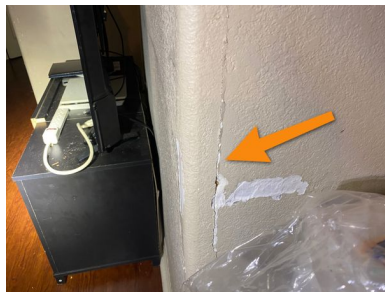
Wall cracks

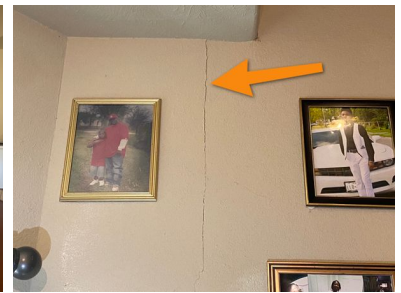
Wall crack, unit b

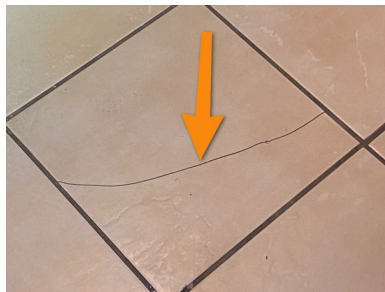
Floor cracks at several locations

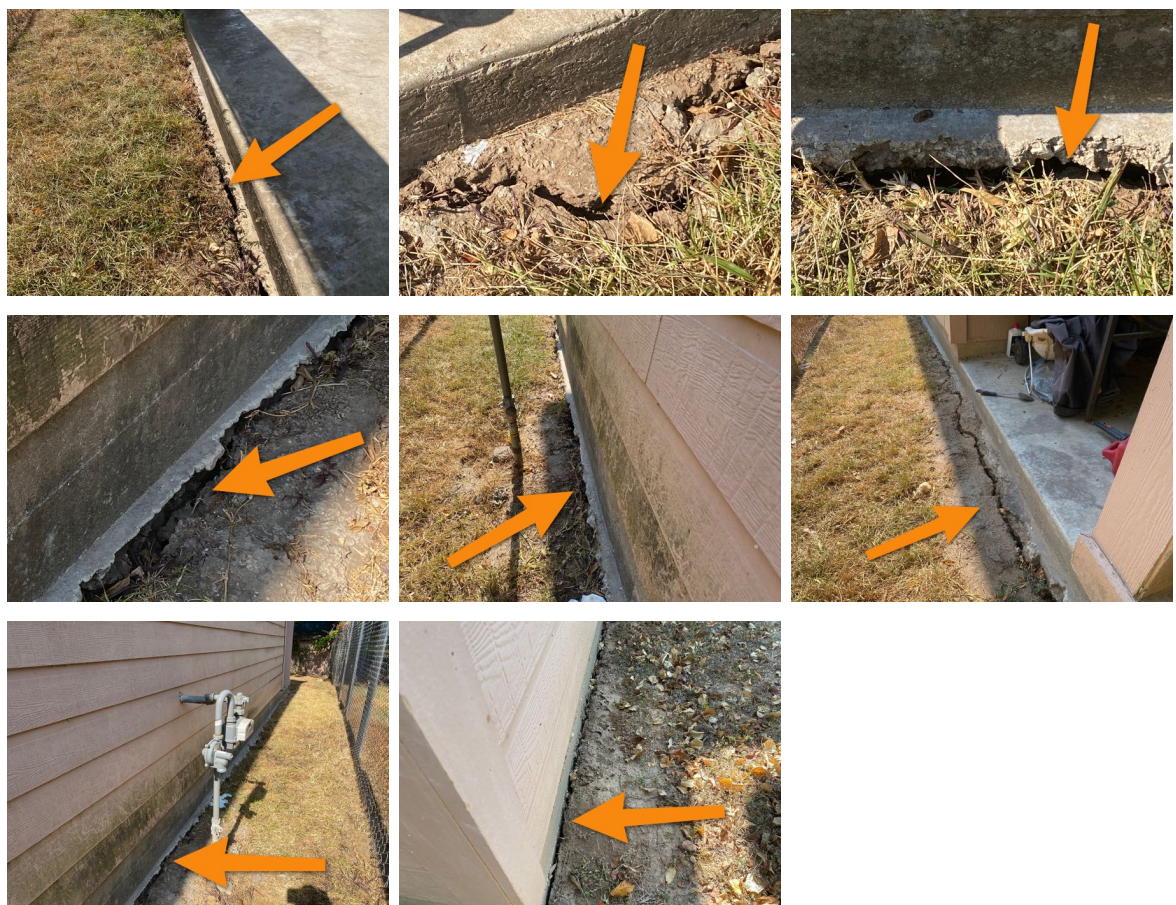
1: Separation of soil around the foundation

There was a large separation of the soil from the foundation around the perimeter of the house. This will allow a significant amount of water to accumulate around the foundation and can contribute to foundation issues. Further evaluation and correction by a landscape professional is recommended.

Recommendation: Contact a qualified landscaping contractor

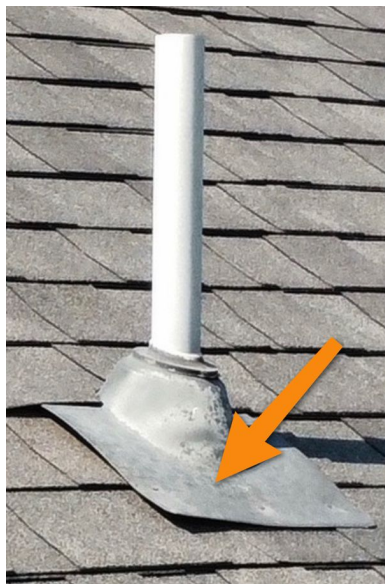
Areas of the roof show lifted flashing areas. Lifted flashing areas will not seal with the lower shingle areas or siding and can allow for water intrusion. Recommend a roofing contractor to replace.

Recommendation: Contact a qualified roofing professional.

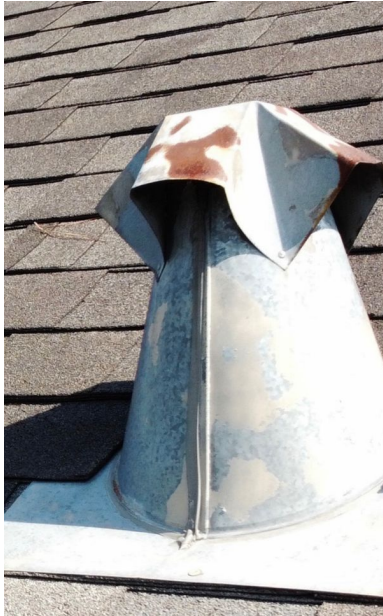
2: Rusted vents

Appliance vent rusted. One or more appliance vents were rusted. These should be replaced or corrected as necessary to avoid roof leaks.

Recommendation: Contact a qualified roofing professional.

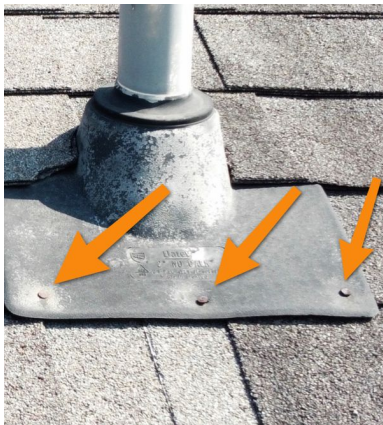
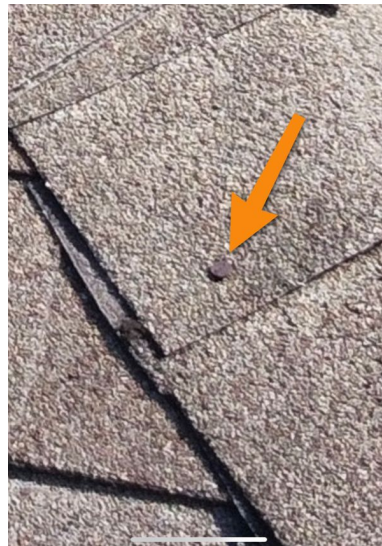
3: Exposed or rusted fasteners

Rusted and/or exposed roofing nails were seen at one or more places on the roof. This can lead to roof leaks and property damage. Repairs as necessary by a roofing professional is recommended.

Recommendation: Contact a qualified roofing professional.

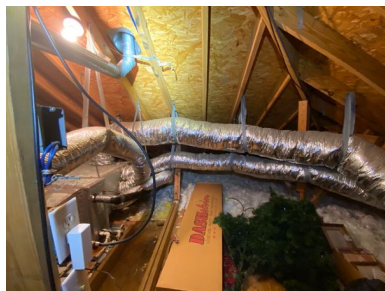
Unit A

Inspected attic from: Limited Attic Walk, Only unit A was accessible

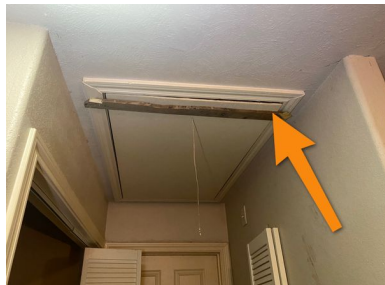
Unit B

The attic was not accessible in unit B of this duplex; it was blocked with a board bolted over it. This prevented entry and inspection of this attic and the water heater and HVAC equipment in this attic.

Recommendation: Contact a qualified general contractor.

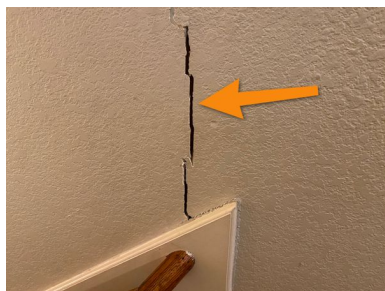
Unit b

Major cracking observed in wall structure that is likely due to structural foundation issues and is considered evidence of a structural deficiency. Recommend a qualified foundation contractor evaluate and advise on course of action.

Recommendation: Contact a foundation contractor.

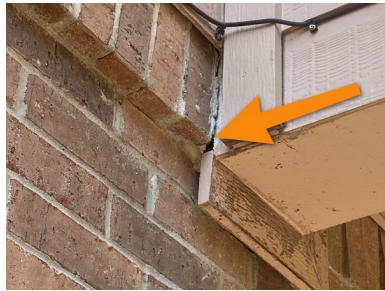
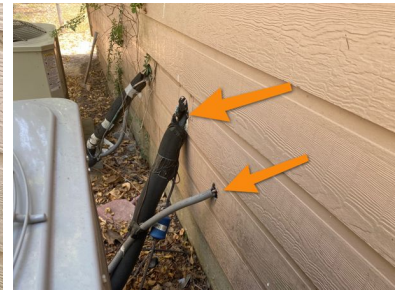
3: Missing sealant, exterior

Sealant or grout was missing at exterior wall penetrations, wall joints, or wall attachments at one or more locations around the house. This can permit water or insect intrusion into the home. Application of proper sealant or grout is recommended.

Recommendation: Contact a qualified general contractor.

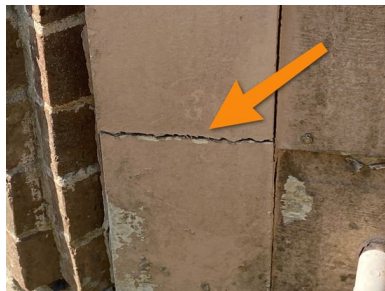
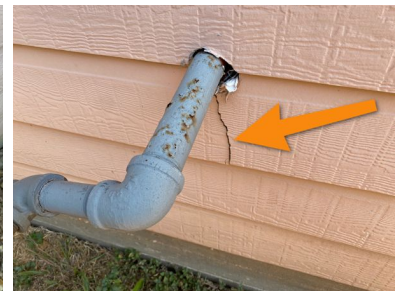
4: Exterior siding or trim damage

Siding or trim damage. There was damage to the exterior siding and trim at one or more locations around the house.

Recommendation: Contact a qualified general contractor.

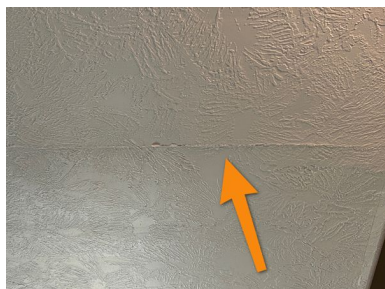
Kitchen

2: Ceiling - sheetrock cracks minor

Minor sheetrock cracking was observed on the ceiling. This is common in structures this age and is often determined to be cosmetic, most often the separation of drywall tape joints. Recommend monitoring these locations for further cracking.

Recommendation: Contact a qualified Do It Yourself

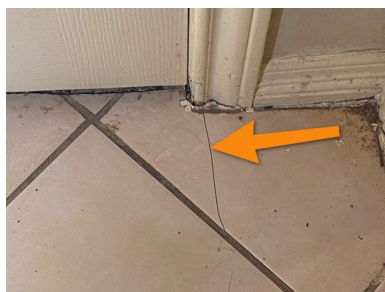
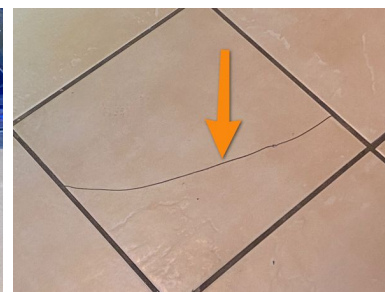
Unit a

Loose tiles that are popped or missing and/or cracking was observed. This is possibly due to structural foundation issues and is considered evidence of a structural deficiency if on the interior of the structure. Recommend a qualified foundation repair company / contractor evaluate and advise on course of action prior to repair of the flooring.

Recommendation: Contact a foundation contractor.

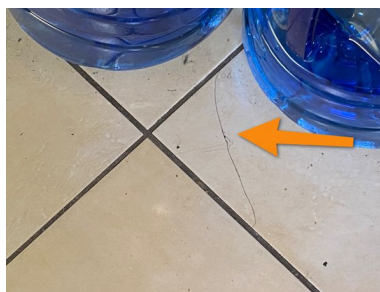
4: Flooring - tiles loose / cracked or missing

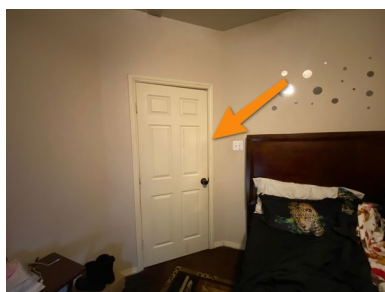
Door doesn't latch to close properly. Recommend handyman repair door, latch, frame, and/or strike plate.

Doors at more than one location did not latch properly

Recommendation: Contact a qualified handyman.

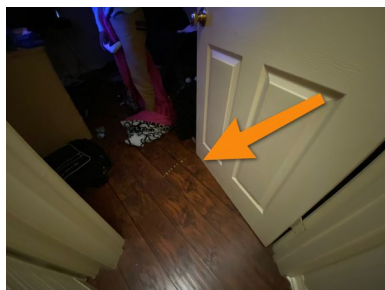
Door sticks, rubs the frame, and is tough or impossible to open and/or close. The door is not aligning with the frame. Recommend hiring a door repair and installation contractor to realign the door or sanding down offending sides.

Doors were binding at more than one location

Recommendation: Contact a qualified door repair/installation contractor.

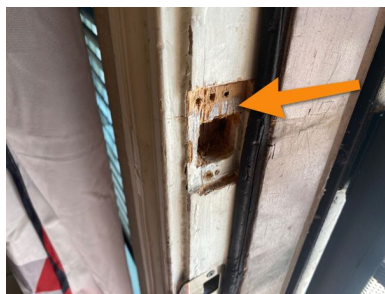
Unit A

The door is missing metal hardware that is installed on the door frame where the door will latch. The missing hardware is used to support the doorknob in the frame and can be ripped from the wood frame without the support. Recommend installation of the missing hardware by a door repair contractor or do-it-yourself.

Recommendation: Contact a qualified door repair/installation contractor.

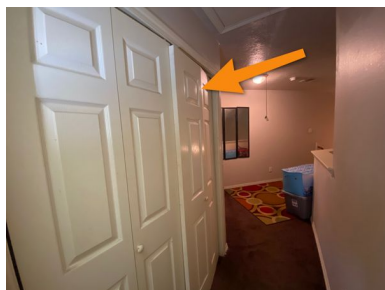
Unit a 2nd Floor

The door is not sliding on it's tracks / rails correctly or is off the tracks completely. Recommend a contractor evaluate and reinstall correctly.

Recommendation: Contact a qualified door repair/installation contractor.

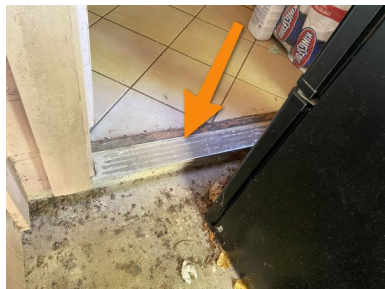
Unit b

The door threshold is not fully supported, loose, causing a trip hazard, or is missing. The door threshold provides for an even transition from the exterior to the interior; it also allows for the door to seal properly and transition to the interior flooring. The door threshold should be firm, fully supported, and even across the bottom of the door.

Recommendation: Contact a qualified door repair/installation contractor.

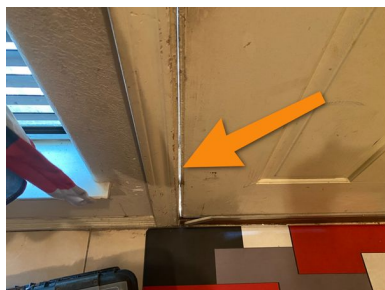
Door has missing or insufficient weather-stripping. This can result in significant energy loss and moisture intrusion. Recommend installation of standard weather-stripping.

Weatherstripping was damaged at doors in both units

Recommendation: Contact a qualified Do It Yourself

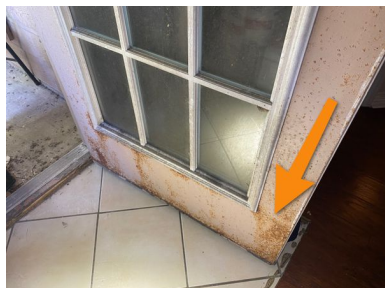
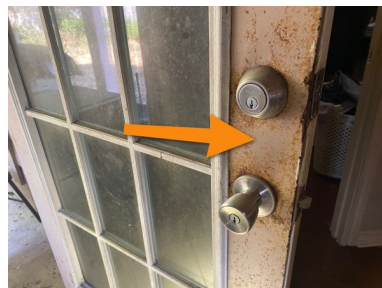
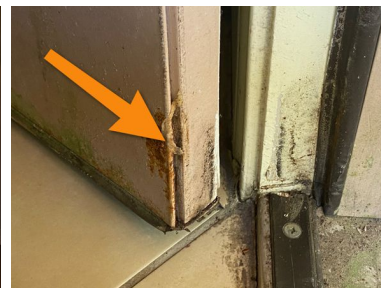
Back door unit A

Doors were damaged at various locations.

Recommendation: Contact a qualified door repair/installation contractor.

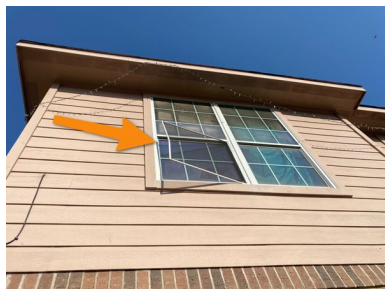
One or more windows has a missing or damaged screen. Recommend replacement depending on preference.

Recommendation: Contact a qualified window repair/installation contractor.

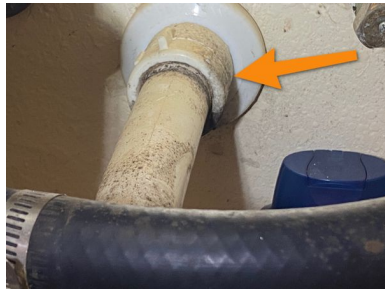
Under sink, unit B

Observed signs of suspected mold (discoloration, mold odor, mold spots, etc.) in one or more areas of both units. Recommend mold inspector identifying source of moisture intrusion and possibly sending samples to a lab for testing.

Recommendation: Contact a qualified mold inspection professional.

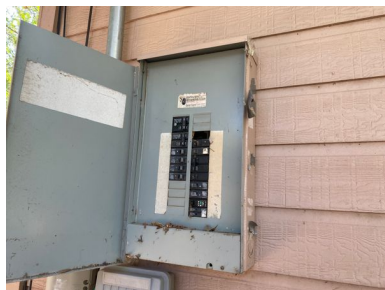
1: Panel missing AFCI breakers

The state requires inspectors, regardless of the structure's age, to mark as "deficient" where any (AFCI) protection is not installed in these areas.

Recommendation: Contact a qualified electrical contractor.

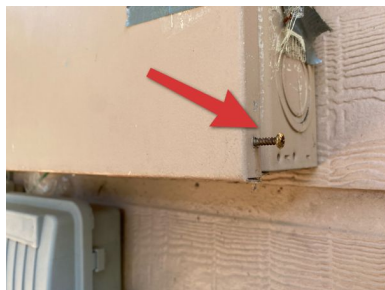
The cover / dead front of the main service panel or sub-panel is misaligned and/or damaged and cannot be installed or oriented correctly. As such, the cover is not fastened correctly, can be removed easily, or is causing a gap between the breakers and the cover. Recommend qualified electrician to remedy.

Improper method to secure the cover

Recommendation: Contact a qualified electrical contractor.

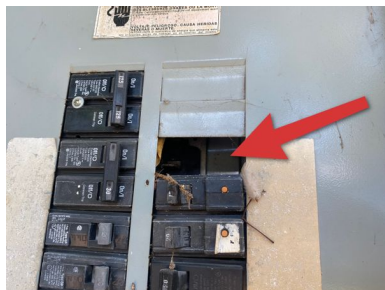
4: Missing breaker filler plates

Breaker filler plates are missing from the breaker panel. Without filler plates, fingers can fit through the slit creating a safety hazard. Recommend installing the filler plates or contacting an electrician who can install them.

Recommendation: Contact a qualified electrical contractor.

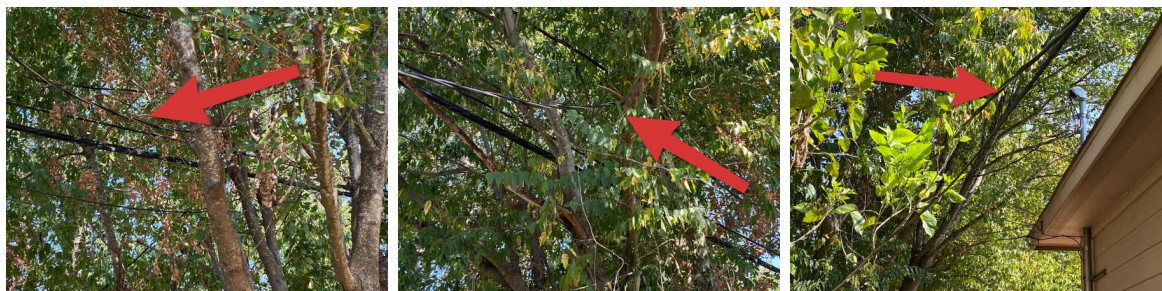
5: Vegetation touching main service wires

vegetation away from the wires for safety.

Recommendation: Contact a qualified landscaping contractor

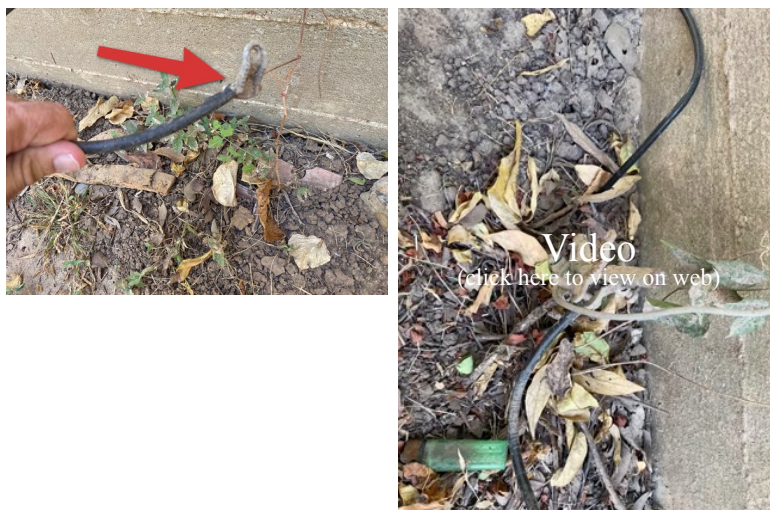
6: Grounding rod missing or disconnected

The grounding rod is missing and/or disconnected from the main service panel. Recommend an electrical contractor re-establish local grounding to the panel by correcting the grounding deficiency.

Recommendation: Contact a qualified electrical contractor.

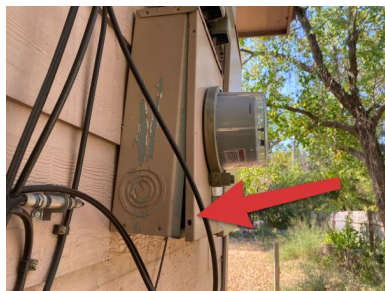
8: Meter panel open

The panel was open on the meter for unit B.

Recommendation: Contact a qualified electrical contractor.

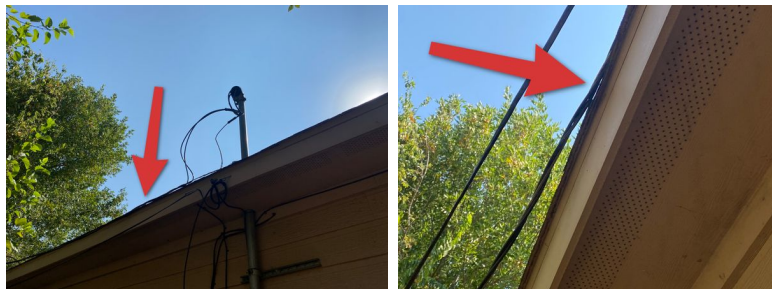
9: Service wires touching the roof

The utility lines were touching the roof. This can result in a house fire and should be corrected immediately.

Recommendation: Contact a qualified electrical contractor.

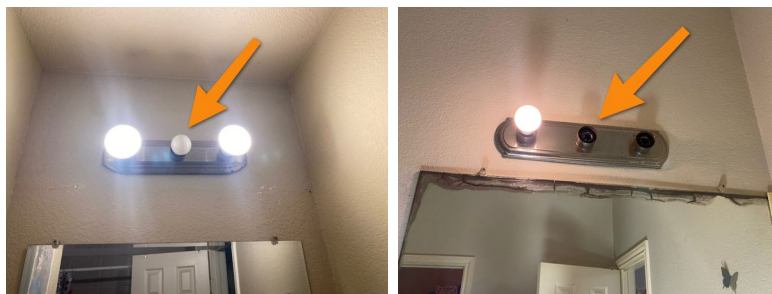
Lights were not working at multiple areas around the house. Photos are representative and do not include all areas of deficiencies.

Recommendation: Contact a qualified electrical contractor.

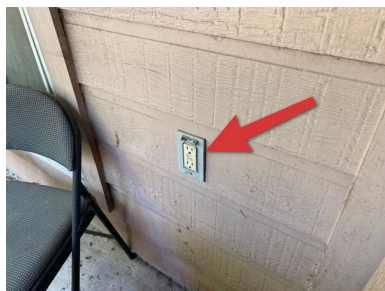
2: Cover plates are not water resistant

The outdoor outlet did not have a water-resistant cover installed, which helps prevent electrical shocks in damp weather. The current standard is an “in-use” cover (or “bubble cover”), which can be fully closed with an extension cord in use.

Recommendation: Contact a qualified electrical contractor.

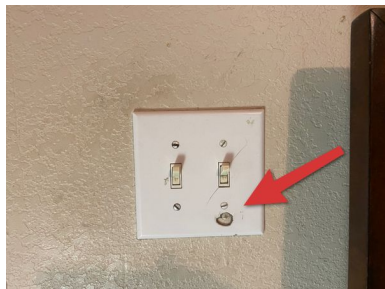
Unit a, Primary Bedroom

One or more electrical receptacles are missing a cover plates, or the plate is damaged. This causes short and shock risk. Recommend replacement of the damaged or missing cover plate.

Recommendation: Contact a qualified electrical contractor.

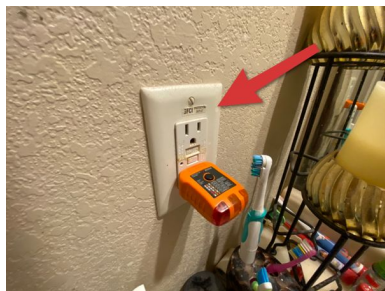
Unit A, Primary Bedroom

GFCI outlet was not functioning properly. This is because it was not tripping or not resetting. Recommend licensed electrician investigating the cause and replacing receptacles that are malfunctioning in all locations necessary.

Recommendation: Contact a qualified electrical contractor.

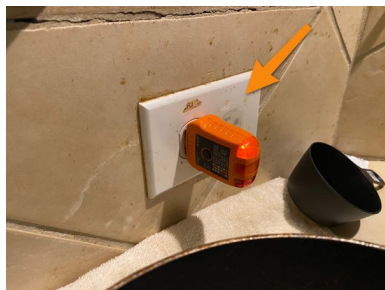
Ungrounded receptacle at one or more locations

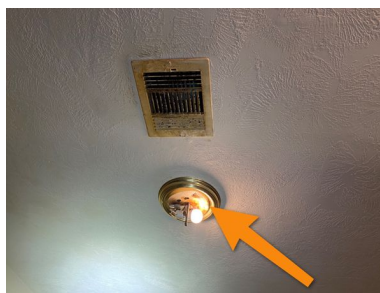
Light fixtures were damaged or missing covers at more than one location.

Recommendation: Contact a qualified electrical contractor.

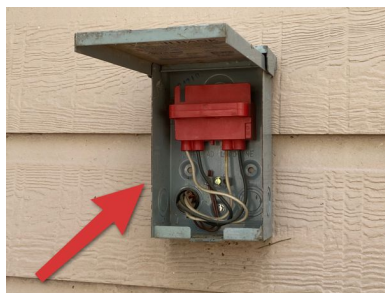
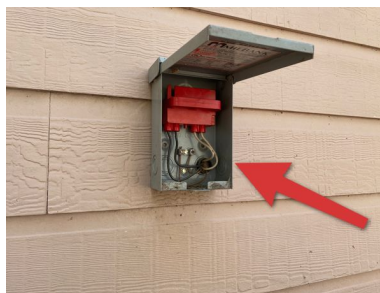
The dead front cover was missing on the two AC disconnect switches at the back of the house. This leaves high voltage wiring exposed to passerby's who can open the panel and potentially be electrocuted.

Recommendation: Contact a qualified electrical contractor.

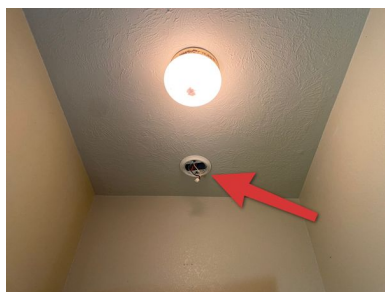
Smoke alarms/detectors are missing in the structure in multiple locations. It is recommended that smoke alarms be installed inside each bedroom, outside each sleeping area and on every level of the structure. On levels without bedrooms, it is recommended that alarms be installed in the living room (or den or family room) or near the stairway to the upper level, or in both locations. Recommend installation of smoke alarms/detectors in all areas of the structure, throughout the property, in all areas that require them.

Recommendation: Contact a qualified Do It Yourself

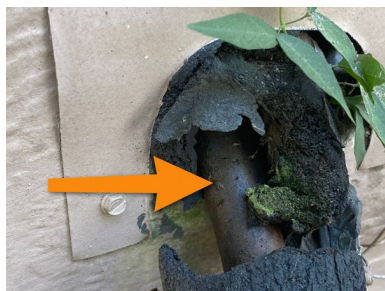
Missing or damaged insulation on the refrigerant line can cause energy loss and condensation. Recommend contacting an HVAC professional to replace the missing or damaged insulation.

Recommendation: Contact a qualified HVAC professional.

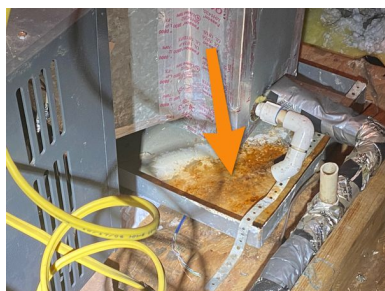
Unit A

Rusted drain pan in unit A. Drain pan under interior AC unit was rusted. This can lead to water leaks in the attic and cause ceiling damage. Repairs as necessary by an HVAC professional is recommended.

Recommendation: Contact a qualified HVAC professional.

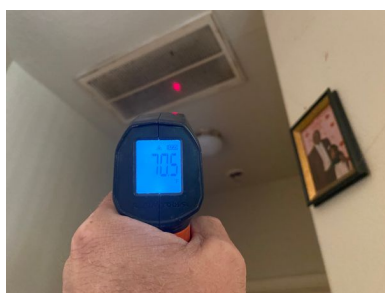
Unit B return

Cooling system was not producing cold enough air at time of inspection. The differential between the return intake and the supply vents was less than the recommended 15°F of minimum difference. A system that is adequately sized and working properly should produce a 15°F to 20°F difference passing through the evaporator coil. Some reasons for a lower differential measurement include:

Recommend qualified HVAC professional evaluate & ensure functionality.

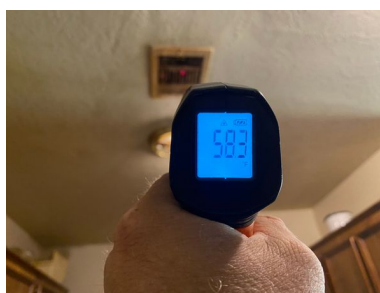
Unit B supply, 12° differential

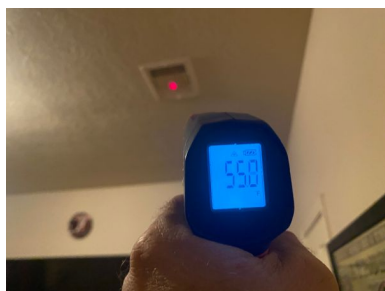
Unit A supply, 10° differential

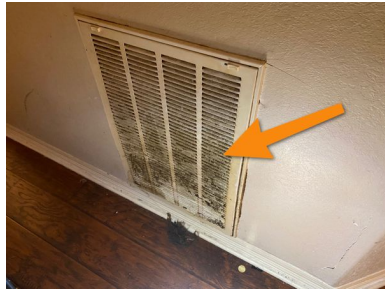
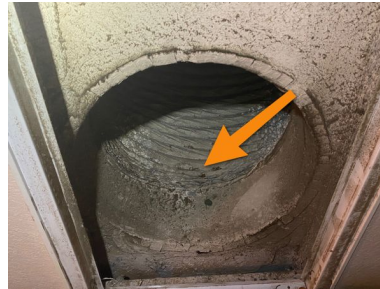
Inspector has discovered evidence that the HVAC duct system should be cleaned. This includes either a visual investigation of the plenums through access ports (if available) or supply vents that are dirty, dusty, and/or clogged with debris.

Recommendation: Contact a qualified HVAC professional.

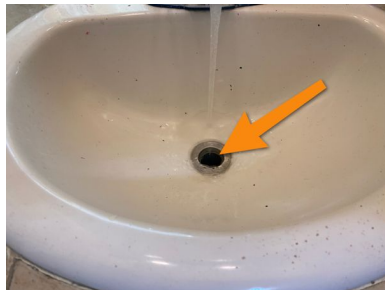
Drain stops missing at various locations

Recommendation: Contact a qualified plumbing contractor.

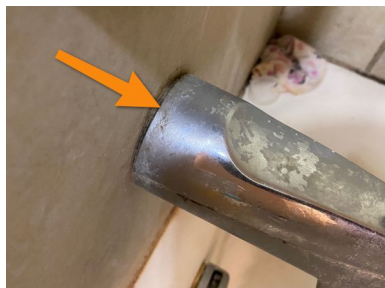
Unit a, bathtub spout

The faucet / spigot drain pull is not functioning properly or missing. Recommend plumbing contractor to resolve issue.

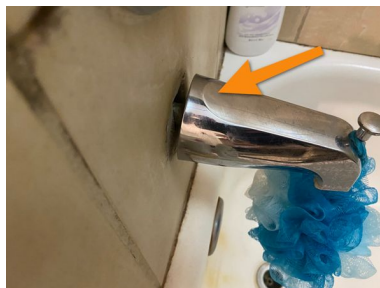
Unit A Primary Bathroom

3: Faucet / fixture / spigot dripping

A faucet, fixture, or spigot is dripping. Recommend qualified handyman or plumber evaluate and repair.

Recommendation: Contact a qualified plumbing contractor.

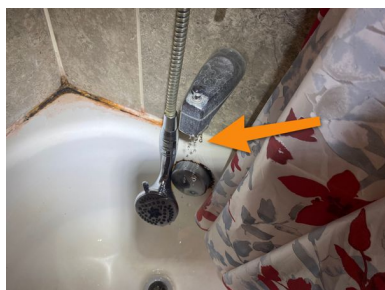
Unit B

4: Tub/shower re-caulking necessary

The tub and/or shower requires re-caulking. Re-caulking is necessary where caulking is missing or mold/mildew stains are present and have permanently set (i.e. they are no longer removable). Re-caulking can be completed DIY, or most general contractors and plumbers can re-caulk a bathroom. Confirm the use of silicon-based sealants that will prevent the penetration of water into the seams and cracks.

Recommendation: Contact a qualified Do It Yourself

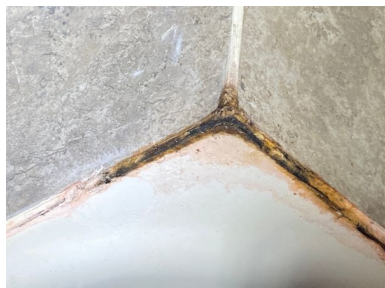
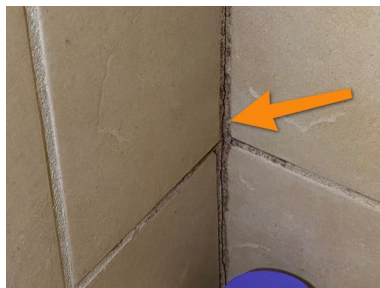
Unit A Primary Bathroom

5: Water distribution pressure is too low

The water distribution pressure was measured below the lowest recommended pressure of 40 pounds per square inch (psi). Low water pressure could be isolated to a single fixture (indicating a line clog or a small pipe) or could be much more extensive, coming from the City water source. In some cases, low water pressure cannot be fixed easily and would require infrastructure changes to the municipal's delivery supply. Recommend further evaluating why the water pressure at the property is low.

Recommendation: Contact a qualified plumbing contractor.

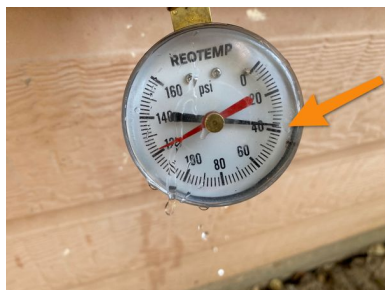
Below 40 psi

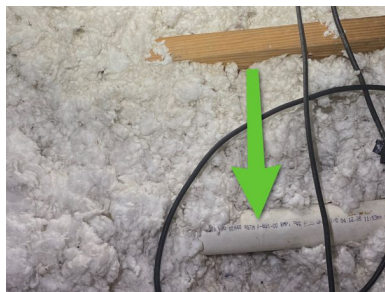
Chemical drain cleaners are corrosive and accelerate the corroding of cast-iron while FOGs can lead to sewer drain clogging. Replacement of ductile / cast iron pipe should be considered when purchasing a property with this type of sewer piping.

PVC drain pipe

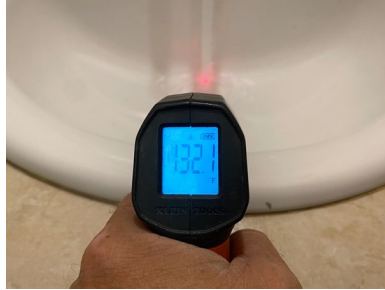
A temperature above one-hundred thirty (130) degrees Fahrenheit is general considered to be unsafe. Recommend a plumbing contractor evaluate why the water heater is producing water that is considered too hot.

Unit B

Recommendation: Contact a qualified plumbing contractor.

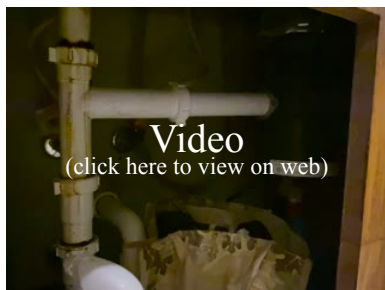
Unit A & B excessive noise

Recommendation: Contact a qualified plumbing contractor.

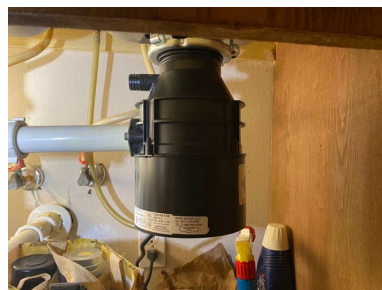
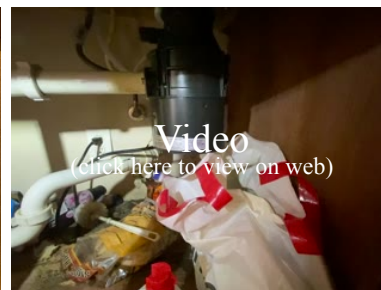
Garbage disposal motor was excessively noisy. Recommend a qualified plumber evaluate and repair or replace.

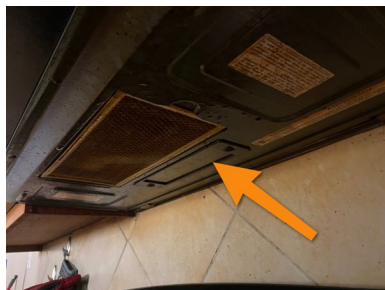
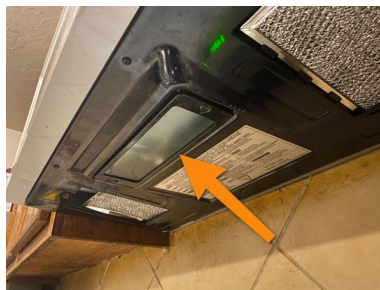
The exhaust fan light was inoperable. This is likely caused by a burnt out lightbulb. Recommend replacement of bulb and/or further investigation for possible exhaust deficiency.

Recommendation: Contact a qualified professional.

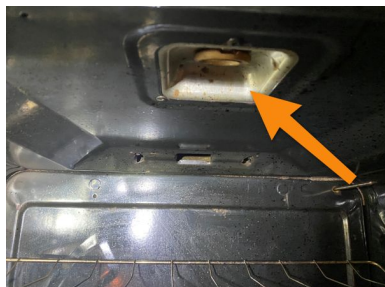
1: Oven light inoperable

The oven light was inoperable. This light bulb is more difficult to replace than a typical appliance bulb and may require the assistance of an appliance repair technician. Recommend further evaluation for self DIY repair, and if too complicated discuss with an appliance repair company.

Unit B

Recommendation: Contact a qualified appliance repair professional.

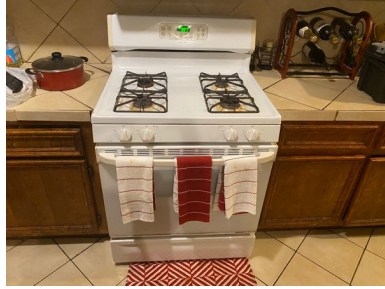
Gas oven wasn't heating up at time of inspection. Recommend a qualified appliance contractor evaluate and repair.

Unit a

Recommendation: Contact a qualified appliance repair professional.

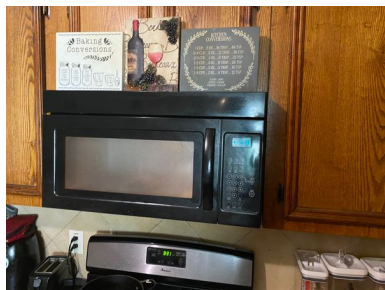
Microwave oven was inoperable at time of inspection. Recommend a qualified contractor evaluate and repair.

Unit B

Recommendation: Contact a qualified appliance repair professional.

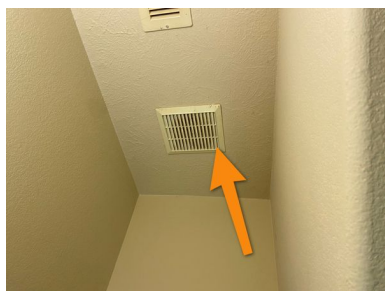
Fan inoperable

Recommendation: Contact a qualified electrical contractor.
