TPI HOME INSPECTION

9669 Windsor Ave
Iola, TX 77861

PROPERTY INSPECTION REPORT FORM

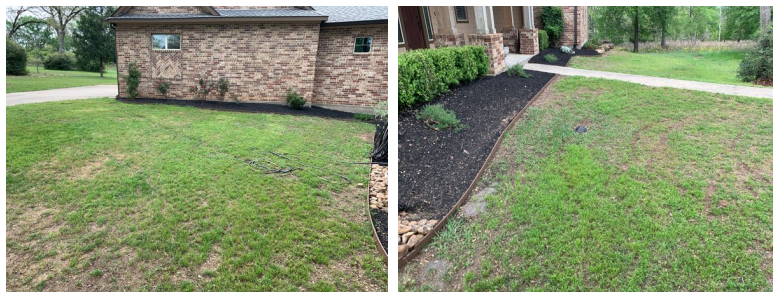
1: Soil level too high at exterior walls

Lower soil to provide adequate clearance from all wall coverings. At least of 4 inches of clearance between soil and siding or masonry wall covering can help prevent water penetration and termite infestation.

Recommendation: Contact a qualified landscaping contractor

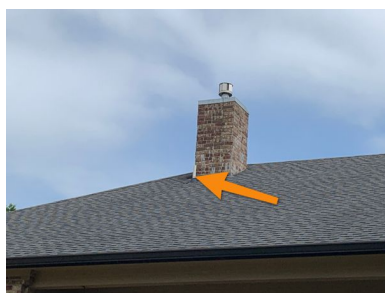
1: Exposed plastic vent pipes

Exposed plastic plumbing pipes above the roof covering need to painted or otherwise protected from UV rays.

Recommendation: Contact a handyman or DIY project

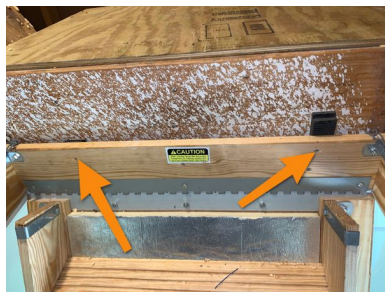
1: Improper fasteners used to Install attic ladder

Screws or finishing nails have been used to secure the attic ladder in place. The manufacturer's instructions require 16 D nails are larger to secure the ladder. screws or finishing nails are of insufficient structural capacity.

Recommendation: Contact a handyman or DIY project

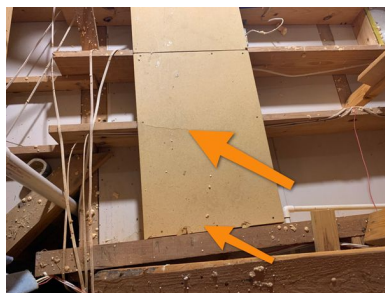
2: Walkway not fully supported

Walk way is not fully supported and should be repaired to prevent injury or premature failure.

Recommendation: Contact a qualified professional.

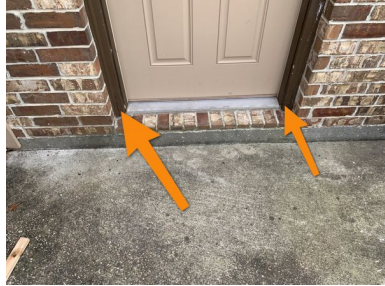
1: Deteriorated wood on exterior

Deteriorated wood will allow moisture penetration and pest intrusion. Excessive moisture in wall cavities can quickly deteriorate building components and allow mold growth. Replace any damaged areas.

Recommendation: Contact a qualified siding specialist.

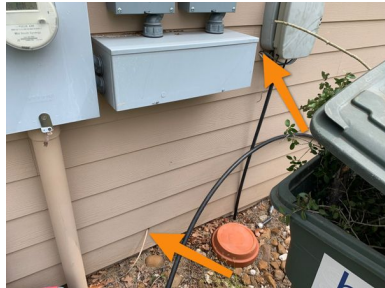
2: Gaps at exterior walls

Make any necessary improvements to prevent moisture damage to materials, water penetration, or pest intrusion. Excessive moisture in wall cavities can quickly deteriorate building components.

Recommendation: Contact a qualified painting contractor.

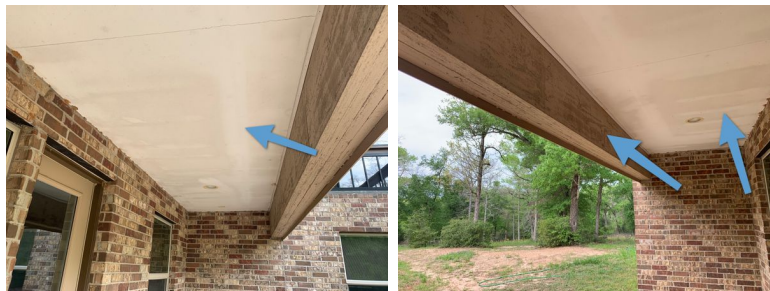
3: Exterior paint in poor condition

Keep exterior walls protected to prevent moisture damage.

Recommendation: Contact a qualified painting contractor.

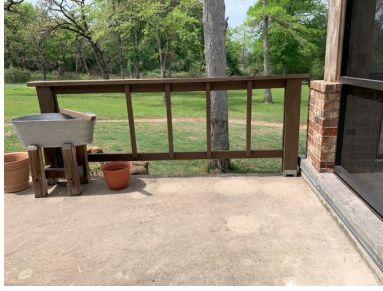
1: Excessive railing spacing

Balusters at railing should be spaces no more than 4 inches apart for safety.

Recommendation: Contact a qualified professional.

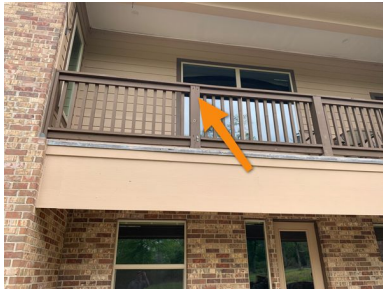
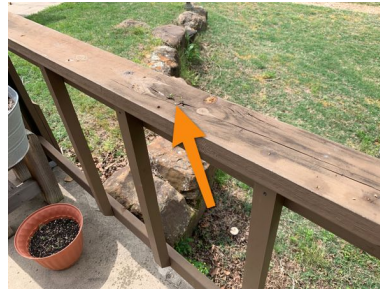
2: Beginning signs of wood decay

Exterior railing is showing signs of minor decay and deterioration.

Recommendation: Contact a qualified professional.

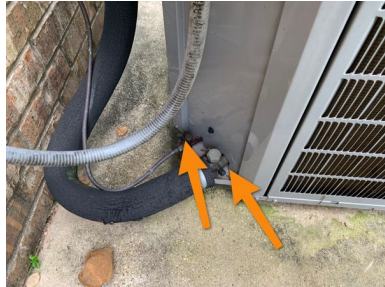
1: Refrigerant port valve caps not tamper resistant

Have locking caps installed at refrigerant access ports to prevent theft or tampering with refrigerant.

Recommendation: Contact a qualified professional.

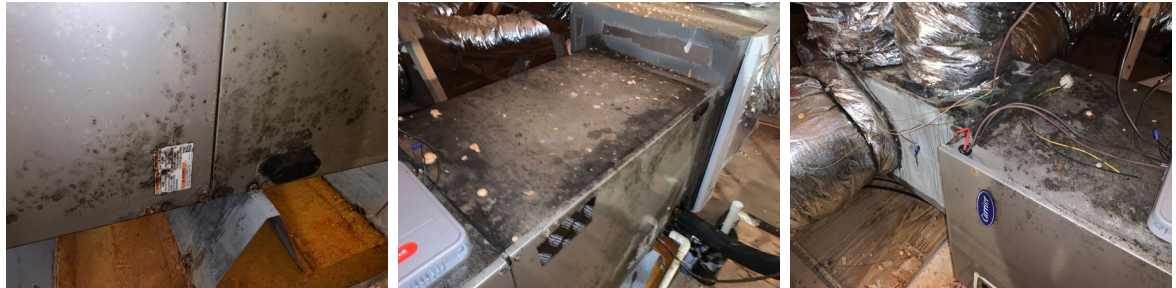
2: Excessive condensation noted

A majority of the unit is covered in surface mold due to excessive condensation.

Recommendation: Contact a qualified professional.

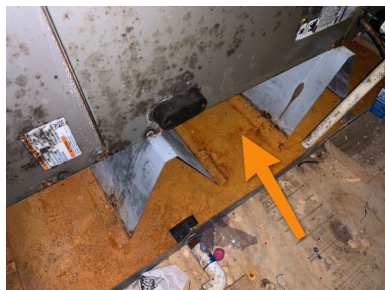
1: Rust in drain pan

Rust in the safety drain pan from past leak may compromise pan integrity. Have pan evaluated by a plumbing contractor.

Recommendation: Contact a qualified plumbing contractor.
