PROPERTY INSPECTION REPORT FORM

8102 Rhobell St B, Houston, TX 77078

08/17/2023 8:00 am

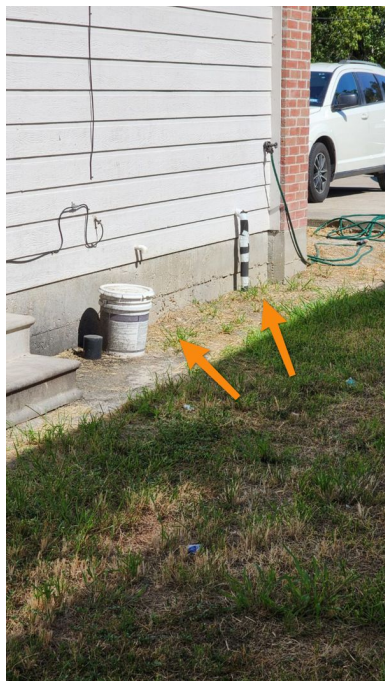
Grading is sloping towards the home in some areas. This could lead to water intrusion and foundation issues. Recommend qualified landscaper or foundation contractor regrade so water flows away from home.

Recommendation: Contact a qualified landscaping contractor

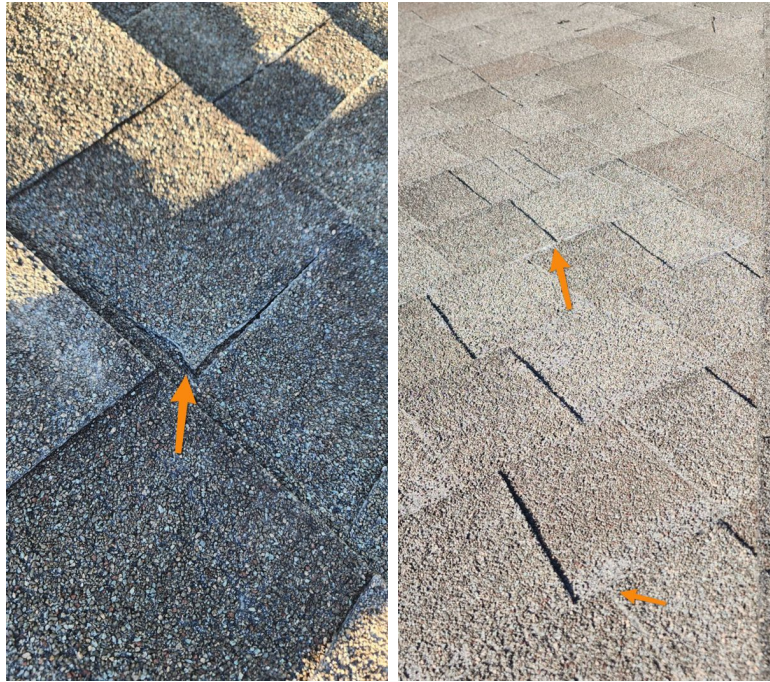
1: Damaged Coverings

Roof coverings exhibited general damage that could affect performance. Recommend a qualified roofer evaluate and repair.

Recommendation: Contact a qualified roofing professional.

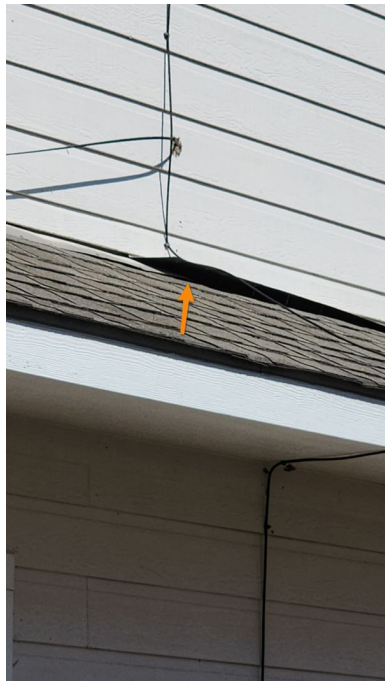
2: Flashings have gaps

Wind driven rain can make its way into these gaps, allowing water to damage to the underlying components leading to expensive repairs. It also allow animals and insects access to the interior space of the home.

Recommendation: Contact a qualified roofing professional.

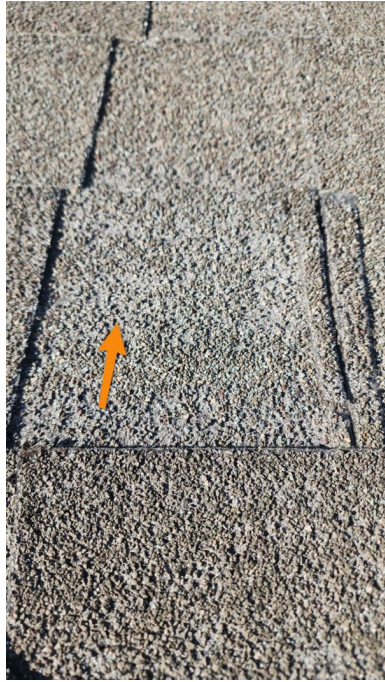
Shingles lose granules as they age. Granules provide UV protection for shingles. Once the granules erode away the sun is able to deteriorate the asphalt and shortens the life of the roofing material.

Recommendation: Contact a qualified roofing professional.

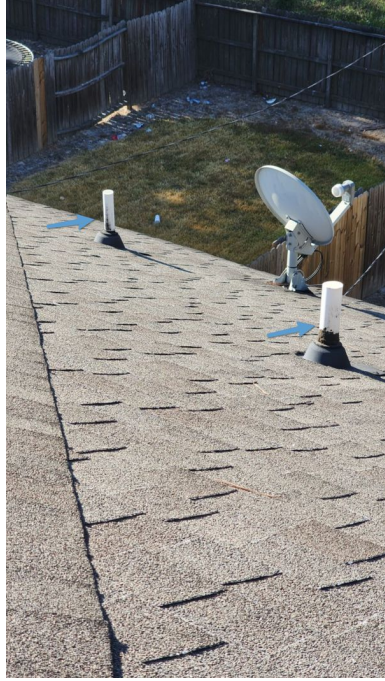
4: PVC is not painted

PVC will deteriorate when exposed to sunlight, which will shorten the lifespan of the material. PVC should be painted or covered to avoid damage.

Recommendation: Contact a handyman or DIY project

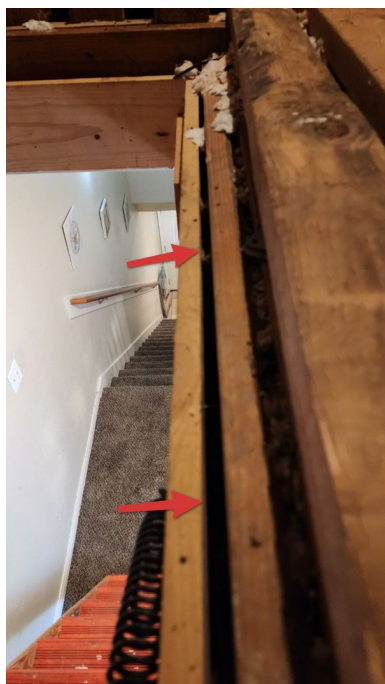
Attic entries need to be secured with 16d nails or lag screws. Most attic entries have labels giving instruction on how to properly install the entry. entrance ladder must be secured directly onto the framing without gaps.

Missing shims at fasteners

Recommendation: Contact a qualified professional.

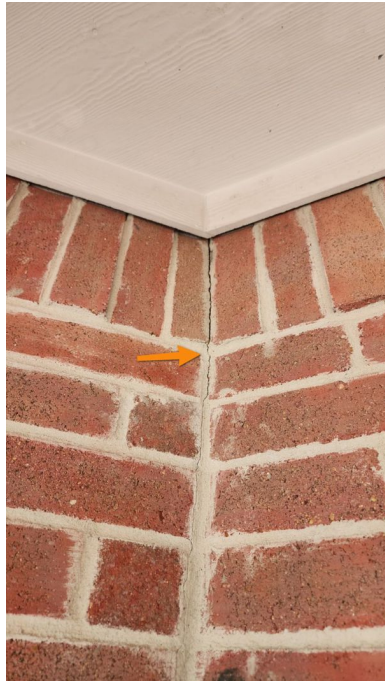
1: Cracks through mortar

These can be caused by age as well as rusted lintels. These are not necessarily a sign of foundation movement. All cracks should be sealed to prevent water penetration.

Recommendation: Contact a qualified professional.

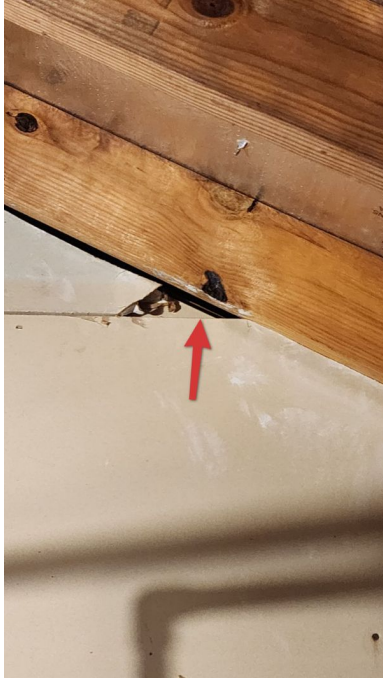
2: Firewall is missing or damaged

Recommendation: Contact a qualified drywall contractor.

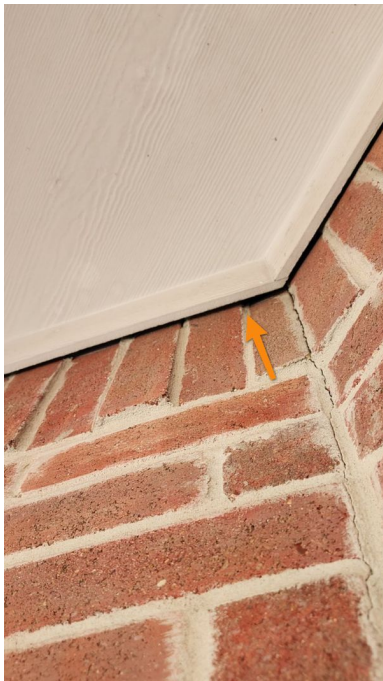
3: Gaps in Siding

Gaps in the siding allow water and insects to penetrate the structure. All gaps should be sealed to prevent damage from interior structural components.

Recommendation: Contact a qualified siding specialist.

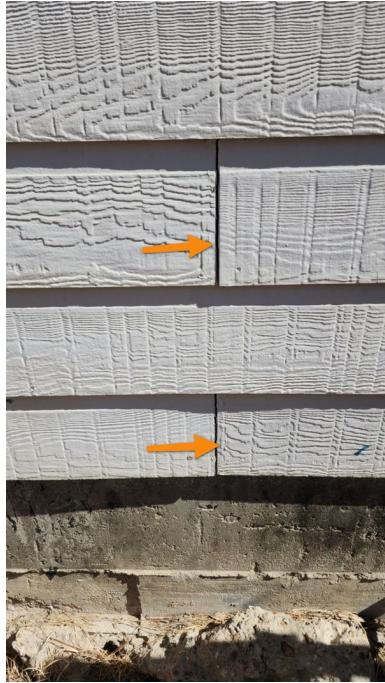
Siding should be sealed at all joints. Reason for separation should be determined in order to assess if repairs are needed to structure.

Recommendation: Contact a qualified professional.

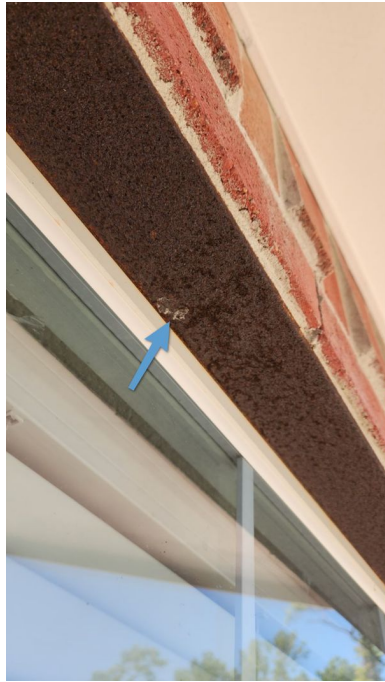
5: Lintels are rusted

Lintels are metal plates that support the brick above them it is important to keep these painted and sealed to prevent rusting. Rust will expand and crack the brick and mortar. In extreme cases, the lintel will not be able to support the brick and will need to be replaced.

Recommendation: Contact a qualified masonry professional.

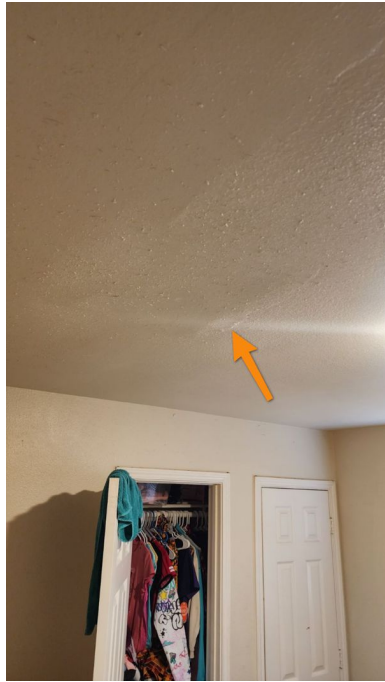
1: Evidence of previous repair

Reason for previous repairs cannot be determined, and can cover latent defects.

Recommendation: Contact a qualified professional.

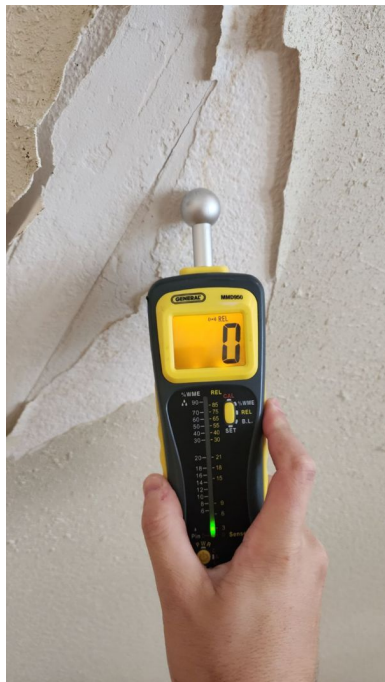
2: Evidence of previous water intrusion

These places had evidence of previous moisture, but were dry at the time of the inspection. They can change with the weather and should be monitored for further change. If further changes occur have moisture source identified, and corrected.

Recommendation: Contact a qualified professional.

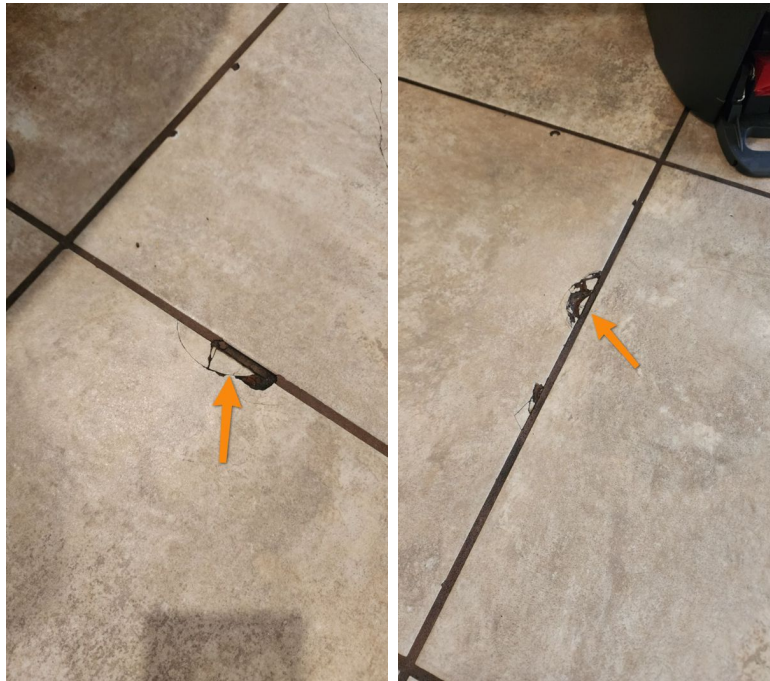
3: Flooring - damaged, loose, or uneven

The home flooring had general moderate damage visible at the time of the inspection. Recommend evaluation by a qualified flooring contractor.

Recommendation: Contact a qualified professional.

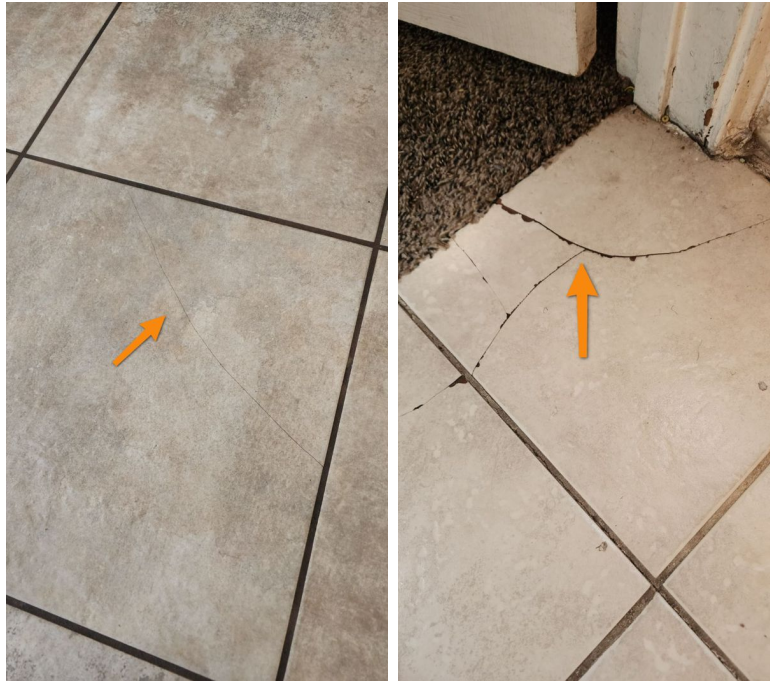
4: Tile is loose or cracked

Recommendation: Contact a qualified flooring contractor

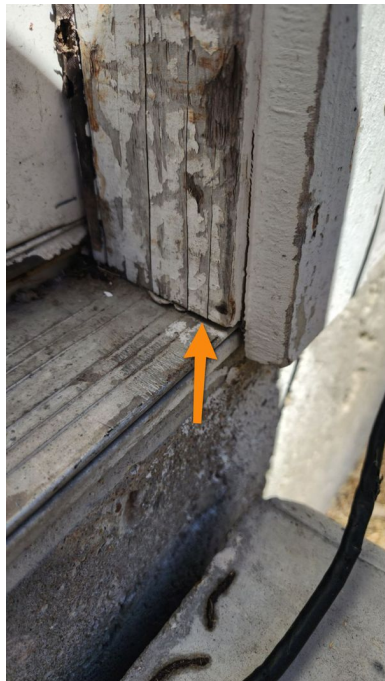
2: Needs sealed at threshold

Sealing will avoid water penetration under the flooring and should be sealed to avoid damage to flooring.

Recommendation: Contact a handyman or DIY project

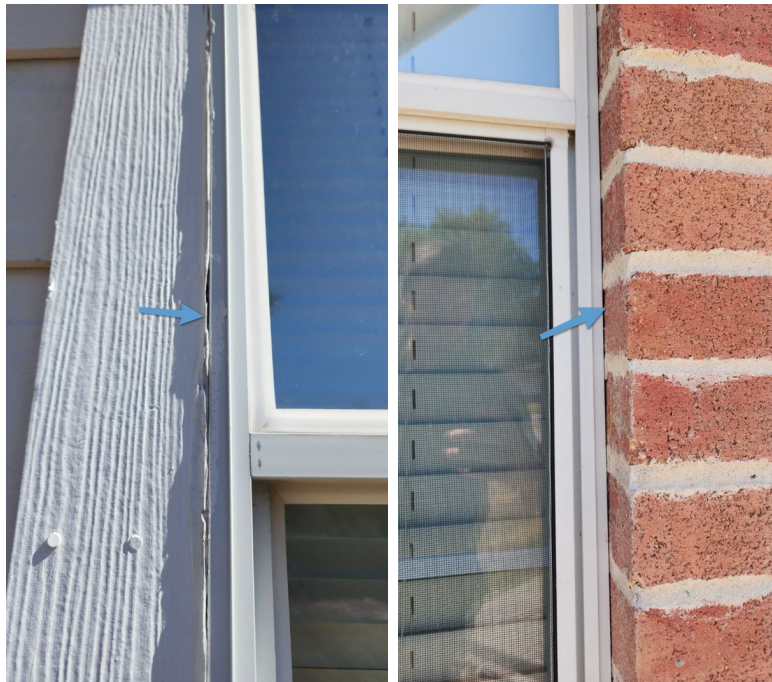
1: Caulking/sealant is deteriorated or missing

Recommendation: Contact a handyman or DIY project

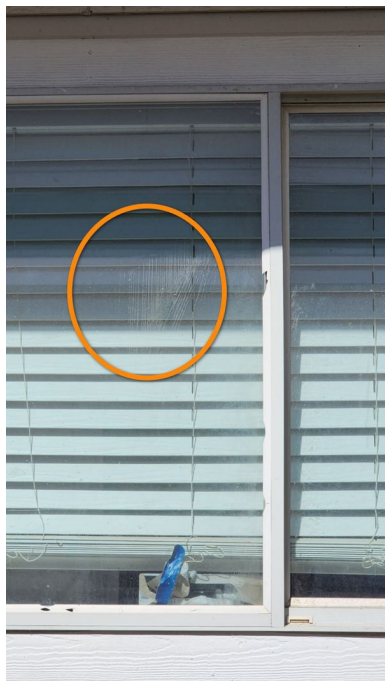
2: Condensation between window panes

Observed condensation between the window panes, indicates a failed seal. Recommend qualified window contractor evaluate and repair or replace as needed.

Recommendation: Contact a qualified window repair/installation contractor.

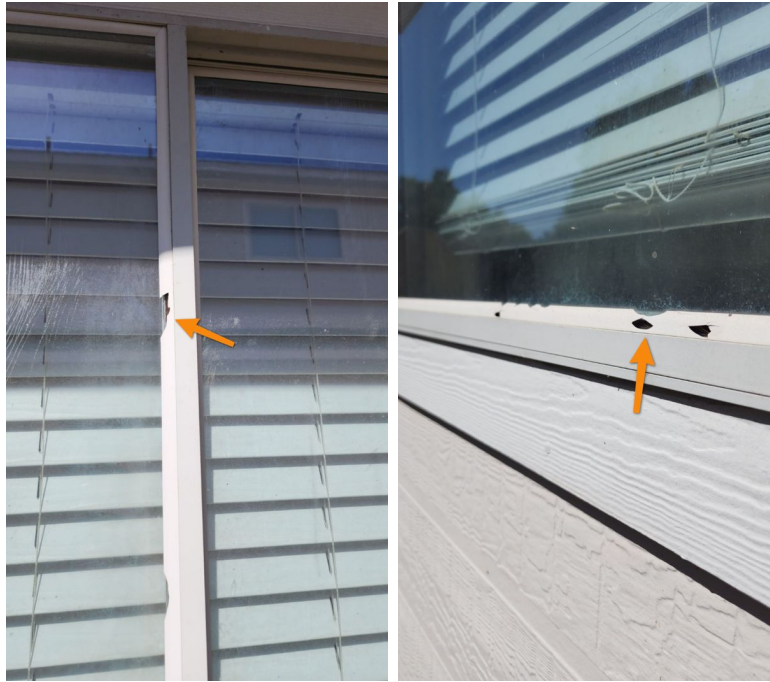
4: Failed seal around window

When the seal between the glass and frame deteriorates it can allow moisture to come through and can cause a loss of HVAC.

Recommendation: Contact a qualified professional.

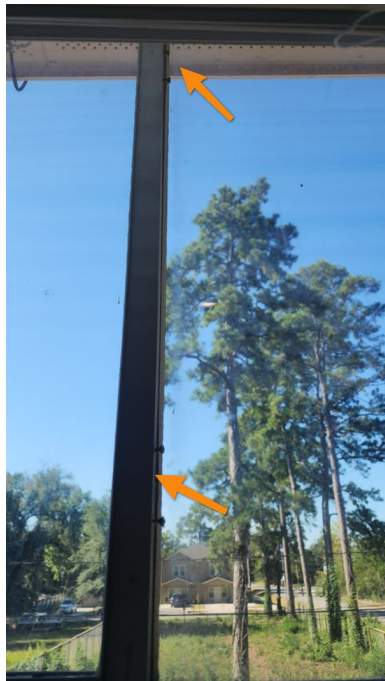
5: Lock is missing, damaged, or not locking properly

Locks keep your windows secure from unwanted entry. Locks may not operate if the window does not fit in the frame properly or the lock is damaged. Repair lock as needed.

Recommendation: Contact a qualified window repair/installation contractor.

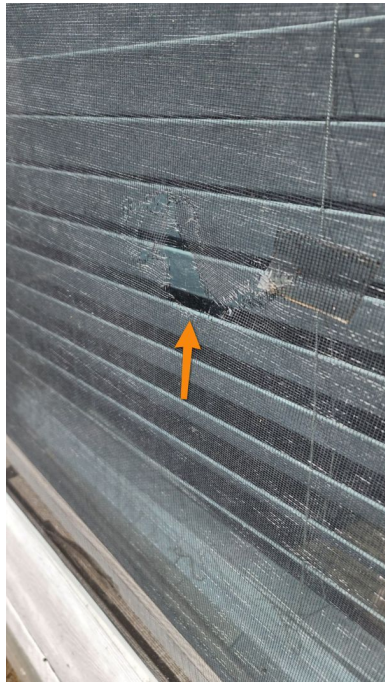
7: Screen is damaged

Damaged screens will let insects enter home when the window is open.

Recommendation: Contact a qualified professional.

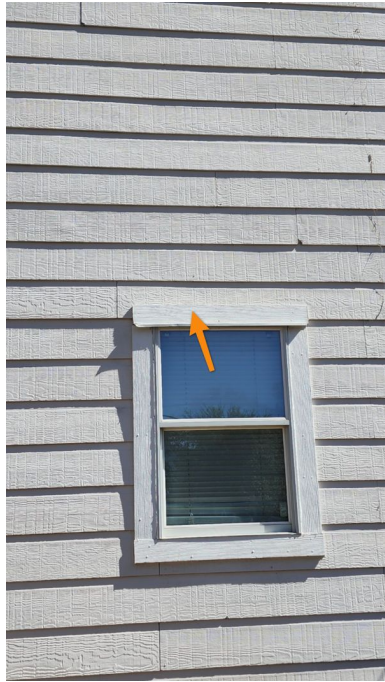
8: Missing flashing above trim on window

Flashing above window trim protects trim and allows moisture to escape from behind siding.

Recommendation: Contact a qualified professional.

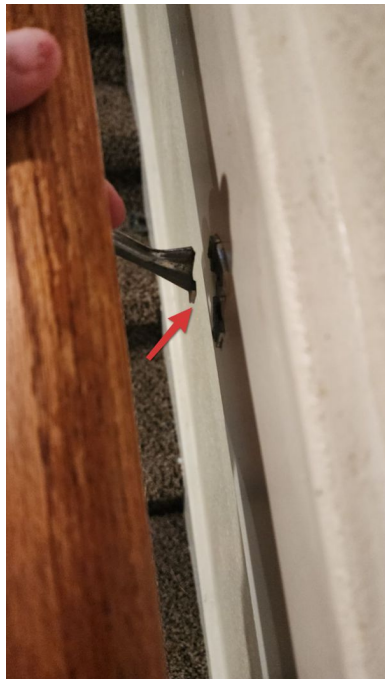
1: Guard/Handrail is loose

Loose handrails and guardrails may not provide sufficient support to prevent a fall, and should be repaired.

Recommendation: Contact a qualified carpenter.

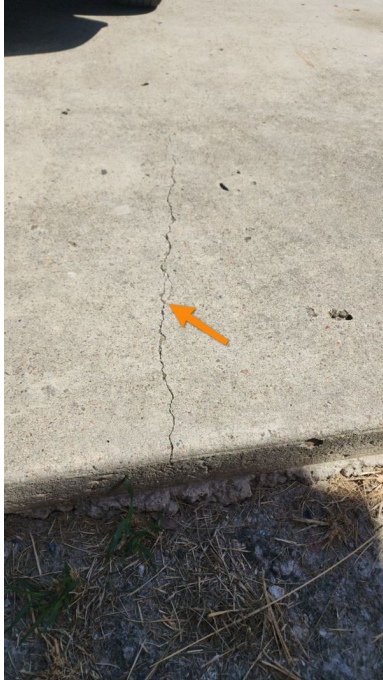
1: Cement on driveway or porch has cracks

Cracks should be sealed to keep water from penetrating the separations caused by the crack.

Recommendation: Contact a qualified professional.

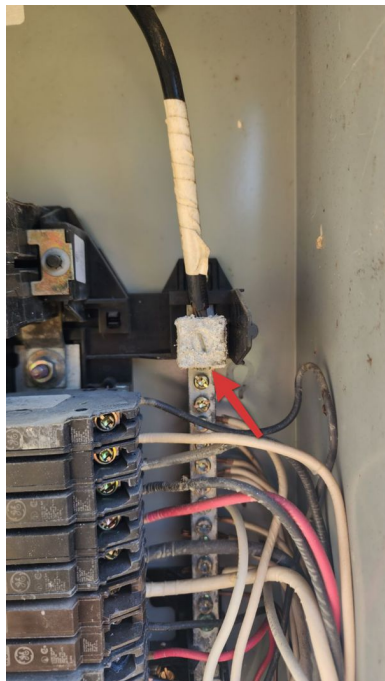
2: Corroded components on/in panel

Corroded electrical components can malfunction and do not operate efficiently. Recommendation- Replace corroded components, and identify any sources of moisture that can cause corrosion.

Recommendation: Contact a qualified electrical contractor.

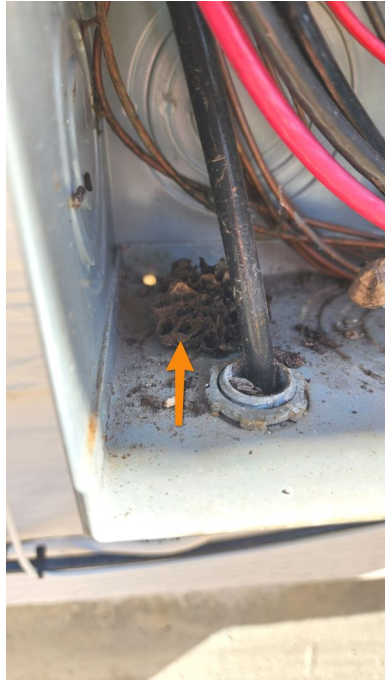
Panel should be free of debris, which could inhibit function or create combustible situation.

Recommendation: Contact a qualified professional.

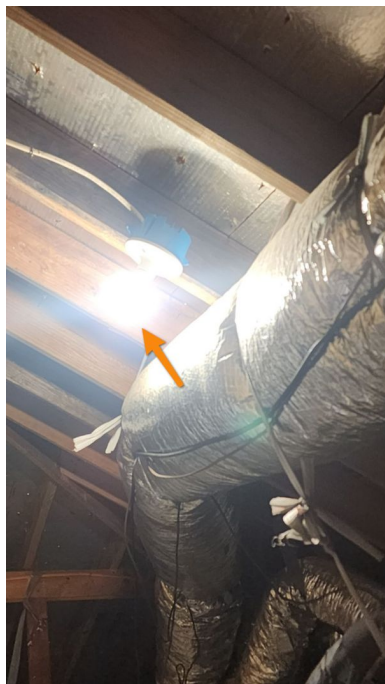
Bulbs that are exposed and could come into contact with people should have cages on them to avoid breakage which could lead to injury.

Recommendation: Contact a qualified professional.

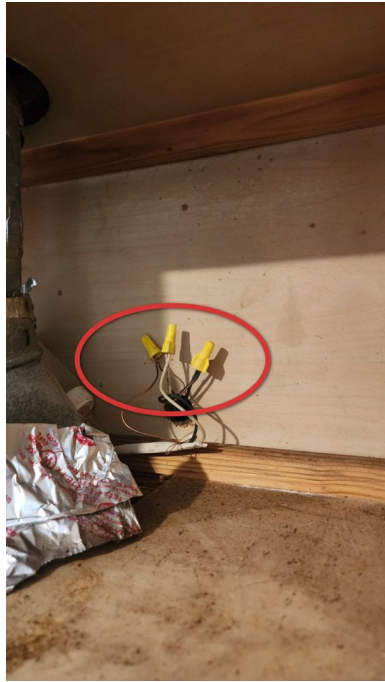
3: Exposed Ends & Splices

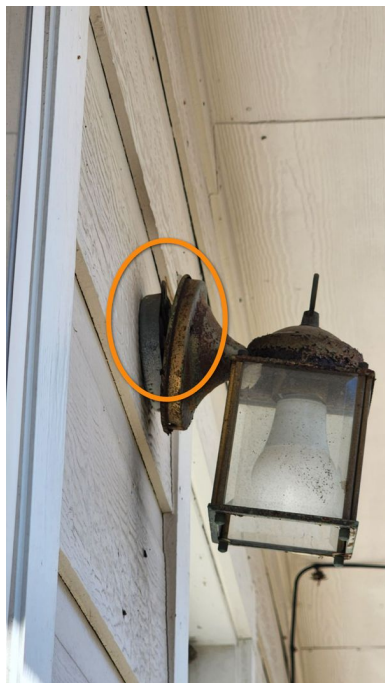
4: Light fixture cover is damaged, missing or loose

Lights covers protect electrical components from insects and the elements.

Recommendation: Contact a qualified professional.

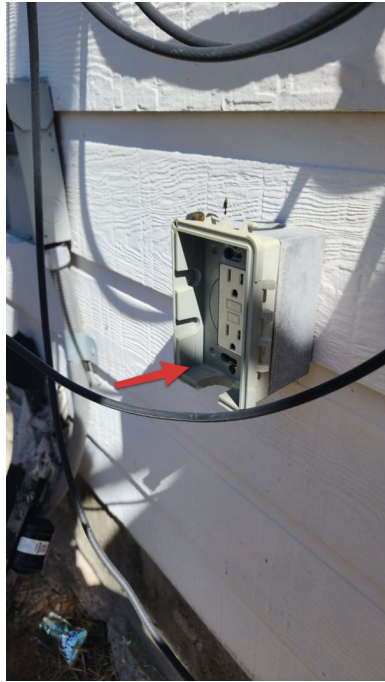
7: Outlets and switches need weatherproof cover on the exterior

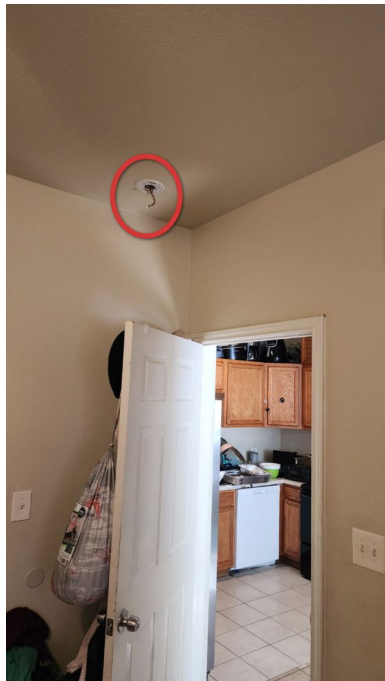
8: Smoke detectors are missing

Smoke detectors alert occupants to evacuate the building in a fire emergency. Smoke detectors should be located in every bedroom, and at least one on every floor.

Recommendation: Contact a qualified professional.

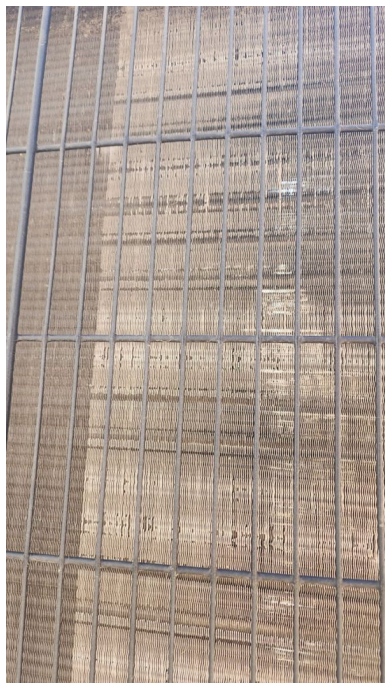
Damaged or dirty condenser fins will not expel heat as efficiently.

Recommendation: Contact a qualified HVAC professional.

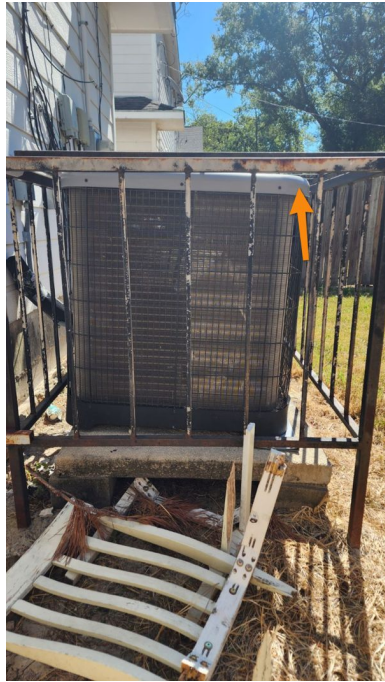
3: Condenser unit is not secured or level

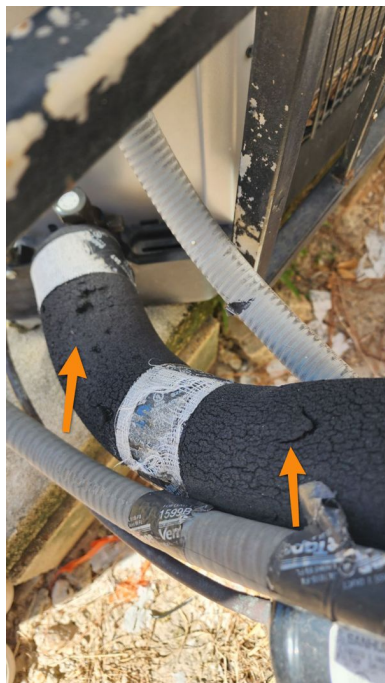
4: Insulation Missing or Damaged

Recommendation: Contact a qualified HVAC professional.

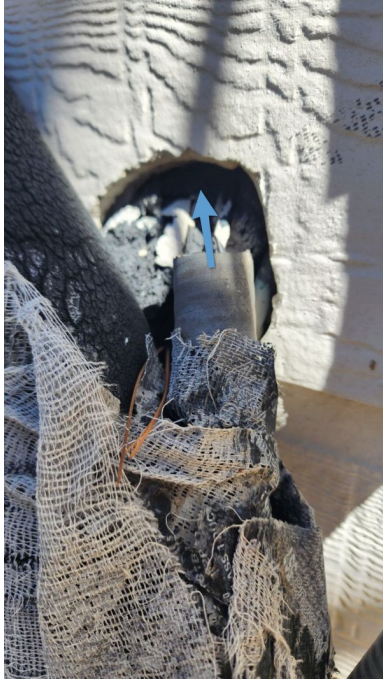
5: Refrigerant lines need to be sealed or resealed at entrance into the home

Recommendation: Contact a qualified professional.

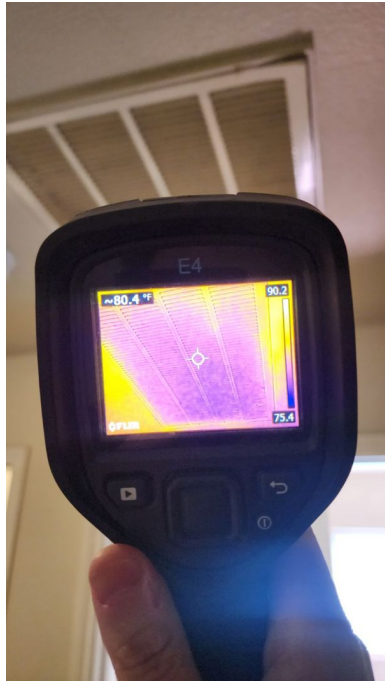
Return

6: Register did not produce sufficient differentials to properly cool the house

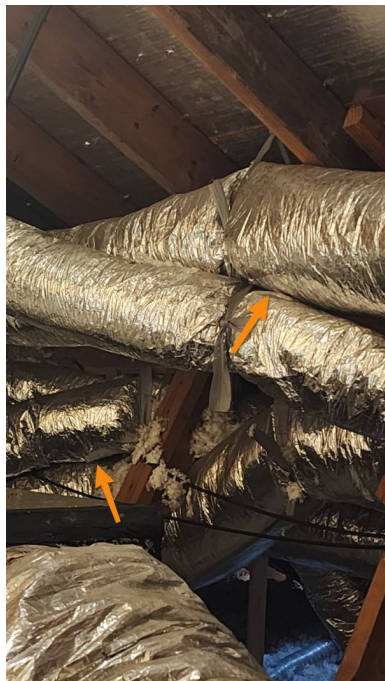
2: Ducts are touching each other and insulation

Recommendation: Contact a qualified heating and cooling contractor

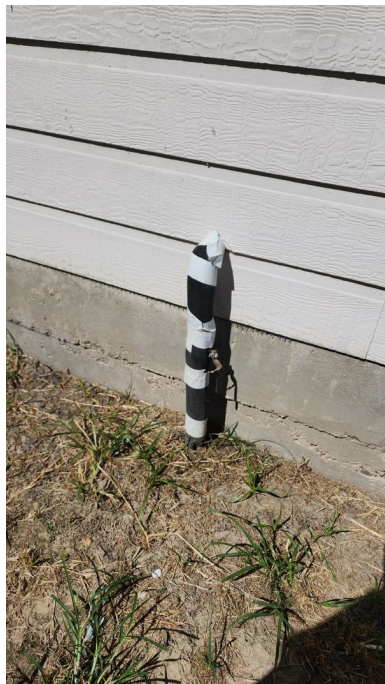
Location of Main Water Supply Valve : Exterior of Home

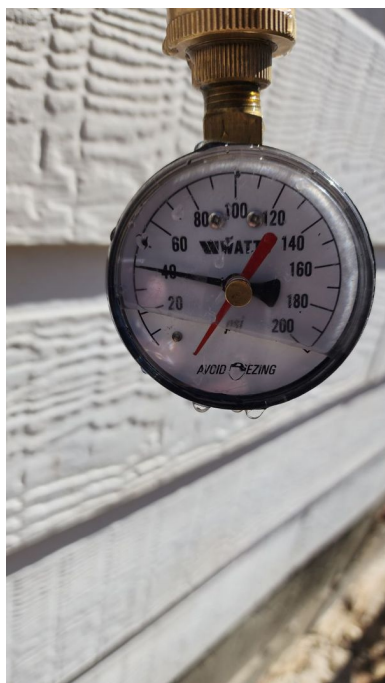
Location of Water Meter: Exterior
Static Water Pressure Reading : 40 psi

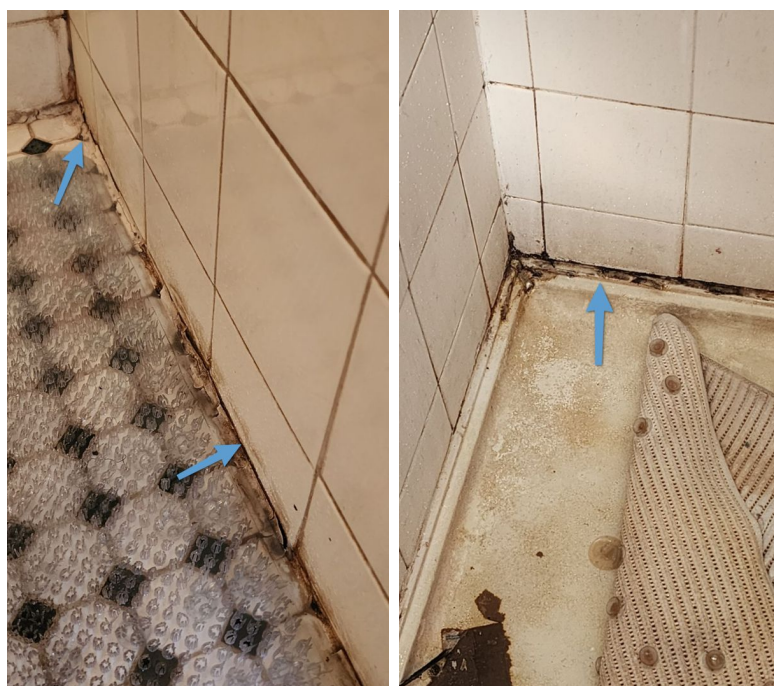
Caulking, while inexpensive is an important part of the home. Caulking around plumbing fixtures and at joints protects finishes and structural members from water damage.

Recommendation: Contact a handyman or DIY project

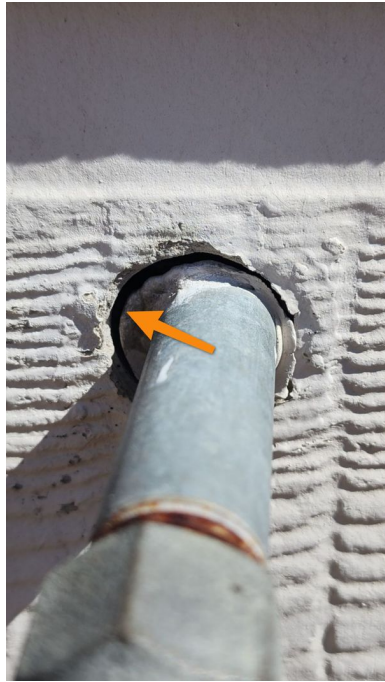
2: Entrance into home is not sealed

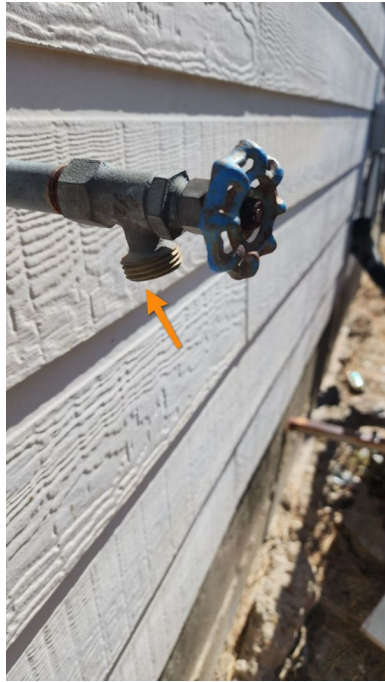
3: Hose bib needs anti-siphon device

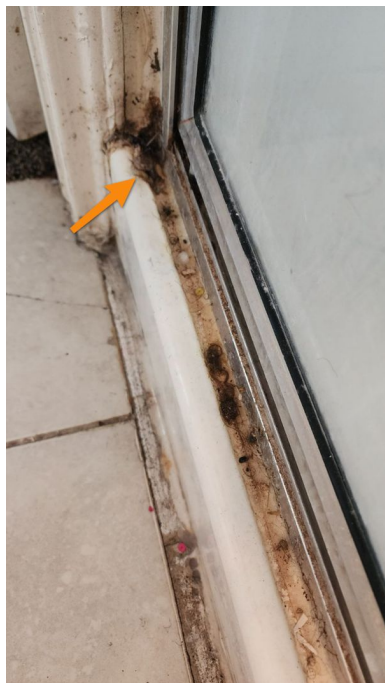
4: Shower door seals are deteriorated or missing

Recommendation: Contact a qualified professional.

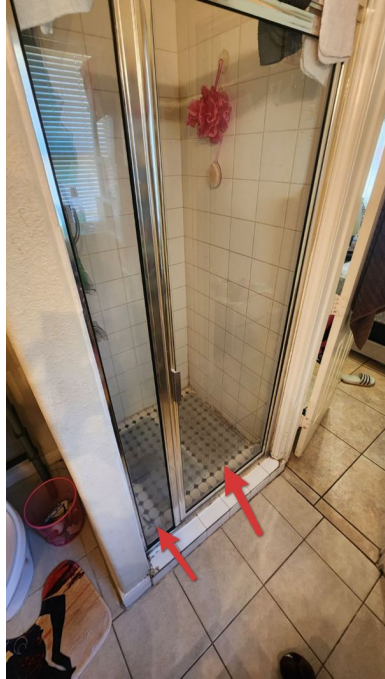
5: Shower glass is required to be tempered and clearly marked

Marking not visible in glass

Recommendation: Contact a qualified general contractor.

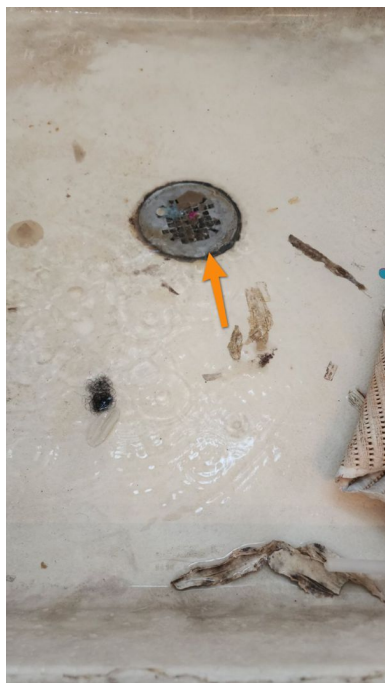
2nd Floor Bathroom shower

Drain was observed to be clogged at time of inspection. Recommend a qualified plumber evaluate and remedy.

Recommendation: Contact a qualified plumbing contractor.

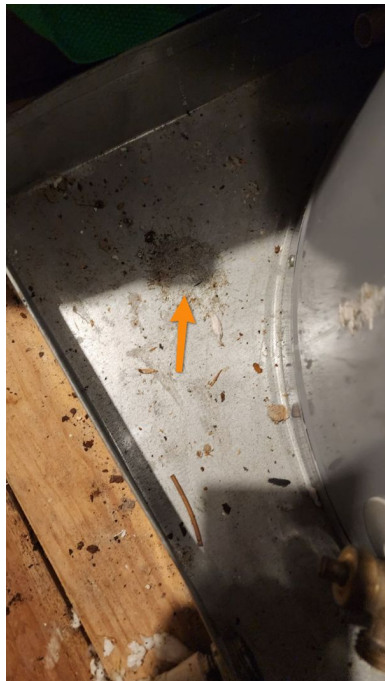
2: Previous moisture in drain pan

Recommendation: Contact a qualified plumbing contractor.

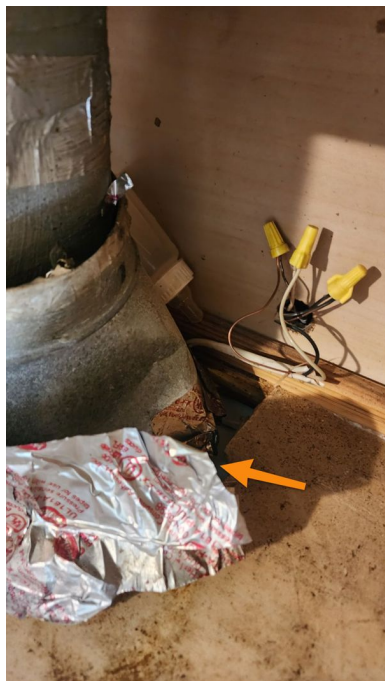
1: Excessive Noise

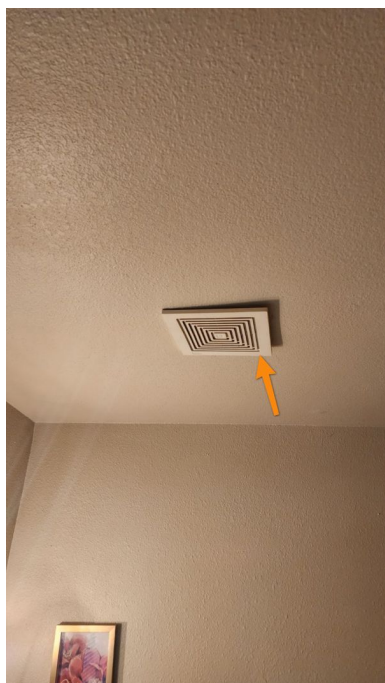
2: Not properly secured to the wall or ceiling

Recommendation: Contact a qualified professional.
