## Inspection Report

**Property Address:**  
3819 Addison Dr  
Pearland TX 77584

# PROPERTY INSPECTION REPORT FORM

Whitney Shook	8/7/2023
<i>Name of Client</i>	<i>Date of Inspection</i>
3819 Addison Dr, Pearland, TX 77584	
<i>Address of Inspected Property</i>	
Daniel Lucena	25167
<i>Name of Inspector</i>	<i>TREC License #</i>
<i>Name of Sponsor (if applicable)</i>	<i>TREC License #</i>

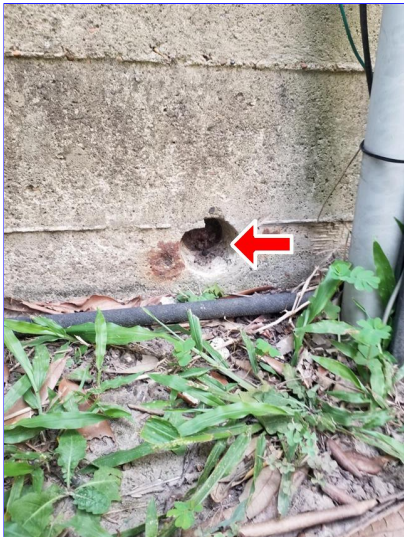
A. Item 1 (Picture) Exterior areas around the foundation

- (1) This is not an engineering report, but is only an opinion based on observation of conditions known to be related to foundation performance, using the knowledge and experience of the inspector.
- (2) The post tension foundation has exposed cable ends that are starting to show signs of deterioration. This is a maintenance issue. Further deterioration will occur if not corrected. I recommend having a qualified person make repairs as needed.

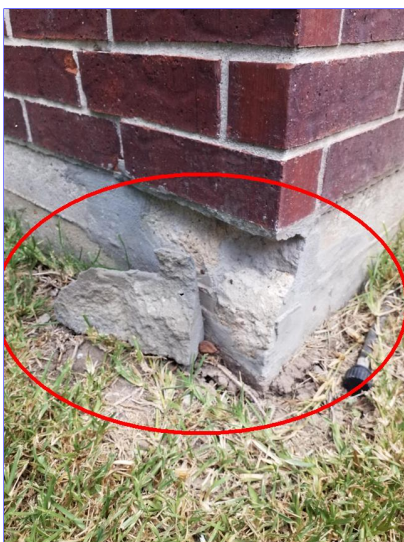
A. Item 2 (Picture) Rear of home right corner

(3) The foundation has large corner pop(s) that are larger than 4 inches. Further deterioration will occur if not corrected. I recommend having a qualified person make repairs as needed.

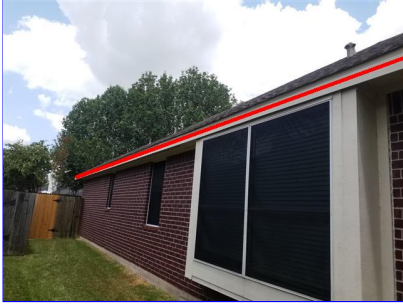
B. Item 1 (Picture) Exterior areas around the house

(1) The home does not appear to have adequate drainage. This will cause erosion if not corrected. I recommend having a qualified person install needed gutters.

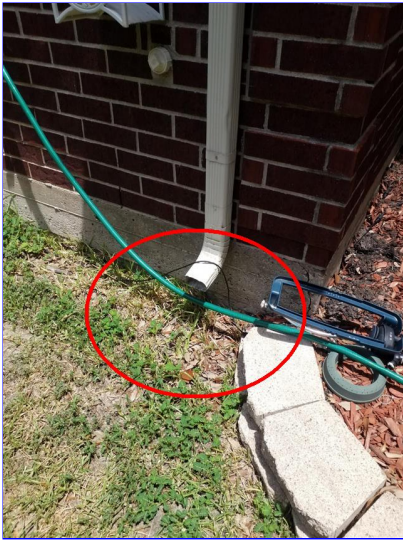
B. Item 2 (Picture) Exterior areas

(2) The gutter downspout(s) missing deflector(s) at the exterior. Erosion can continue or become worse if not corrected. A qualified contractor should inspect and replace as needed.

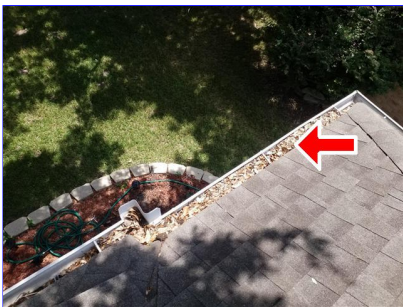
B. Item 3 (Picture) Gutters

(3) The gutters are full of debris in areas and needs to be cleaned. The debris in gutters can also conceal rust, deterioration or leaks that are not visible until cleaned, and I am unable to determine if such conditions exist.

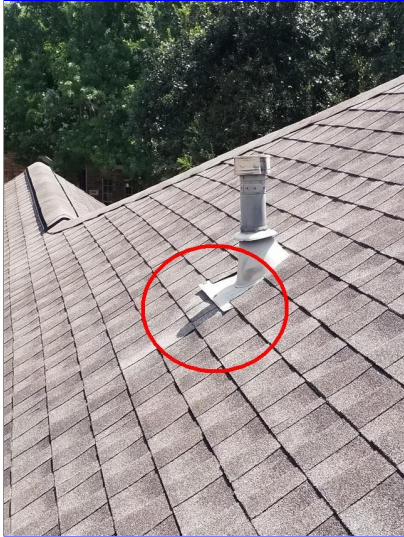
C. Item 1 (Picture) Roof area

- (1) This inspection does not warrant against roof leaks.
- (2) The flashing is loose and needs repair. I recommend having a qualified person make repairs as needed.

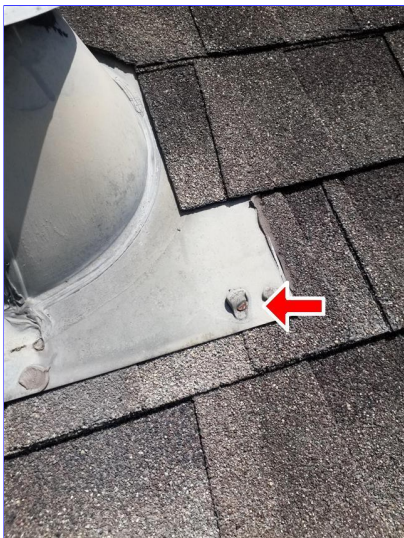
C. Item 2 (Picture) Roof area

- (3) The roofing surface has exposed nail heads that are showing signs of deterioration. Further deterioration will occur if not corrected. I recommend having a qualified person repair or replace as needed.

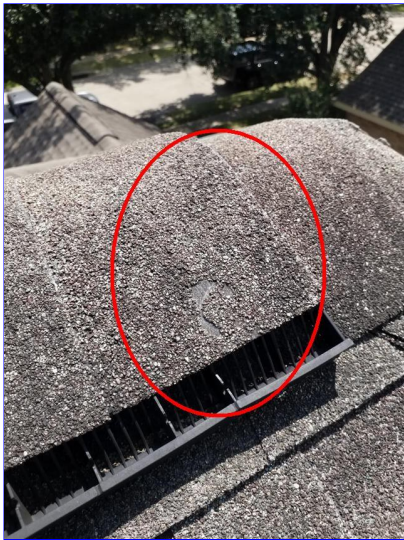
C. Item 3 (Picture) Roof area

- (4) The steep pitches in areas of the roof limited the inspection to areas that were safely accessible at the time of inspection.
- (5) The roof shingles showing wear and granular loss. (Granules provide UV protection for shingles. Once

the granules erode away the sun is able to deteriorate the asphalt and shortens the life of the roofing material.) I recommend consulting with a roofing professional.. A qualified person should repair or replace as needed.

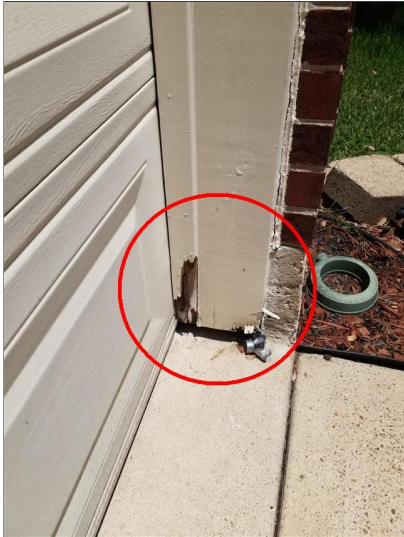
G. Item 1 (Picture) Garage door frame

(1) Door frame is showing signs of deterioration at the bottom. Repairs are needed to stop further deterioration.

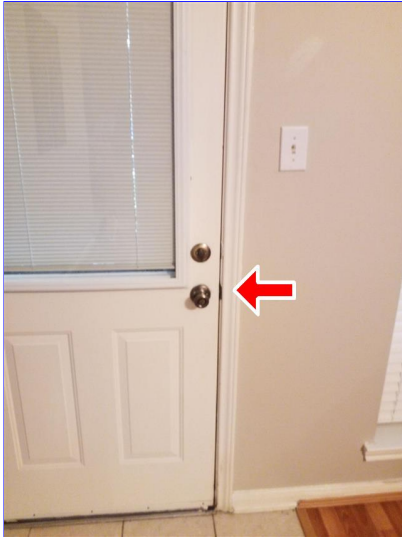
G. Item 3 (Picture) Patio door

(3) The interior door does not shut and latch properly. This is a maintenance issue and is for your information. A qualified contractor should inspect and repair as needed.

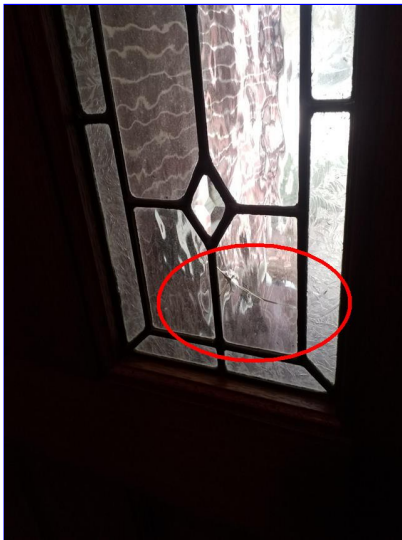
H. Item 1 (Picture) Entry door

There is a cracked glass pane in window. I recommend having a qualified person make repairs as needed.

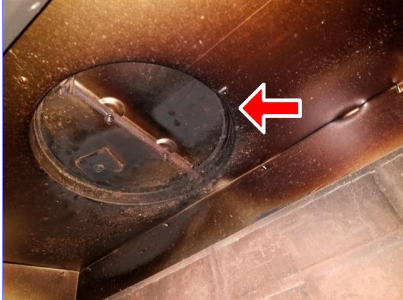
J. Item 1 (Picture) Fireplace

- (1) I do not inspect the shape of fireplace or the design to determine if your fireplace has a proper air draw.
- (2) The damper is missing the required clamp or bracket to prevent complete closure on a gas log fireplace. This not considered to be today's standard. I recommend having a qualified person make repairs as needed.

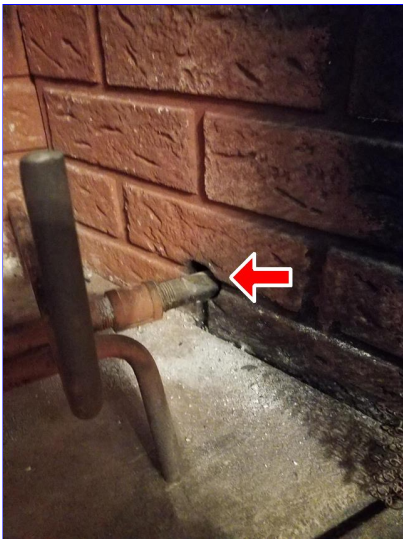
J. Item 2 (Picture) Fireplace

- (3) The (Burn Area) for the fireplace is not properly sealed. This burn area should be fireproof. Any repairs should be performed according to the manufacturer's specifications.

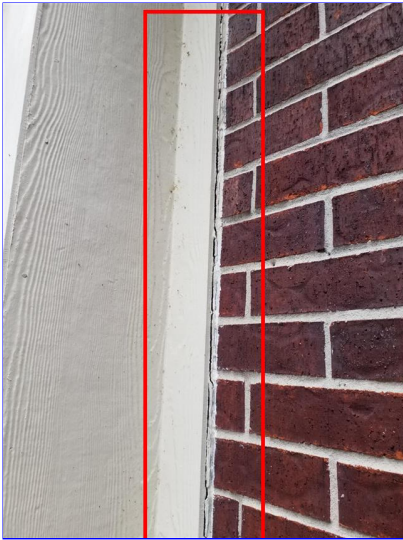
L. Item 2 (Picture) Multiple areas exterior

(2) Areas of the home have caulking or grout missing or damaged. Deterioration could occur if not corrected. I recommend having a qualified contractor inspect and make repairs as needed.

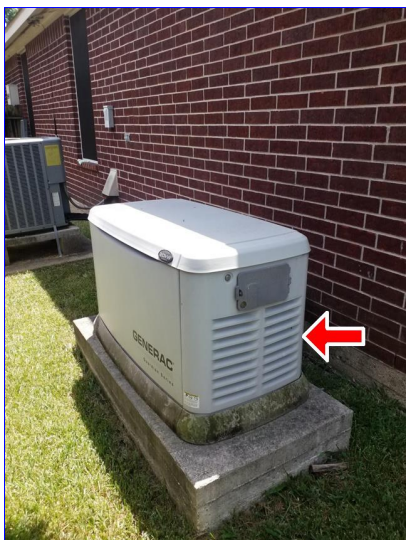
C. Item 1 (Picture) Right side of home

Home has a generator. Generator was not inspected. I recommend having a qualified generator company service and repair as needed.

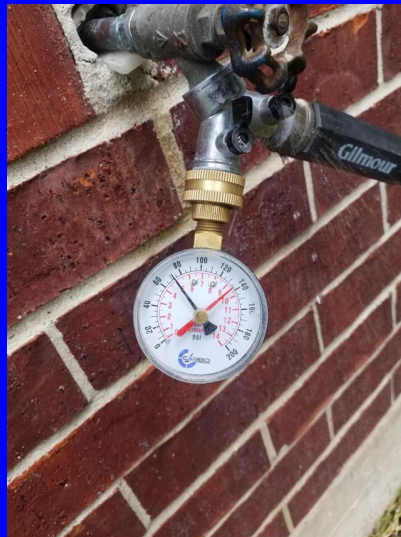
Water pressure 70 psi

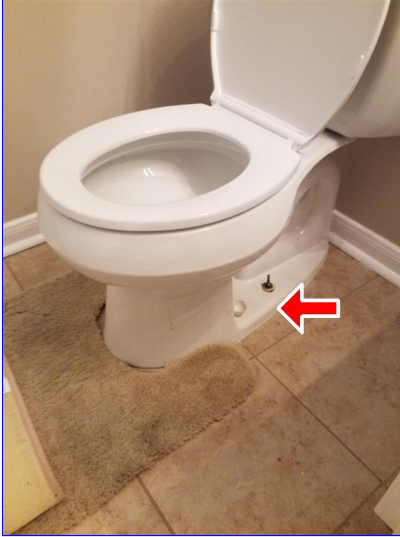
A. Item 1 (Picture) Shared bathroom

- (1) All supply lines were not visible at time of inspection process due to cabinetry or construction materials. This is for your information.
- (2) The toilet is loose and needs to be secured at the . Repairs are needed A qualified licensed plumber should repair or correct as needed.

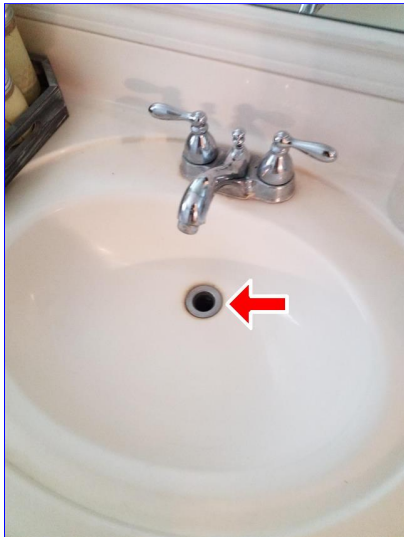
B. Item 1 (Picture) Shared bathroom

(2) The bath sink stopper mechanism is not working properly. I recommend repairs as needed.

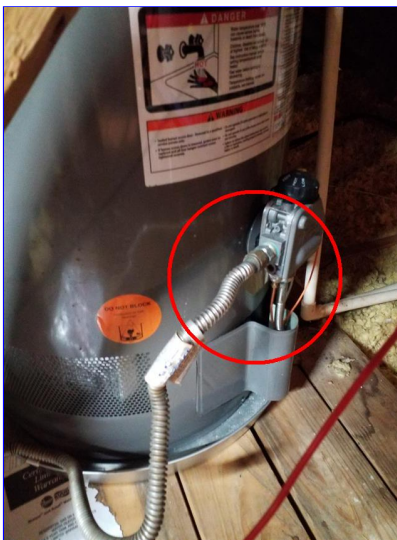
The water heater is installed without the recommended sediment trap or "drip leg" that is designed to extend the life of the unit. This is not considered to be today's standard. I recommend having a qualified plumber make repairs as needed.

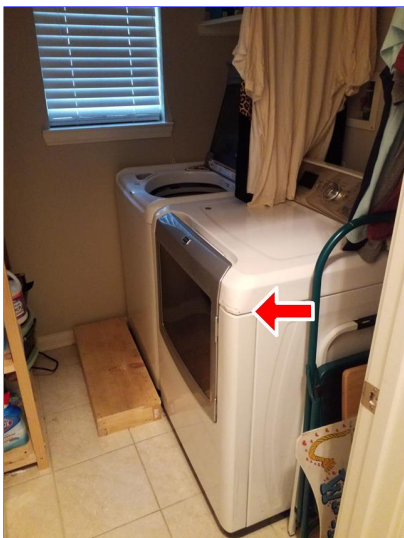
H. Item 1 (Picture) Laundry room

(1) The dryer vent piping is long and vertical which can trap lint at elbow. Vent pipes should be cleaned regularly if they are longer than normal ( 10 feet or more) or vented vertically. I recommend cleaning and/or repair as needed.

(2) Washer and dryer area was inspected with limited visibility due to appliances being installed. This is for your information.
