Inspection Report

Property Address:
4218 Joshua Cir
Houston TX 77014

HG Home Inspection / Hilsher Group LLC

PROPERTY INSPECTION REPORT FORM

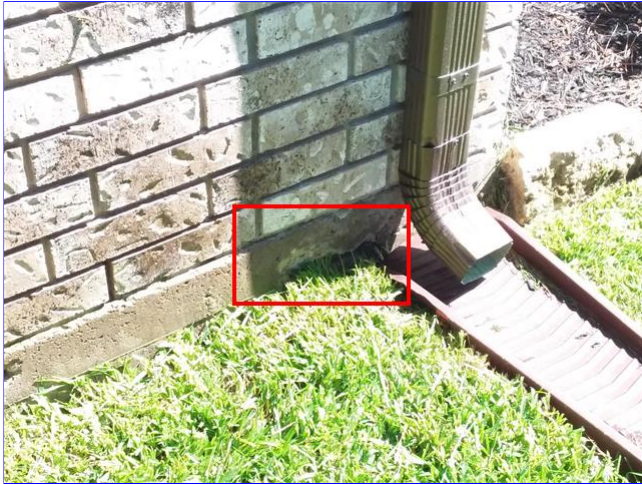
A. Item 1(Picture) left side

- (1) This is not an engineering report, but is only an opinion based on observation of conditions known to be related to foundation performance, using the knowledge and experience of the inspector.
- (2) The foundation is poured on grade with post tension cables and appears to be performing as designed.
- (3) The foundation wall appears to be showing signs of flaking and deterioration. I recommend having a qualified person make repairs as needed.

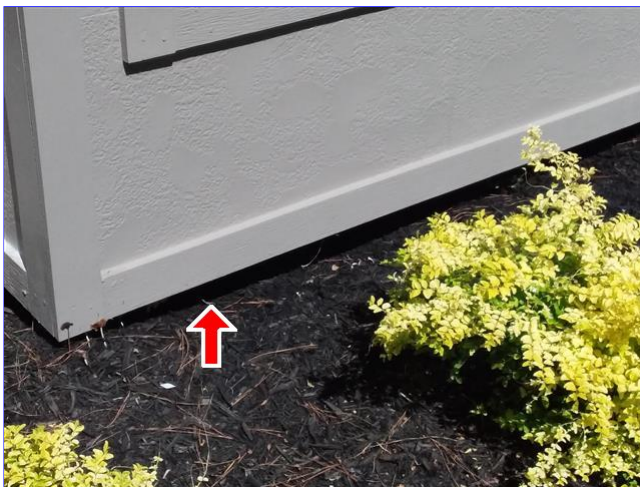
B. Item 2(Picture) front left

(2) Downspouts discharges onto roofing surface in areas of the roof. Deterioration could occur if not corrected. I recommend having a qualified contractor make repairs as needed.

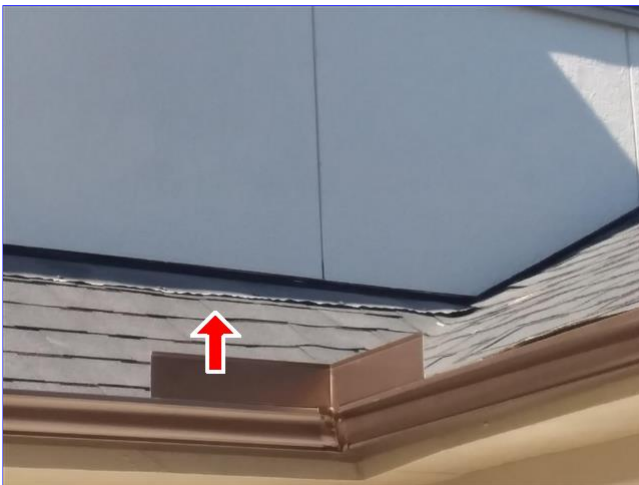
C. Item 2(Picture) right side

- (4) The flashing is loose and needs repair. I recommend having a qualified person make repairs as needed.

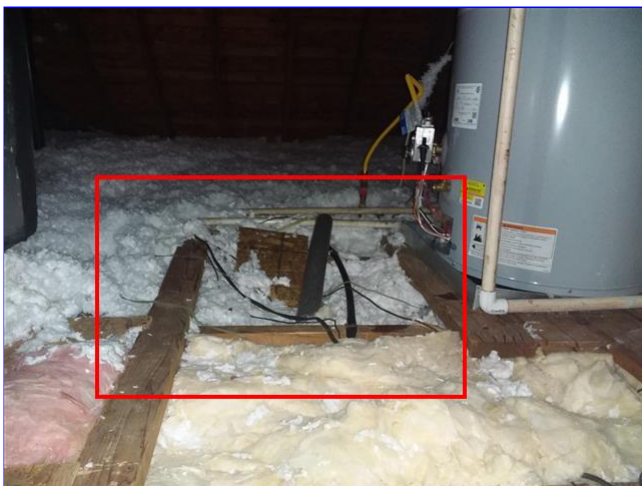
D. Item 10(Picture) missing water heater decking

(3) The attic space is missing adequate service access decking. This is not considered to be today's standard. I recommend having a qualified person install decking.

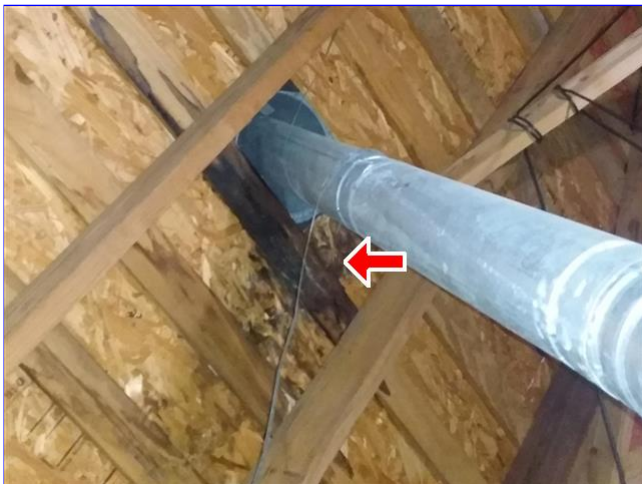
D. Item 11(Picture) furnace exhaust

(4) The wood near the furnace exhaust appears to be charred. It is possible that the discoloration is from previous water intrusion. A minimum of 1 inch separation from the pipe and wood required. Direct contact is a potential safety hazard. Make sure the pipe maintains minimum separation.

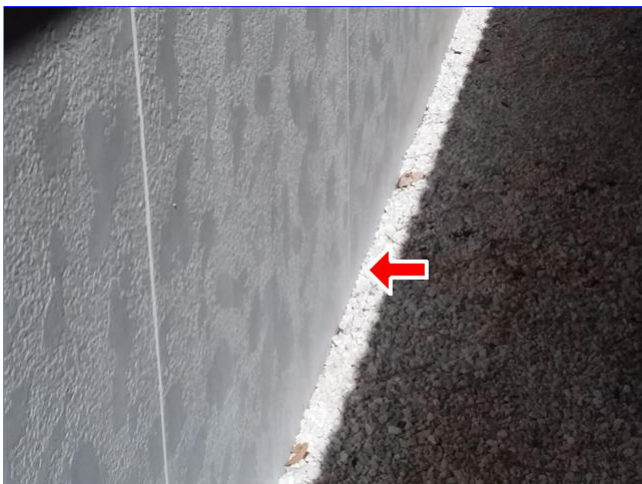
E. Item 1(Picture) garage exterior

(1) Siding in contact with ground. Because the siding is in contact with ground it is possible for framing to be deteriorated. We did not inspect behind this siding. Recommend a ground clearance of six to eight inches where possible.

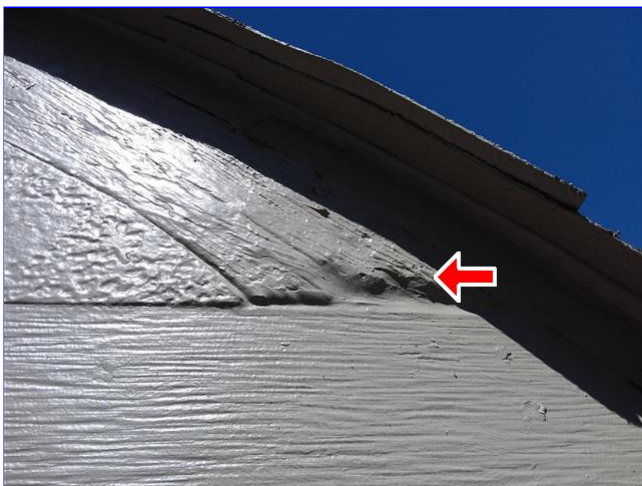
E. Item 3(Picture) front left

(2) The exterior siding and trim is deteriorated in areas. Further deterioration will occur if not corrected. A qualified contractor should inspect and repair as needed.

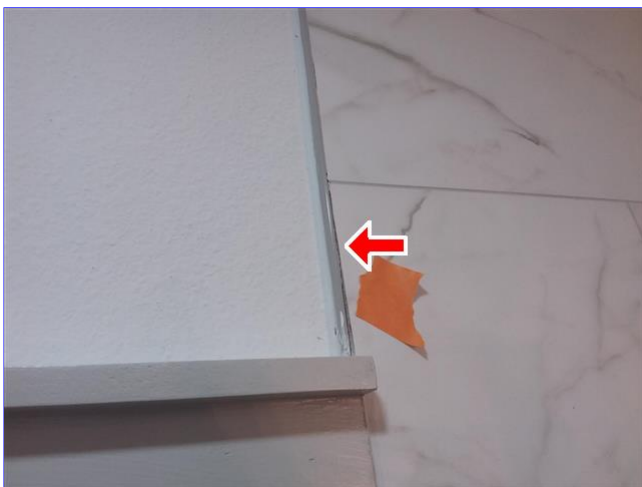
E. Item 4(Picture) master bathroom

(3) The Tile on the wall has missing or loose grout at the master bath. While this damage is cosmetic, it needs to be repaired. A qualified contractor should inspect and repair as needed.

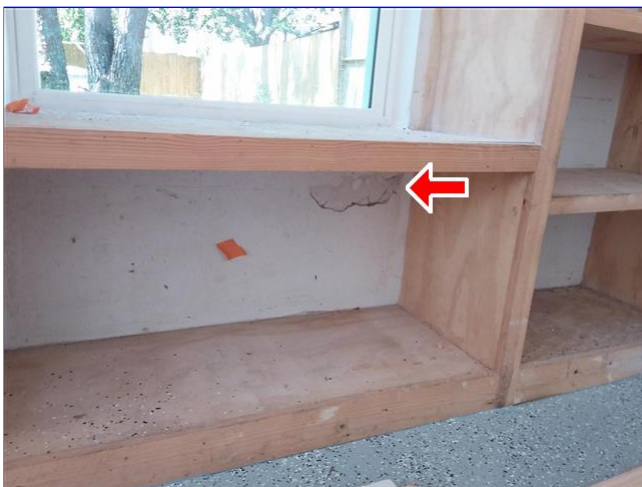
E. Item 5(Picture) garage

(4) The drywall on the wall is damaged. While this damage is cosmetic, it needs to be repaired. A qualified person should repair or replace as needed.

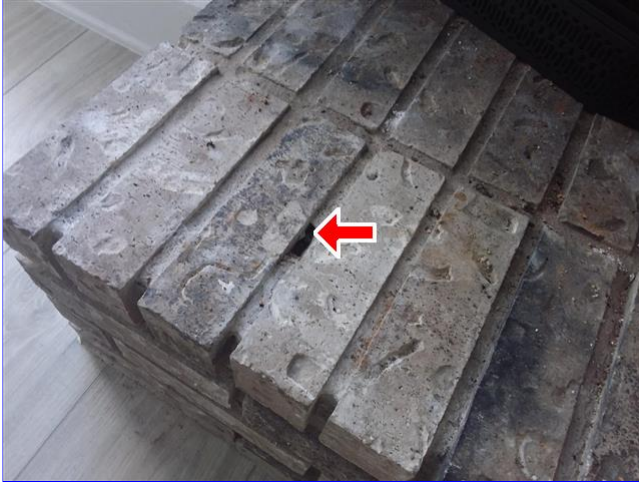
E. Item 6(Picture) fireplace

(5) The masonry siding had voids in the mortar in the brick. A qualified person should inspect and repair as desired.

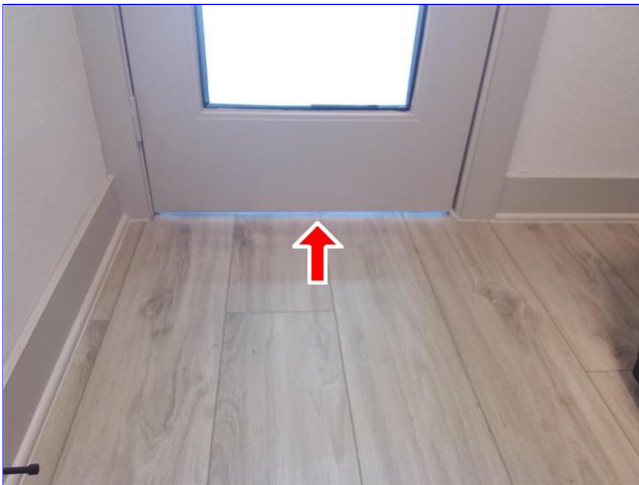
G. Item 1(Picture) laundry room

(1) The entry door reveals daylight when latched at areas missing weather-stripping. This can cause some heat loss in winter and loss of cool air in summer if not corrected. I recommend adding insulation.

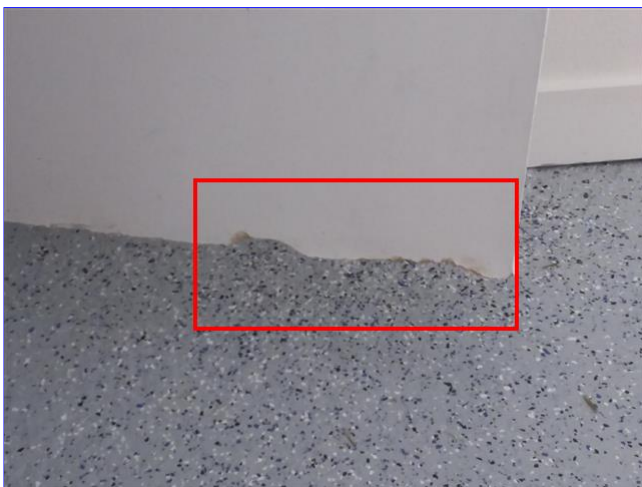
G. Item 4(Picture) garage storage door

(3) The doors are damaged in areas. Repair or replacement is recommended as needed.

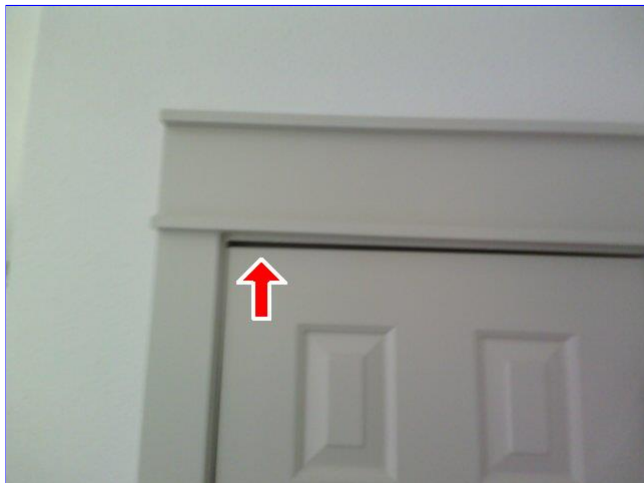
G. Item 5(Picture) stairway closet door

(4) The alignment for the stairway closet door is incorrect. This is cosmetic and for your information.

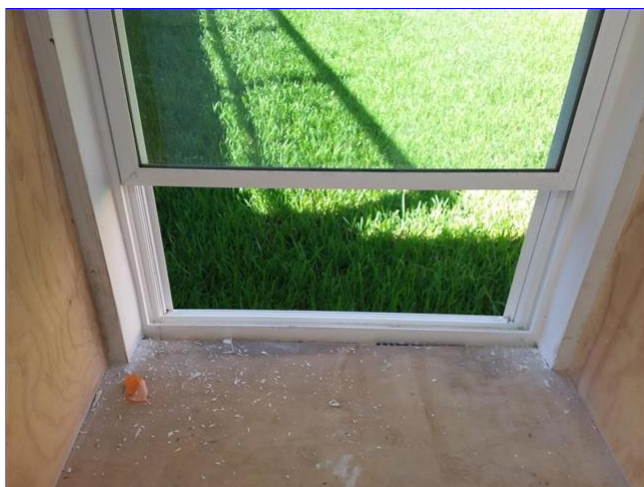
H. Item 1(Picture) missing screens in areas

(1) Windows have damaged or missing screens. This is not considered to be today's standards. I recommend having a qualified person make repairs as needed.

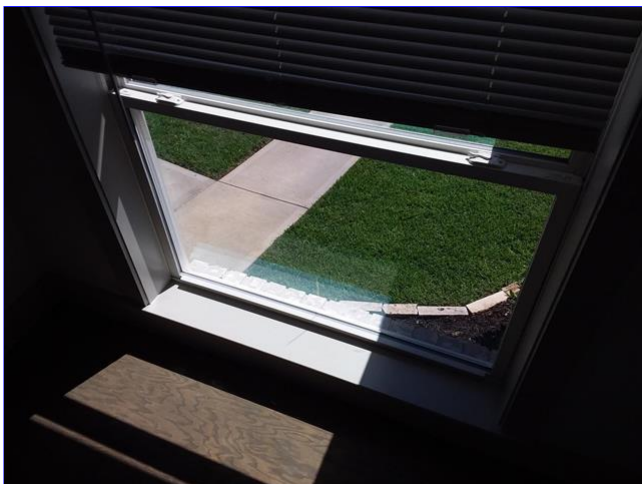
H. Item 2(Picture) stairway

(2) There are windows in required tempered glass area's that are missing the required markings. This is not considered to be today's standard and is a safety hazard until glass is confirmed to be and marked tempered. I recommend having glass professional evaluate and mark or replace as needed.

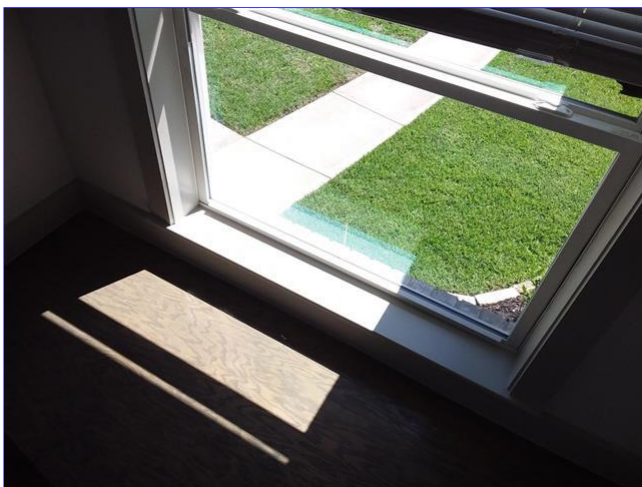
H. Item 3(Picture) stairway

(3) (Today's standard) In sleeping rooms windows cannot exceed 44" and must have an opening of not less than 5.7 feet. This is so that children or the elderly can get out of the window in an emergency. On upper stories, windows must be a minimum of 24" inches from the floor to protect children from accidentally falling through the window.

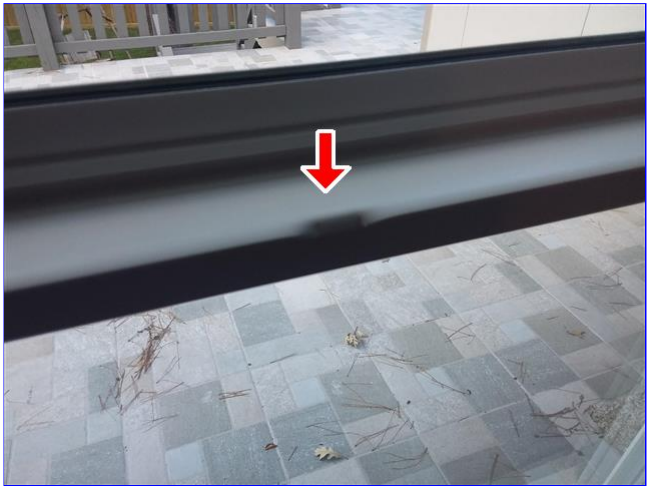
H. Item 4(Picture) left upstairs bedroom

(4) The window frame is damaged. This is cosmetic and for your information.

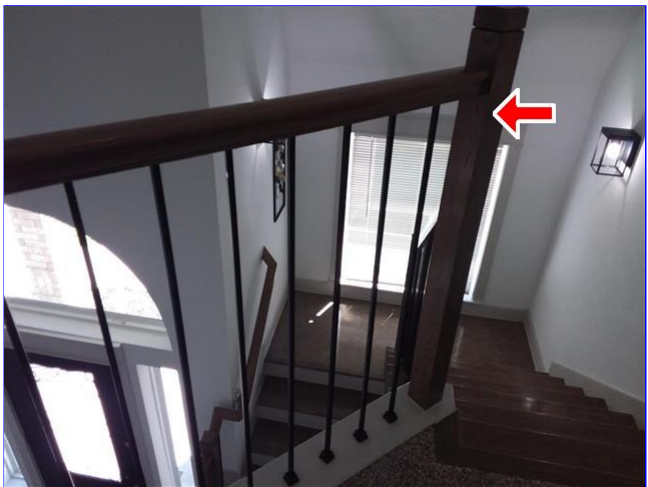
I. Item 1(Picture) loose handrail

The hand/guard rail for the upstairs is loose. A fall or injury could occur if not corrected. A qualified contractor should repair or replace as needed.

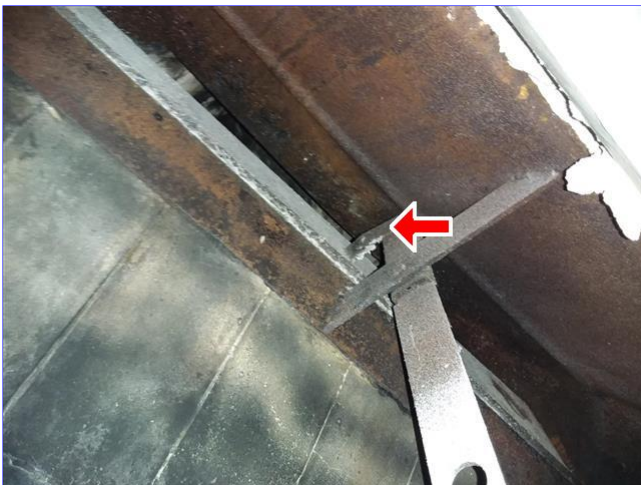
J. Item 2(Picture) damper seized

(3) The damper for fireplace at the same location is rusted tight or "seized" (non-operational). Repairs should be made so unit works properly. I recommend a qualified contractor inspect and repair as needed.

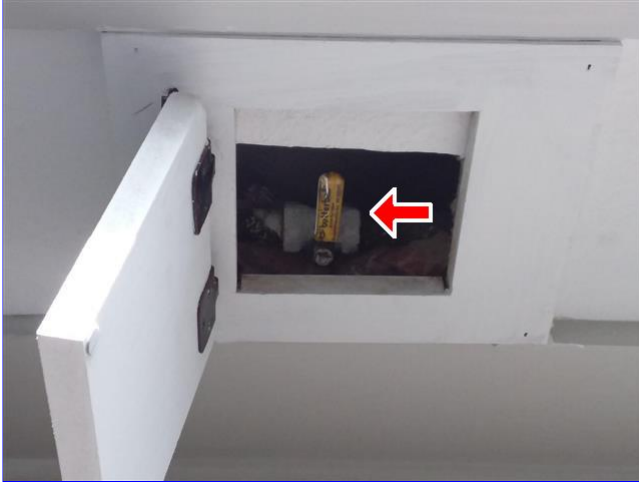
J. Item 3(Picture) incorrect valve installation

(4) The valve is installed incorrectly. Valve handles should be in line with the pipe when open. This is a potential safety hazard. Proper valve installation is recommended.

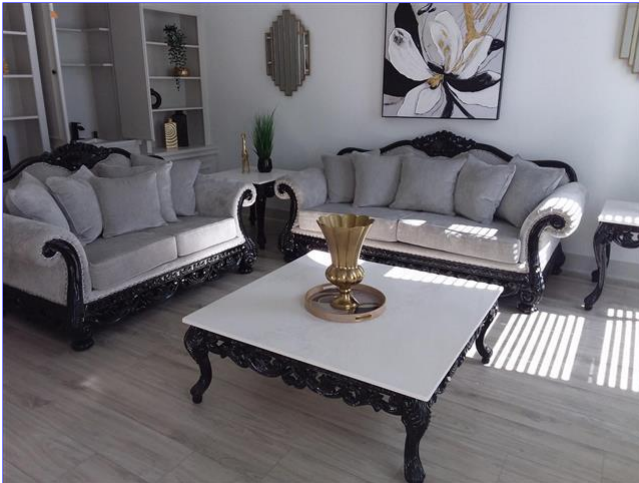
L. Item 1(Picture) home occupied

(1) Areas of the home have limited access due to furniture or occupants belongings. This is for your information.

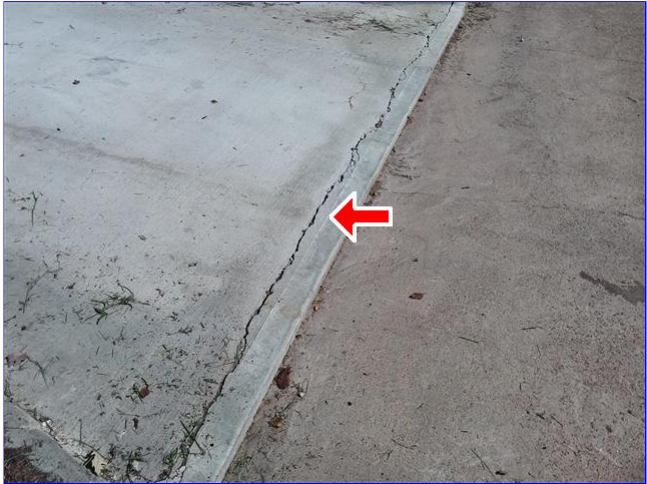
L. Item 2(Picture) driveway cracks

(2) The concrete drive and concrete walkway at the front of home has settlement cracks. Further deterioration can occur if not repaired. A qualified person should repair or replace as needed.

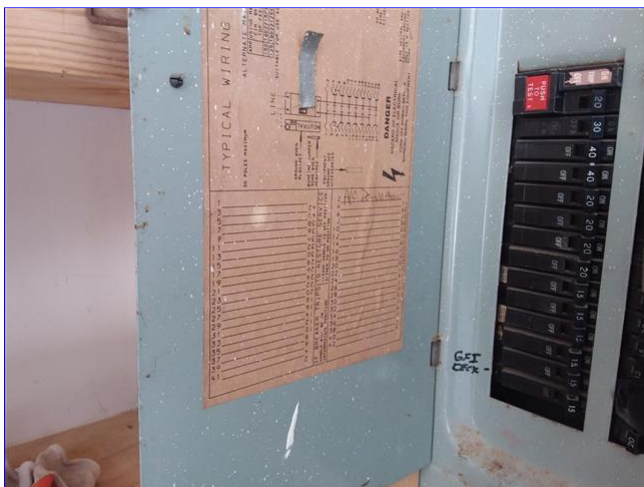
A. Item 1(Picture) missing labels

(1) The panel is missing circuit identification. **This is a safety hazard.** I recommend having a qualified person mark circuits as needed.

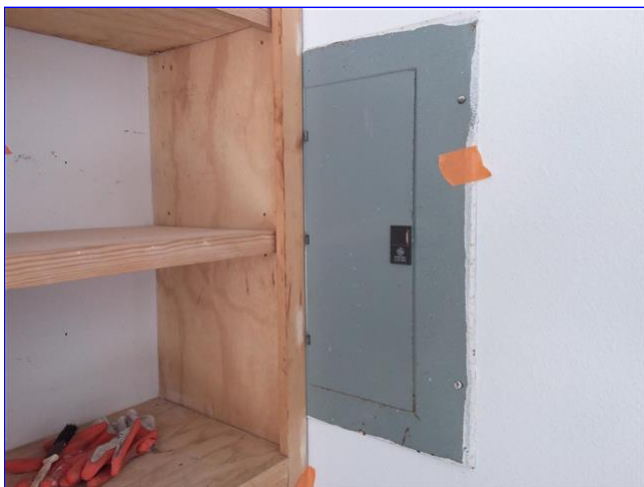
A. Item 2(Picture) panel obstructed

(2) The panel is obstructed by the shelving in the garage. The panel cover cannot be removed. This is a electrical hazard. Removal of the shelving is recommended to allow access to the panel interior.

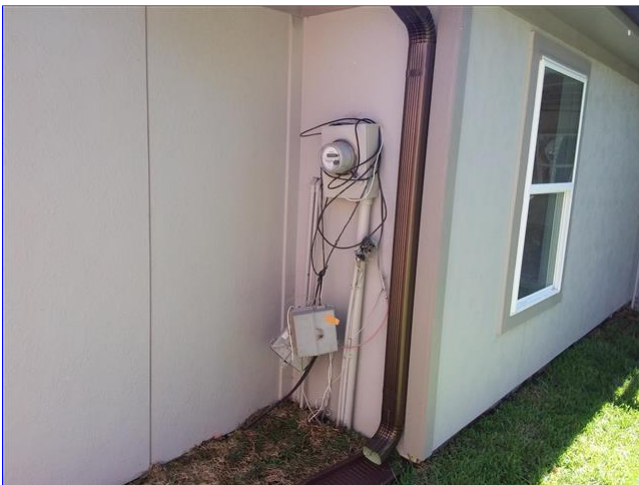
A. Item 4(Picture) garage exterior

(4) The coax connections are loose and hanging on the electrical meter. This is a potential electrical hazard. Removal of the lines or securing them to the wall is recommended.

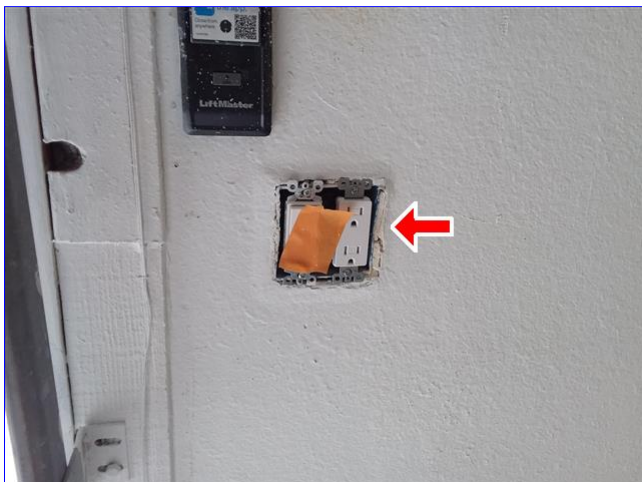
B. Item 2(Picture) garage

(3) The outlet cover is damaged and needs to be replaced. I recommend having a qualified person make repairs as needed.

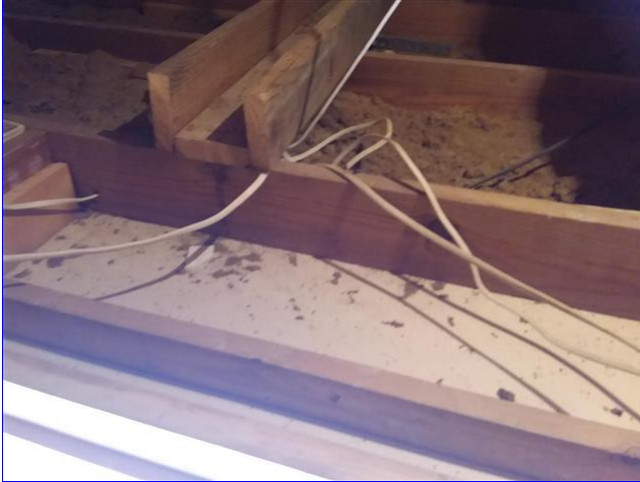
B. Item 10(Picture) garage attic

(5) The electrical wiring in attic was not secured to wood members properly and was not installed neatly or in 90 degree turns as in standard workmanlike practices. This may indicate that a licensed electrical contractor did not perform the work or did not follow standards (for your information).

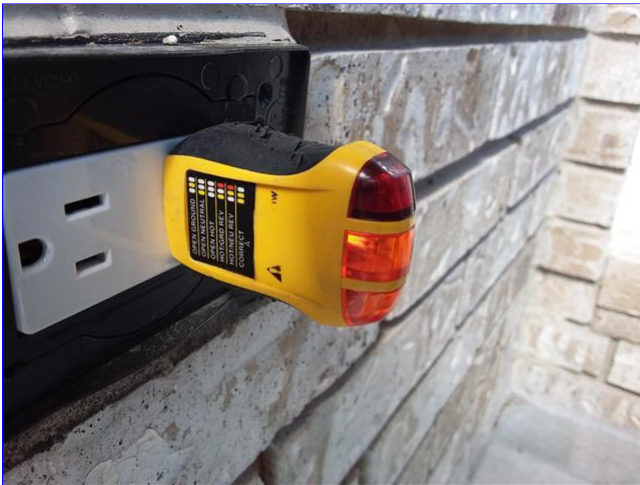
B. Item 11(Picture) main entry exterior

(6) Outlets are not grounded in areas. This is a safety issue that needs to be corrected. A qualified licensed electrical contractor should perform repairs that involve wiring.

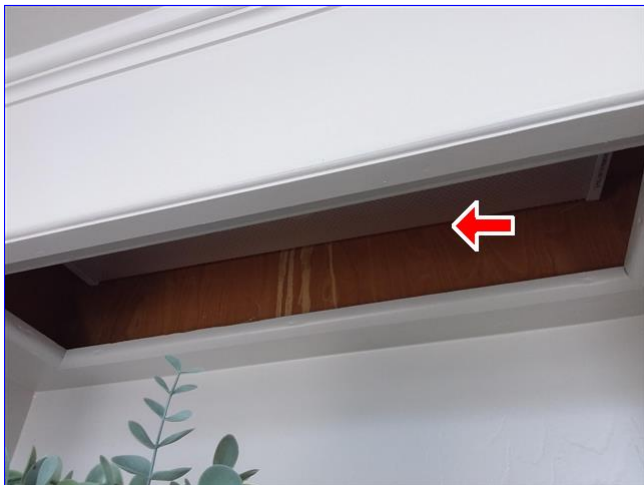
B. Item 13(Picture) living room bookshelf

(7) The light fixture is missing cover at the in areas. I recommend repair or replacement as needed.

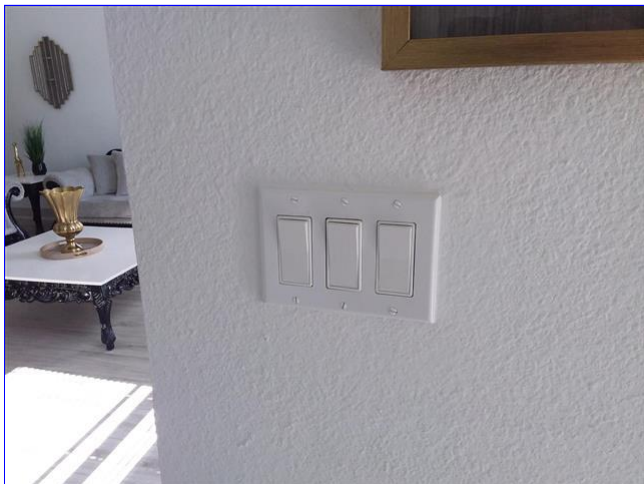
B. Item 14(Picture) living room

(8) Some switches could not be identified. Further evaluation is recommended.

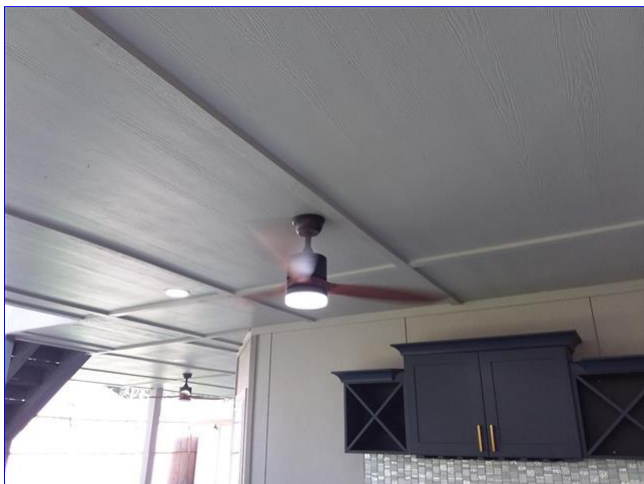
B. Item 15(Picture) back patio

(9) Ceiling fan wobbles at time of inspection process. A qualified electrician should inspect and repair as needed.

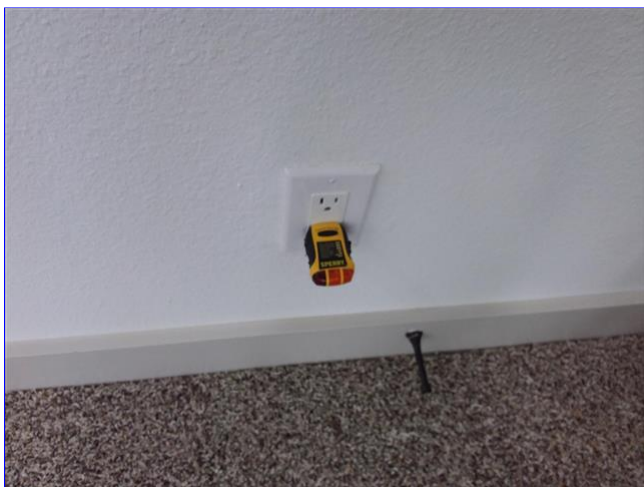
B. Item 16(Picture) master bedroom

(10) Outlets are not working in areas. Further inspection is needed by a qualified licensed electrical contractor. I recommend repair as needed.

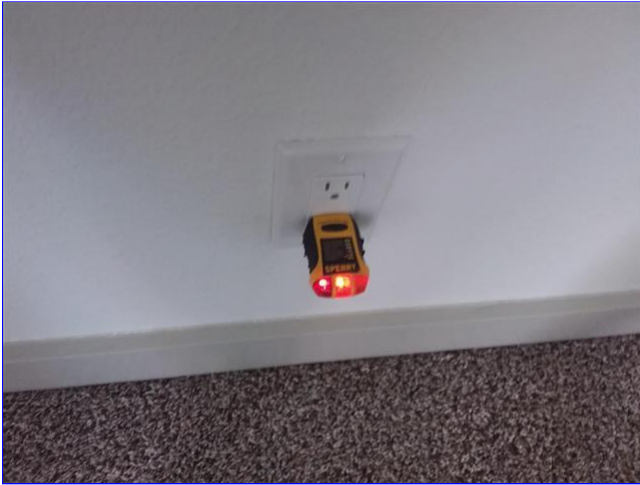
B. Item 18(Picture) left upstairs bedroom front wall

(11) Outlets are incorrect "reverse polarity" in the bedroom. Electrical issues are considered a hazard until repaired. A qualified licensed electrical contractor should perform repairs that involve wiring.

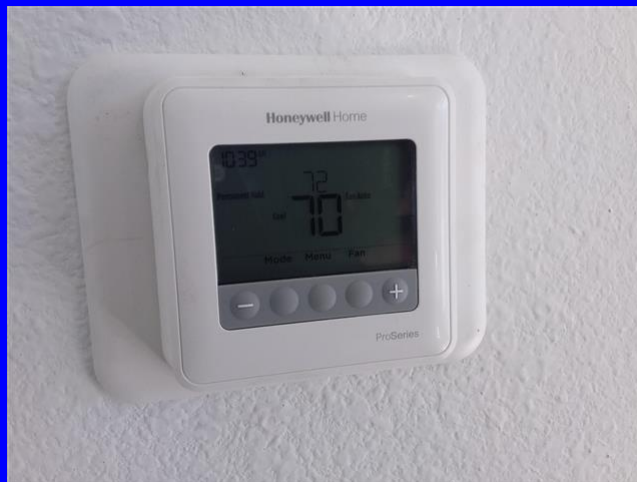
thermostat outside master bedroom

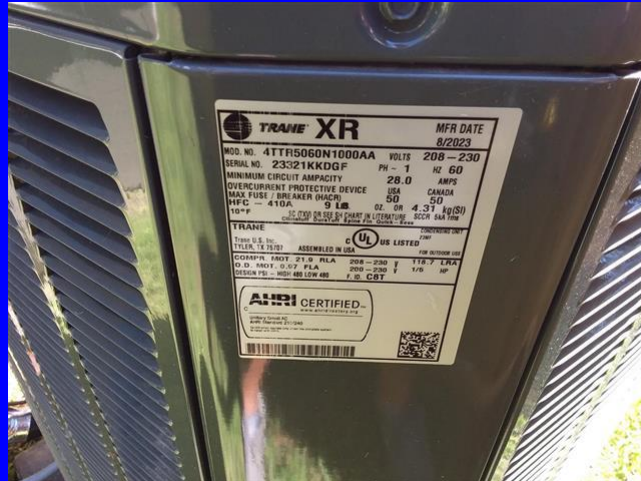
unit label

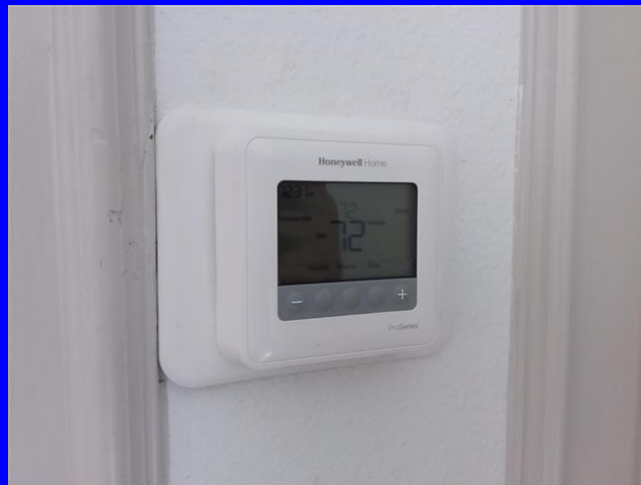
thermostat upstairs living room

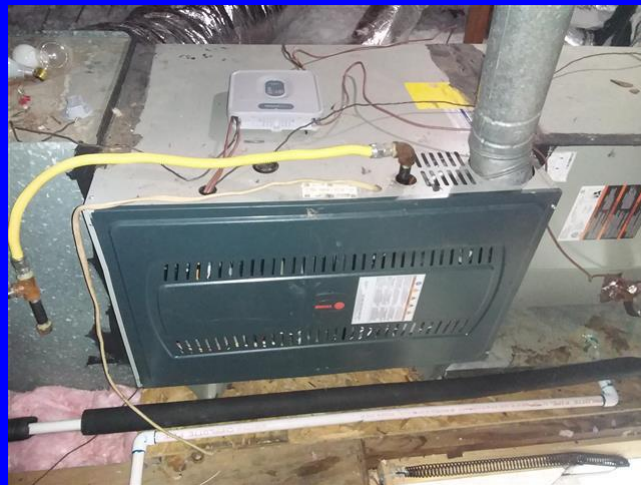
gas furnace upper attic

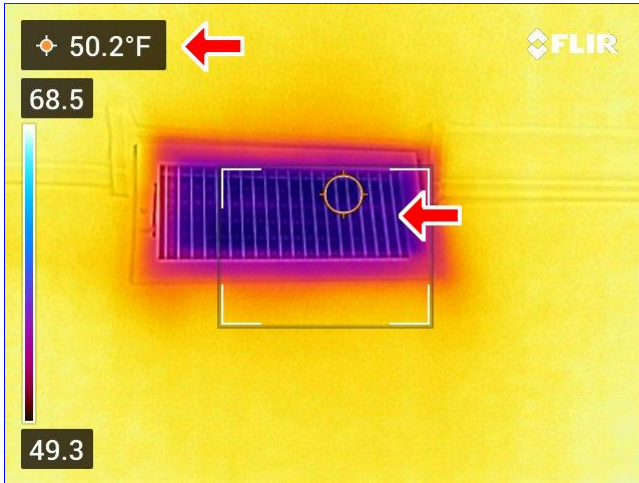
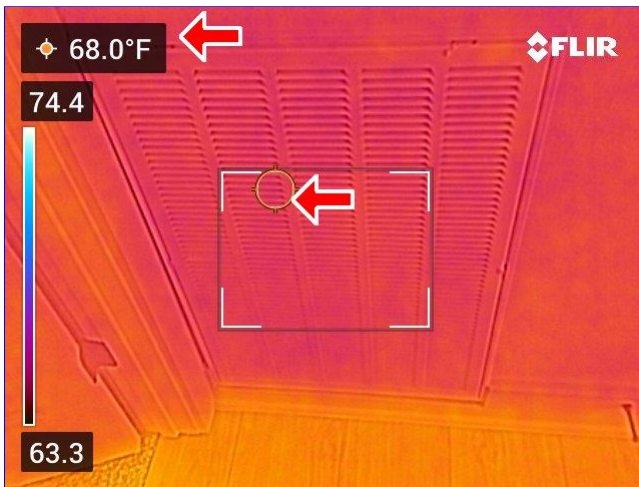
B. Item 1(Picture) 50 at vent

- (1) The ambient air test was performed by using infrared thermal equipment at the supply vents of Air conditioner to determine if the difference in temperatures of the supply and return air are between 15 degrees and 22 degrees which indicates that the unit is cooling as intended. The supply air temperature on your system read 50 degrees and the return air temperature was 68 degrees. This indicates the range in temperature drop is normal.

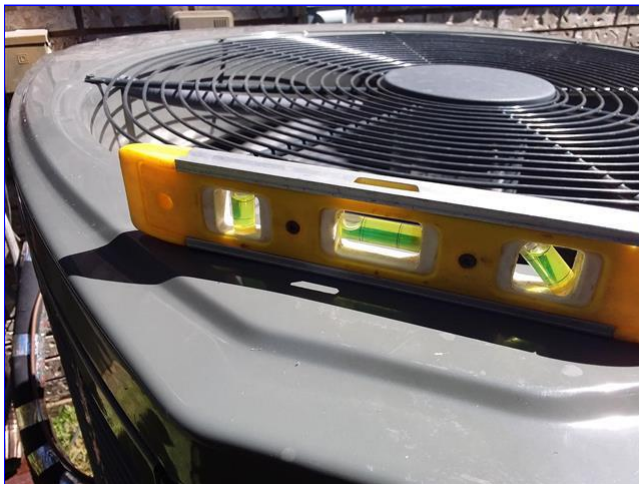
B. Item 3(Picture) unit not level

(2) The condenser is not level. This can cause damage to the unit or shorten its life span. I recommend service or repair as needed.

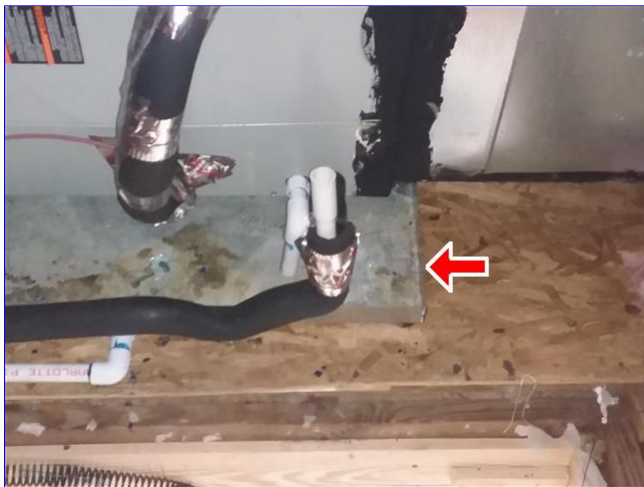
B. Item 4(Picture) missing pan switch

(3) The emergency overflow drain pan for the HVAC system is showing signs of deterioration. Further deterioration may occur if not corrected. I recommend having a qualified person make repairs as needed.

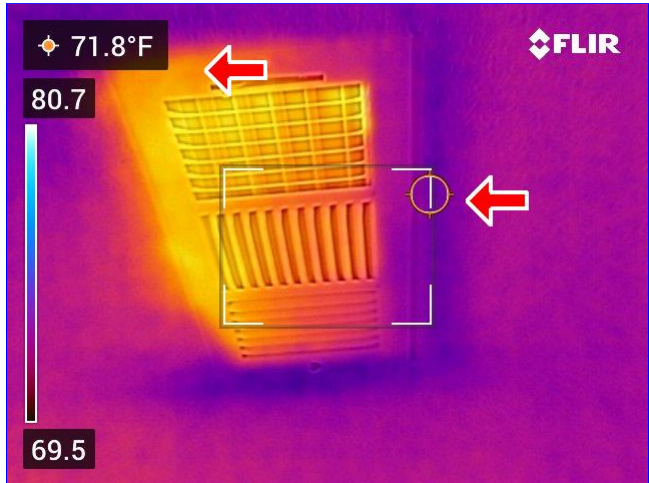
C. Item 1(Picture) upstairs AC temperature reading

(2) There was no air flow when testing the AC to the upstairs bedrooms and bathroom. When testing the furnace, there was no air flow to the downstairs vents, but there was air flow upstairs. Further evaluation from a HVAC technician is recommended.

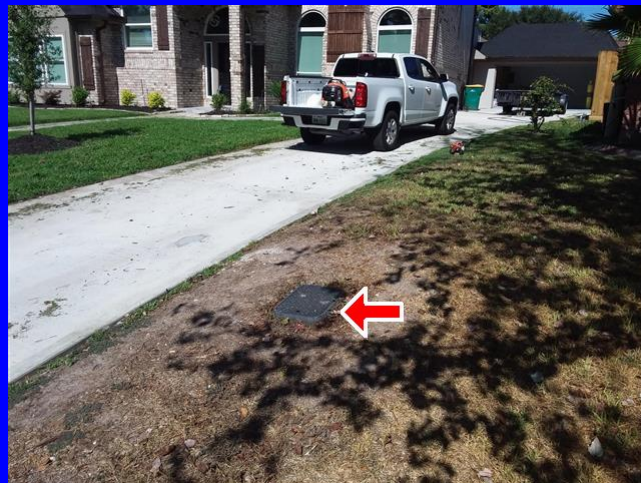
water meter front right

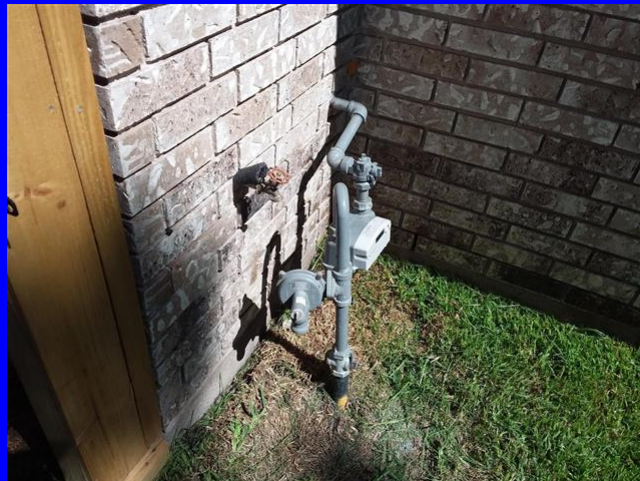
gas meter left side

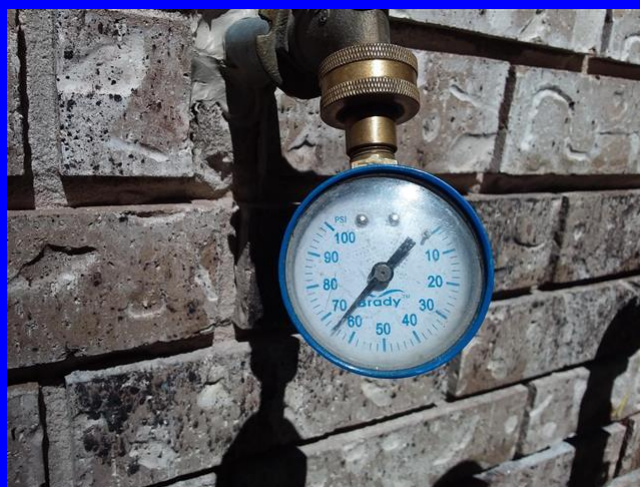
water pressure 65 psi

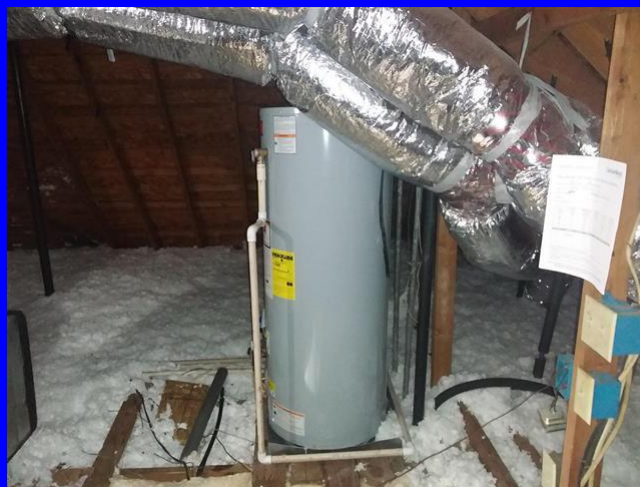
50 gallon water heater in attic

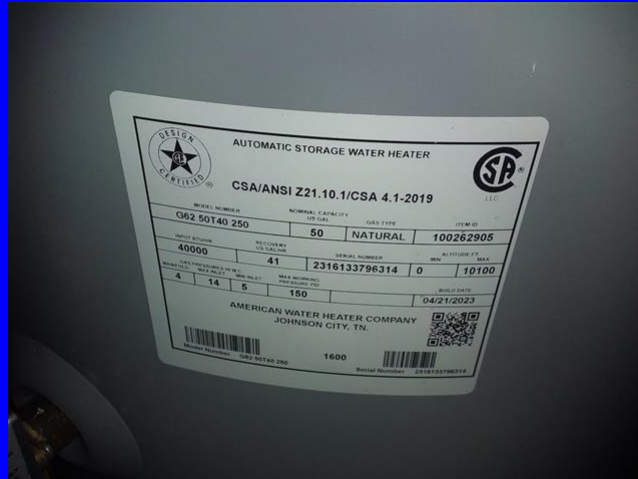
water heater label

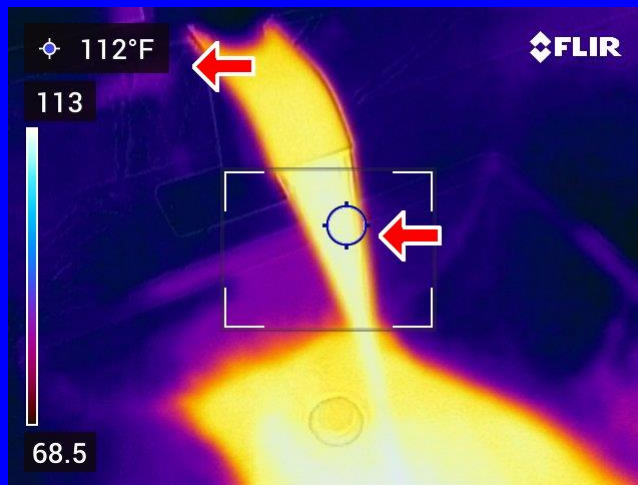
hot water temperature

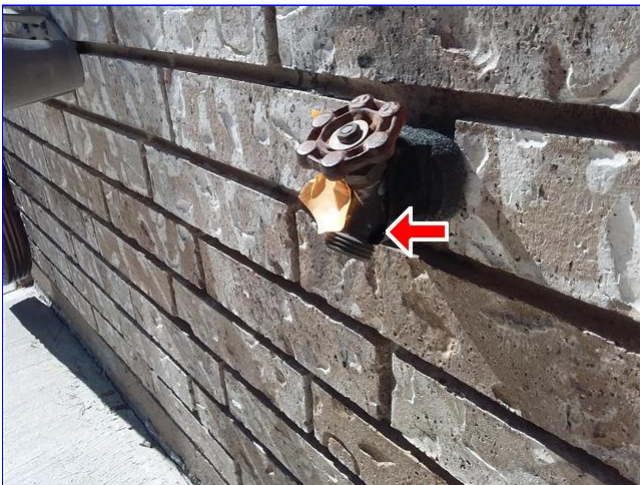
A. Item 3(Picture) missing anti siphon

(3) There is no Anti Siphon device installed on exterior faucet(s). This is not considered to be today's standard. I recommend having a qualified person make repairs as needed.

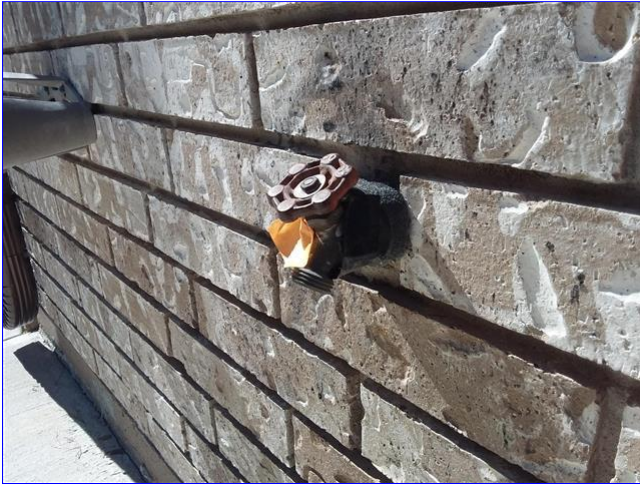
A. Item 4(Picture) right exterior

(4) The spigot was not functional. Further evaluation from a licensed plumber and repair is recommended.

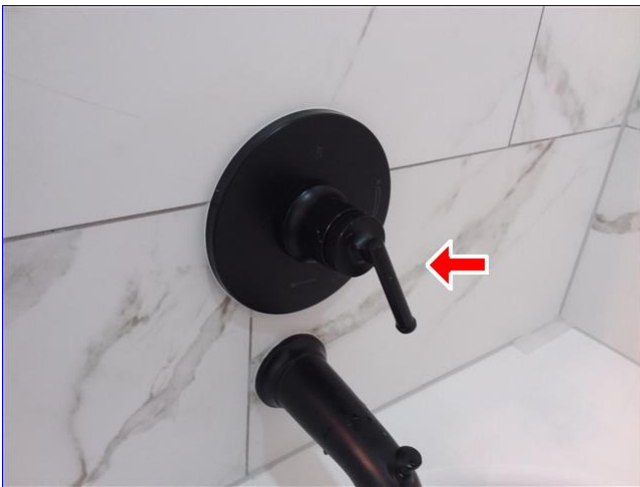
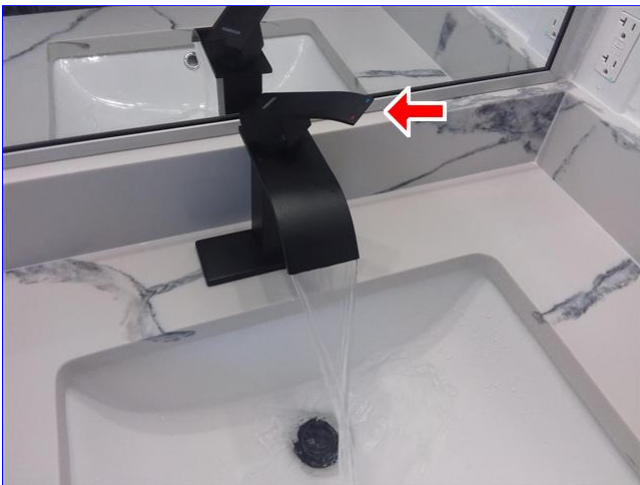
A. Item 5(Picture) all master bathroom handles

(5) The hot and cold controls are reversed in the bathroom. I recommend repair as desired.

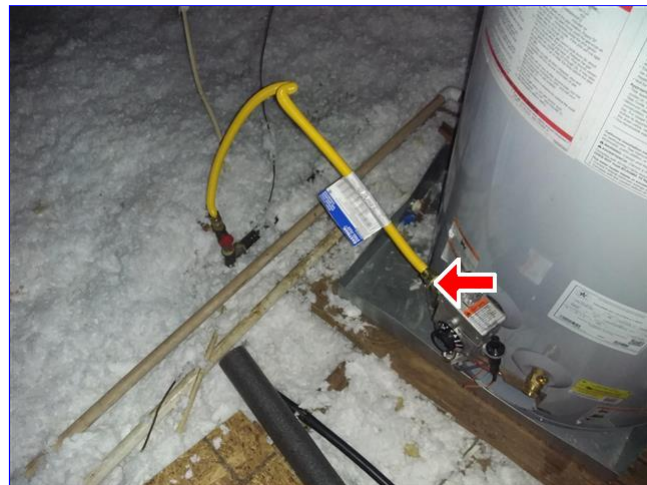
C. Item 2(Picture) missing drip leg

The water heater is installed without the recommended sediment trap or "drip leg" that is designed to extend the life of the unit. This is not considered to be today's standard. I recommend having a qualified plumber make repairs as needed.

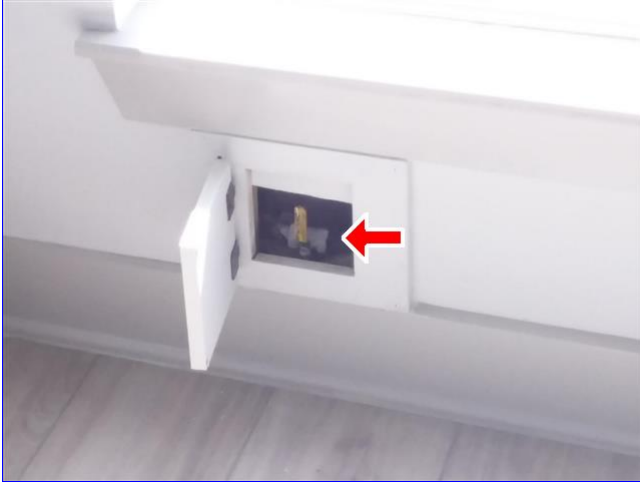
A lingering gas odor was observed after testing the fireplace. This is a potential safety hazard. Further evaluation from a licensed plumber is recommended if the odor persists.

E. Item 1(Picture) fireplace gas valve

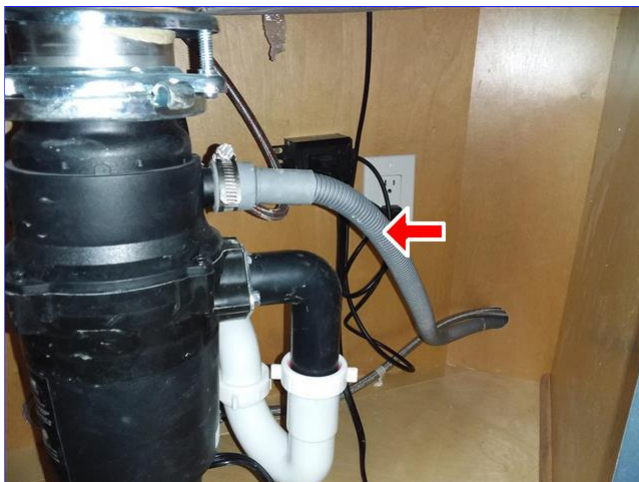
(2) The dishwasher drain hose did not perform a loop to create a trap under sink. I recommend repair as necessary.

A. Item 2(Picture) missing high loop

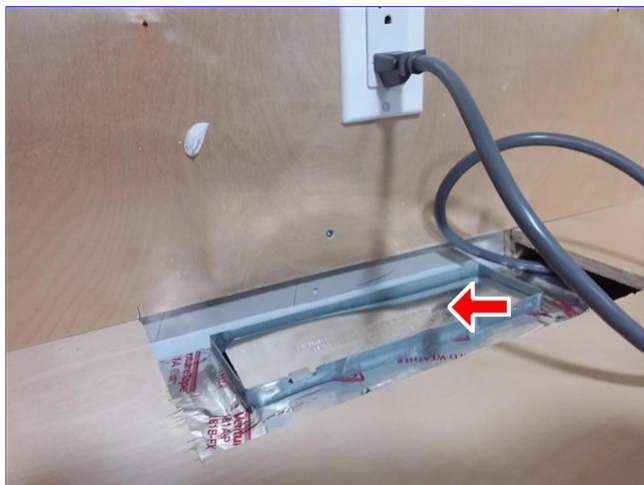
(2) The kitchen vent hood does not vent to the outdoors. This is not considered to be today's standard.

C. Item 1(Picture) vents into cabinet

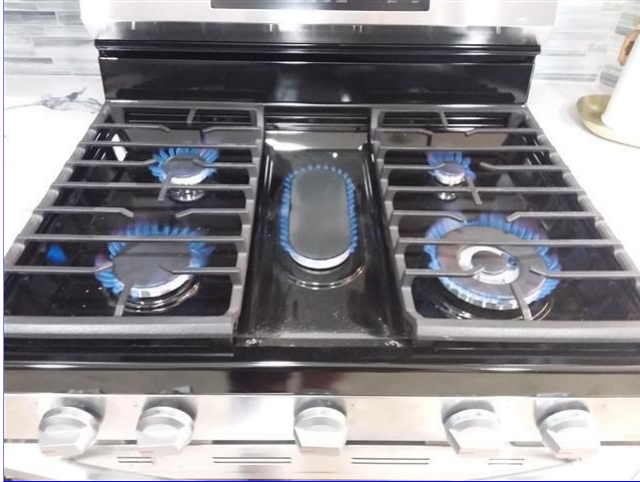
D. Item 1(Picture) functional range

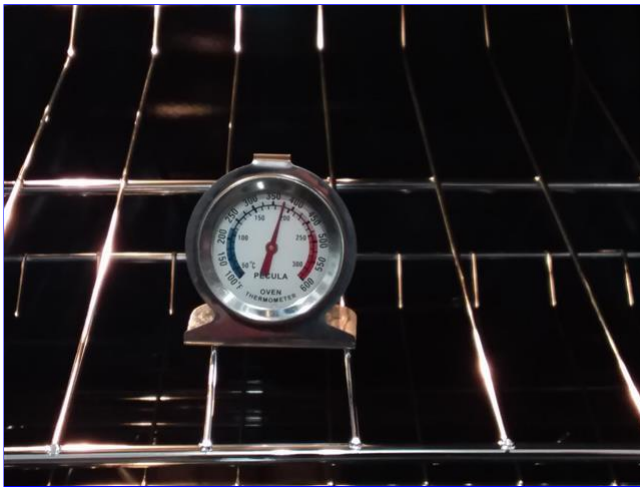
D. Item 2(Picture) 350 degree setting

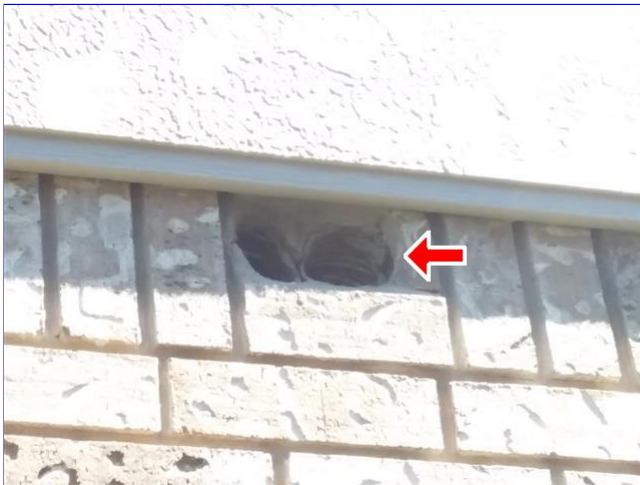
F. Item 1(Picture) left exterior

(2) The exhaust vent cover is missing on the exterior. Cover installation is recommended.

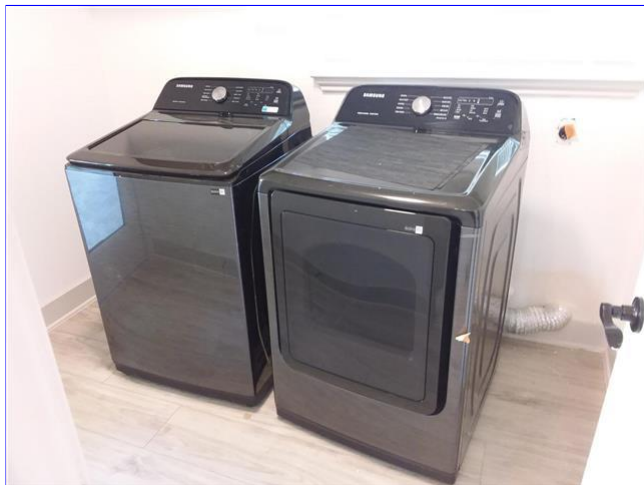
Washer and dryer area was inspected with limited visibility due to appliances being installed. This is for your information.

H. Item 1(Picture) washer and dryer installed

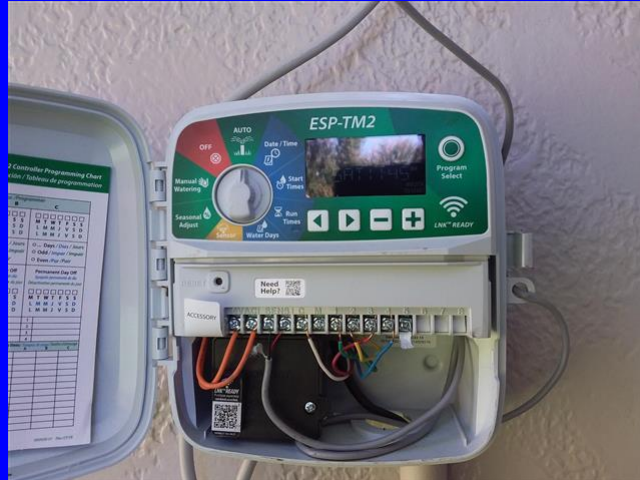
sprinkler system control panel garage exterior 4 wired zones

Tested and working properly at the time of inspection however some sprinkler heads spray patterns will need adjustment or replacement. Zone 1 covers the front left. Zone 2 covers the front right and right flower bed. Zone 3 covers the front left flower beds and left side. Zone 4 covers the back yard.
