Inspection Report

Property Address:
8515 Vista Oaks Manor
Houston TX 77028

HG Home Inspection/Hilsher Group LLC

PROPERTY INSPECTION REPORT FORM

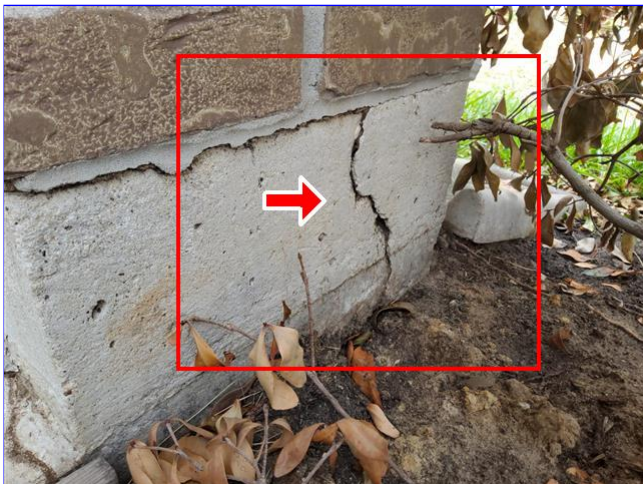
A. Item 1 (Picture) Front right corner

- (1) This is not an engineering report, but is only an opinion based on observation of conditions known to be related to foundation performance, using the knowledge and experience of the inspector.
- (2) The foundation has large corner pop(s) that are larger than 4 inches. Further deterioration will occur if not corrected. I recommend having a qualified person make repairs as needed.

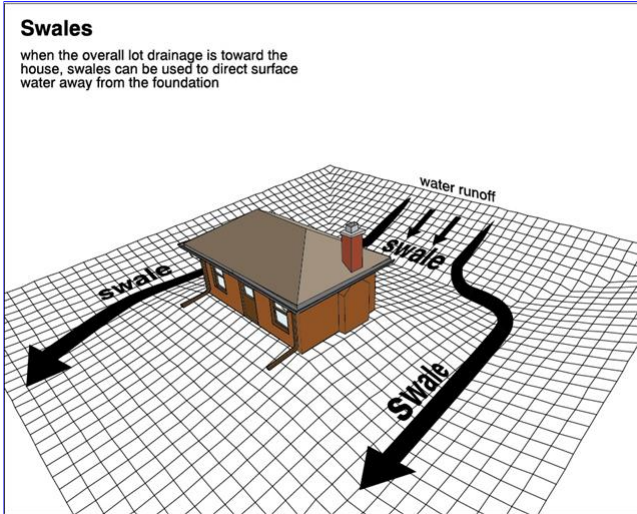
B. Item 1 (Picture)

Grading on the lot does not appear to drain water properly. I recommend having a qualified person grade lot properly.

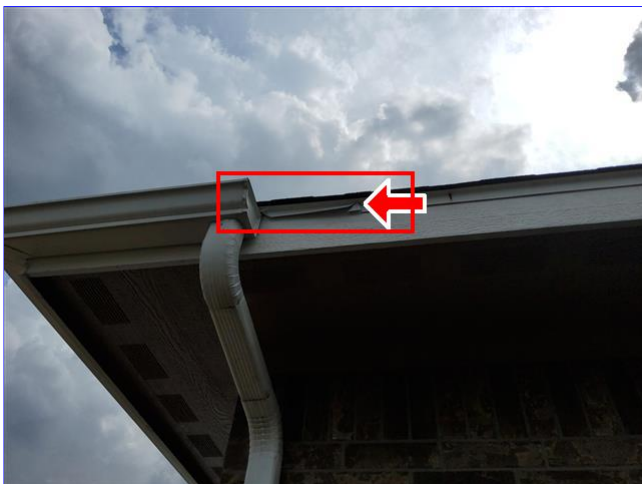
C. Item 1 (Picture) Right side

(2) The drip edge flashing appears to be improperly installed/damaged. I recommend having a qualified person evaluate and make repairs as needed.

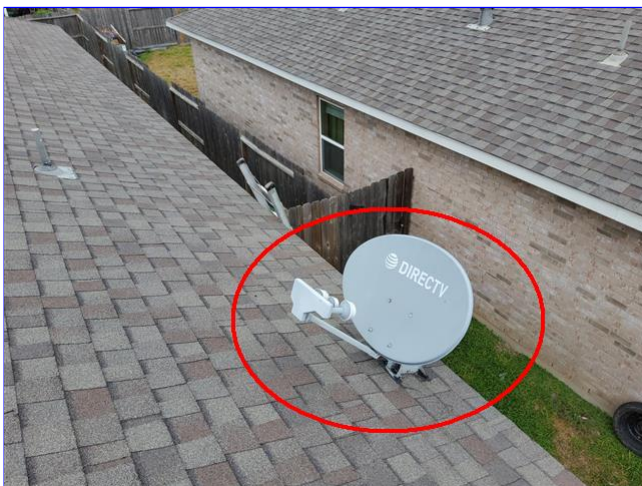
C. Item 2 (Picture) Roof

(3) There is a satellite dish bracket mounted on roof that is screwed directly through roofing surface. This is not considered to be today's standard. I recommend having a qualified person remove and patch roofing as needed. (The area will need periodic maintenance)

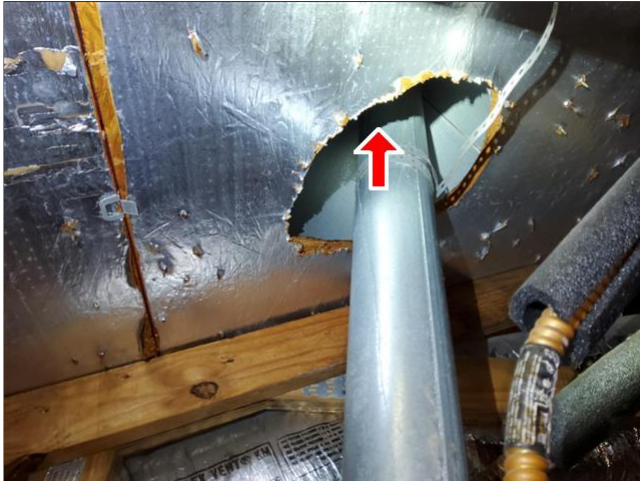
C. Item 3 (Picture)

(4) Inspector noted active leak running down the water heater exhaust flue into the attic space at the time of inspection. This is not a common practice in today's standards. Recommend having a qualified roofing contractor/ plumber further evaluate and correct as needed.

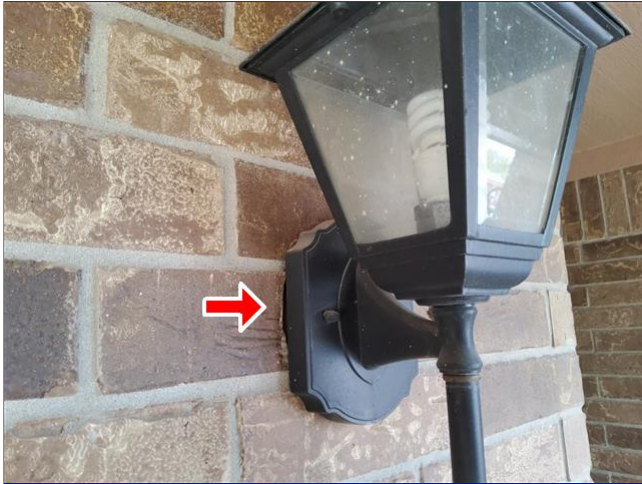
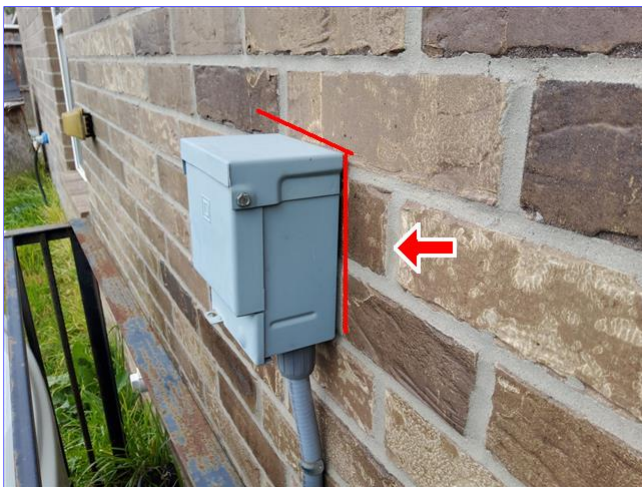
(1) Areas where wiring or piping passes through walls should be sealed. I recommend having a qualified person seal as needed. Multiple locations

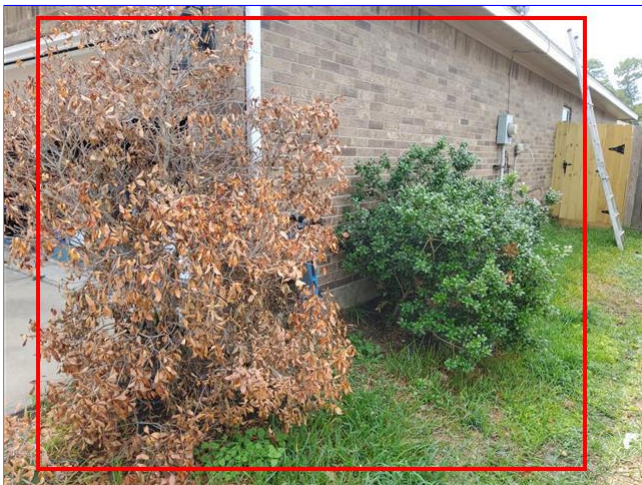
E. Item 4 (Picture) Front/right side

(2) There is vegetation growth on exterior of the home. This can cause damage, contribute to premature

deterioration and create conducive conditions for certain wood destroying insects. I recommend removal of vegetation and having a qualified pest control company inspect and treat as needed.

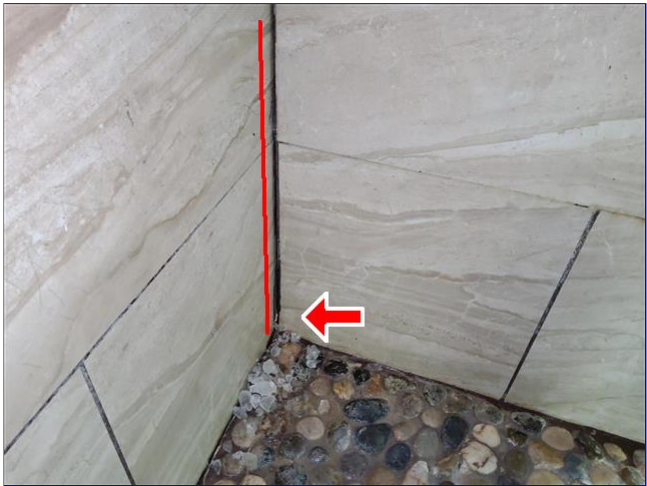
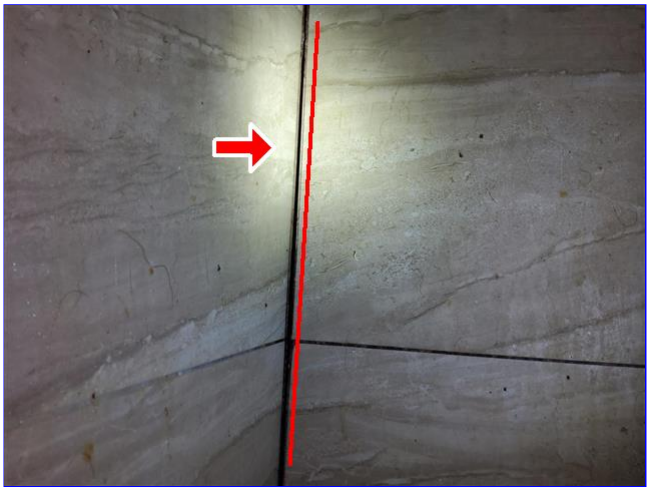
(3) The Tile surround at shower on the wall missing silicone caulk at inside corners and at shower pan (floor) perimeter Water is entering behind covering and needs correcting at the master bath. Repairs are needed to prevent water damage to shower/bath. A qualified contractor should inspect and repair as needed.

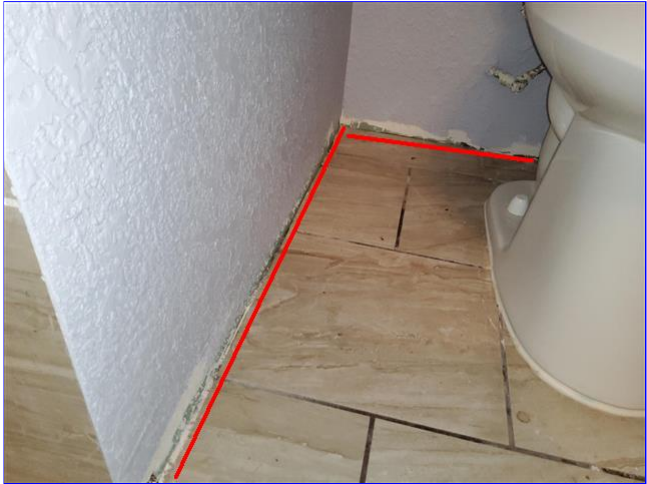
F. Item 1 (Picture) Guest bathroom

(1) I recommend silicone caulking along floor at all cabinets and baseboards in wet areas. Multiple locations

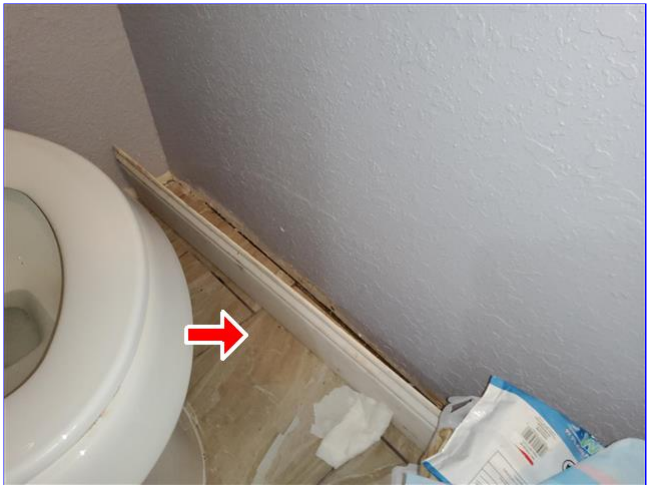
F. Item 2 (Picture) Guest bathroom

(2) Inspector noted loose/damaged baseboards at the time of inspection. This is not a comment practice in today's standards. Recommend having it corrected as needed by qualified contractor. Multiple locations

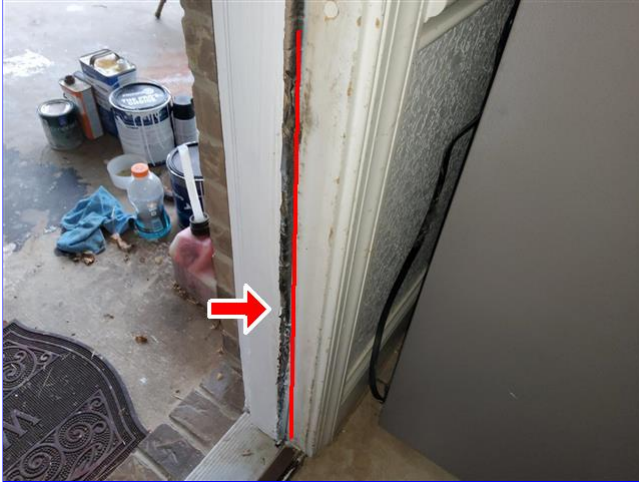
G. Item 1 (Picture) Back porch door

Inspector noted damaged weather stripping to the back porch door at the time of inspection. Recommend having it replaced and corrected as needed by a qualified person.

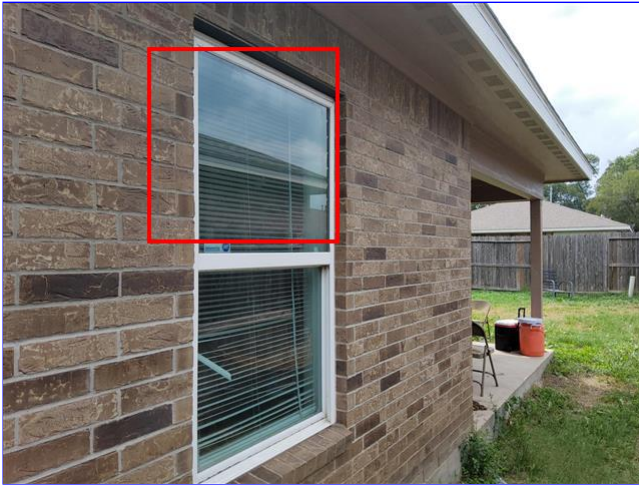
H. Item 1 (Picture) Right side

(1) The glazing between glass panes appear to be failing at some windows causing cloudy glass (If there are multiple windows that are the same age and style it is safe to assume others will soon start to fail as well). I recommend having a qualified person make repairs as needed.

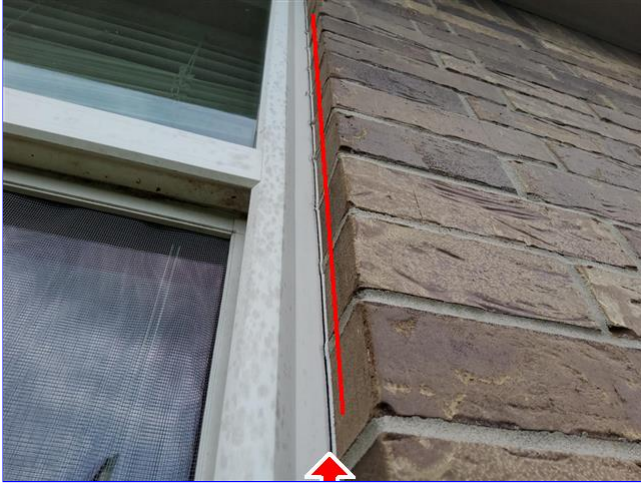
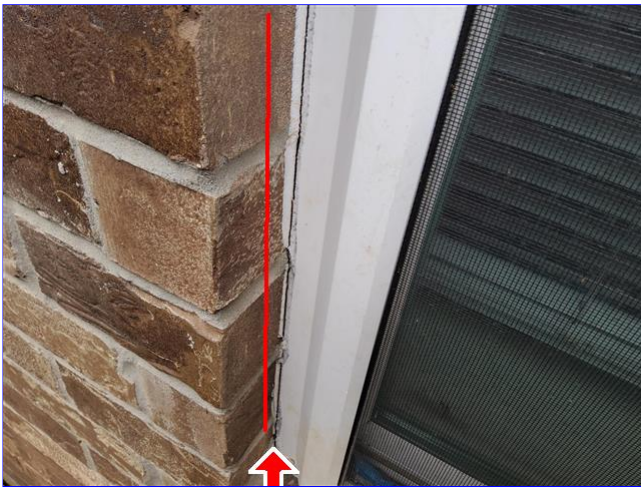
(2) There are window frames that are not properly sealed. This can cause energy loss/ possible water intrusion. I recommend having a qualified person seal and repair as needed. Multiple window locations

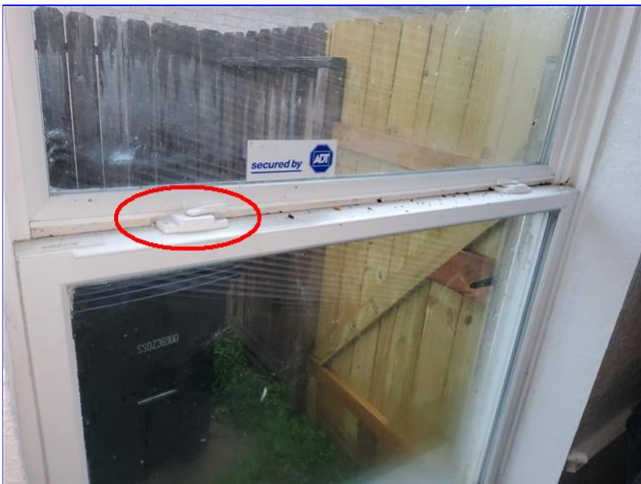
H. Item 4 (Picture) Living room area

(3) Some windows does not lock properly in areas. This type of installation is not standard and may require maintenance and repair. A qualified person should repair or replace as needed.

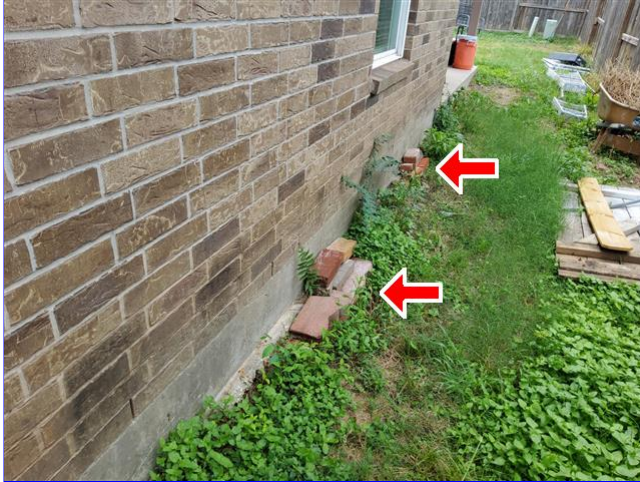
L. Item 5 (Picture) Right side

(2) There are bricks stacked against the foundation wall creating conducive conditions for certain types wood destroying insects. I recommend having a qualified pest control company inspect and treat as needed.

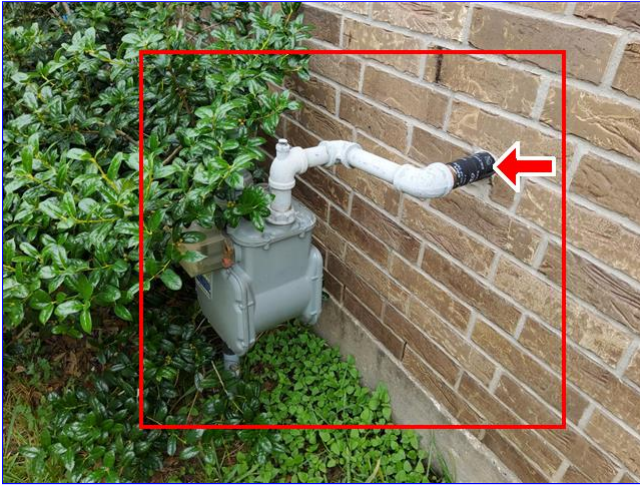
A. Item 1 (Picture) Right side

(1) I did not see a bond/ground wire on metal plumbing. If there is not one then I recommend a ground wire and clamp be installed on metal plumbing line within five feet from where plumbing line enters home.

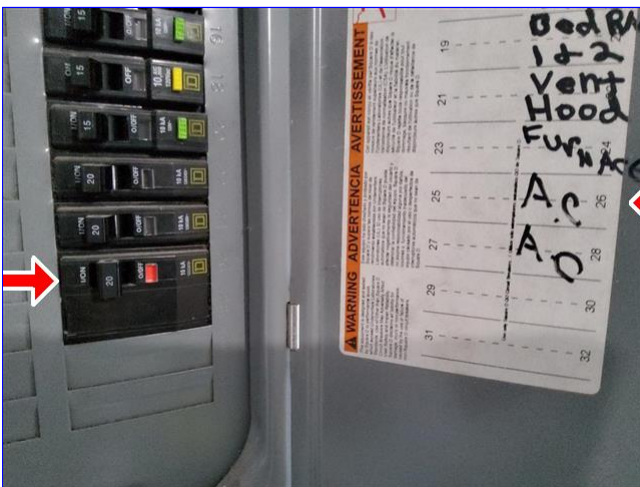
A. Item 2 (Picture) Electrical service panel

(2) Inspector noted breaker in the off position to the ac unit at the time of inspection. Inspector did not reset breaker for safety purposes. Recommend having a licensed HVAC Technician further evaluate and correct as needed

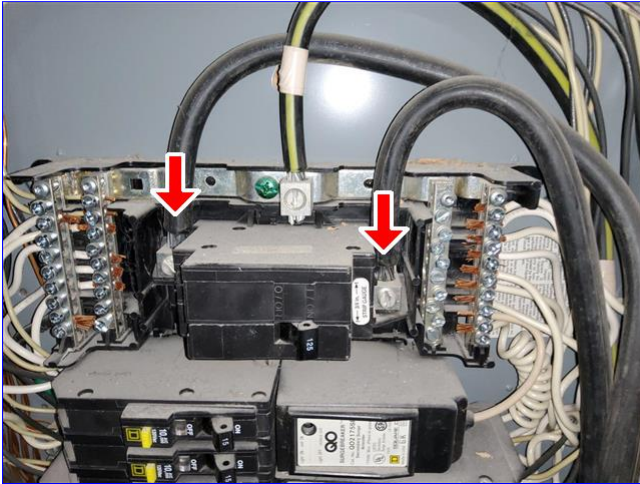
A. Item 3 (Picture) Electrical main panel

(3) There is no antioxidant on aluminum conductors feeding panel. This is not considered to be today's standard. I recommend having a qualified electrician evaluate make repairs as needed.

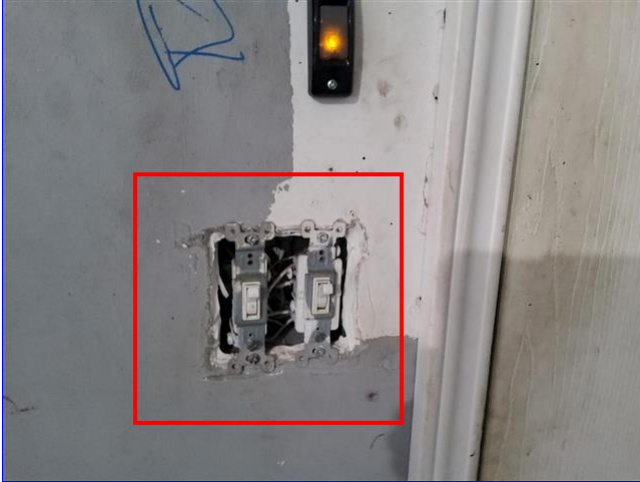
B. Item 1 (Picture) Garage

- (1) I recommend checking all smoke detectors for functionality and putting fresh batteries in each unit upon move in. It is recommend to have smoke detection in each bedroom, hallways and living area. Carbon monoxide detection is recommended in all homes, especially if equipped with gas fired appliances. Some detectors may not be available for inspection due to limiting circumstances (ex. wired with alarm company).
- (2) The wall switch cover is missing in areas. This is a safety issue that needs to be corrected. A qualified licensed electrical contractor should correct as needed. Multiple locations

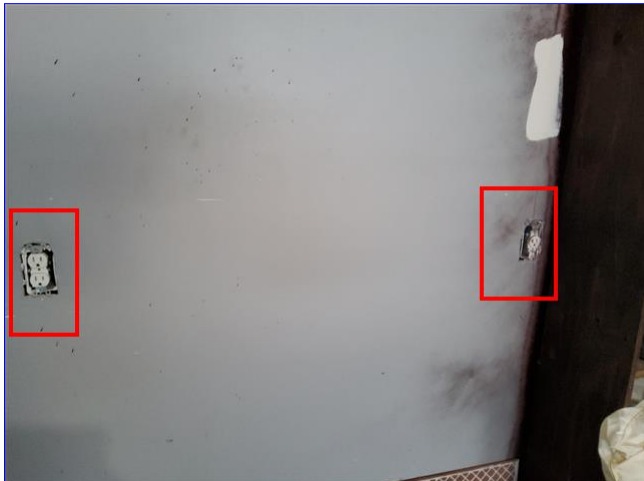
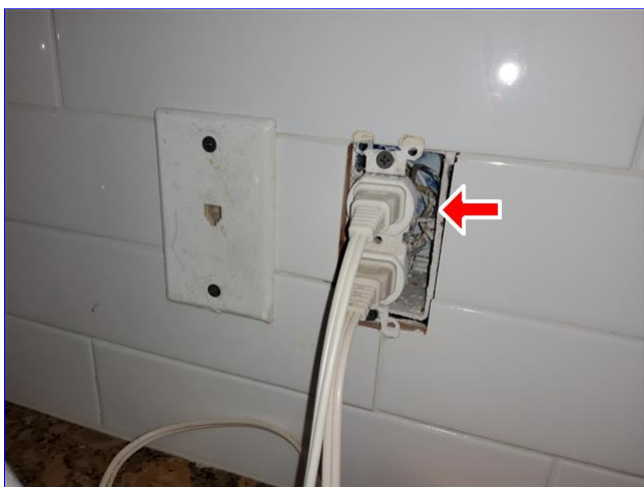
(3) There is damaged/missing receptacle cover plates and exposed wiring in areas of the home. This is a safety hazard. I recommend having a qualified electrician inspect and make repairs as needed. Multiple locations

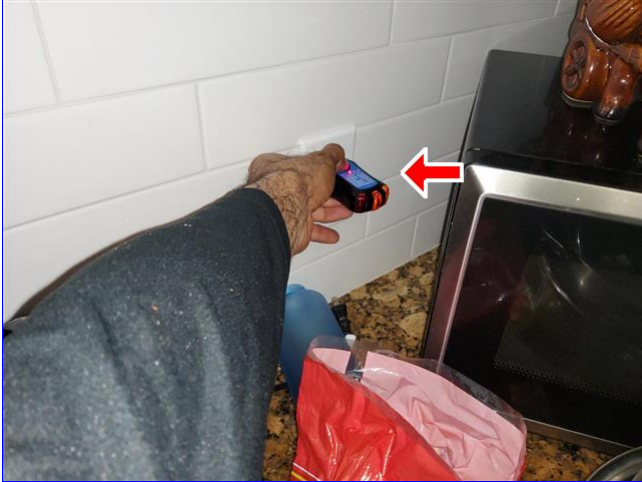
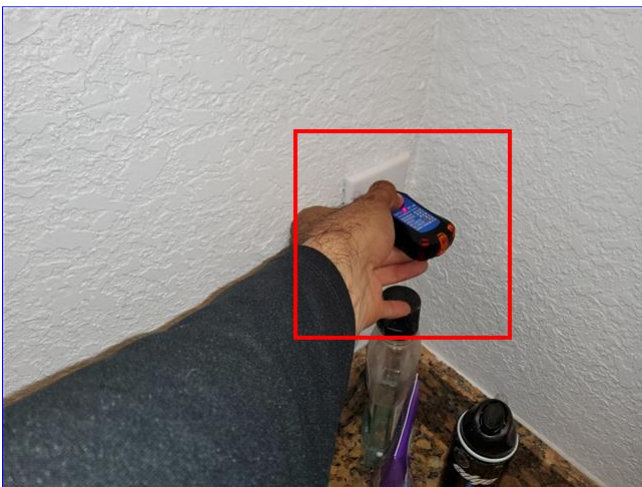
(4) There are no GFCI protected circuits in required area's. This is not considered to be today's standard. I recommend having a qualified electrician make repairs as needed. Multiple locations

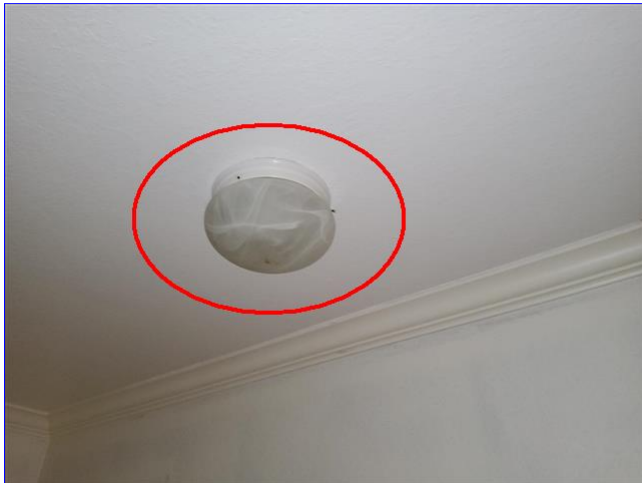
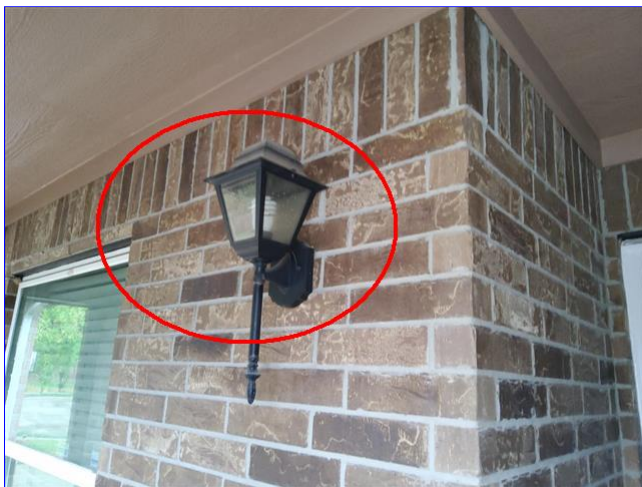
(5) The light fixture does not work (try bulb first). Electrical issues are considered a hazard until repaired. A qualified licensed electrical contractor should perform repairs that involve wiring. Multiple locations

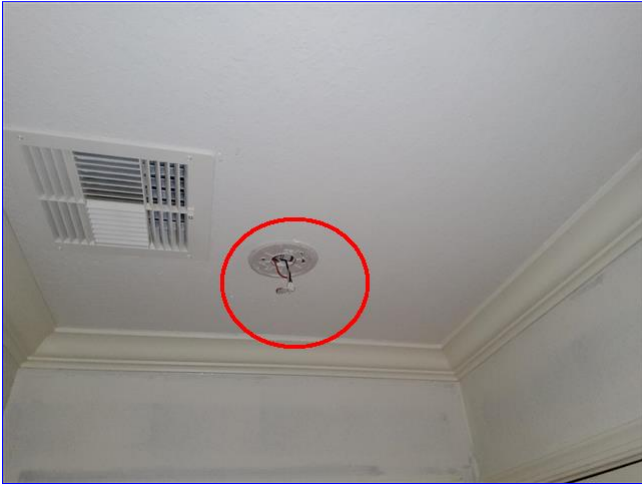
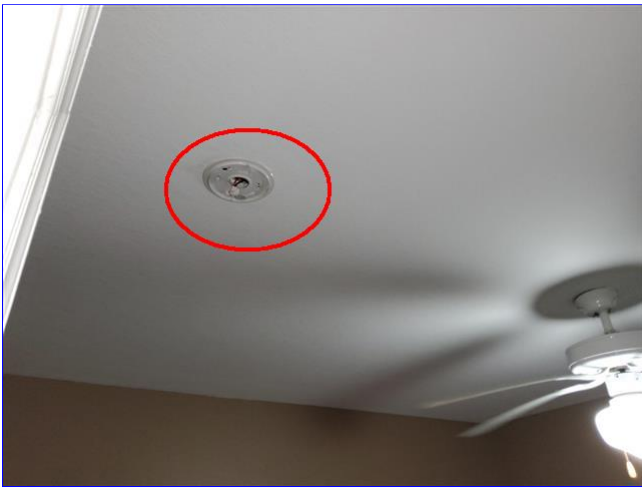
(6) The smoke detector has been disconnected intentionally at the common hallway to bedrooms. Without a working smoke detector in your home you have no first alert to a possible fire. I recommend repair or replace as needed using a qualified person. Multiple locations

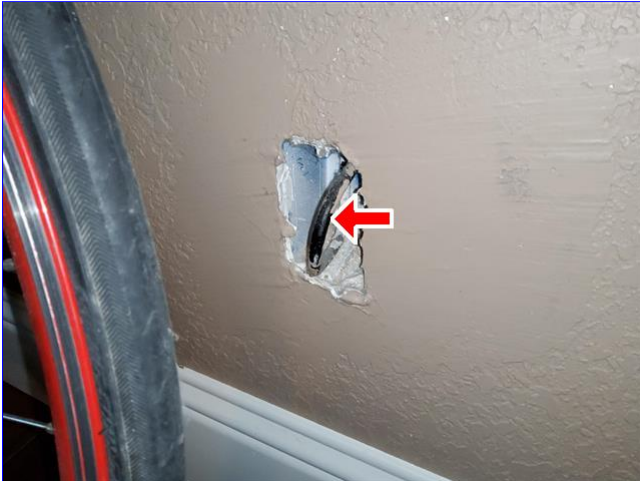
B. Item 12 (Picture) Master bedroom

(7) There is exposed wiring in areas of the home. This is a safety hazard. I recommend having a qualified electrician inspect and make repairs as needed. Multiple locations

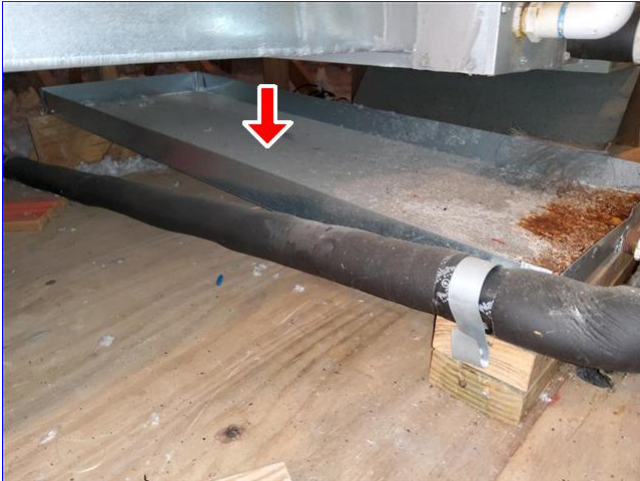
B. Item 1 (Picture) Secondary drain Pan

- (1) It is recommended to have HVAC systems serviced annually.
- (2) Unit is located in the attic space, however the secondary drain pan does not have a pan switch. I recommend having a qualified HVAC contractor make repairs as needed.

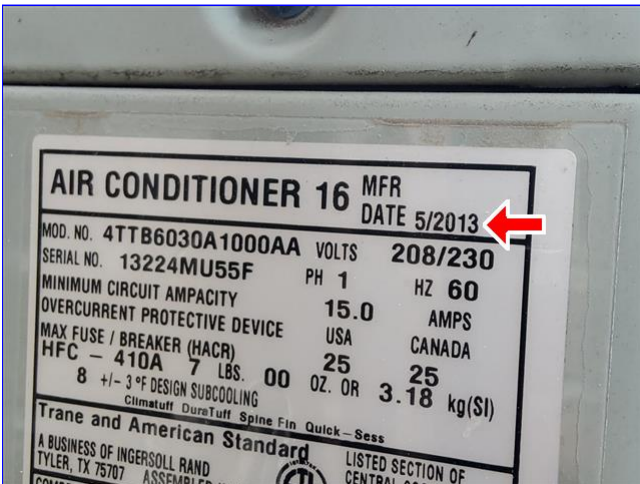
B. Item 3 (Picture) Condenser data plate

(3) The condenser outside (AC unit) did not properly work at the time of inspection and is old/ near end of life expectancy

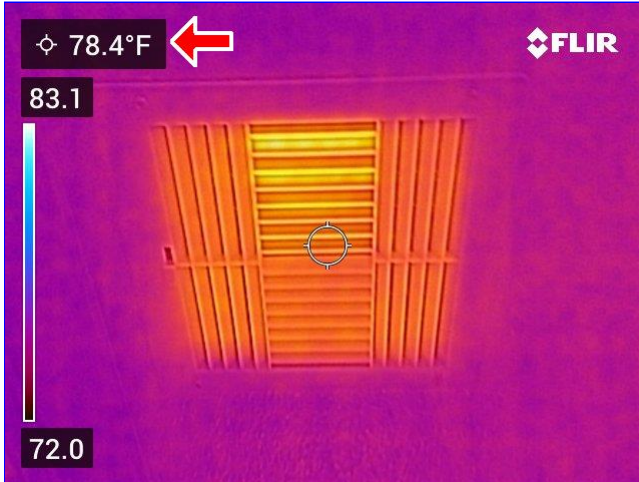
B. Item 4 (Picture) Supply

(4) The ambient air test was performed by using infrared thermal equipment at the supply vents of Air conditioner to determine if the difference in temperatures of the supply and return air are between 15 degrees and 22 degrees which indicates that the unit is cooling as intended. The supply air temperature on your system read 78 degrees and the return air temperature was 75 degrees. This indicates that the unit is **not** cooling properly and a licensed Heat/Air contractor should inspect for cause or problem.

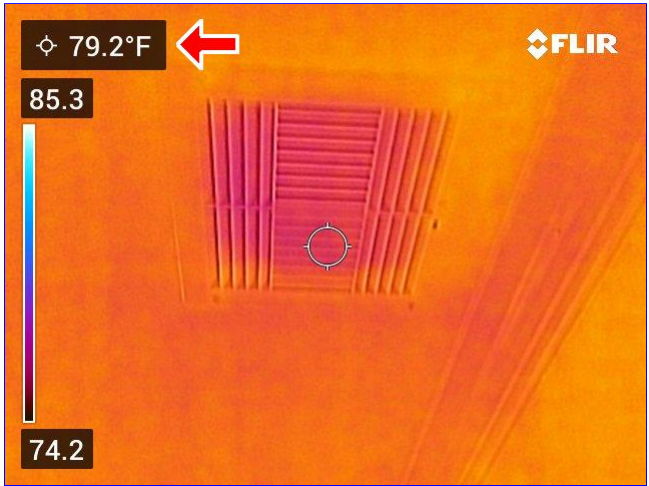
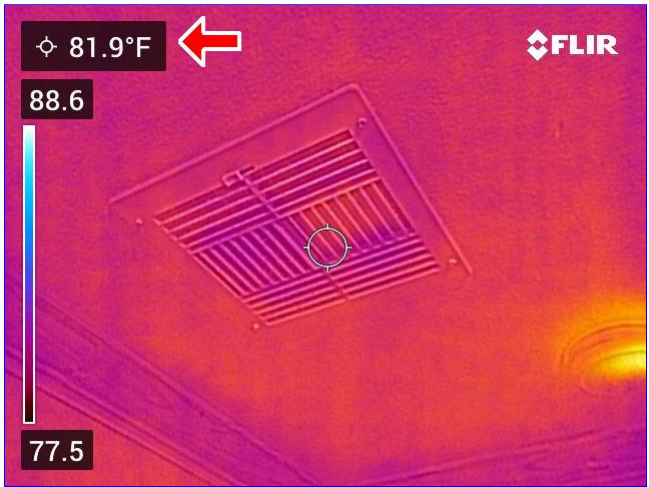
(2) The supply register is weak/ no flow in the master bedroom and multiple supply registers at the time of inspection. A more thorough inspection by a qualified contractor is needed. A licensed HVAC contractor should service or repair unit.

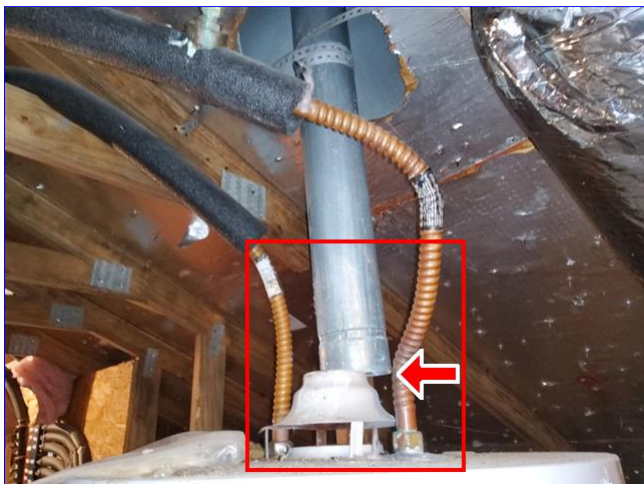
C. Item 1 (Picture) Attic Space

(1) The gas water heater has improper venting. This is a safety hazard until corrected. I recommend having a qualified plumber evaluate and make repairs as needed.

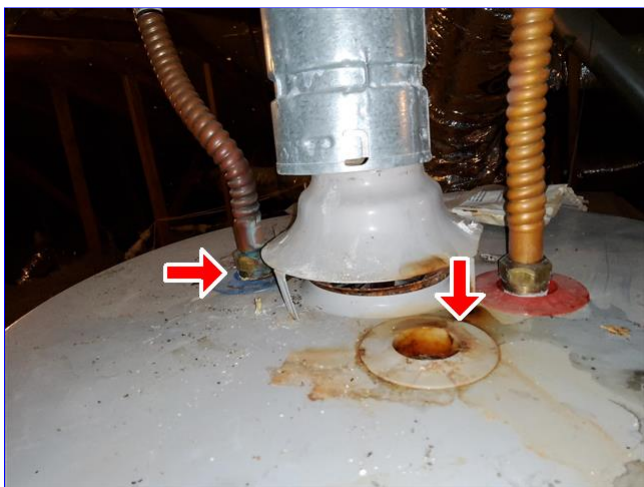
C. Item 2 (Picture)

(2) The water heater has corrosion at fittings/components. I recommend having a qualified person make repairs as needed.

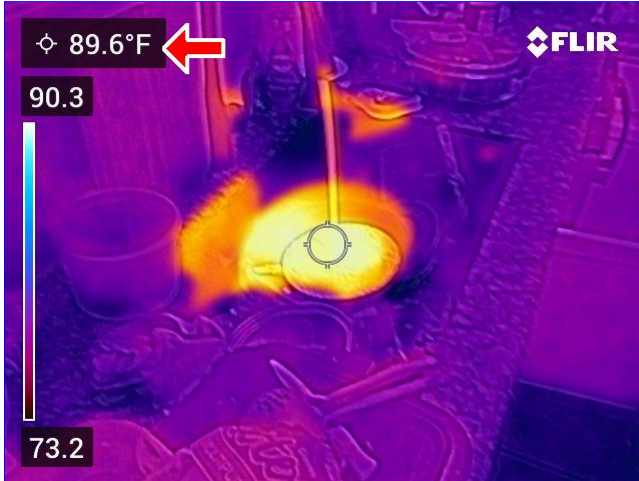
C. Item 3 (Picture) Water Temperature

(3) The water heater was working at the time of inspection however the water was not reaching proper heat temperature levels and it is my professional opinion that the water heater is near its life expectancy.

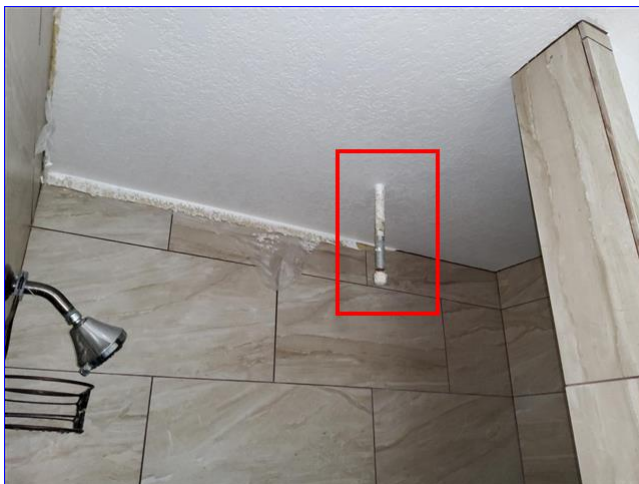
F. Item 1 (Picture) Master bathroom

Inspector noted discontinued plumbing in the master bathroom ceiling. This is not a common practice in today standards. Recommend further evaluation by a licensed plumber and correct as/if needed.

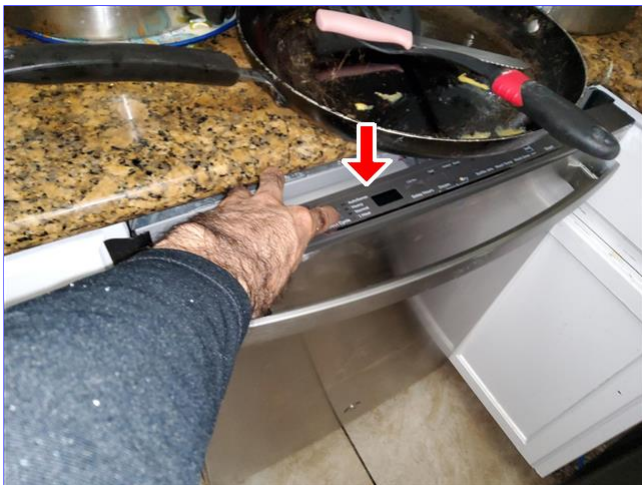
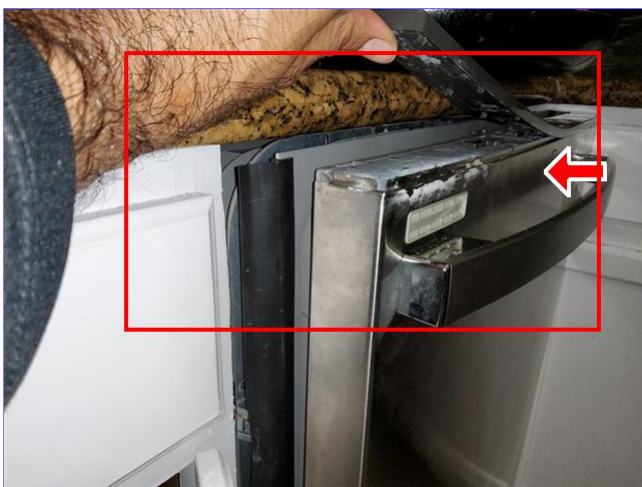
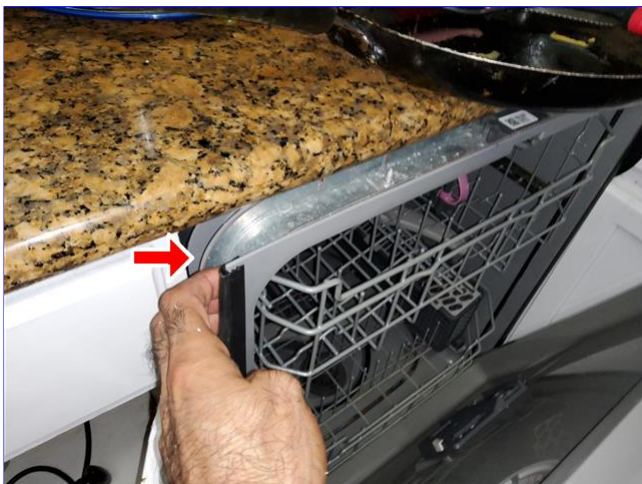
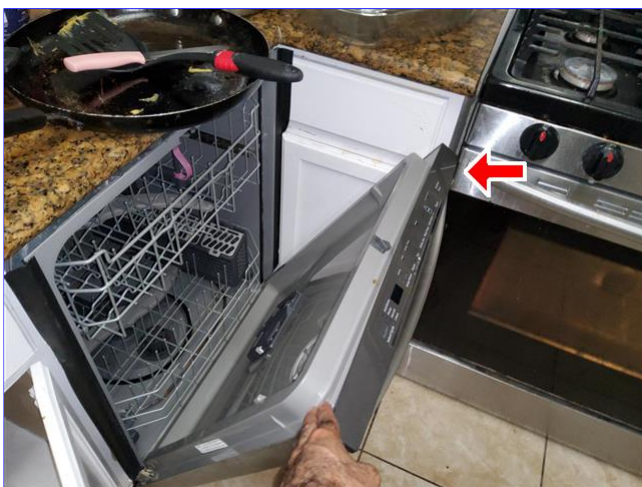
The dishwasher is damaged in multiple areas and did not operate when tested. Inspector also noted that the dishwasher door is obstructed/not properly opening and loose at the time of inspection. I recommend repair as necessary.

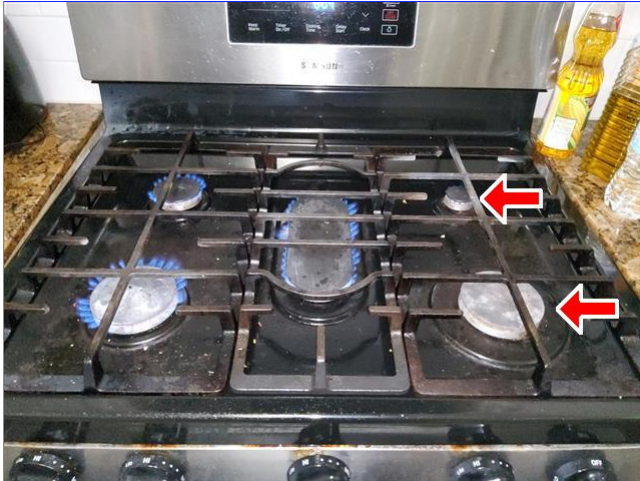
D. Item 1 (Picture) Range -Tested

(1) The front and back right burners (on cook top) did not work properly when tested. I recommend repair as needed. Recommend having a qualified technician further evaluate and correct as needed.

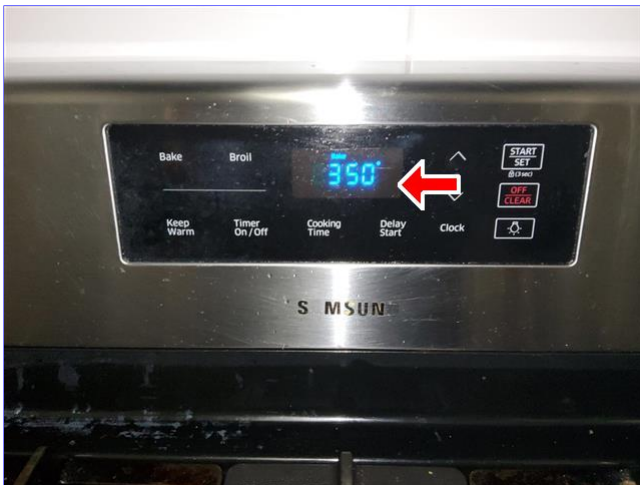
D. Item 2 (Picture) Oven -Tested

(2) Oven was tested and not working properly at time of inspection process. I recommend repairs as needed.

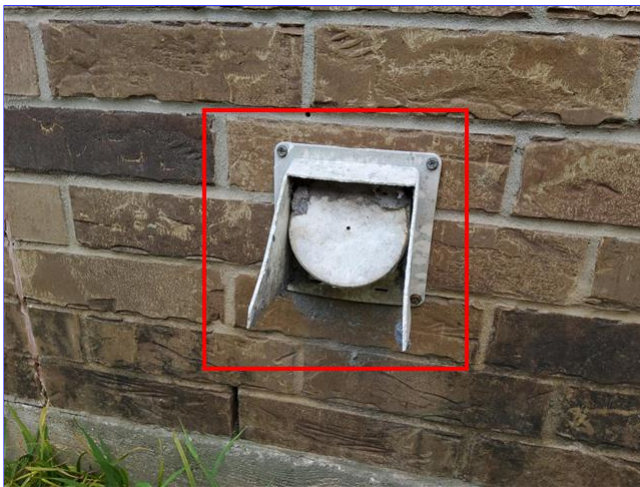
H. Item 1 (Picture) Right side

Inspector noted damaged dryer exhaust vent cover at the time of inspection. This is not a common practice in today's standards. Recommend having it replaced and corrected as needed by a qualified contractor.
