PROPERTY INSPECTION REPORT

Concerning: 4119 Campeche Court , Galveston, TX 77554
(Address or Other Identification of Inspected Property)

By: Danny Marlow Lic.#: 23187 01/07/2020
(Name and License Number of Inspector) (Date)

Home Inspection Report

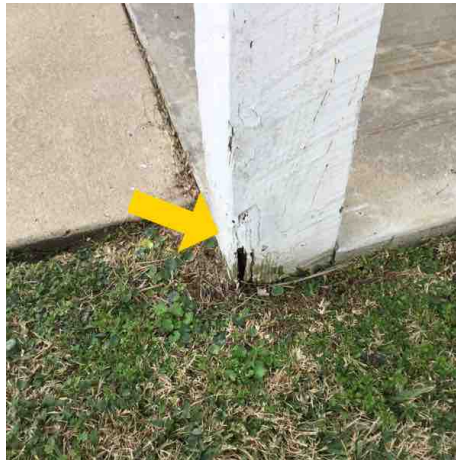
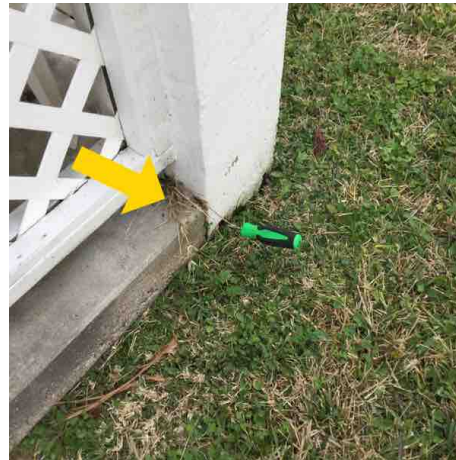
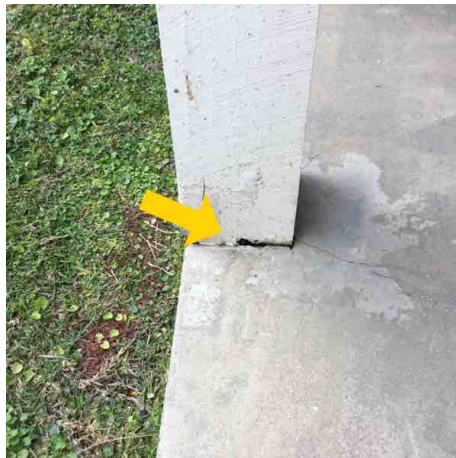
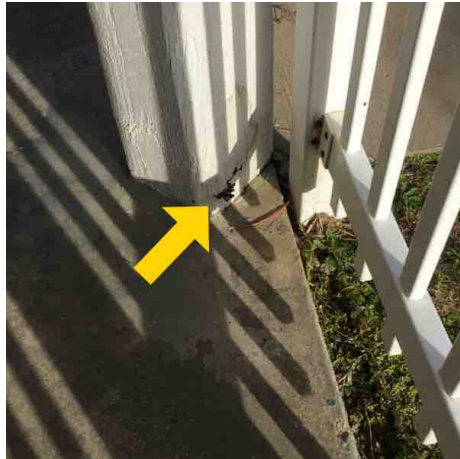
A. Foundations

- Foundation is pier & beam and was performing as designed at time of inspection.
- There were miscellaneous pilings that were showing signs of wood rot. Recommend further evaluation by a qualified contractor and repairs as needed.

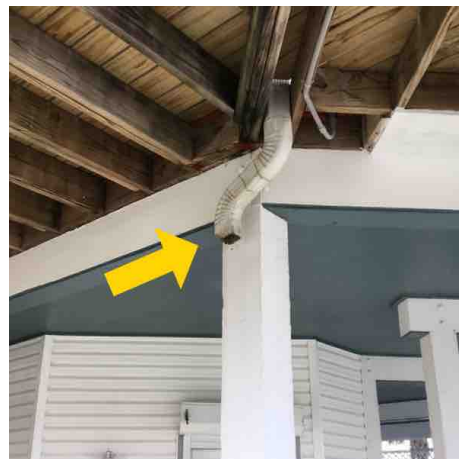
B. Grading and Drainage

- There was damaged rain gutter noted on front side of home. Recommend repairs for proper drainage.

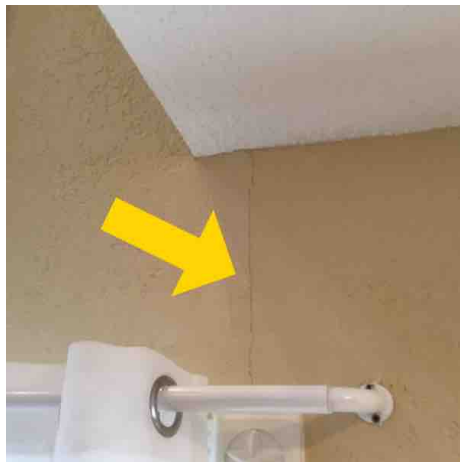
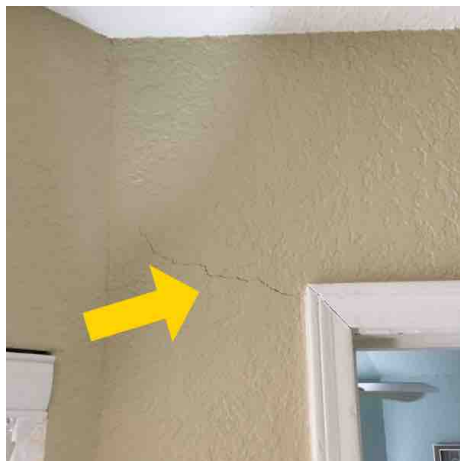
E. Walls (Interior and Exterior)

- Vinyl siding (exterior). Drywall with wood trim (interior).
- There were minor stress cracks noted in living areas and 1st level bedroom.

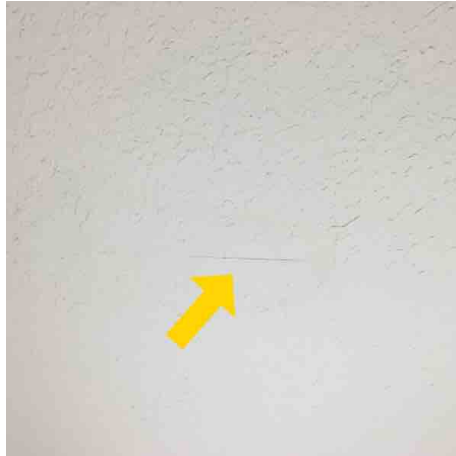
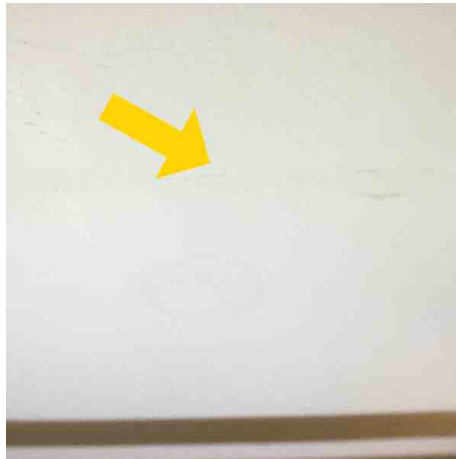
F. Ceilings and Floors

- There was a minor stress crack noted in ceiling of dining area.
- There were previous water stains noted on ceiling of living area and bedroom on the right. There was no moisture detected with moisture meter at time of inspection.

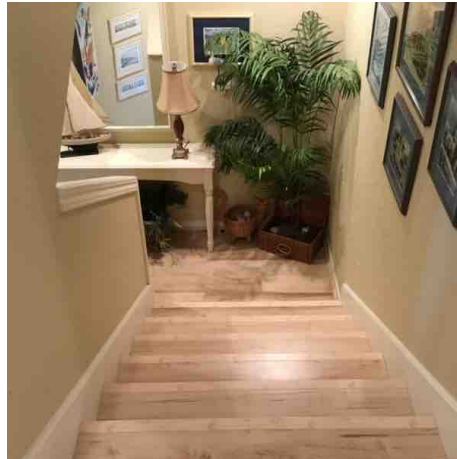
I. Stairways (Interior and Exterior)

- Stairways we're missing graspable type handrails. Recommend installing graspable handrails for safety.

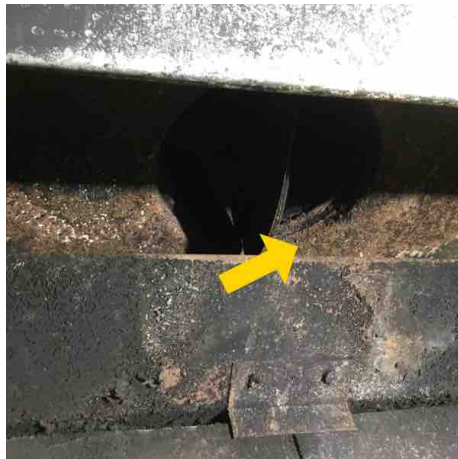
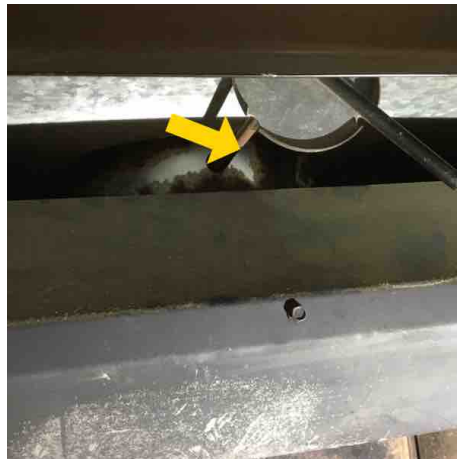
J. Fireplaces and Chimneys

- Damper and metal flue were showing signs of heavy rusting.
- Recommend further evaluation by qualified contractor and repair or replacement as needed for safety and proper operation.

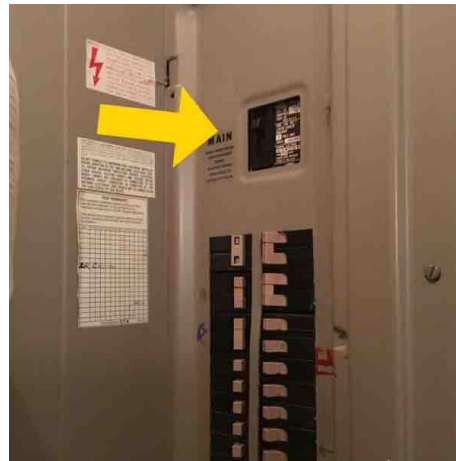
A. Service Entrance and Panels

- 120/240 volt, 200 amp service.
- Grounding is through grounding rod to earth.
- Main disconnect is located in service panel in back bedroom closet.
- Normal operating temperatures observed with a thermographic camera on the day of the inspection
- Provide permanent labeling to promote breaker identification

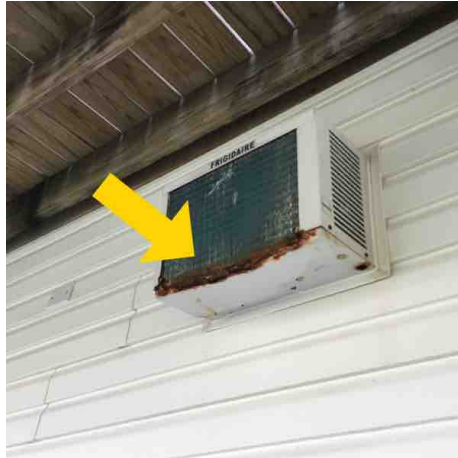
B. Cooling Equipment

- Split system.
- System was operating as designed at time of inspection.
- Safety pan in the attic was noted to be rusting.
- Window unit in garage was showing heavy rusting on exterior.

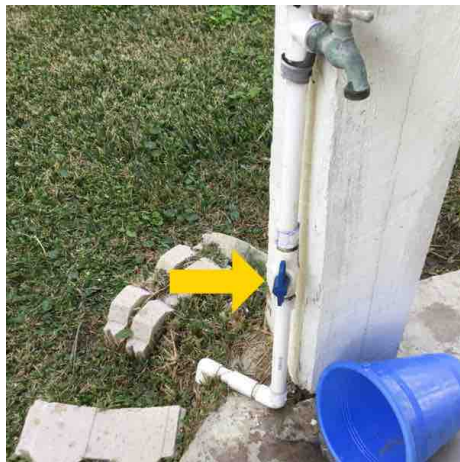
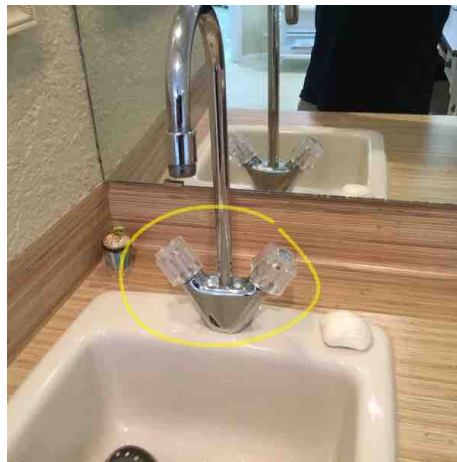
A. Plumbing Supply, Distribution Systems, Fixtures

- Water meter is located in front yard.
- Main water cut off is located on piling under home on left side.
- Static water pressure was 60 psi. at time of inspection. Normal water pressures should be between 40 and 80 psi.
- Faucet at upstairs bar sink was not functioning properly at time of inspection. Recommend further evaluation and repairs or replacement as needed for proper operation.
- Hose bibs are missing the anti-siphon device. Recommend adding these to prevent back flow into the house water supply.
