C&S Roofing and Restoration, LLC

9/25/2023 | 18 Photos

# 12622 Northwood Colony Trl

# Replaced Vents

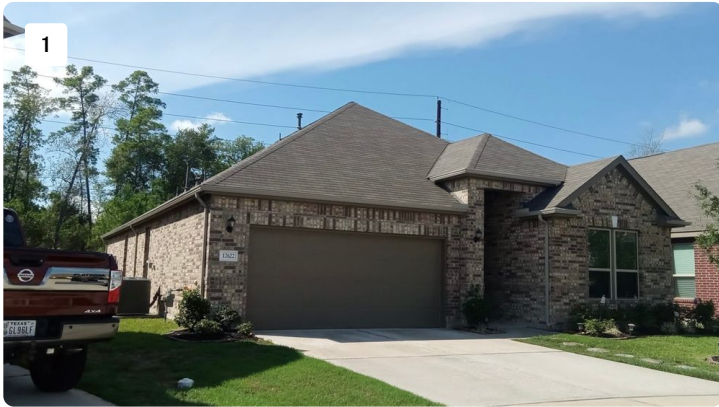
Project: 12622 Northwood Colony Trl  
Date: 9/24/2023, 10:52am  
Creator: Victor Saucedo

Front of home.

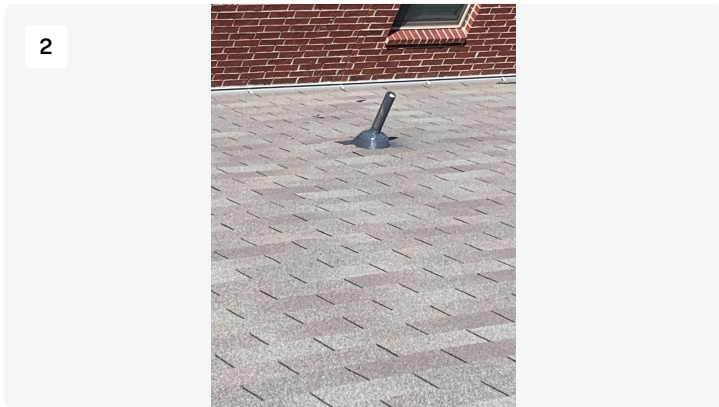
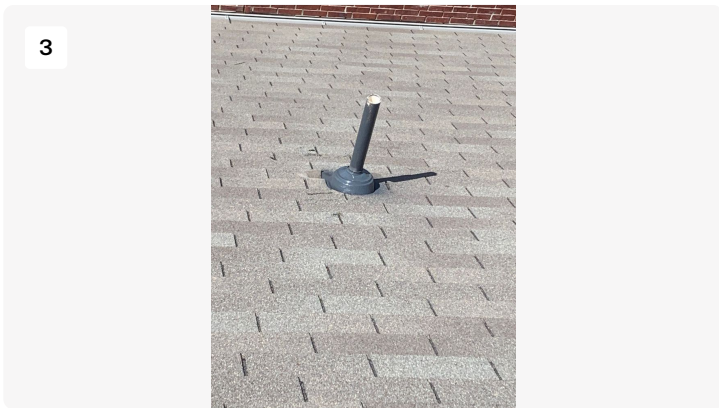
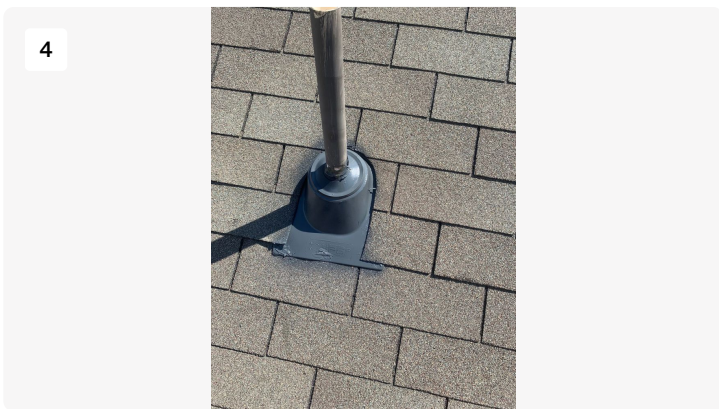
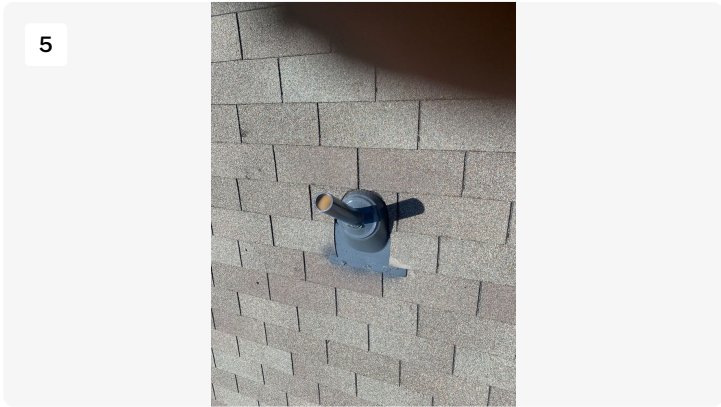
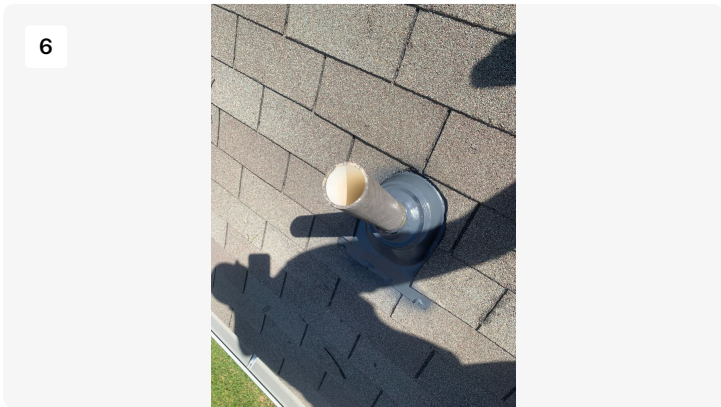
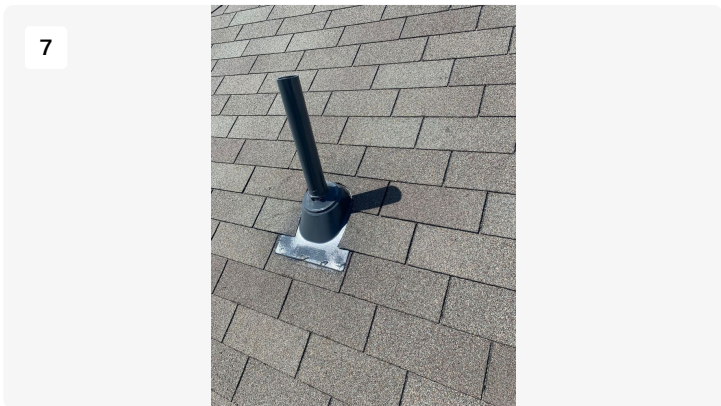
All existing plumbing boots were incorrect size. All bases were 3" with a slip over collar installed (in our best guess) from the builder. Slip over collars are only meant for temporary emergencies while a more permanent repair is made, they cannot be silicone or sealed.

Replaced 8 boot/collar combos total with proper fitted boots, caulked and painted. All photos are geotagged and time stamped for reference.

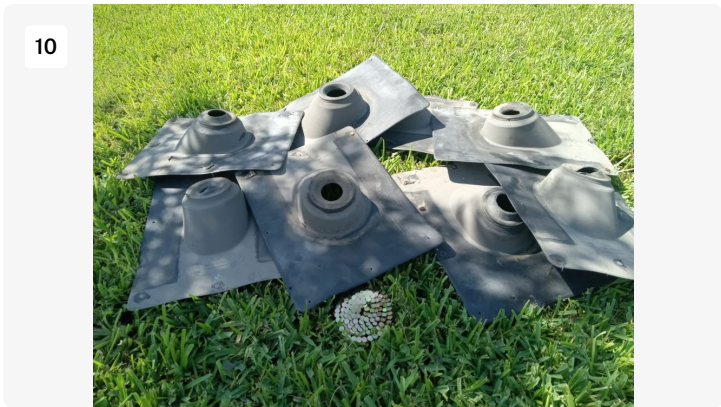
Project: 12622 Northwood Colony Trl  
Date: 9/24/2023, 12:50pm  
Creator: Victor Saucedo

Old boots. Note ring size compared to 5.5" coil.

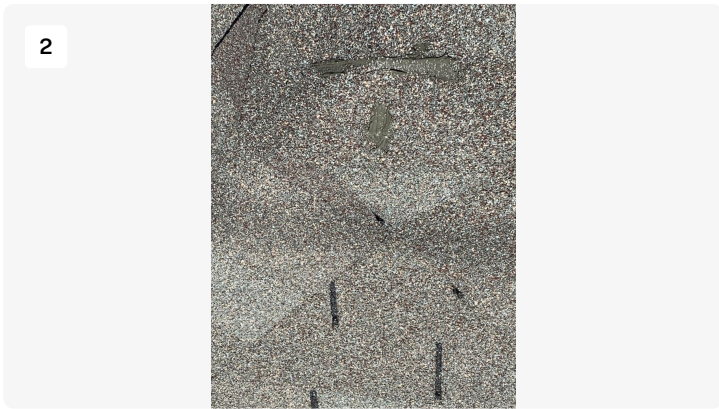
Project: 12622 Northwood Colony Trl  
Date: 9/24/2023, 12:42pm  
Creator: Victor Saucedo

End of ridge

Caulked any exposed nail with roofing sealant. Pictures reflect sealant was applied to round vent, shingle lap on ridge vent, end of ridge, and other misc. locations that required sealant.

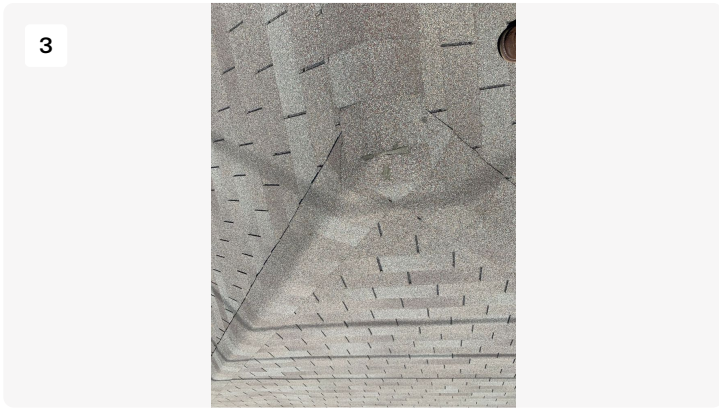
Project: 12622 Northwood Colony Trl  
Date: 9/24/2023, 12:42pm  
Creator: Victor Saucedo

End of ridge

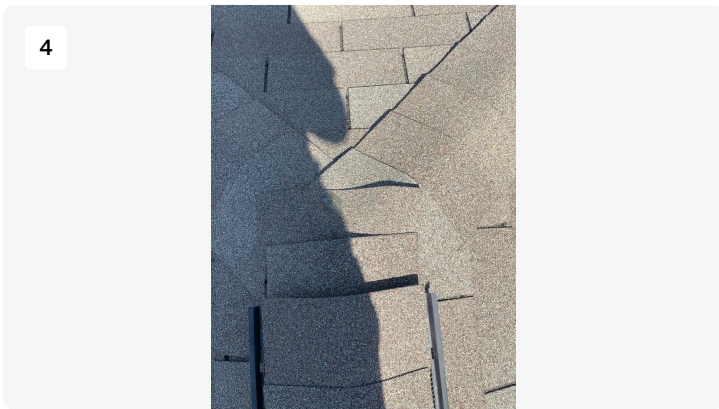
Project: 12622 Northwood Colony Trl  
Date: 9/24/2023, 12:42pm  
Creator: Victor Saucedo

End of ridge exposed nail
