TEXAS OFFICIAL WOOD DESTROYING INSECT REPORT

3403 Ramsgate Dr

1F. 11/14/2023
 Inspection Date

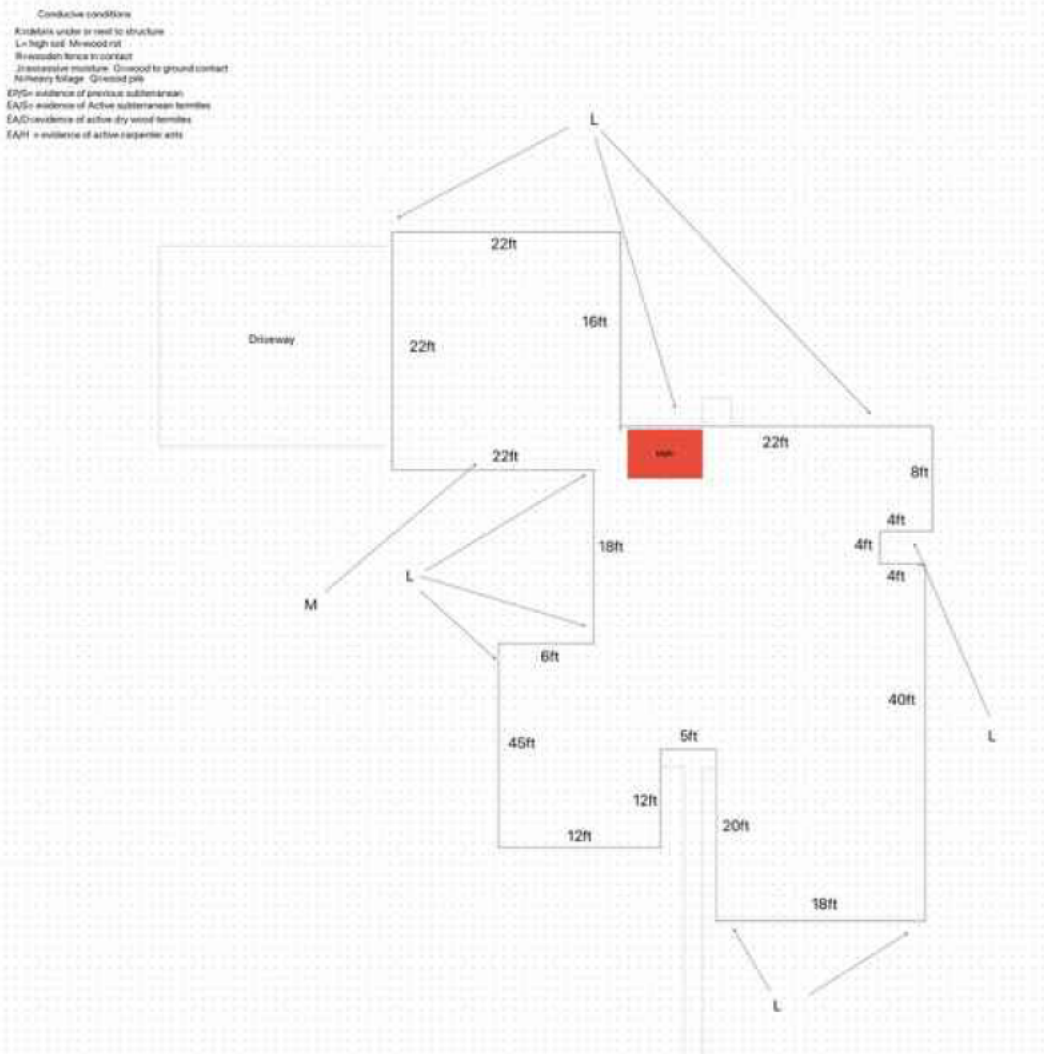
Diagram of Structure(s) Inspected

10B. Conducive Conditions include but are not limited to:
 Debris under or around structure (K) [] Wood to Ground Contact (G) [] Formboards left in place (I) [] Excessive Moisture (J) []
 Footing too low or soil line too high (L) [X] Wood Rot (M) [] Heavy Foliage (N) [X]
 Wooden Fence in Contact with the Structure []
 Planter box abutting structure (O) [] (R) [] Insufficient ventilation (T) []
 Wood Pile in Contact with Structure (Q) [] Other (C) [] Specify: _____

The inspector must draw a diagram including approximate perimeter measurements and indicate active or previous infestation and type of insect by using the following codes: E-Evidence of Infestation; A-Active; P-Previous; D-Drywood Termites; S-Subterranean Termites; F-Formosan Termites; C-Conducive Conditions; B-Wood Boring Beetles; H-Carpenter Ants; Other(s) - Specify

Specify reason: Mechanical correction of High soil low footing. Wood rot. Or preventative treatment and regular follow up visits by a licensed pest control professional. Refer to Scope of Inspection Part J

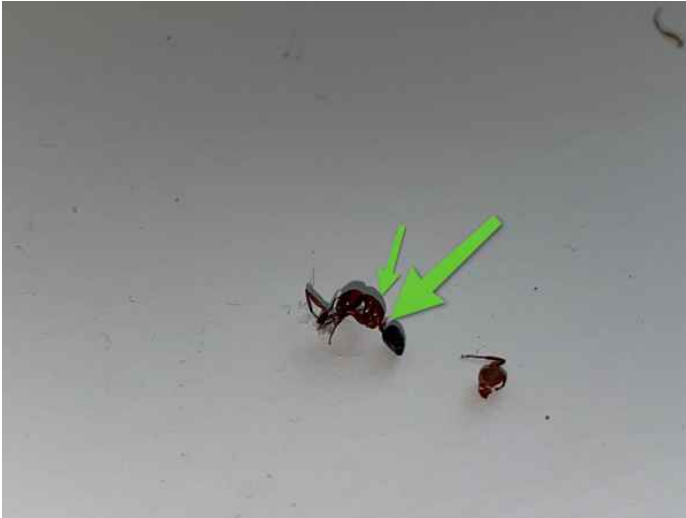
11G. Visible evidence of: Carpenter ants has been observed in the following areas: Bedroom 3, rear wall at base of windowsill and floor. Visually identified carpenter ants.

Carpenter ants identified, rounded thorax and raised node behind thorax
