PROPERTY INSPECTION REPORT

Concerning: 5226 Kiam Street # 1003 Houston, TX 77007 FICS file # 3052907

By: Art Byrd 1171 09/13/2023

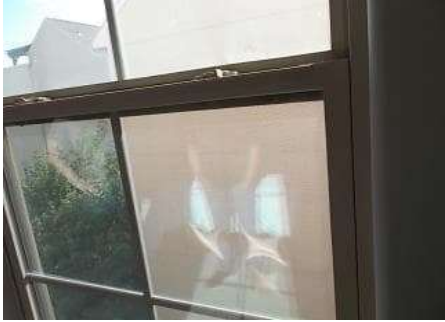
Comments:
<input type="checkbox"/>	<input type="checkbox"/>	<input type="checkbox"/>	<input checked="" type="checkbox"/>	H. Windows
				Comments: The window in the front bedroom does not close/latch properly.
				Any visible failed thermal pane windows? No

Window Not Latching/Closing Properly

(I) H. Windows: The window in the front bedroom does not close/latch properly.

Recommendations: Window contractor to correct the window in the front bedroom which does not close/latch properly.

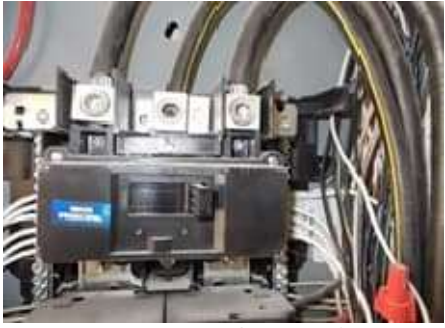
<input type="checkbox"/>	<input type="checkbox"/>	<input type="checkbox"/>	<input checked="" type="checkbox"/>	A. Service Entrance and Panels
				Comments: Anti-oxidant gel is missing at the service cable wire in the panel.
				Amps: 200 Volts: 120/240 Type of Panels: Breakers
				Number of Electrical Panels: 1 Locations of Panels: Garage
				Is the electrical service adequate to meet the needs of the dwelling? Yes

Missing Anti-Oxidant Gel

(II) A. Service Entrance and Panels: Anti-oxidant gel is missing at the service cable wire in the panel.

Recommendations: Licensed electrician to install anti-oxidant gel at the service cable wire in the panel.

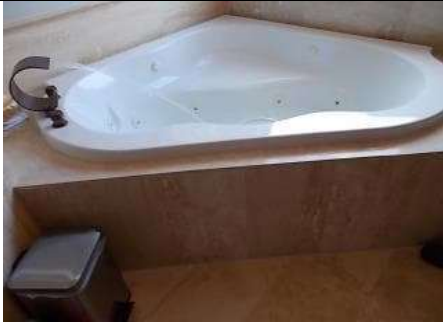
I	NI	NP	D	
				Energy Source(s)/Capacity: (see unit section below) Unit 1: Location: Attic Capacity: 50 gal. Approx Age: 1 yrs. Design Life: 10 yrs. Unit 2: Location: Attic Capacity: gal. Approx Age: yrs. Design Life: yrs. Energy Source(s): Gas
<input checked="" type="checkbox"/>	<input type="checkbox"/>	<input type="checkbox"/>	<input type="checkbox"/>	D. Hydro-Massage Therapy Equipment
				Comments: Please note: An access to the hydro-therapy equipment is not present. Recommend installing. Access panel is absent or inaccessible for area under tub. Yes, see above.

Hydro Therapy Tub				
<input checked="" type="checkbox"/>	<input type="checkbox"/>	<input type="checkbox"/>	<input type="checkbox"/>	E. Gas Distribution Systems and Gas Appliances
				Comments: Location of Gas Meter: Unknown Type of Gas Distribution Piping Material: Black Steel
<input type="checkbox"/>	<input type="checkbox"/>	<input checked="" type="checkbox"/>	<input type="checkbox"/>	F. Other

(I) K. Porches, Balconies&, Decks, and Carports: Limited evaluation of the garage due to storage/vehicle (40% visible).
IV. PLUMBING SYSTEMS
(IV) D. Hydro Massage Therapy Equipment: Please note: An access to the hydro-therapy equipment is not present. Recommend installing.

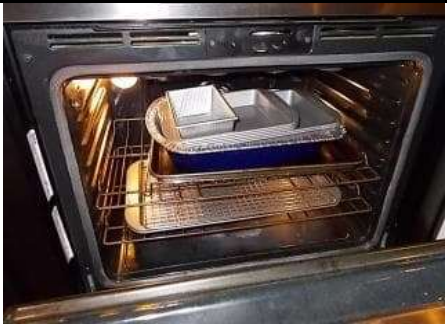
I	NI	NP	D	
<input type="checkbox"/>	<input checked="" type="checkbox"/>	<input type="checkbox"/>	<input type="checkbox"/>	D. Ranges, Cooktops, and Ovens
				Comments: The oven was not tested due to storage. Recommend confirming proper operation.
				Oven: Electric Elements Range: Gas Burner
				Was oven temperature within 25 degrees of 350 degree setting? Yes

<p>Storage in Oven</p>				
<input checked="" type="checkbox"/>	<input type="checkbox"/>	<input type="checkbox"/>	<input type="checkbox"/>	E. Microwave Ovens
				Comments:
<input checked="" type="checkbox"/>	<input type="checkbox"/>	<input type="checkbox"/>	<input type="checkbox"/>	F. Mechanical Exhaust Vents and Bathroom Heaters
				Comments:
				Location of exhaust fan termination: Exterior
				If no exhaust, is there an operable window? N/A
<input checked="" type="checkbox"/>	<input type="checkbox"/>	<input type="checkbox"/>	<input type="checkbox"/>	G. Garage Door Operators

V. APPLIANCES
(V) D. Ranges, Cooktops, and Ovens: The oven was not tested due to storage. Recommend confirming proper operation.

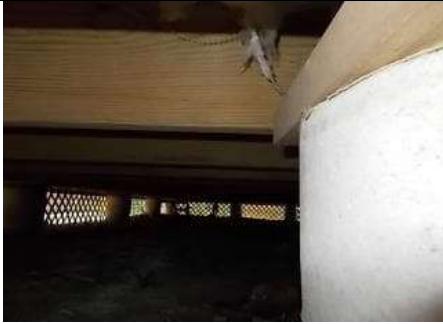
I. STRUCTURAL SYSTEMS
(I) A. Foundations: Limited evaluation of the structure due to finishings (50% visible). Viewed from Opening - Limited evaluation of the crawl space due to height (49% visible).

Crawl Space

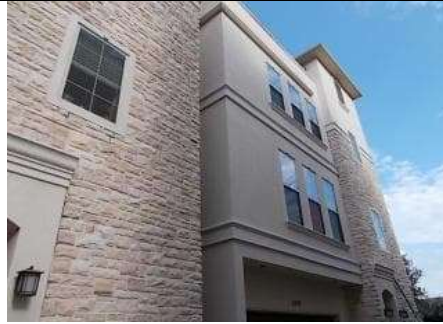
(I) C. Roof Covering Materials: From Ground/Deck- Limited evaluation of the roof due to design/height (10% visible).
(I) D. Roof Structures & Attics: Entered - Limited evaluation of the attic due to ductwork/limited walkboards (75% visible).

Roof Viewed From Ground

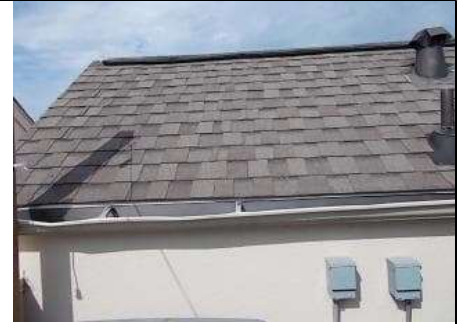
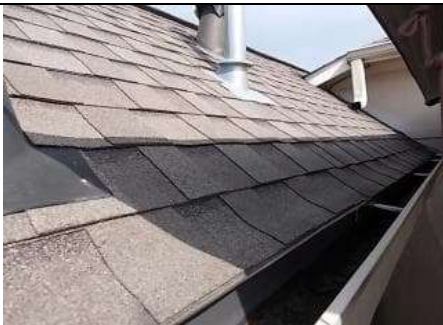
Roof Viewed From Deck

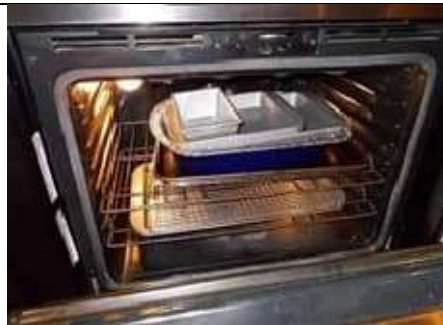
Storage in Oven

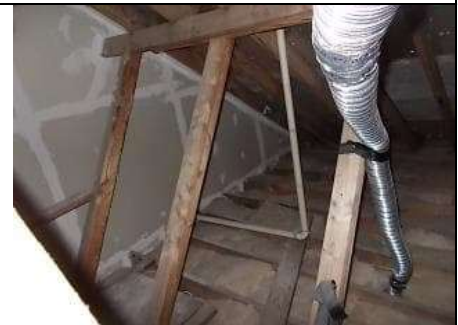
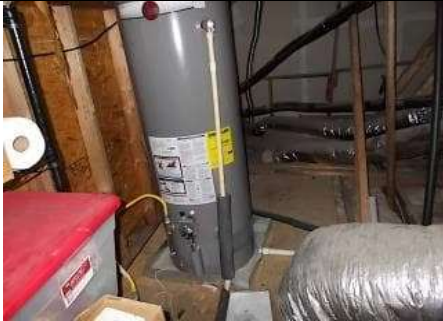
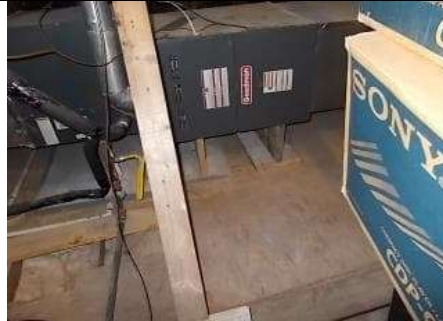
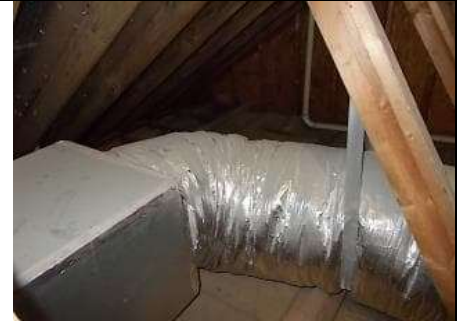
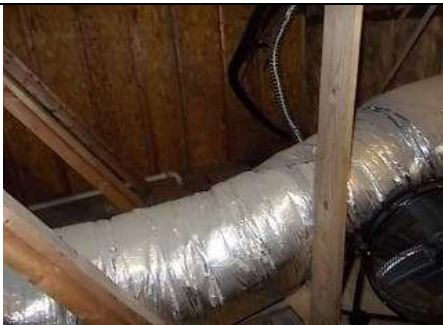
Attic
