BOOKER HTX - REAL ESTATE INSPECTIONS

2507 Berkley Ct
Richmond, TX 77406

PROPERTY INSPECTION REPORT FORM

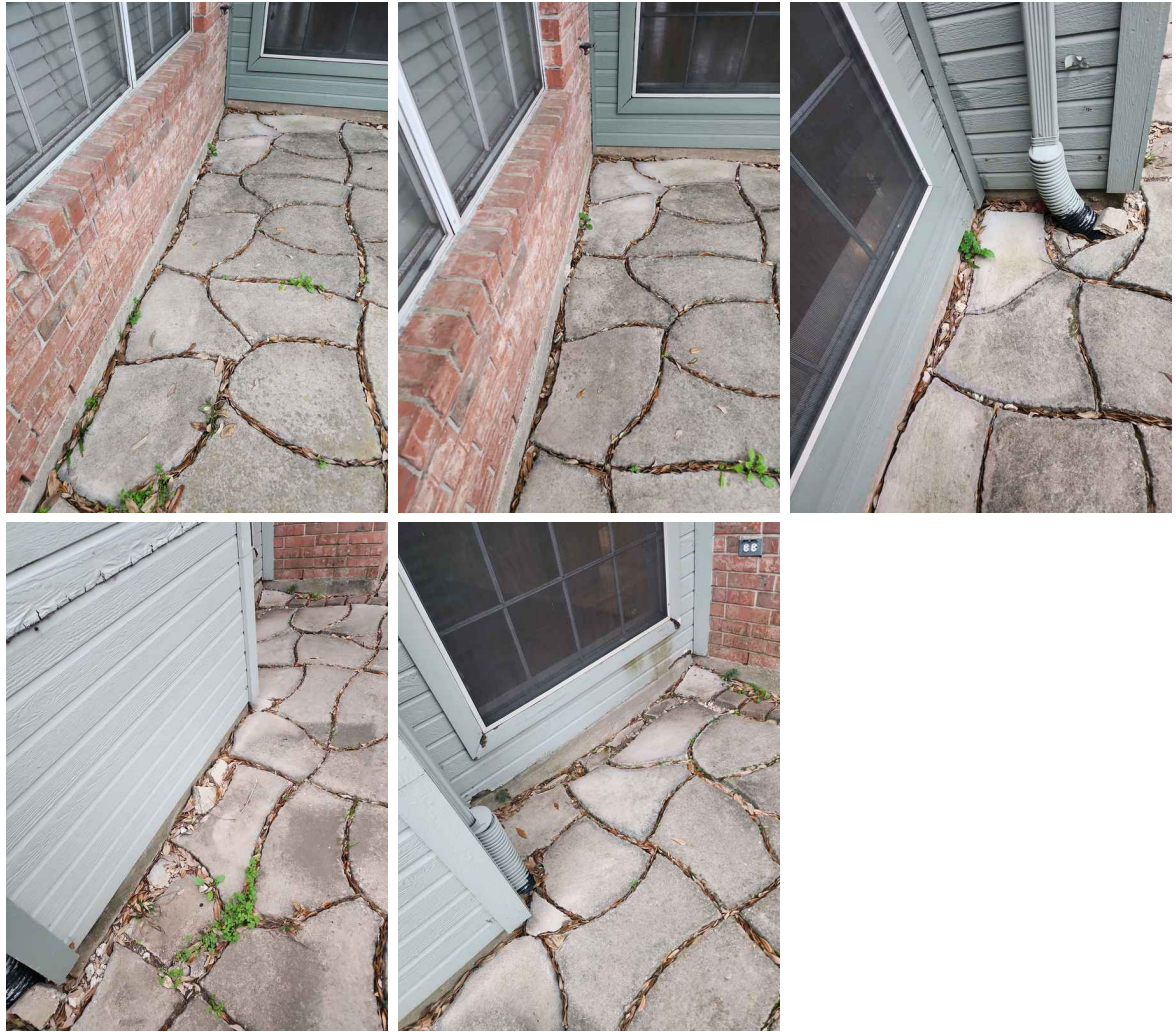
1: Negative Grading

Grading is sloping towards the home in some areas. This could lead to water intrusion and foundation issues. Recommend qualified landscaper or foundation contractor regrade so water flows away from home.

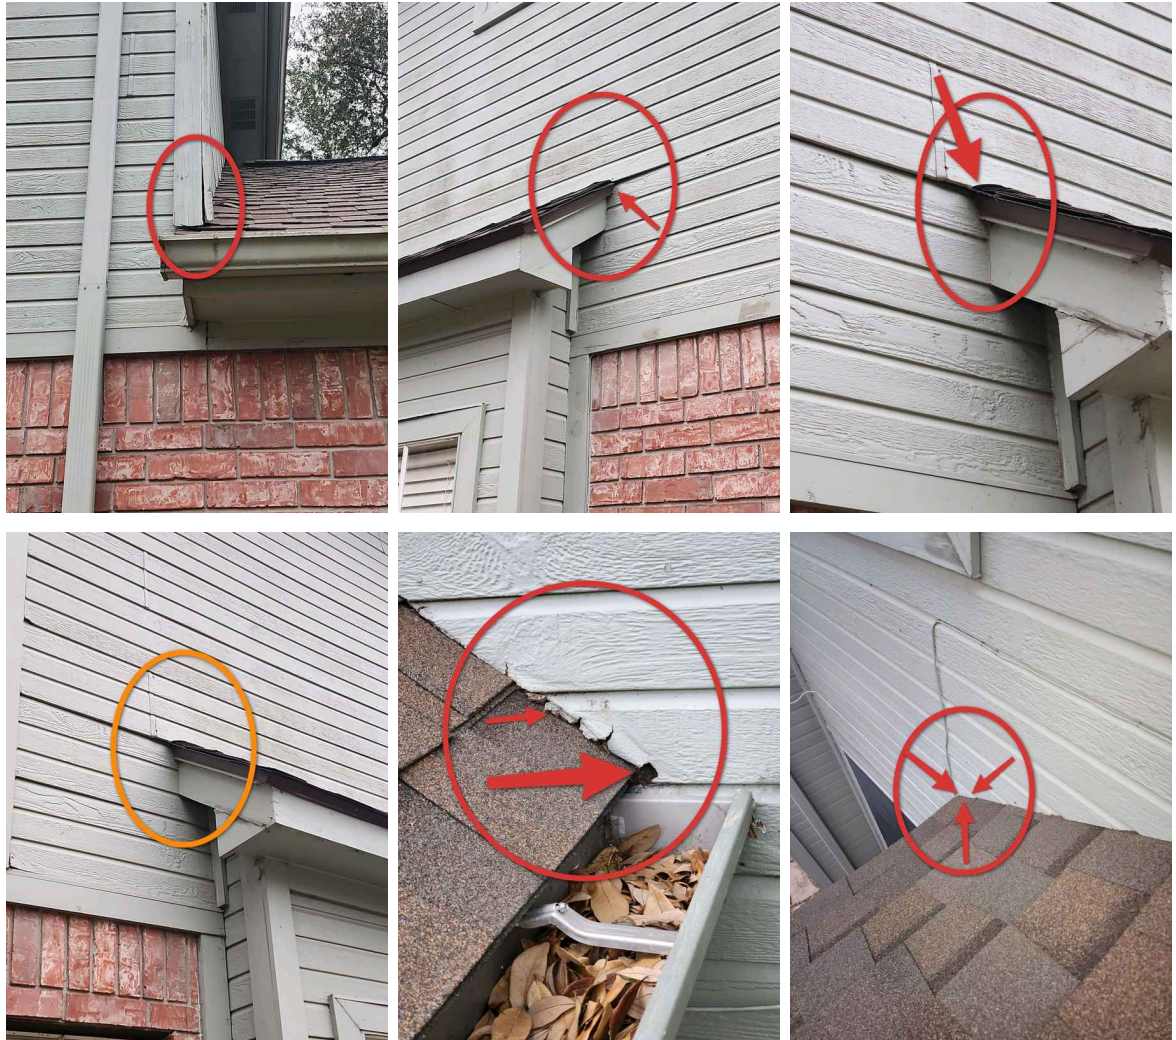
1: Missing kickout flashing

Roof

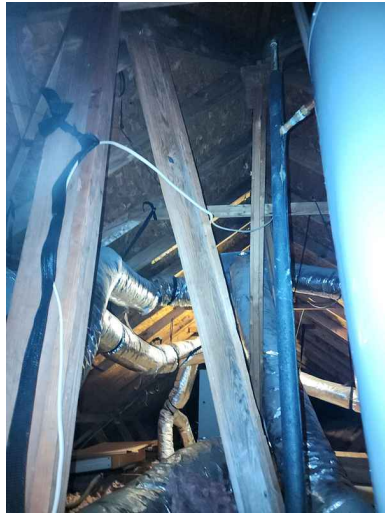
In good shape

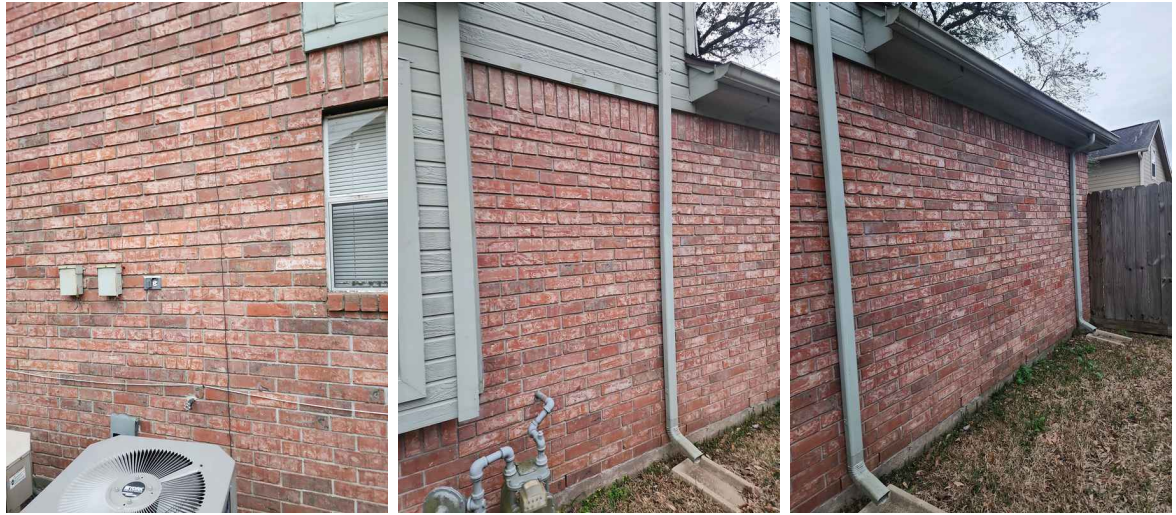
1: Cracks - Major

Major cracking observed in wall structure. This could be from moisture intrusion at the structure and/or soil movement. Recommend a qualified structural engineer evaluate and advise on course of action.

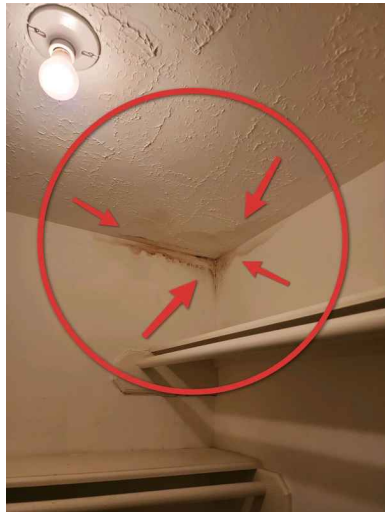
2nd Floor Bedroom closet

2: Ceiling - Recent Roof Leak Damage

Stains on the ceiling appear to be the result of roof leaks. The source of leakage should be identified and corrected, and the ceiling re-painted.

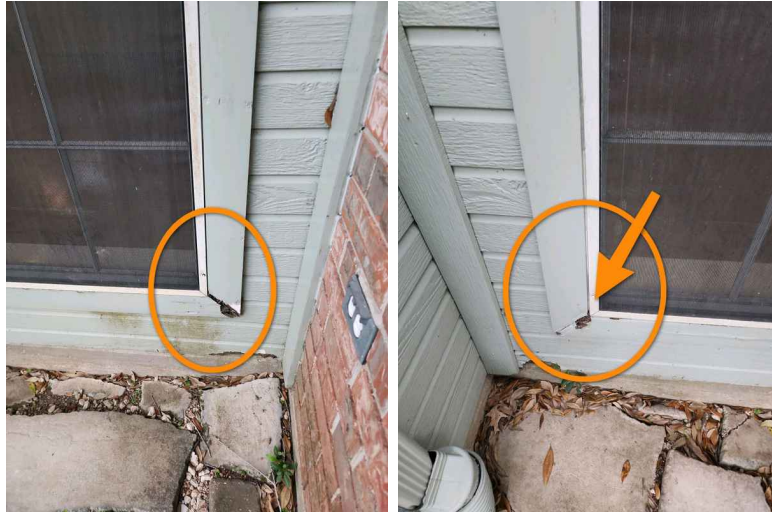
Back porch

1: Damaged

One or more windows appears to have general damage, but are operational. Recommend a window professional clean, lubricate & adjust as necessary.
