# Inspection Report

**Property Address:**  
4011 Ivywood Dr  
Pearland TX 77584

**HG HOME INSPECTION**

**By:** BYRON LEE TREC #23870 / HG HOME INSPECTION 7/13/2021  
(Name and License Number of Inspector) (Date)

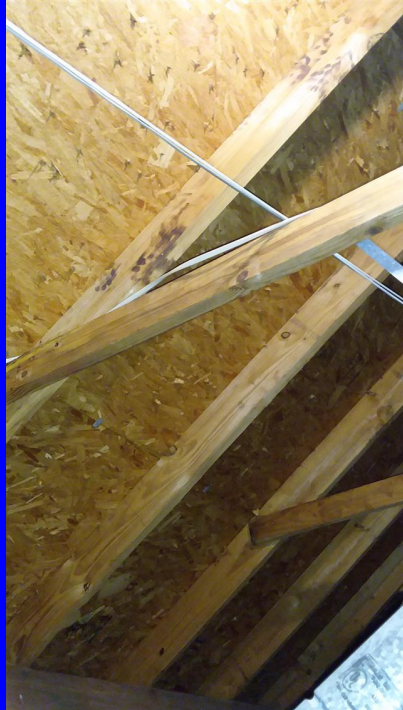
stick built roof structure

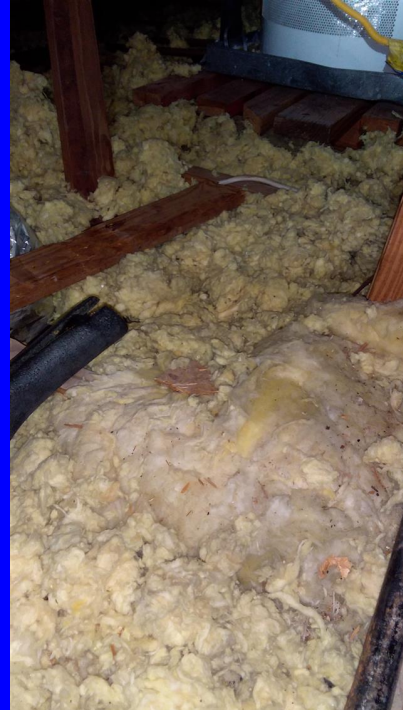
blown insulation 8 inches

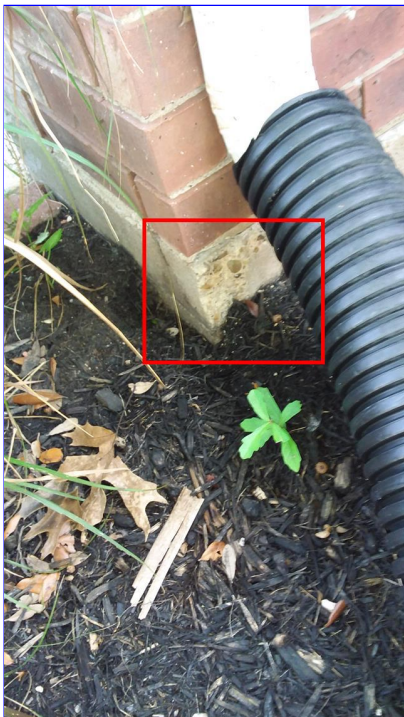
A. Item 1(Picture) garage right

(3) The foundation has large corner pop(s) that are larger than 4 inches. Further deterioration will occur if not corrected. I recommend having a qualified person make repairs as needed.

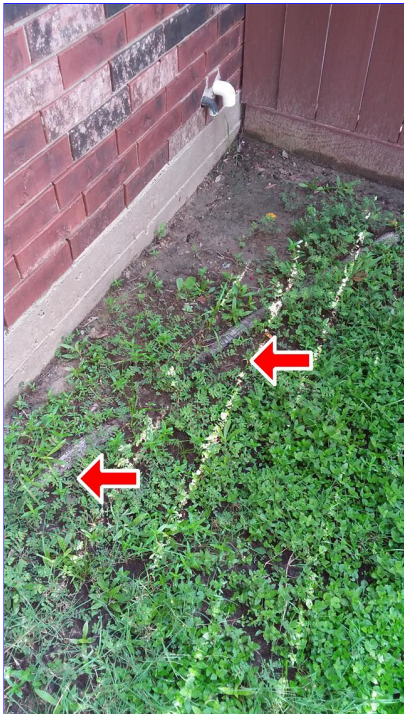
A. Item 2(Picture) right

(4) There are trees roots too close to the foundation. I recommend removal or the use of root diverters.

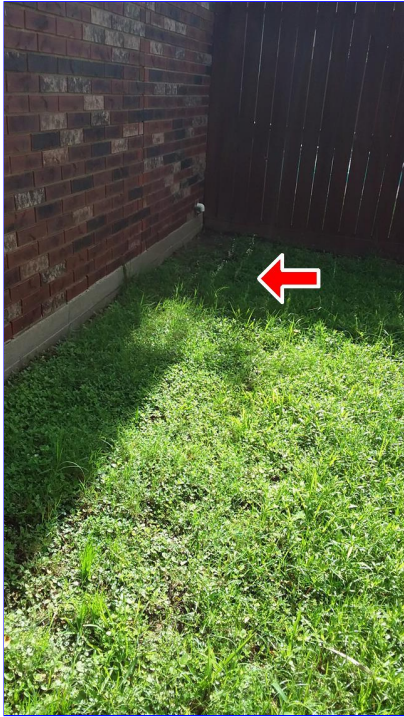
B. Item 1(Picture) right

(1) There is a negative slope at the exterior areas and can cause or contribute to water intrusion or deterioration. I recommend correcting landscape to drain water away from home.

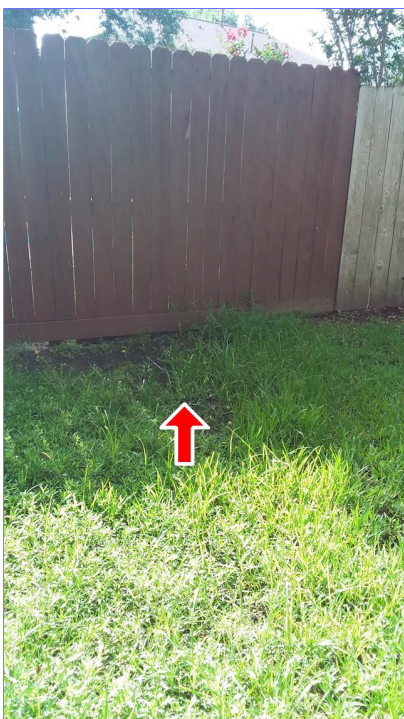
B. Item 6(Picture) right

(2) The landscape at the exterior may require a trench or drain if water stands or puddles after heavy rain. I am unable to determine due to no rain during inspection period.

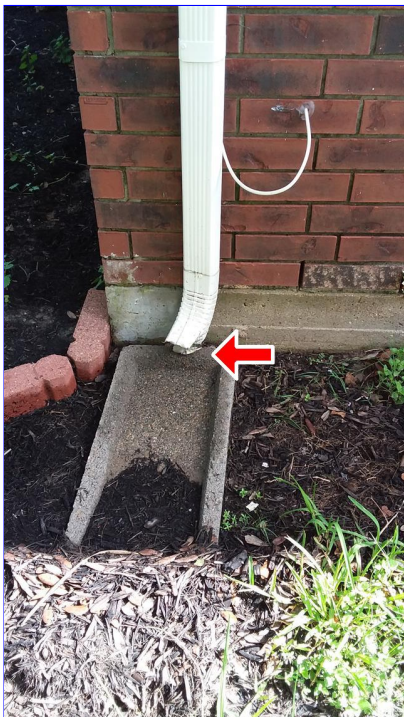
B. Item 8(Picture) right

(3) The gutter is damaged at the exterior. Gutters that drain poorly or clogged can lead to many costly

problems such as deterioration of fascia, soffit or roof edge. It can also cause gutters to pull loose and lead to possible water intrusion. A qualified person should repair or replace as needed.

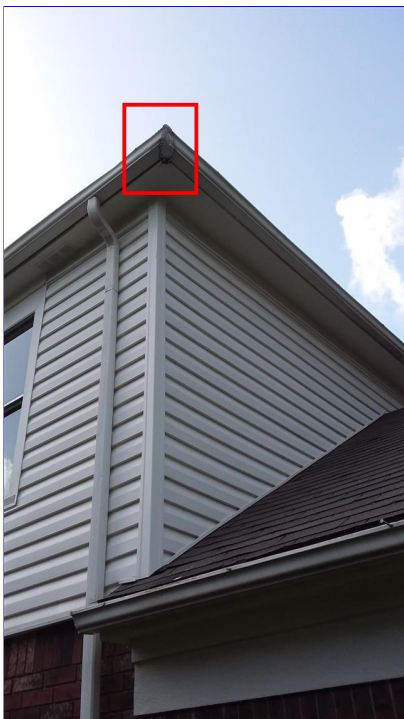
B. Item 10(Picture) multiple areas

(4) Gutters are not properly secured to the home. Further deterioration or erosion can occur if not corrected. I recommend having a qualified person make repairs as needed.

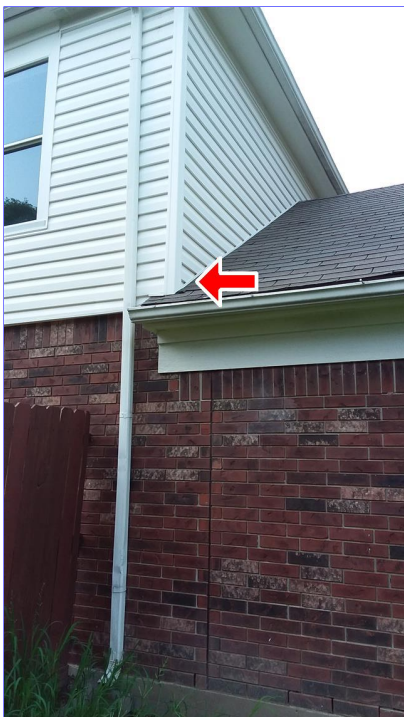
C. Item 2(Picture) left

(4) Kick out flashing is missing in areas of the roof. This is not considered today's standard. I recommend having a qualified roofing company make repairs as needed.

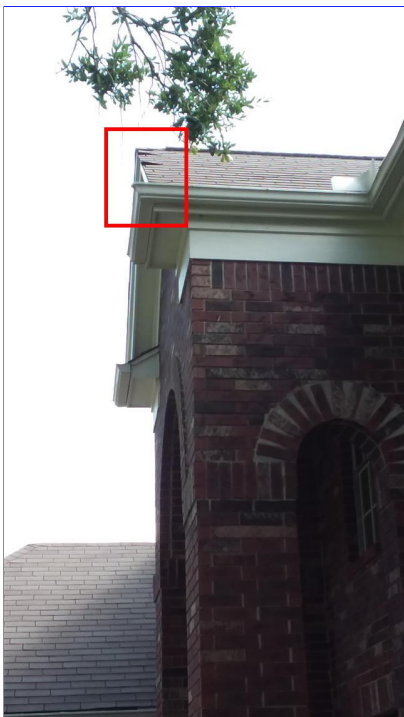
C. Item 4(Picture) front

(6) Shingles appear to be lifted in areas of the roof. Damage could occur if not corrected. I recommend having a qualified roofing contractor further evaluate and make repairs as needed.

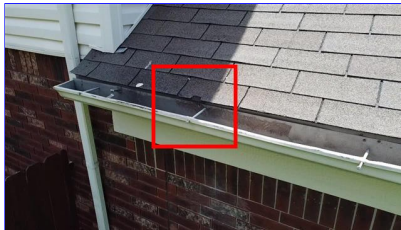
C. Item 10(Picture) left

(7) The roof covering is damaged in areas. These areas may need replacement and or periodic maintenance. A qualified roofing contractor should inspect and repair as needed.

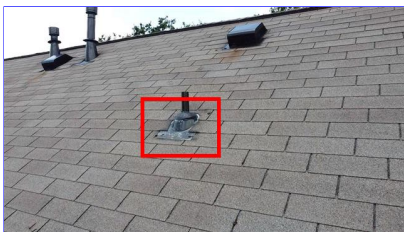
C. Item 11(Picture) rear

(8) The plumbing vent flashings appears to be defective. I recommend having a qualified roof professional make repairs as needed,

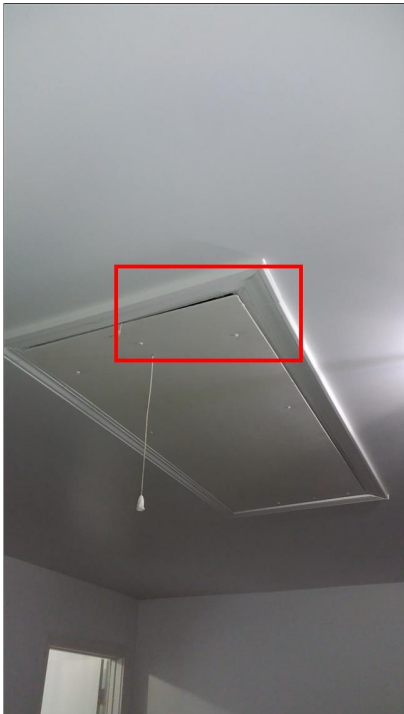
D. Item 1(Picture) garage

- (1) Attic space inspected with limited access. This is for your information.
- (2) There were no insulation markers present at the time of the inspection. This is for your information.
- (3) The pull down stairs does not shut properly. This can cause some heat loss in winter and loss of cool air in summer if not corrected. A qualified contractor should inspect and repair as needed.

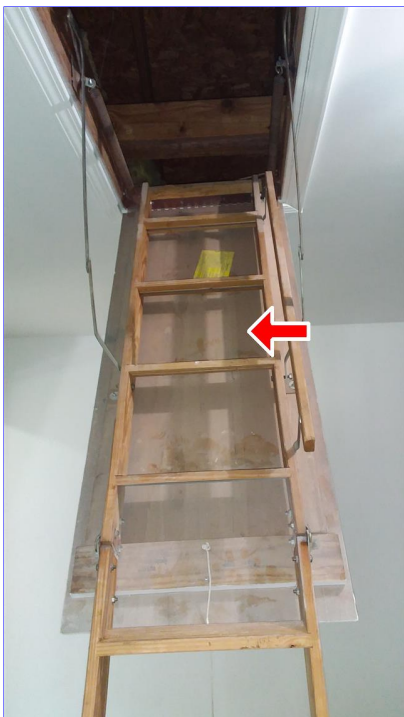
D. Item 2(Picture) garage

(4) The pull down stairs are not properly insulated. This can cause some heat loss in winter and loss of cool air in summer if not corrected. I recommend repair as desired.

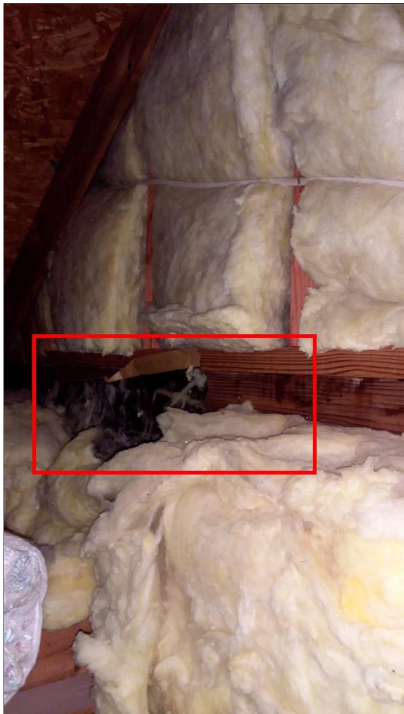
D. Item 5(Picture) garage attic

(6) The attic space has areas of missing insulation. This is causing energy loss and is not today's standard. I recommend having a qualified person evaluate and add insulation as needed.

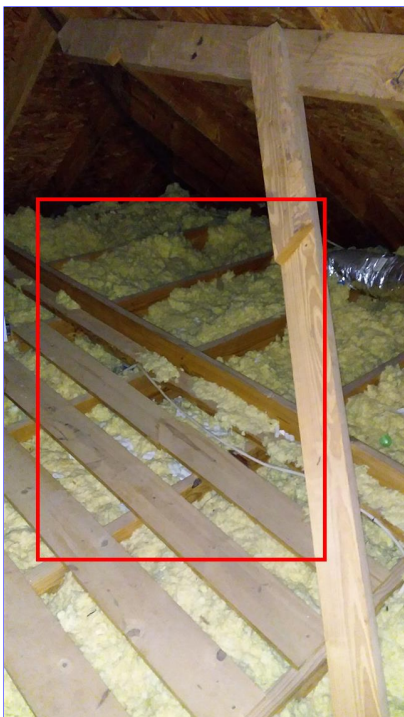
D. Item 6(Picture) upper attic

(7) The attic space has areas of thin insulation. This is causing energy loss and is not today's standard. I recommend having a qualified person evaluate and add insulation as needed.

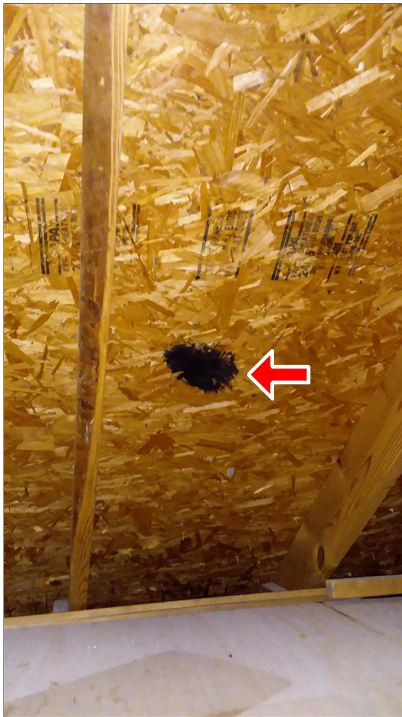
D. Item 8(Picture) garage attic

(8) There decking has been patched in the attic space. I recommend having a qualified person evaluate and repair as needed.

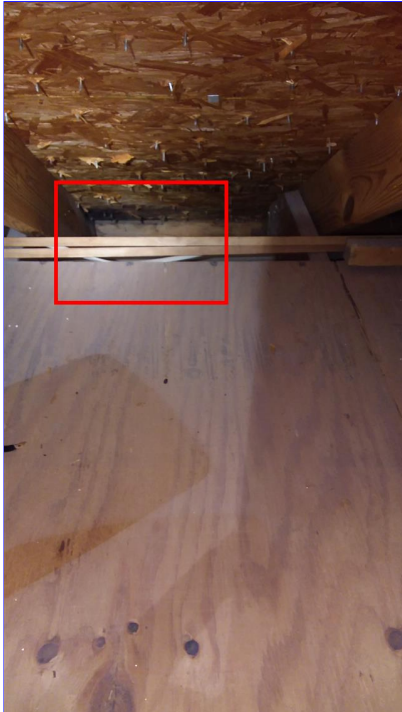
D. Item 9(Picture) garage attic right

(9) The roof structure in the attic has water stain indicating a leak did or still exists in areas. A qualified contractor should inspect and repair as needed.

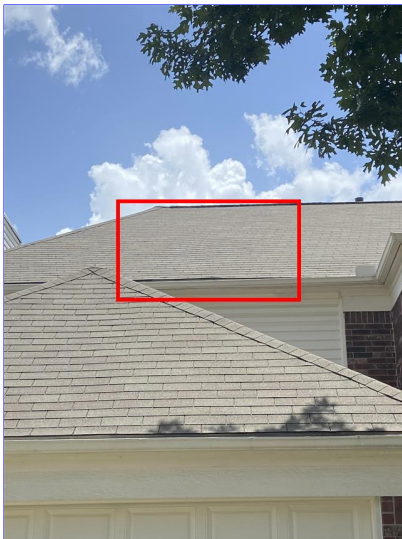
D. Item 11(Picture) front

(10) There are some dips or sags in the roof in areas. This is typical of older construction where possibly the rafters were undersized and created a sag. A qualified contractor should repair as needed.

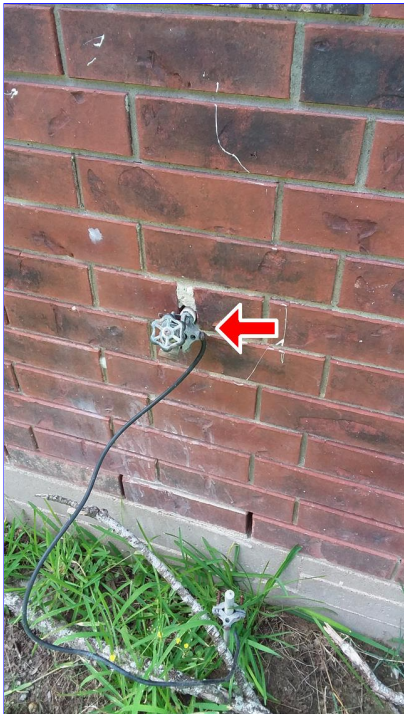
E. Item 1(Picture) left

(1) Areas where wiring or piping passes through walls should be sealed. I recommend having a qualified person seal as needed.

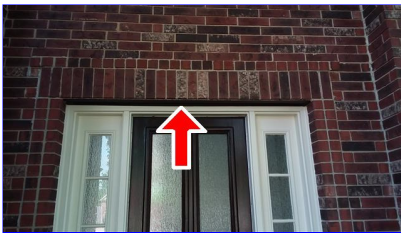
E. Item 6(Picture) entry

(3) Lintels above exterior doors are showing signs of deterioration. Further deterioration may occur if lintels are not primed and painted. A qualified person should repair as needed.

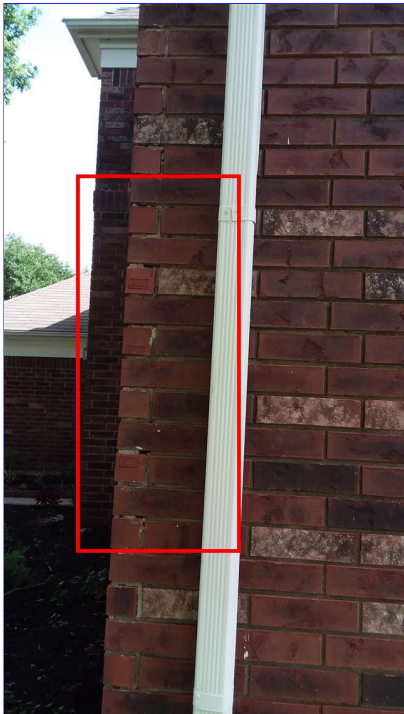
E. Item 7(Picture) right

(4) The brick siding at the exterior has hairline cracks. Deterioration can eventually occur if not corrected. A qualified contractor should inspect and repair as needed.

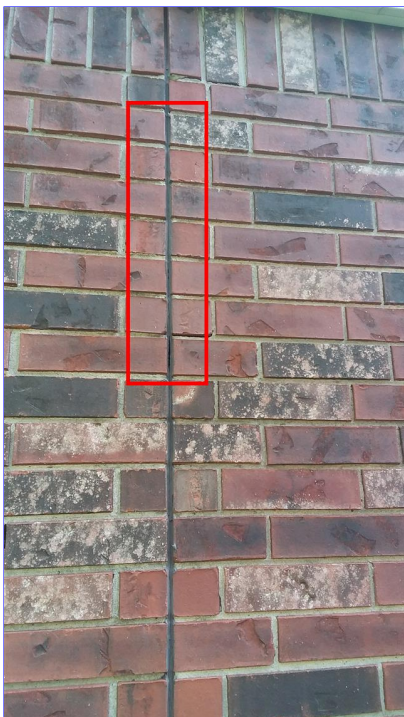
E. Item 9(Picture) right

(5) The brick siding at the exterior of the home has expansion joint sealant that is weathered or missing. Further deterioration can occur if not corrected. A qualified person should repair or replace as needed.

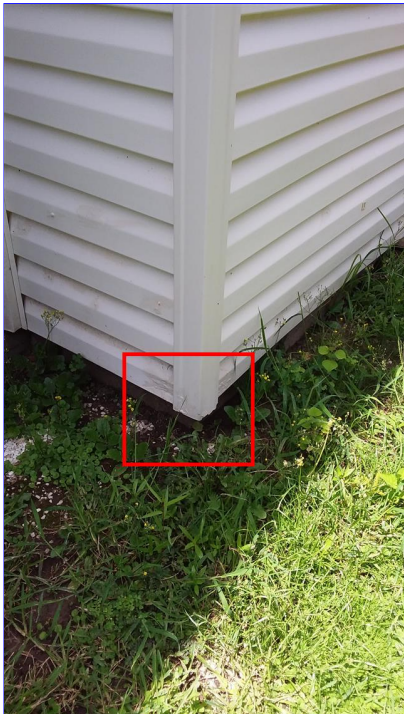
E. Item 11(Picture) left

(7) The vinyl siding exterior is damaged. Further deterioration can occur if not corrected. A qualified person should repair or replace as needed.

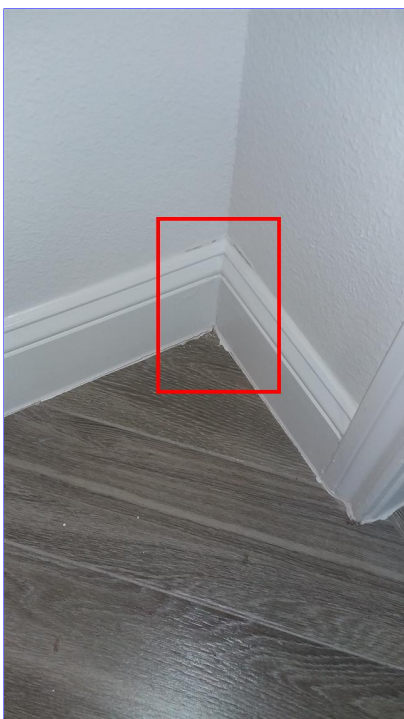
E. Item 13(Picture) entry

(8) Baseboards have some separation and deterioration of caulking. I recommend having a qualified person make repairs of needed.

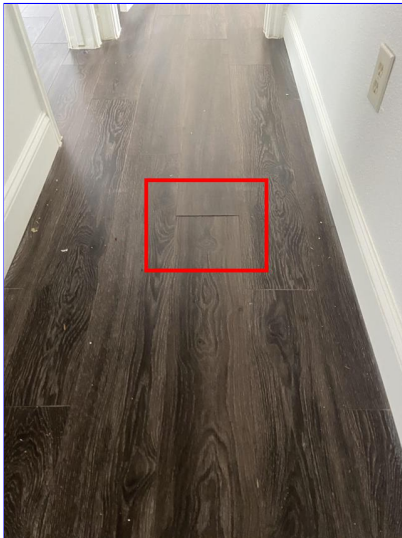
F. Item 1(Picture) hallway upstairs

(1) The Vinyl was not installed according to standard workmanlike practices at the in areas. This damage is considered cosmetic. A qualified person should repair or replace as needed.

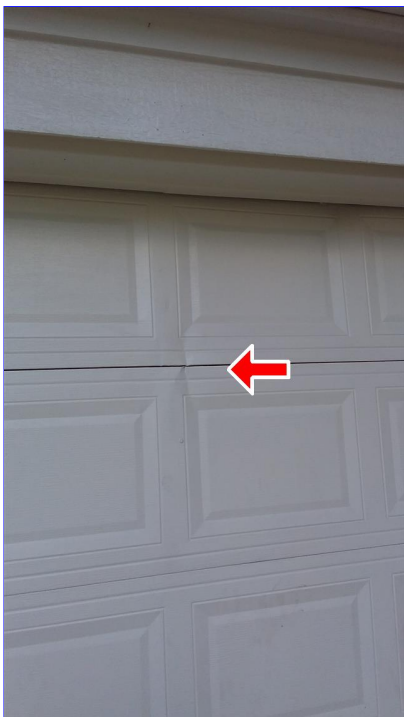
G. Item 1(Picture) middle

(1) The garage door at the front of home is damaged at panel. This is a maintenance issue and is for your information. A qualified person should repair or replace as needed.

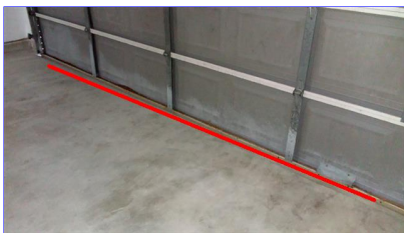
G. Item 2(Picture) lower panel

(2) The garage door at the front of home is deteriorated at panel. This is a maintenance issue and is for your information. A qualified person should repair or replace as needed.

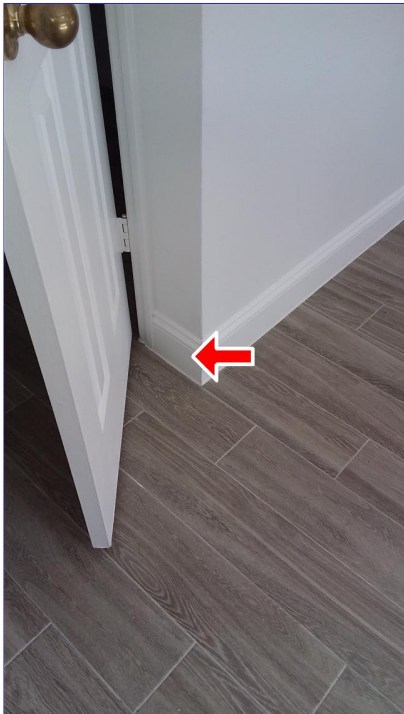
G. Item 3(Picture) entry closet

(3) There are door stops missing in the home. This is not considered to be today's standard I recommend having a qualified person make repairs as needed.

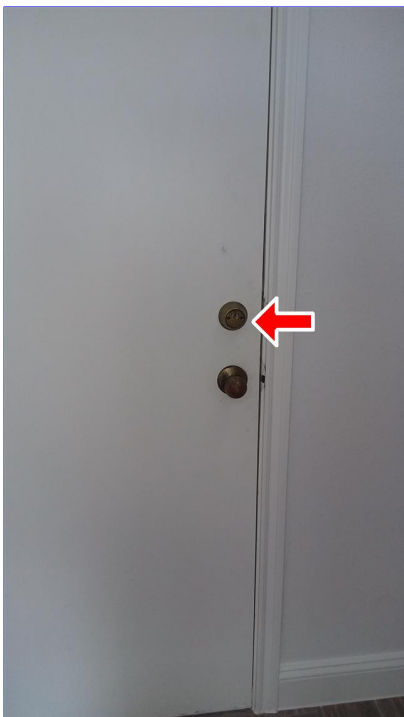
G. Item 5(Picture) garage

(4) The exterior door has keyed dead bolt lock. This prevents proper egress and is a safety hazard until repaired. I recommend having a qualified person make repairs as needed.

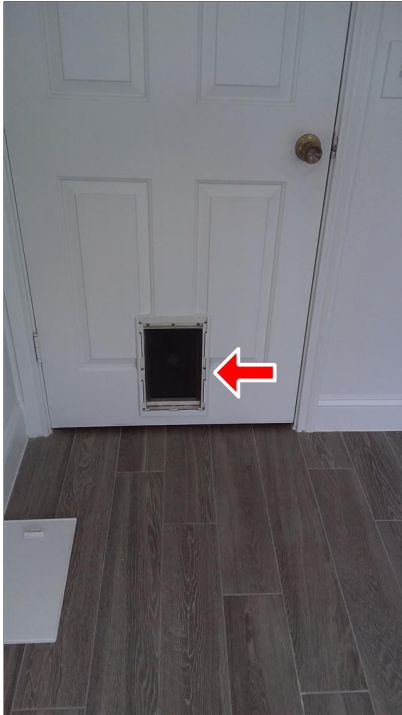
G. Item 6(Picture) garage entry

(5) The main entry door has a pet access door installed. This is a maintenance issue and is for your information. A qualified person should repair or replace as needed.

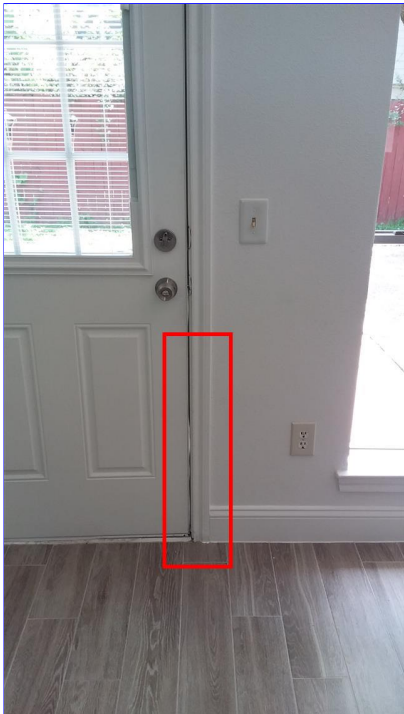
G. Item 7(Picture) patio

(6) The main entry door reveals daylight when latched at areas missing weather-stripping. This can cause some heat loss in winter and loss of cool air in summer if not corrected. A qualified person should repair or replace as needed.

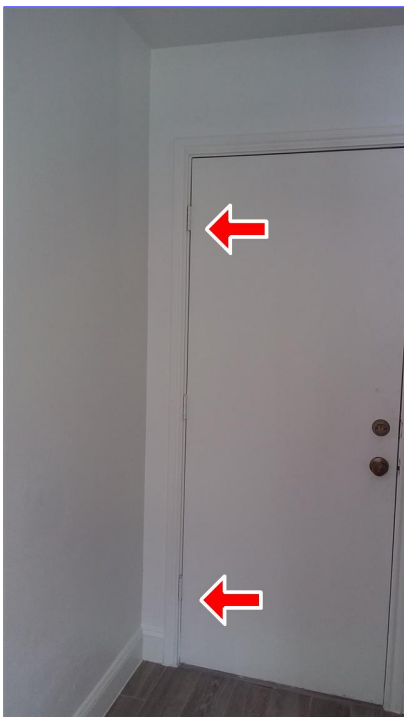
G. Item 8(Picture)

(7) The interior garage door does not have the required self closing hinge. This is not considered to be today's standard. I recommend having a qualified person make repairs as needed.

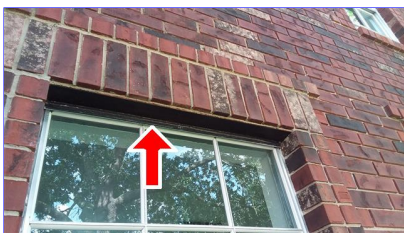
H. Item 1(Picture) front

(1) Lintels above windows are showing signs of deterioration in areas. Further deterioration may occur if lintels are not primed and painted. A qualified person should repair as needed.

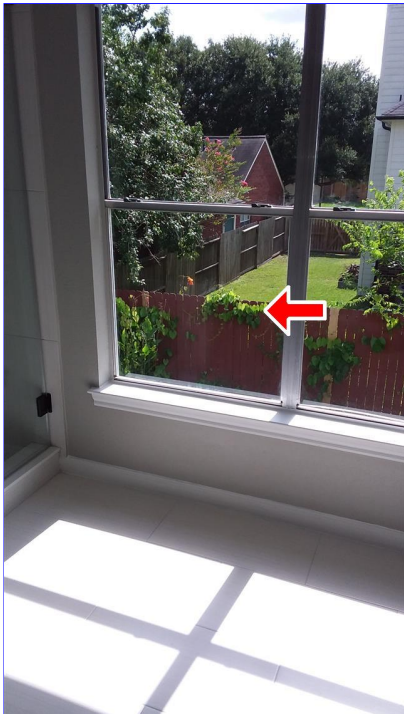
H. Item 2(Picture) primary bath

(2) There are windows in required tempered glass areas that are missing the required markings. This is not considered to be today's standard and is a safety hazard until glass is confirmed to be and marked tempered. I recommend having glass professional evaluate and mark or replace as needed.

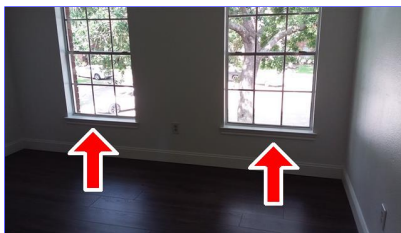
H. Item 5(Picture) all bedrooms

(3) Window does not have proper clearance from flooring in upstairs bedroom. A fall or injury could occur. This is for your information.

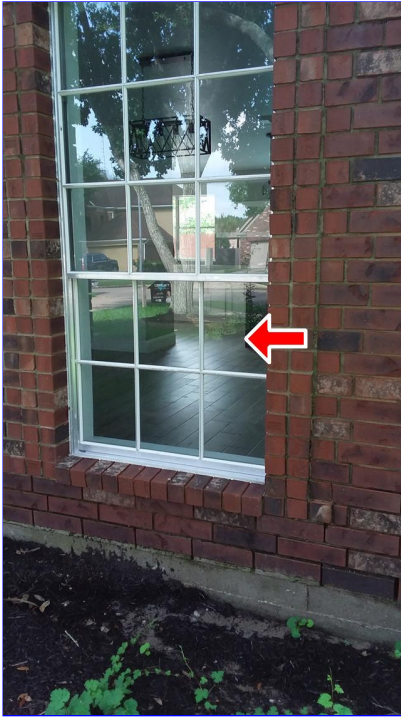
H. Item 6(Picture) front

(4) Windows have damaged or missing screens. This is not considered to be today's standards. I recommend having a qualified person make repairs as needed.

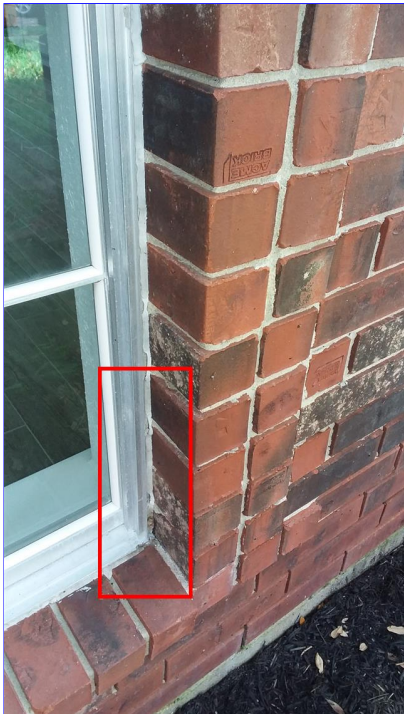
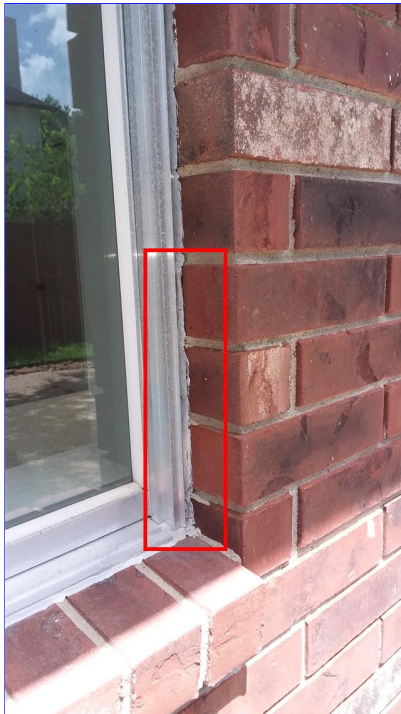
(5) There are window frames that are not properly sealed. This can cause energy loss. I recommend having a qualified person seal and repair as needed.

H. Item 8(Picture) front

H. Item 9(Picture) multiple windows

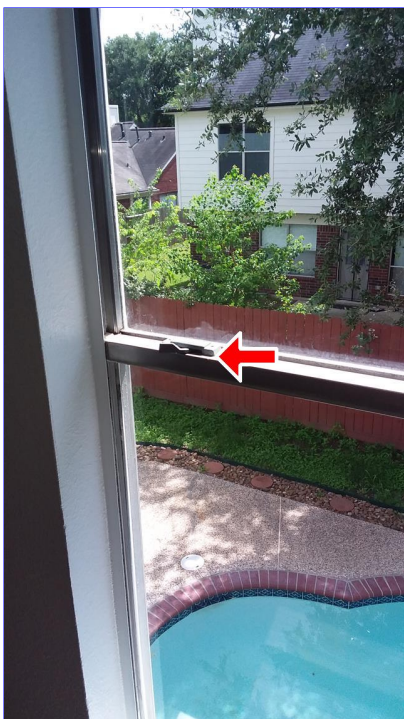
H. Item 10(Picture) rear right bedroom

(6) Some windows do not lock properly in areas. This is a maintenance issue and is for your information. A qualified person should repair or replace as needed.

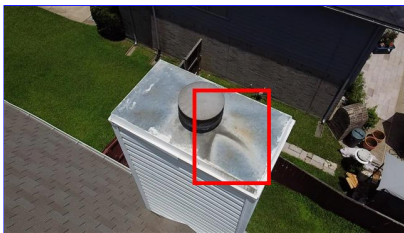
J. Item 1(Picture)

- (1) I do not inspect the shape of fireplace or the design to determine if your fireplace has a proper air draw.
- (2) Metal rain cap on chimney crown is rusting. I recommend repair by a qualified person.

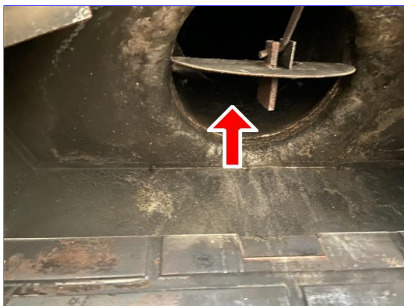
J. Item 2(Picture)

- (3) The flue pipe was partially visible and appeared good, but due to creosote build-up we could not inspect for cracks. I recommend a licensed chimney sweep clean and inspect for safety.

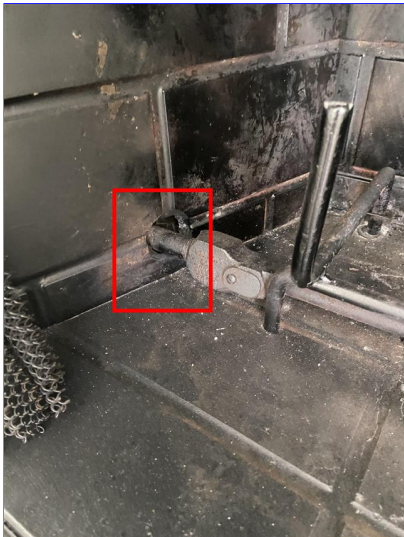
- (4) The (Burn Area) for the fireplace at the living room is not properly sealed. This burn area should be fireproof. Any repairs should be performed according to the manufacturer's specifications.

J. Item 3(Picture) seal gap at gas line

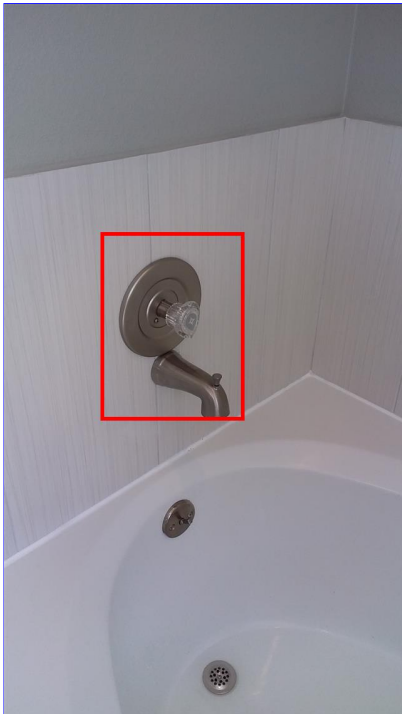
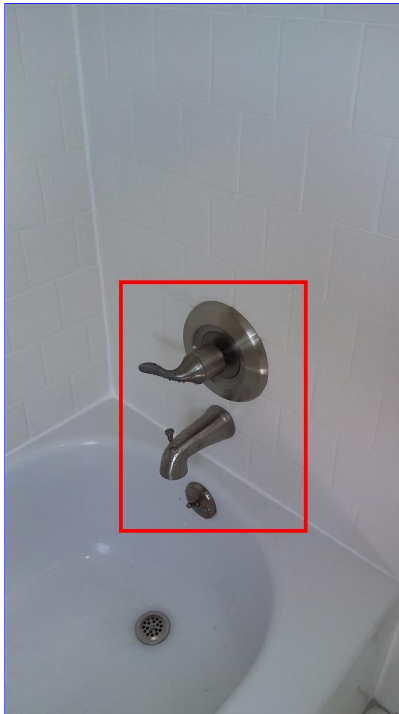
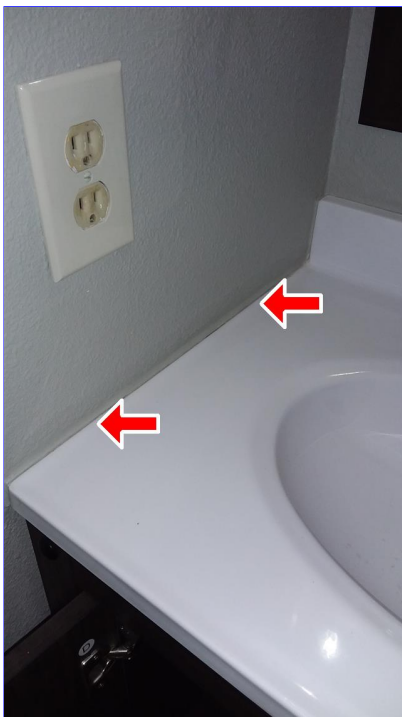
(1) Areas of the home have caulking or grout missing or damaged. Deterioration could occur if not corrected. I recommend having a qualified contractor inspect and make repairs as needed.

L. Item 1(Picture) primary bath

L. Item 2(Picture) hall bath

L. Item 3(Picture) multiple areas

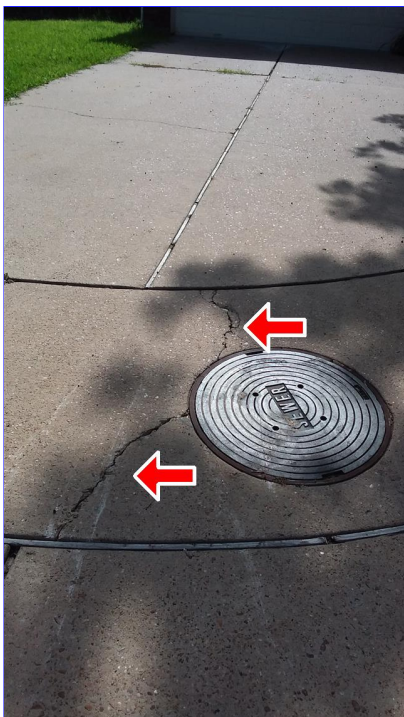
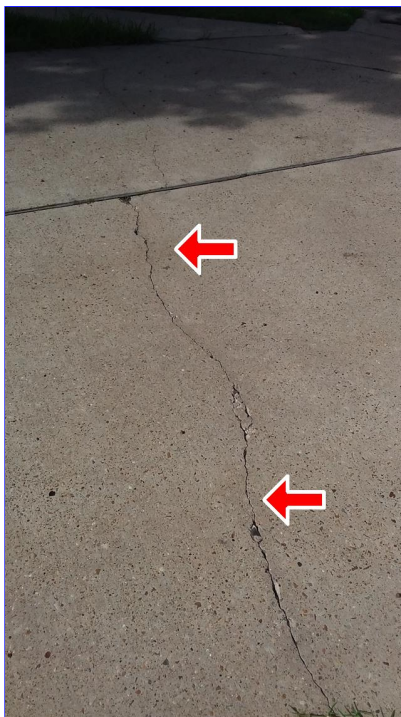
(2) The concrete walkway at the exterior areas has settlement cracks. Further deterioration can occur if not repaired. A qualified person should repair or replace as needed.

L. Item 4(Picture) driveway

L. Item 5(Picture) driveway

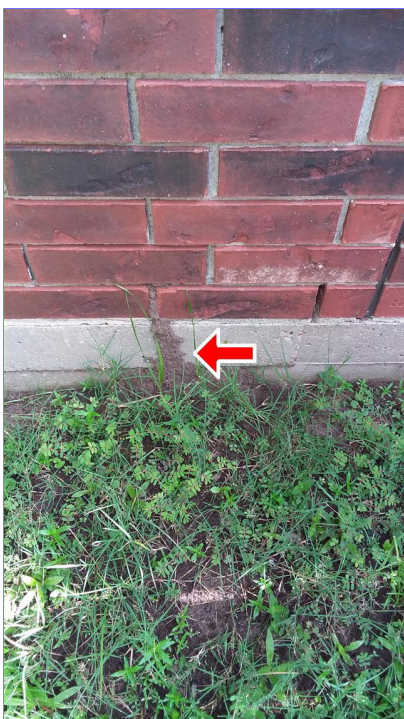
L. Item 6(Picture) right

(3) There is what appears to be an active insect colony. I recommend contacting a qualified pest control company to inspect and treat as needed.

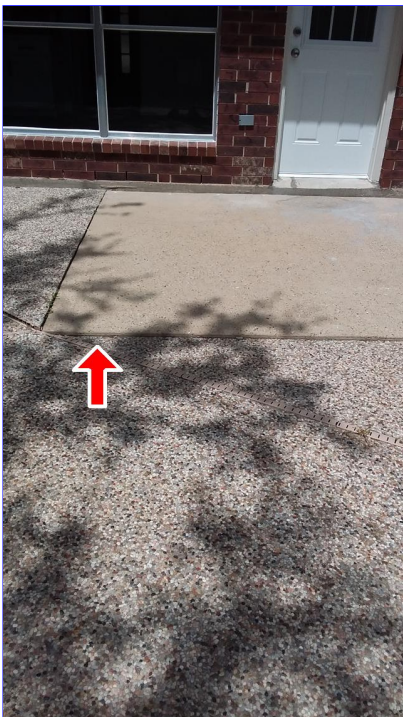
L. Item 8(Picture) rear

(5) The landscape walkway at the front of home is uneven and can be a tripping hazard. A fall or injury can occur if not corrected. A qualified person should repair or replace as needed.

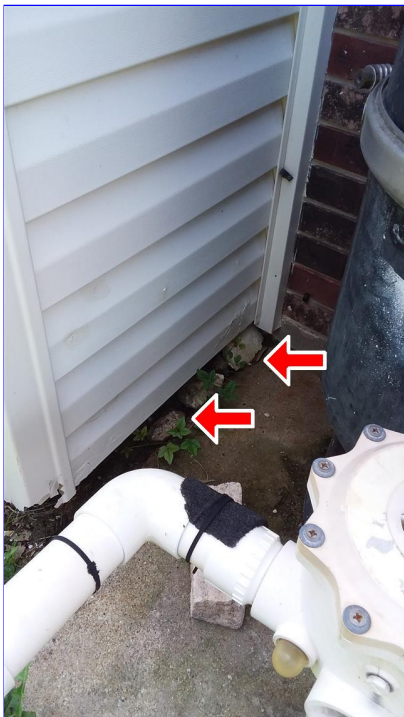
L. Item 9(Picture) rear left

(6) There are bricks stacked against the foundation wall creating conducive conditions for certain types wood destroying insects. I recommend having a qualified pest control company inspect and treat as needed.

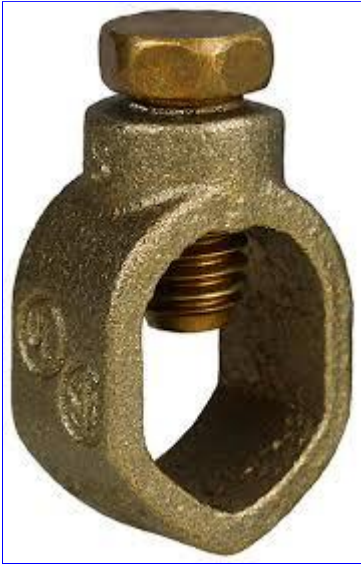
A. Item 1(Picture) left

(1) The grounding rod near meter is using improper clamp for grounding of main panel (solid brass clamp is recommended). This is not considered to be today's standard. I recommend having a qualified person replace with proper clamp to assure proper grounding.

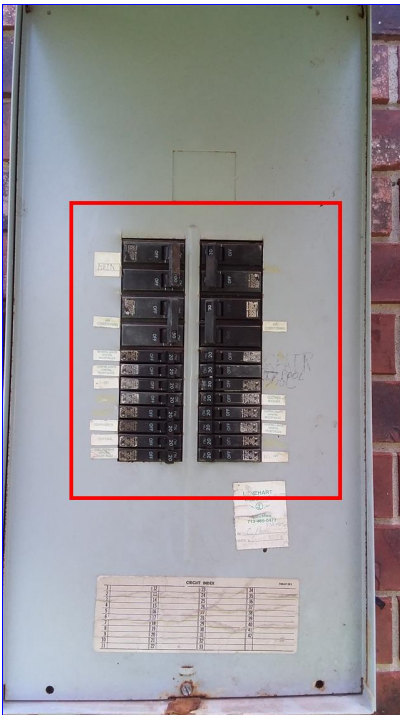
A. Item 3(Picture)

(2) Some labels are present, but are illegible or confusing. I recommend correcting for safety reasons.

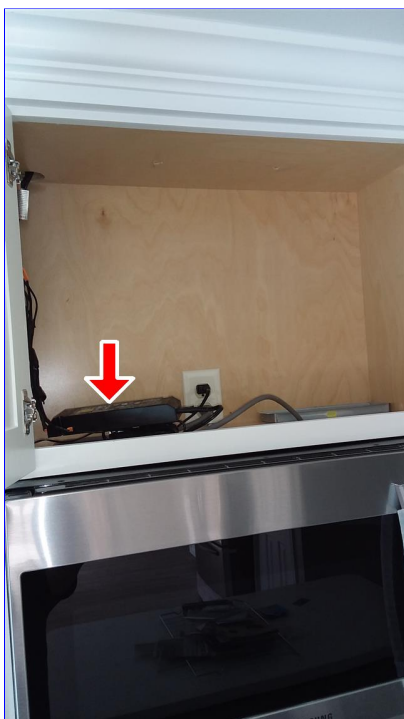
B. Item 5(Picture) above microwave

(4) There is an extension cord being used as permanent wiring and needs to be properly wired or removed.

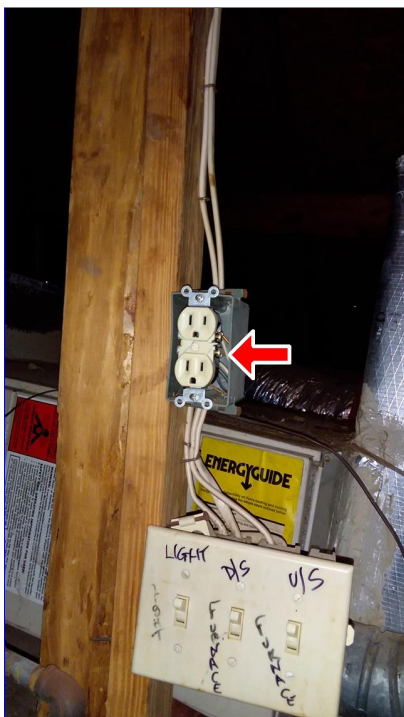
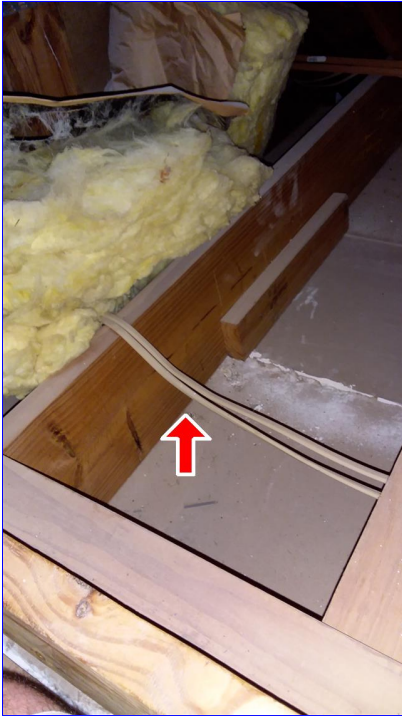
B. Item 8(Picture) upper attic

(6) The electrical wiring in attic was not secured to wood members properly and was not installed neatly or

in 90 degree turns as in standard workmanlike practice. This may indicate that a licensed electrical contractor did not perform the work or did not follow standards (for your information).

B. Item 9(Picture) garage attic

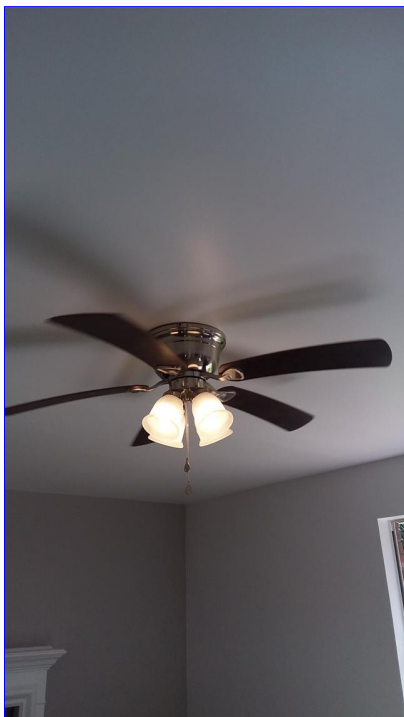
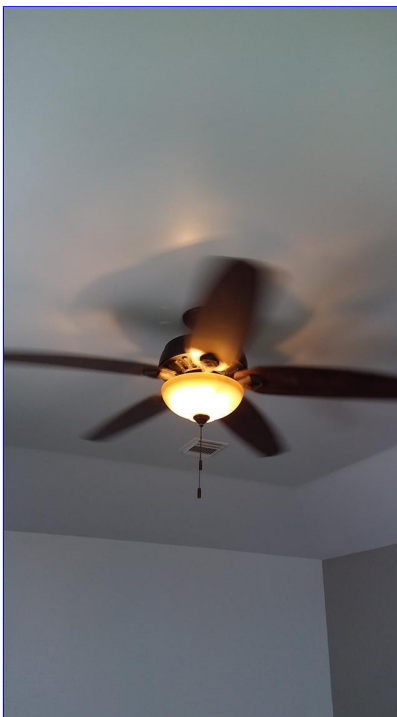
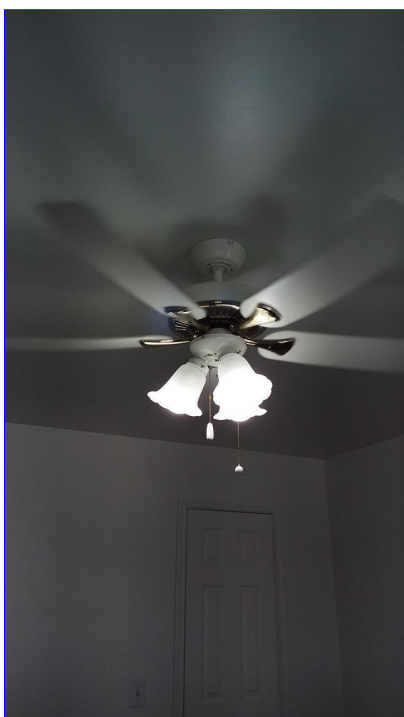
(7) The ceiling fan "wobbles". Some fans that wobble cannot be corrected without replacement. A qualified licensed electrical contractor should perform repairs that involve wiring.

B. Item 10(Picture) living room

B. Item 11(Picture) primary bedroom

B. Item 12(Picture) multiple areas

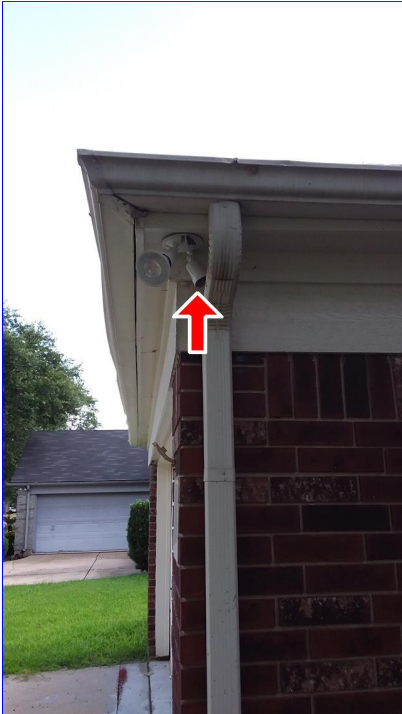
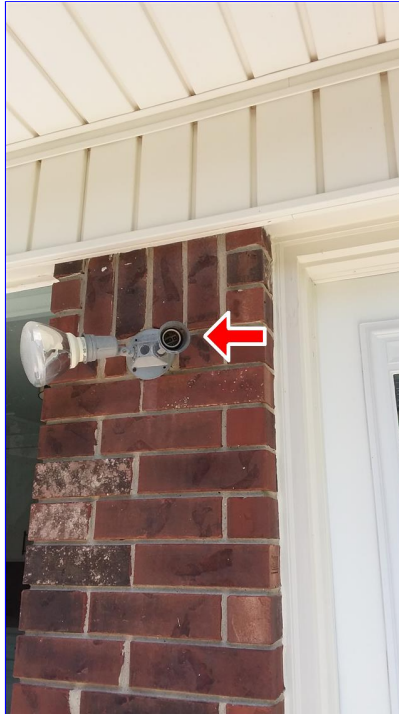
(8) The light fixture does not work (try bulb first). Electrical issues are considered a hazard until repaired. A qualified licensed electrical contractor should perform repairs that involve wiring.

B. Item 13(Picture) front

B. Item 14(Picture) patio

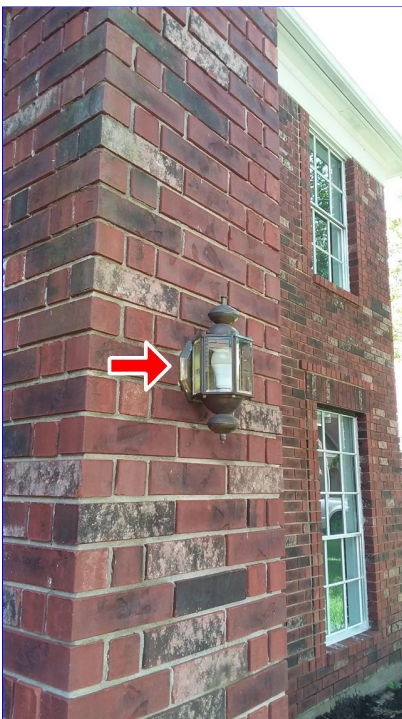
B. Item 15(Picture) entry lights

(9) The light fixture is loose in areas. Electrical issues are considered a hazard until repaired. A qualified licensed electrical contractor should perform repairs that involve wiring.

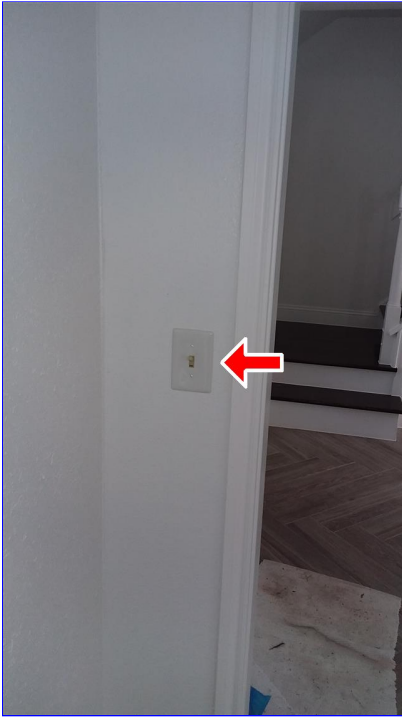
B. Item 16(Picture) dining room left

(10) The wall switch purpose is unknown (could not identify) in areas. This is for your information. A qualified licensed electrical contractor should perform repairs that involve wiring.

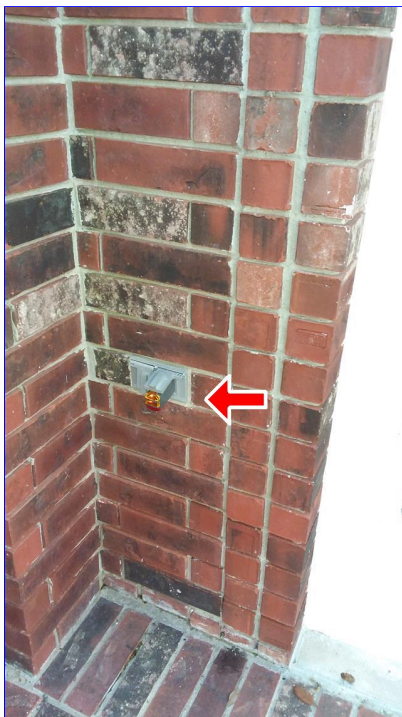
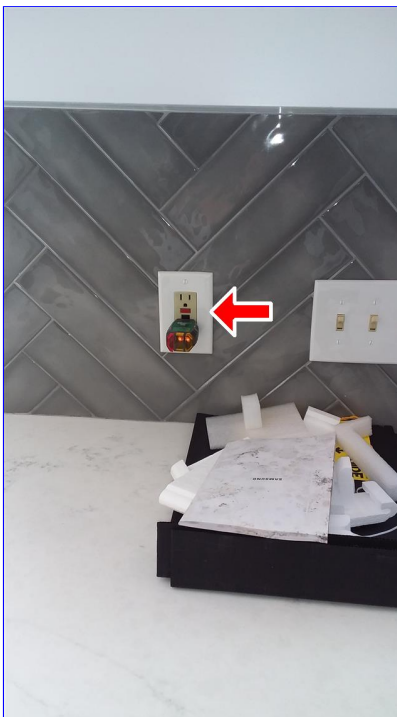
(11) There are no GFCI protected circuits in required areas. This is not considered to be today's standard. I recommend having a qualified electrician make repairs as needed.

B. Item 17(Picture) entry

B. Item 18(Picture) kitchen

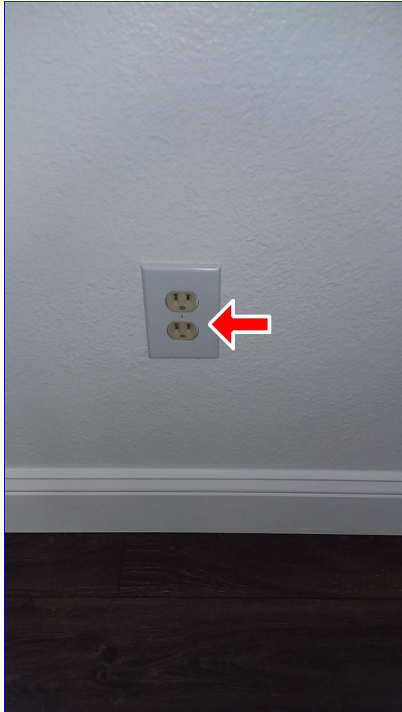
B. Item 20(Picture) front right bedroom

(12) The outlet cover is damaged and needs replaced. I recommend having a qualified person make repairs as needed.

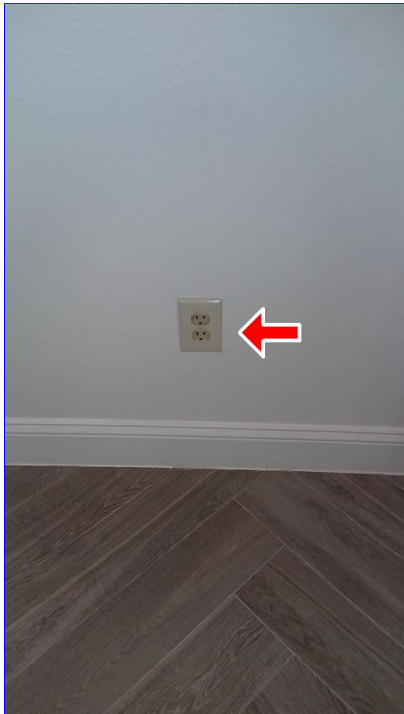
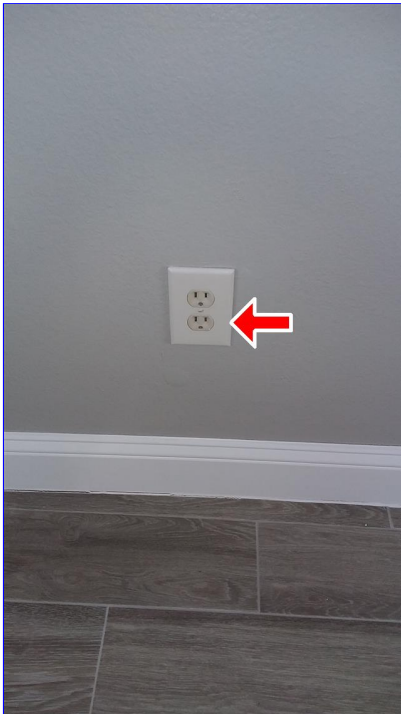
(13) "Three-prong" outlets are loose in wall. Electrical issues are considered a hazard until repaired. A qualified licensed electrical contractor should perform repairs that involve wiring.

B. Item 22(Picture) entry

B. Item 23(Picture) dining room

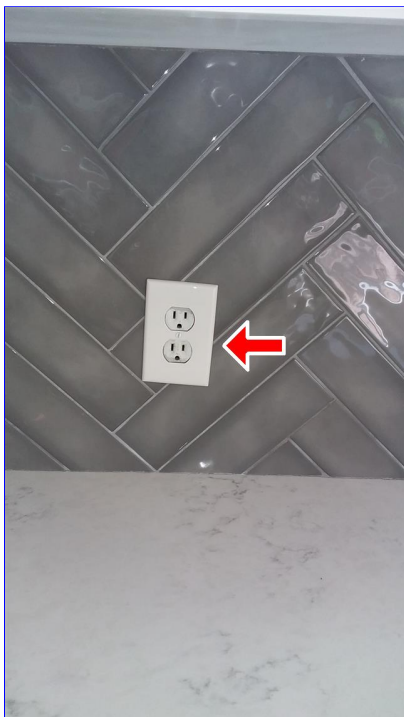
B. Item 24(Picture) multiple outlets

(14) "Three-prong" outlets are broken or damaged. Electrical issues are considered a hazard until repaired. A qualified licensed electrical contractor should perform repairs that involve wiring.

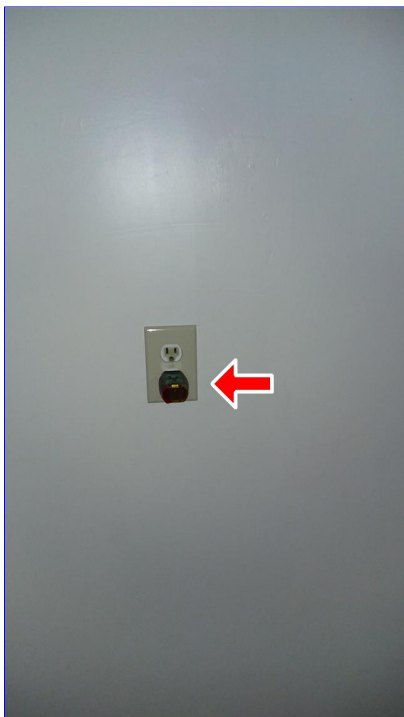
B. Item 27(Picture) rear

(15) "Three-prong" outlets are not working in the garage. Electrical issues are considered a hazard until repaired. A qualified licensed electrical contractor should perform repairs that involve wiring.

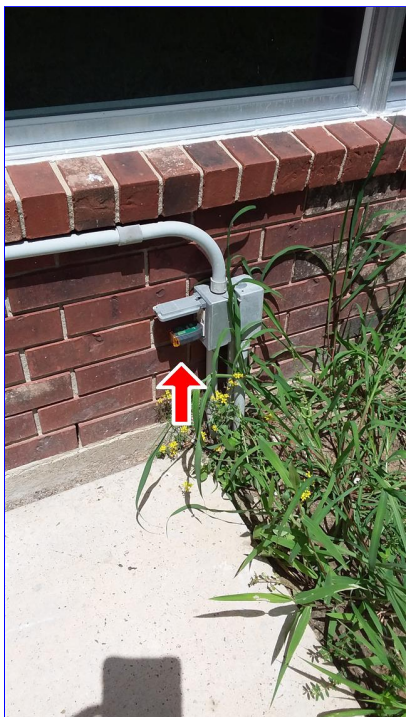
B. Item 30(Picture) patio

(17) The exterior outlet at the rear of home did not work or there is no power to outlet. Electrical issues are considered a hazard until repaired. A qualified licensed electrical contractor should perform repairs that involve wiring.

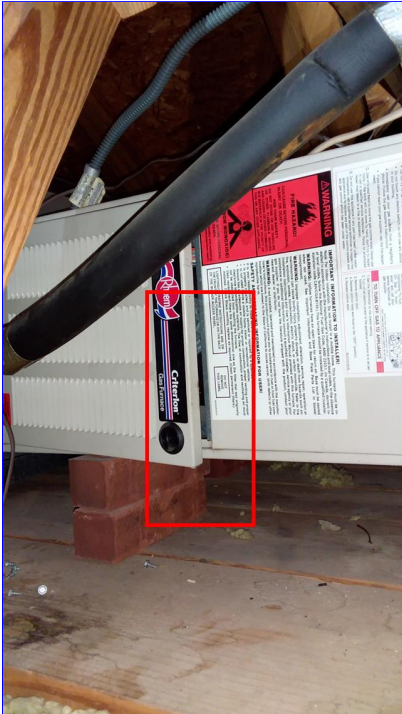
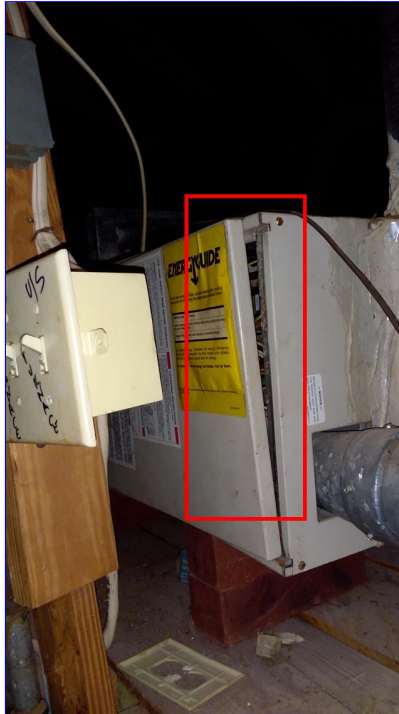
- (4) The gas furnace has a loose cover. This is a maintenance issue and should be repaired. I recommend service or repair as needed.

A. Item 3(Picture) front unit

A. Item 4(Picture) rear unit
