# Inspection Report

**Property Address:**  
4011 Ivywood Dr  
Pearland TX 77584

**HG HOME INSPECTION**

**By:** BYRON LEE TREC #23870 / HG HOME INSPECTION 7/13/2021  
(Name and License Number of Inspector) (Date)

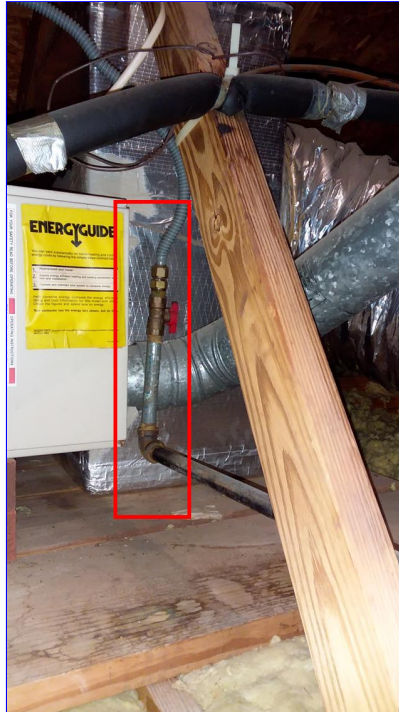
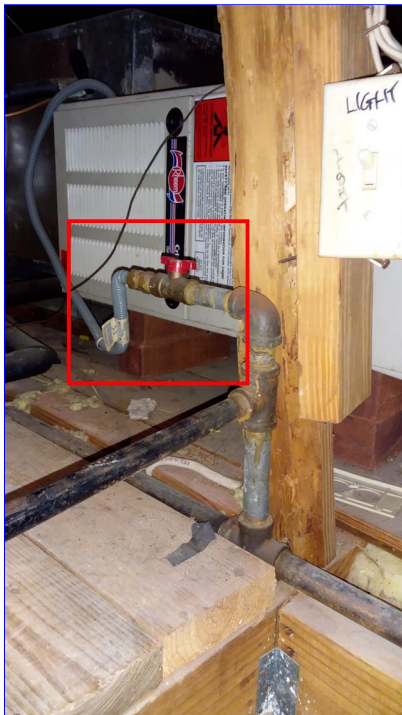
(5) The gas furnace is installed without the recommended sediment trap or "drip leg" that is designed to extend the life of the unit. This is not considered to be today's standard. I recommend having a qualified person make repairs as needed.

A. Item 6(Picture) front unit

A. Item 7(Picture) rear unit

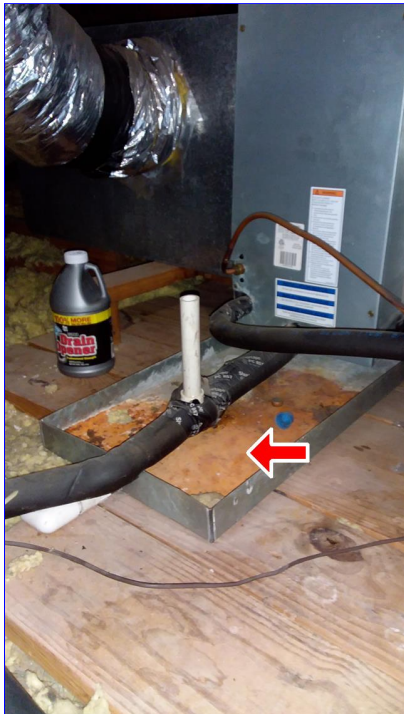
B. Item 5(Picture) front unit

(3) The emergency overflow drain pan for the HVAC system is showing signs of deterioration. Further deterioration may occur if not corrected. I recommend having a qualified person make repairs as needed.

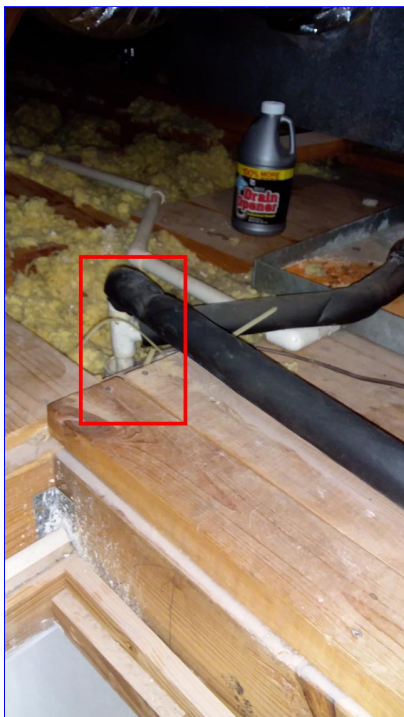
B. Item 6(Picture) front unit

(4) The air handler is missing foam sleeve in area(s). A replacement is needed. I recommend service or repair as needed.

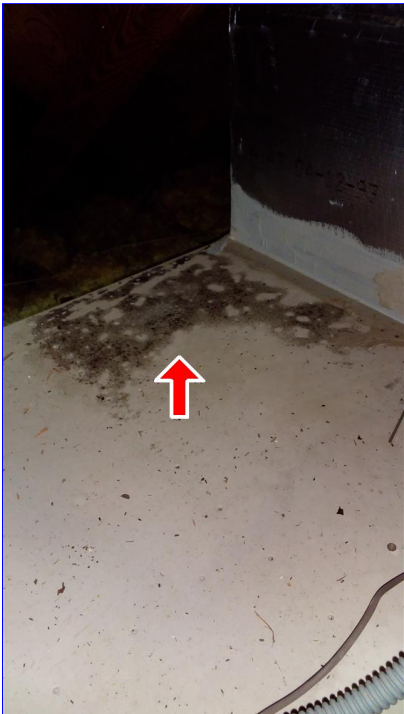
B. Item 9(Picture) front unit

(5) Signs of fungi growth is present on ductwork or furnace in the attic space. This could indicate that furnace may not be sealed properly. We did not inspect, test or determine if this growth is or is not a health hazard. The underlying cause is moisture. I recommend having the unit serviced and properly cleaned.

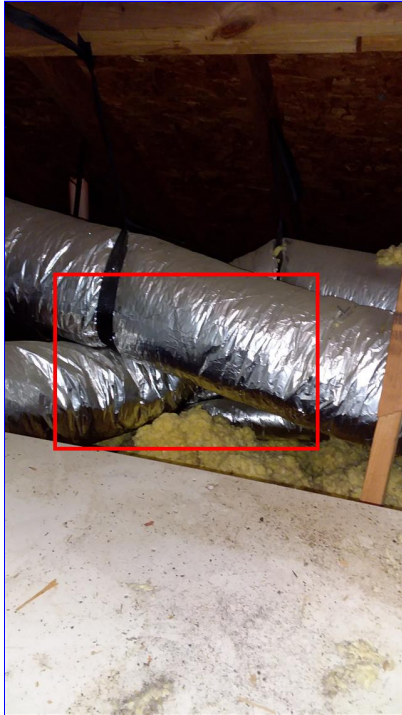
C. Item 1(Picture) rear

(2) Duct piping appears to be in contact with one another in the attic space. Condensation could occur if not corrected. I recommend having a qualified HVAC contractor further evaluate and make repairs as needed.

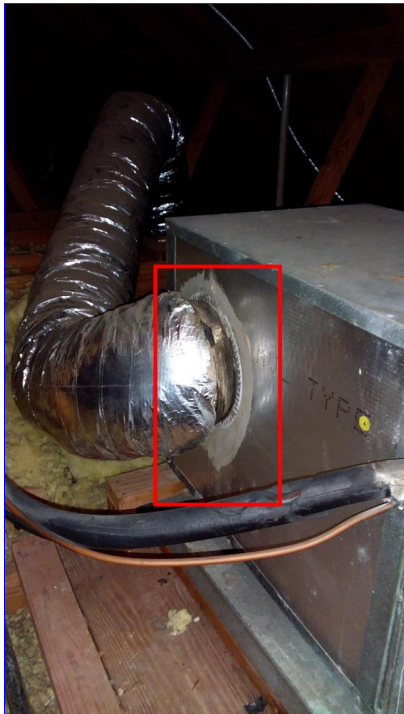
C. Item 3(Picture) rear unit

(3) The supply is not sealed in the attic. Energy loss is occurring. I recommend service or repair as needed.

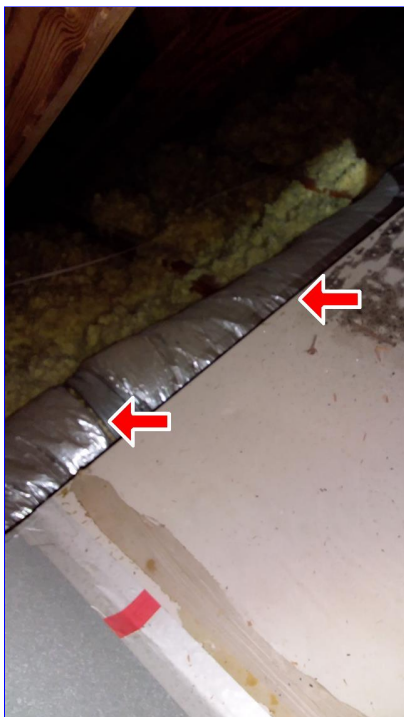
C. Item 5(Picture) front

(4) The supply needs support straps in the attic. Energy loss is occurring. I recommend service or repair as needed.

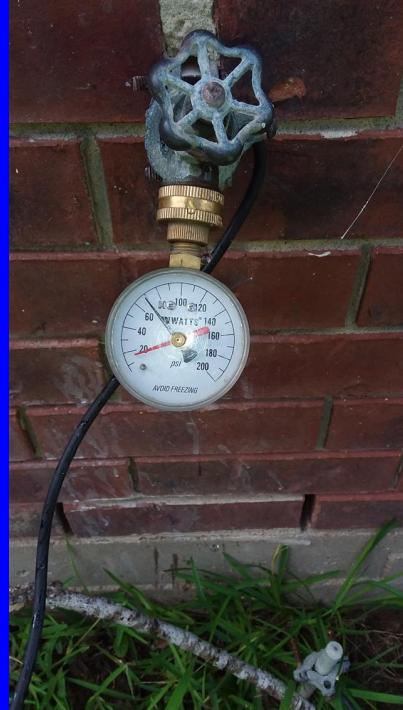
water pressure 69 psi

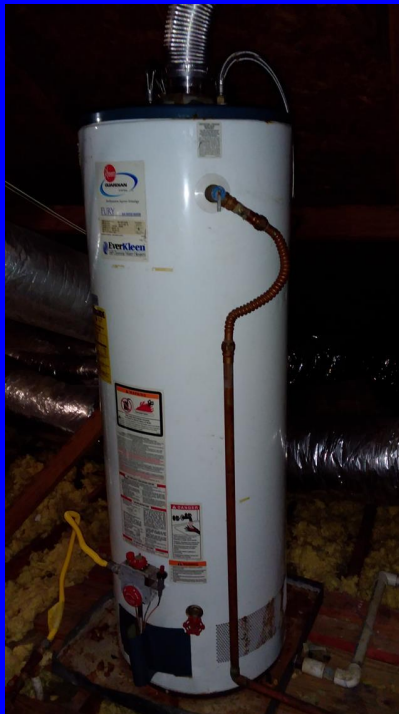
50 gallon water heater attic

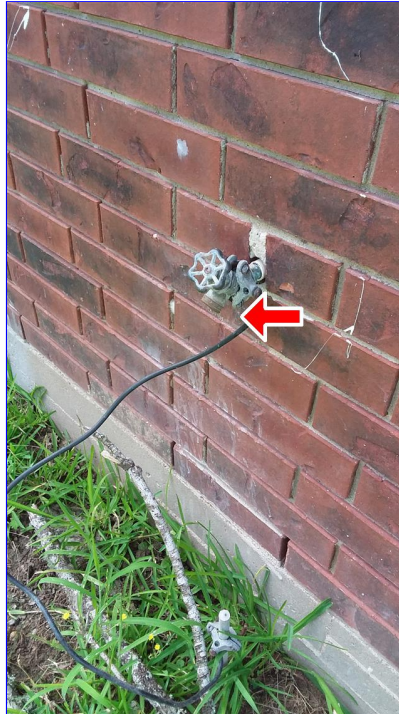
A. Item 2(Picture) left

(1) There is no Anti Siphon device installed on exterior faucet(s). This is not considered to be today's standard. I recommend having a qualified person make repairs as needed.

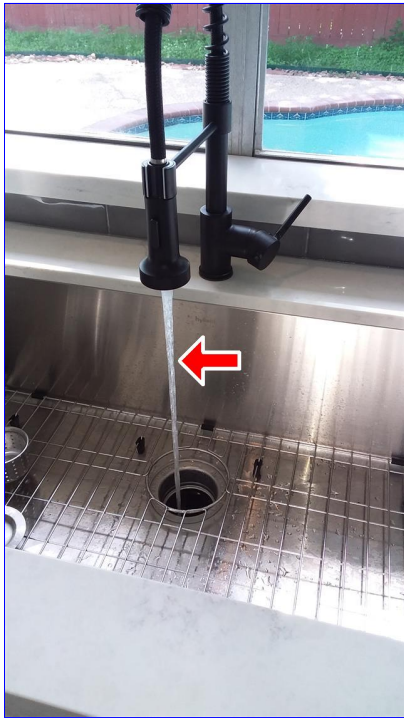
A. Item 4(Picture) kitchen sink

can vary from simple to complex. The repair could also be simple to complex. A qualified licensed plumber should repair or correct as needed.

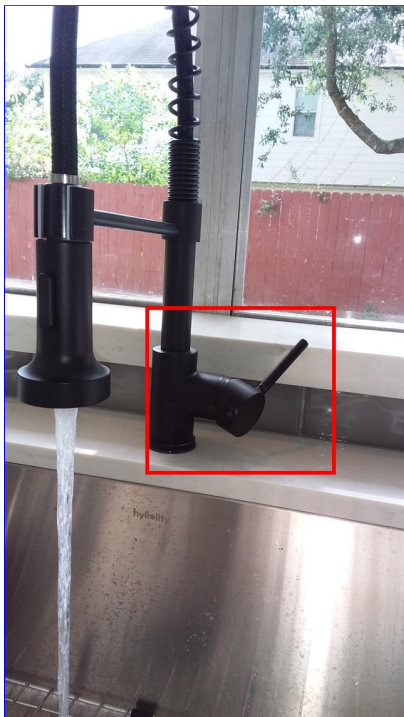
A. Item 5(Picture) kitchen

(4) The control knob is reversed (hot is cold, cold is hot). This is not considered up to today's standard. A qualified licensed plumber should repair or correct as needed.

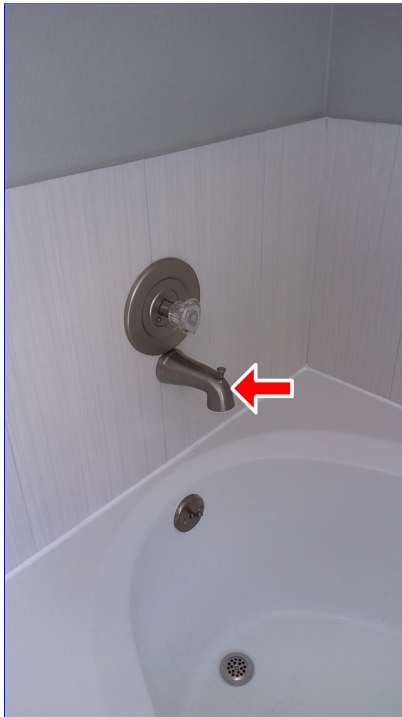
A. Item 6(Picture) primary bath

(5) The tub spout diverter is loose at the bath areas. This is not considered up to today's standard. A qualified person should repair as necessary.

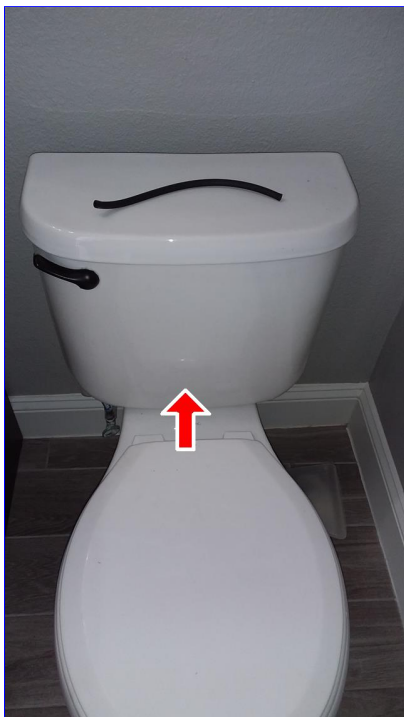
B. Item 4(Picture) half bath

(2) The toilet is loose at tank mount at the bath areas. This is not considered up to today's standard. A qualified person should repair as necessary.

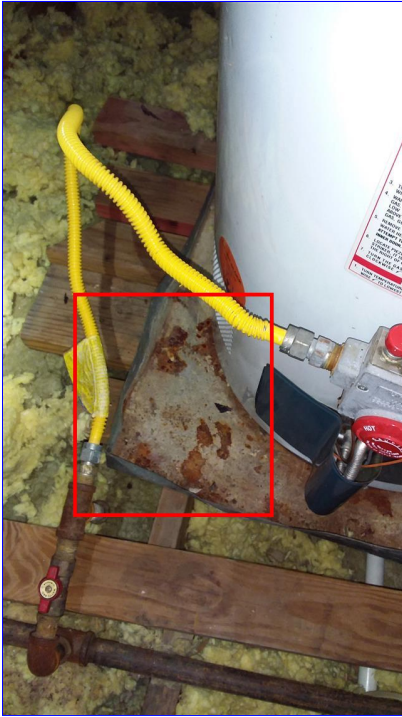
C. Item 3(Picture)

(3) The emergency over flow drain pan for the unit is deteriorated. I recommend replacement.

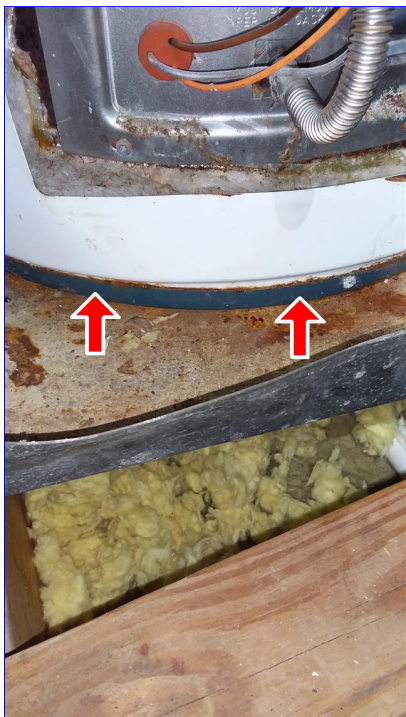
C. Item 4(Picture)

(4) The water heater is old, rusted and at the end of its life expectancy. No leaks at present. A more thorough inspection by a qualified contractor is needed. A qualified licensed plumber should repair or correct as needed.

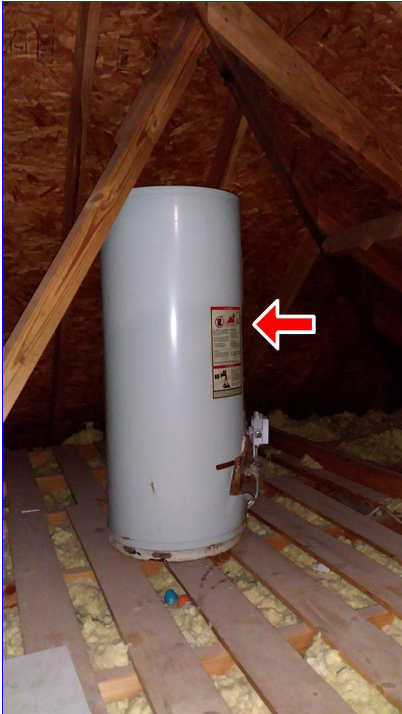
C. Item 7(Picture) upoer attic

(6) There is an old water heater present in the attic area. I recommend removal by a qualified person.

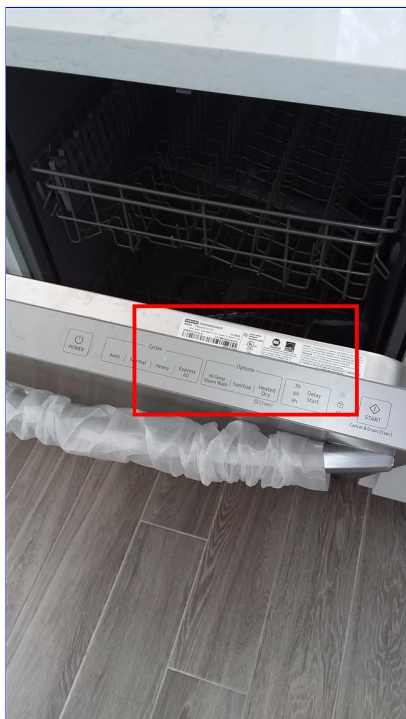
A. Item 3(Picture)

(2) The dishwasher did not operate when tested. I recommend repair as necessary.

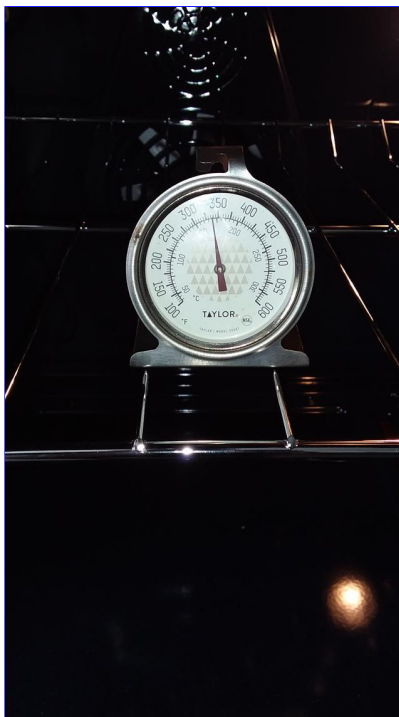
D. Item 2(Picture) oven tested at 350°

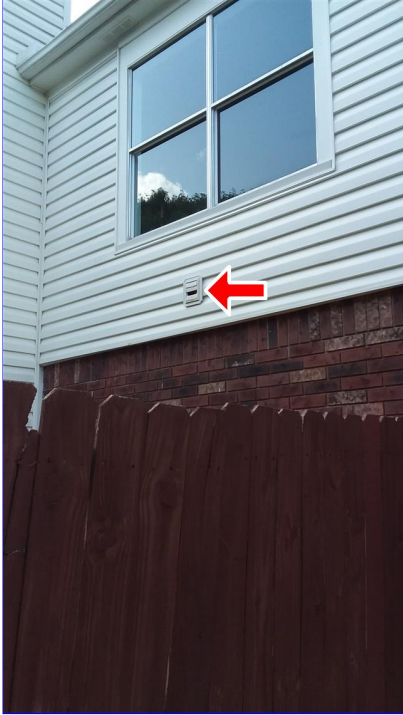
F. Item 1(Picture) left

- (1) Tested and working properly at the time of inspection.
- (2) The exhaust fan has a damaged vent cover outside. This may allow insects or critters to enter home. A qualified person should repair or replace as needed.

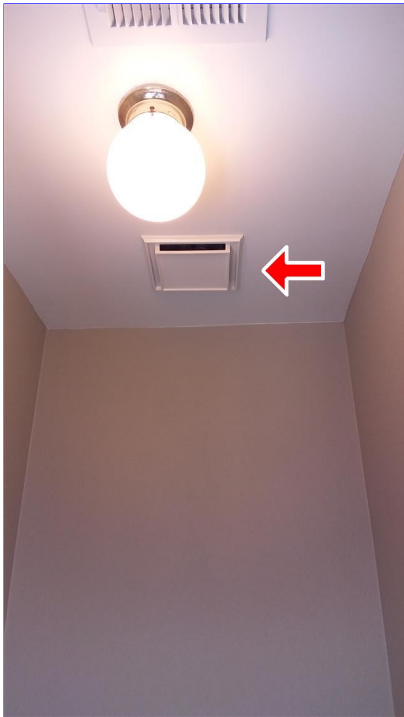
F. Item 3(Picture) primary bath

(4) The exhaust fan is noisy at the bath areas. This is for informational purpose to you. A qualified person should repair or replace as needed.

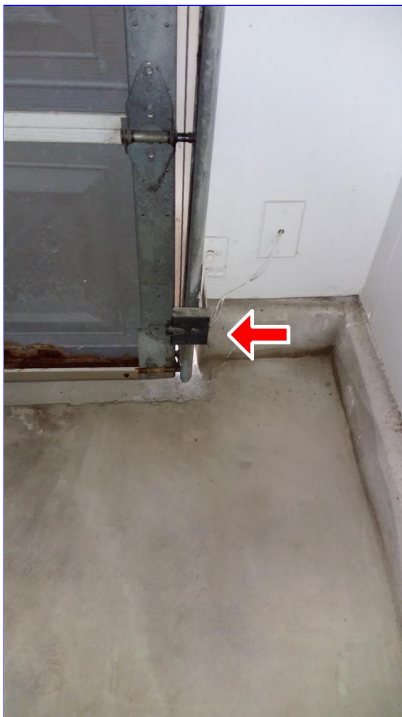
(2) The automatic opener for garage door at the front of home has electronic sensors located higher than six inches off floor which may not be installed according to manufacturers specification. This is considered unsafe and needs correcting. A qualified person should repair or replace as needed.

G. Item 2(Picture) both sensors

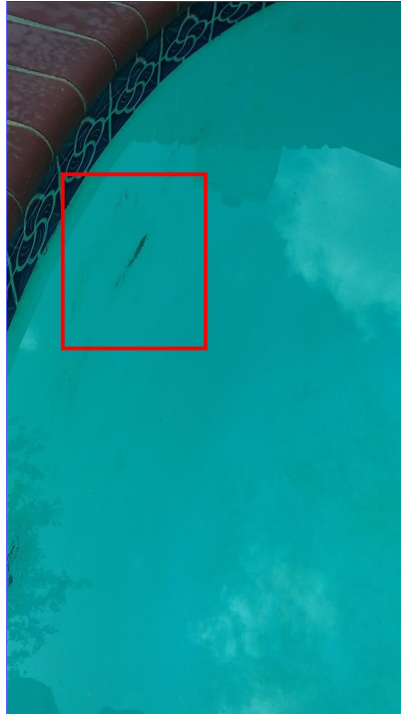
B. Item 2(Picture)

(3) Concrete walls and Pool floor bottom is discolored. A qualified pool professional should evaluate and repair as needed..

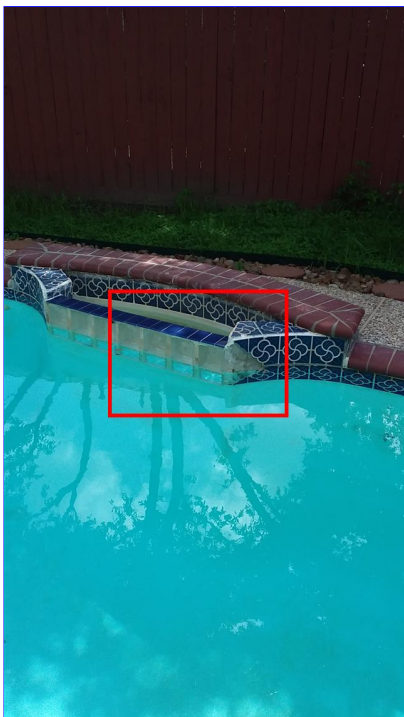
B. Item 4(Picture)

(4) Tile wall is loose or deteriorated. I recommend repair by a qualified person.

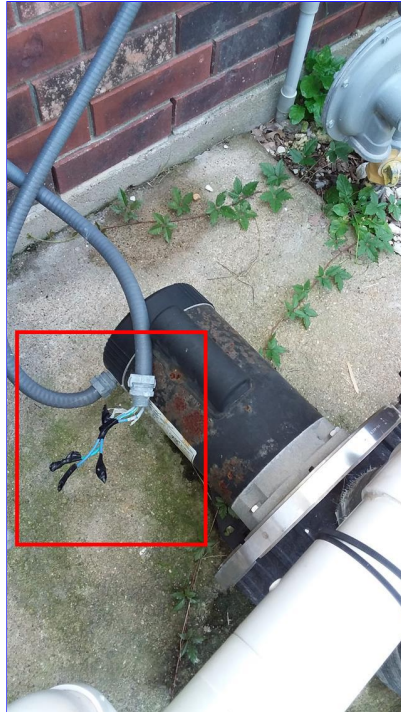
(5) Pool equipment has valves that not clearly marked and the equipment does not appear to be properly bonded. I recommend having a pool professional evaluate, mark and repair as needed.

B. Item 7(Picture) not grounded properly

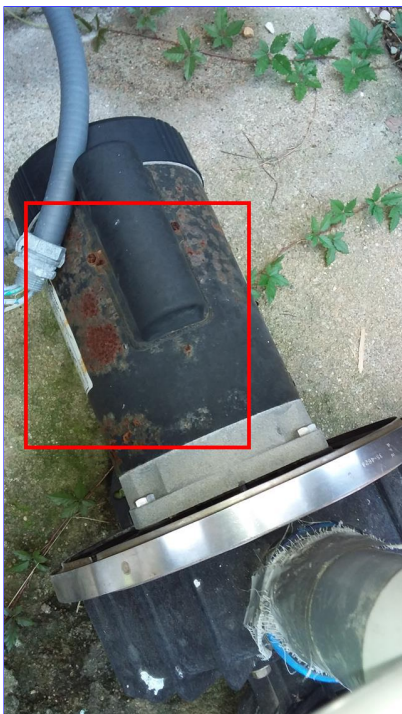
B. Item 8(Picture) equipment rusting

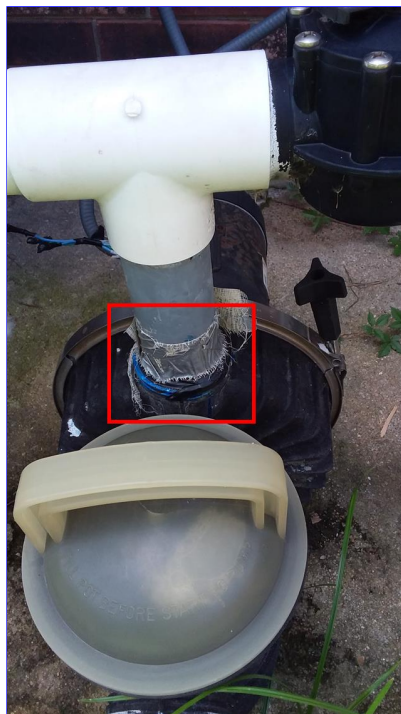
B. Item 9(Picture) pipes repaired inproperly
