Property Inspection Report

890 So TINKLE LANE, CRYSTAL BEACH, TX 77650
Inspection prepared for: STAGGS BETH
Real Estate Agent: Beth Staggs -

Date of Inspection: 2/12/2020 Time: 11:30am
Age of Home: 3+ yrs Size: 1253 sf
Occupied and furnished beach cabin. Buyer is present.

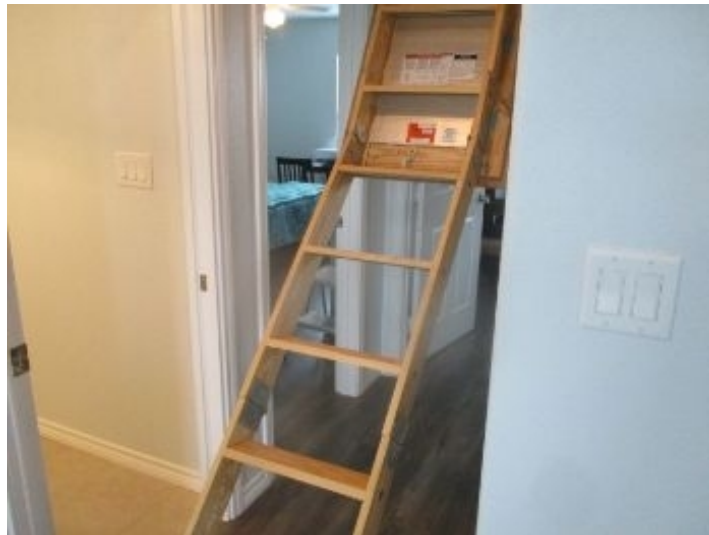
- Pull down attic stairs correctly open / close at time of inspection.
- Hand rails are secure at time of inspection.
- Pull down attic stairs in hallway are too long, recommend adjustments.

Pull down attic stairs in hallway are too long, recommend adjustments.

STRUCTURAL SYSTEMS		
Page 9 Item: I	Stairways (Interior & Exterior)	• Pull down attic stairs in hallway are too long, recommend adjustments.
PLUMBING SYSTEM		
Page 12 Item: B	Drains, Wastes, and Vents	• Disconnected drain stop at tun in hallway bathroom.

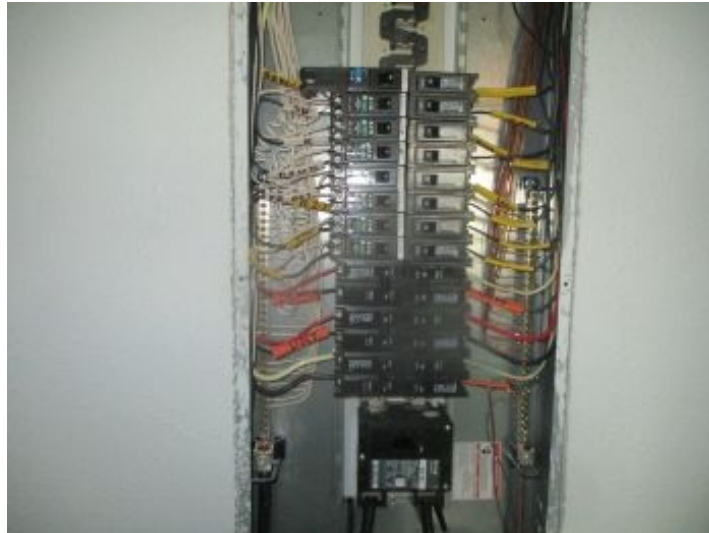
Panel Locations:
Materials & Amp Rating:
Comments:
• Buried service wires to distribution panel located in rear left bedroom. Service wires are copper. 200 amp main disconnect in exterior panel on side of cabin and in the interior panel.

A view of wiring to breakers at interior panel

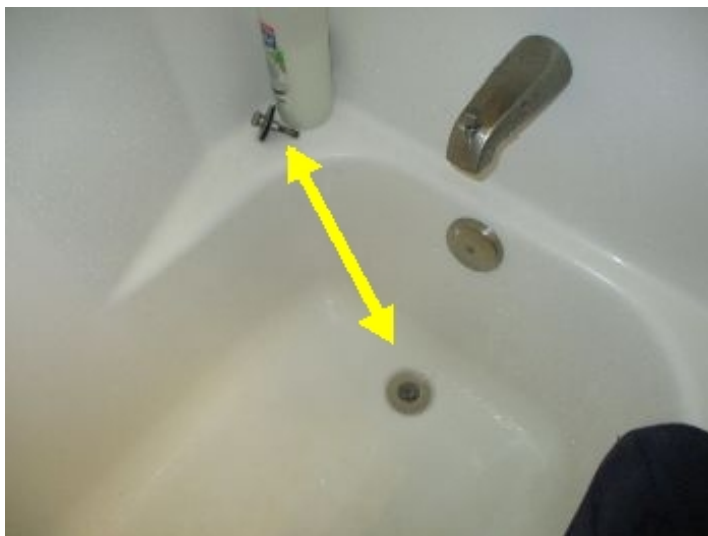
- Visible drain lines are PVC.
- All visible drains flowed normal at time of inspection.
- Inspector can not see pipes in walls or in ground, therefore, no comment can be made on what can not be seen.
- **Disconnected drain stop at tun in hallway bathroom.**

Disconnected drain stop at tun in hallway bathroom.
