RESIDENTIAL INSPECTION REPORT

6107 Settlers Square Ln
Katy, TX 77449

PROPERTY INSPECTION REPORT FORM

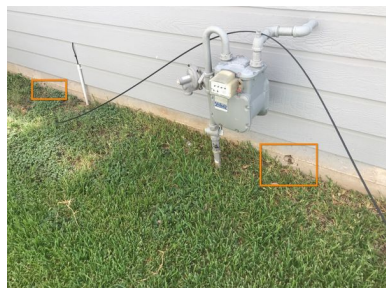
Left Exterior Utility Room

Post tension cable(s) exposed along the perimeter of the foundation. Evaluation and remediation is recommended.

Recommendation: Contact a qualified professional.

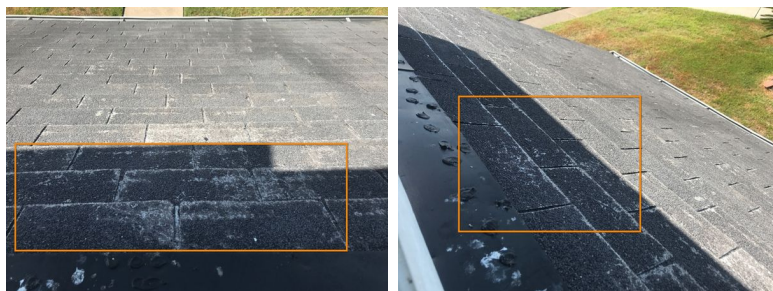
3: Loss of adhesion

Adhesive strips not fully bonded. Shingles with this condition can be vulnerable to wind uplift. Evaluation and repair by a qualified roofing professional is recommended.

Recommendation: Contact a qualified roofing professional.

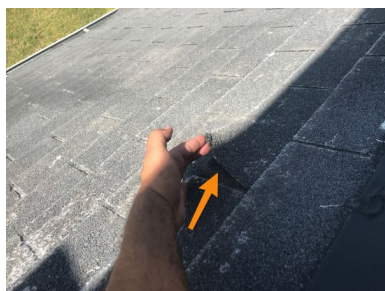
4: Shingles: Damaged/Torn/Missing

Roof shingle material was missing, damaged, or torn in areas. Evaluation and/or repair by a qualified roofing professional is recommended.

Recommendation: Contact a qualified roofing professional.

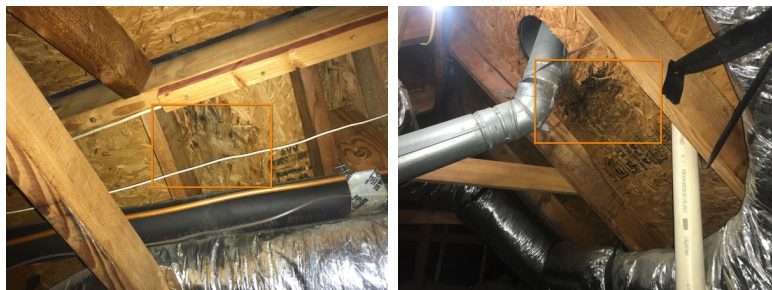
3: Insulation: Voids

Gaps or areas of poor insulation coverage were observed in one or more locations of the attic. This may reduce the R value of the insulation system. Evaluation and remediation is recommended.

Recommendation: Contact a qualified insulation contractor.

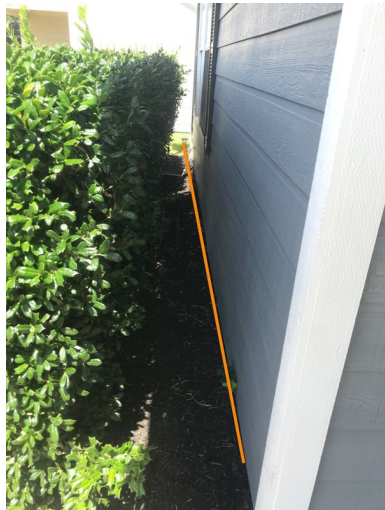
Front Exterior

A high soil level was observed. The foundation should have at least 4 inches of exposure. Evaluation and remediation is recommended.

Recommendation: Contact a qualified landscaping contractor

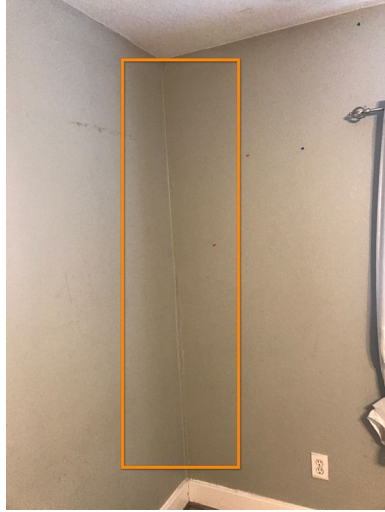
2nd Floor Front Right Bedroom

Wrinkled tape joint can be evidence of current and/or previous structural movement. Evaluation and remediation is recommended.

Recommendation: Contact a qualified professional.

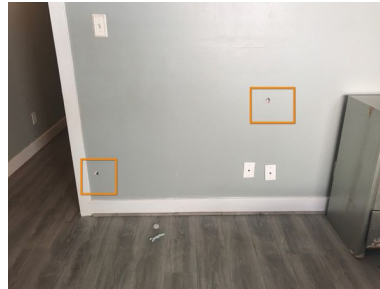
2nd Floor Rear Left Bedroom

Wall structure showed signs of previous water intrusion. Tested negative for moisture at the time of the injection. Evaluate and remedy as needed.

Recommendation: Contact a qualified professional.

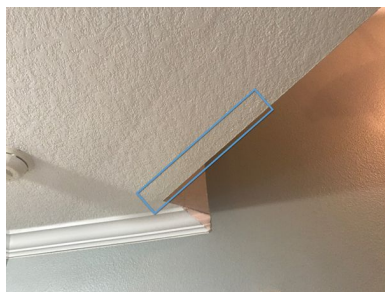
1st Floor Staircase

Texture cracks were observed in ceiling joints and appear cosmetic in nature. These are not typically caused by structural defects.

Recommendation: Contact a handyman or DIY project

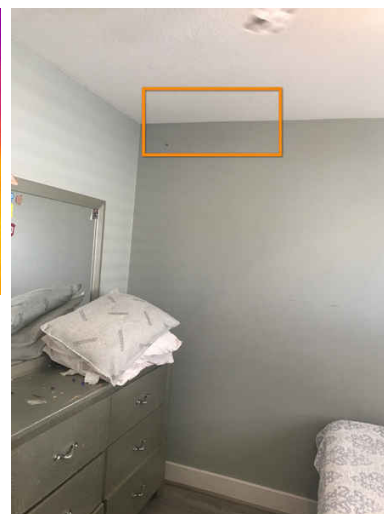
2nd Floor Rear Left Bedroom

Observed signs of possible microbial growth indicating prior moisture intrusion. It is recommended that the source of any moisture intrusion be identified, and the issue remediated.

Recommendation: Contact a qualified mold inspection professional.

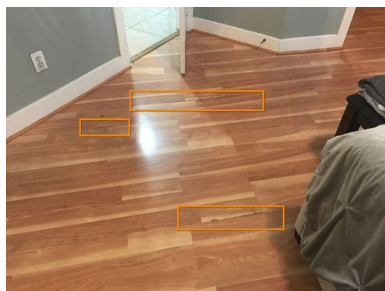
Primary Bedroom

Flooring had evidence of previous moisture contact at the time of inspection. Evaluation and remediation is recommended.

Recommendation: Contact a qualified professional.

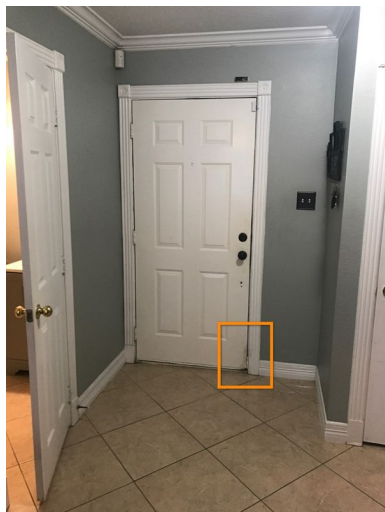
Front Entry

Gaps were observed between the door and frame, which could result in energy loss. Evaluate and remedy as needed.

Recommendation: Contact a qualified door repair/installation contractor.

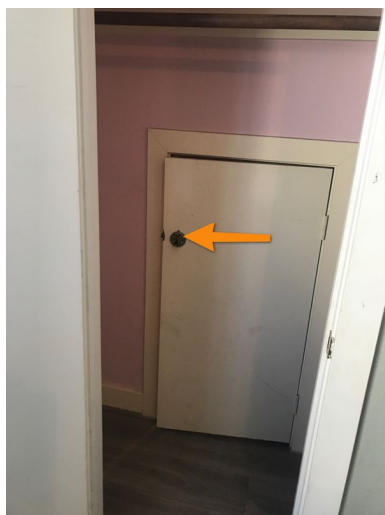
2nd Floor Rear Attic Access

One or more door had missing or damaged hardware. Evaluation and remediation is recommended.

Recommendation: Recommended DIY Project

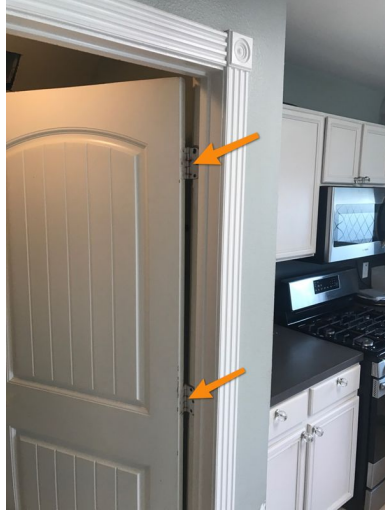
Laundry Area

Loose hinges were observed. Loose hinges can cause door to stick or eventually fall out of place. Evaluation and remediation is recommended.

Recommendation: Recommended DIY Project

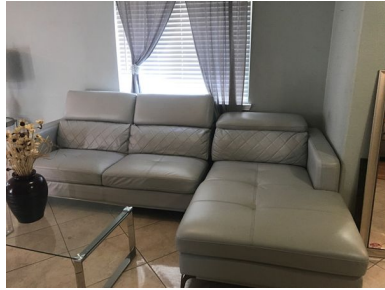
One or more windows were not accessible due to furniture/storage items.

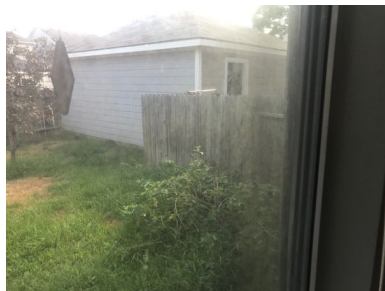
Dirty glazing limited the visual inspection of one or more windows.

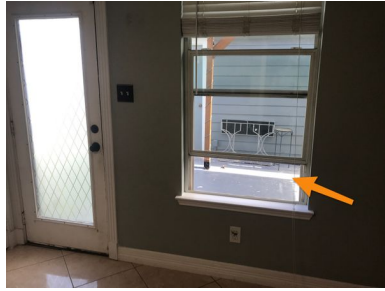
Kitchen

One or more windows are missing a screen or had a damaged screen. Replacement of screens is recommended.

Recommendation: Contact a qualified window repair/installation contractor.

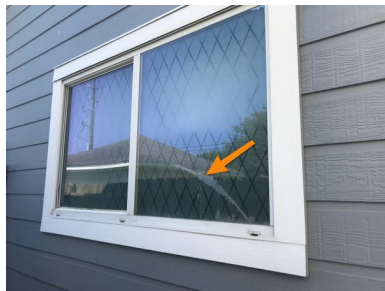
Left Exterior

Cracked or broken glass panes were present. Evaluation and remediation is recommended.

Recommendation: Contact a qualified window repair/installation contractor.

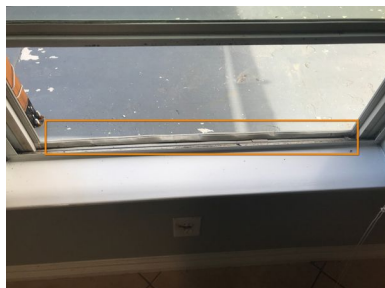
Kitchen

One or more windows appears to have general damage, but are operational. Evaluation and remediation by a window professional as necessary.

Recommendation: Contact a qualified window repair/installation contractor.

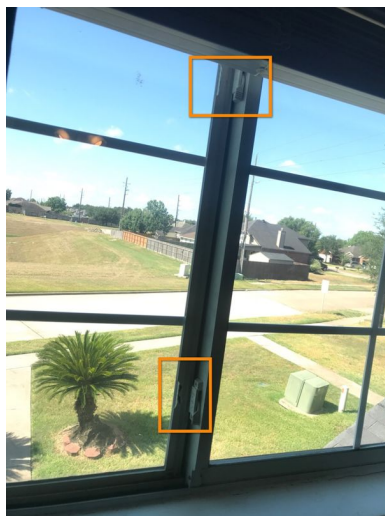
2nd Floor Front Right Bedroom

Plastic trim around windows is either damaged or missing. Evaluation and remediation is recommended.

Recommendation: Contact a qualified window repair/installation contractor.

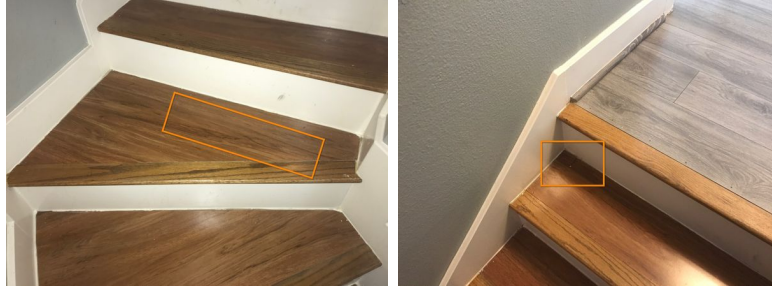
Damaged -

Stair treads exhibit conditions that do not appear to meet current building standards. Evaluation by a qualified contractor is recommended for safety.

Recommendation: Contact a qualified professional.

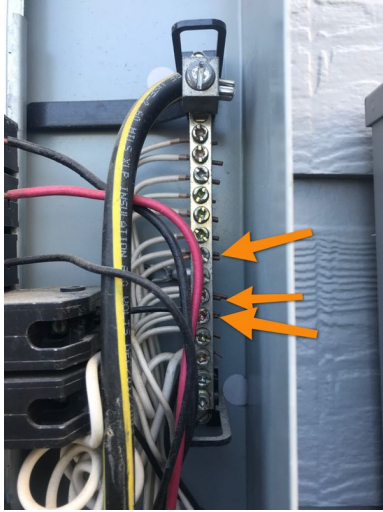
Double lugged neutral wires were on the neutral bus bar inside the distribution panel. One neutral wire per lug is recommended. Evaluation and remediation is recommended.

Recommendation: Contact a qualified electrical contractor.

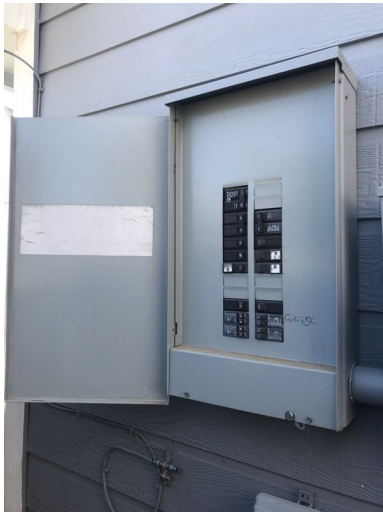
2: Circuits Not Labeled

Circuits in the distribution panel were not properly labeled. Evaluation and remediation is recommended.

Recommendation: Contact a qualified electrical contractor.

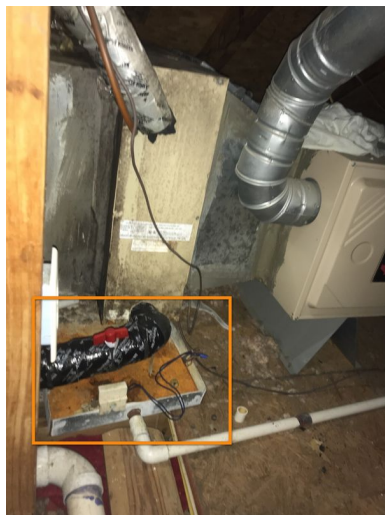
The emergency overflow pan is rusted. Further evaluation by an HVAC professional is recommended.

Recommendation: Contact a qualified HVAC professional.

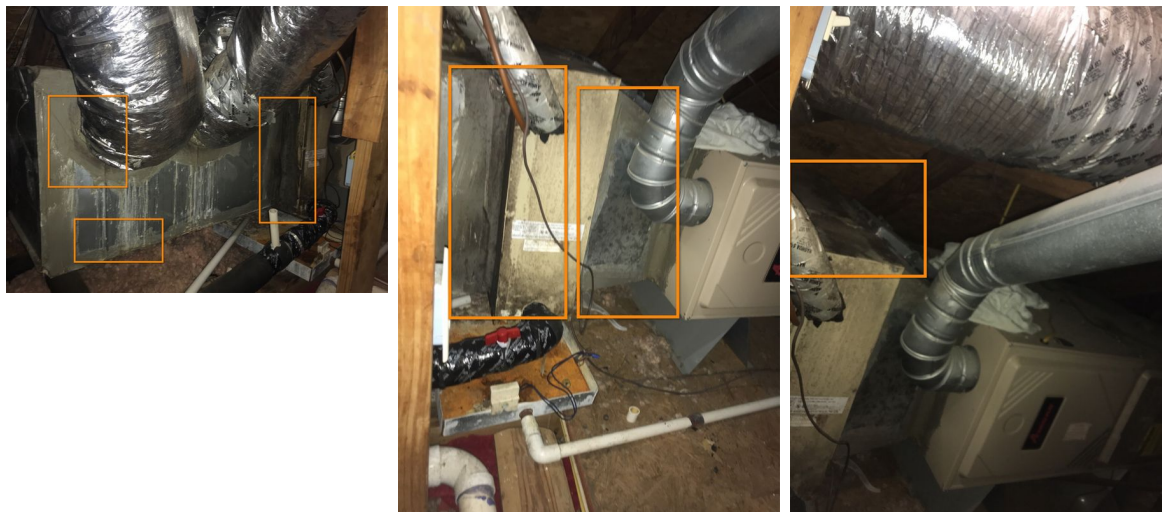
Discoloration on HVAC equipment indicates prior moisture contact or excessive condensation. Evaluation and remediation is recommended.

Recommendation: Contact a qualified HVAC professional.

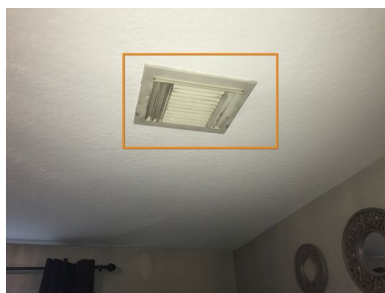
Primary Bedroom

A dark substance was observed on an air supply register in the home. Servicing and cleaning of the system by a qualified HVAC contractor is recommended, as this can be a result of excessive water vapor/humidity in the conditioned air.

Recommendation: Contact a qualified HVAC professional.

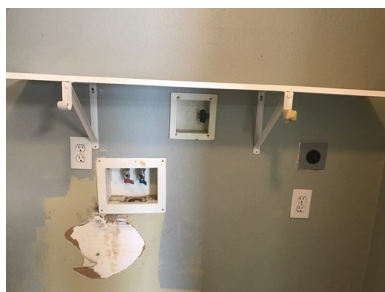
Location of main water supply valve: Interior Wall - Laundry Area

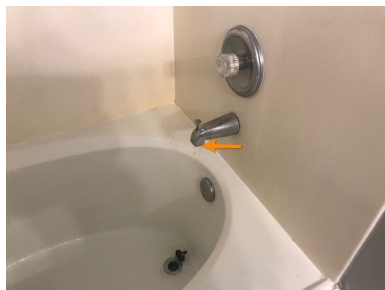
Water did not completely stop coming out of the faucet spout after the shower diverter was activated. Evaluate and remedy as needed.

Recommendation: Contact a qualified professional.

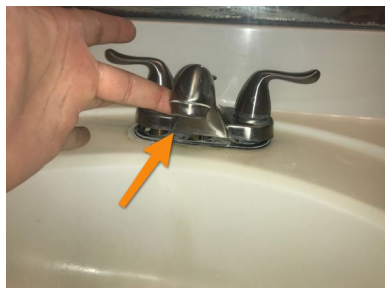
2: Fixtures: Loose

The faucet was loose. Evaluation and remediation is recommended.

Recommendation: Contact a qualified plumbing contractor.

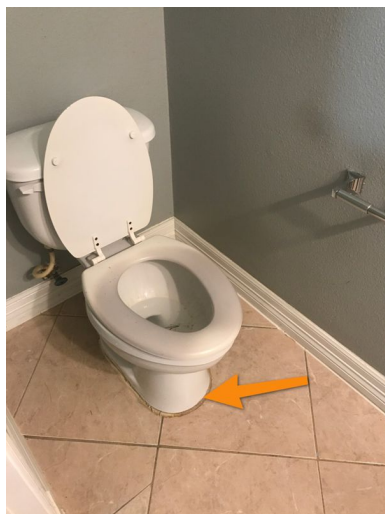
Evaluate and remedy as needed.

Recommendation: Contact a qualified professional.

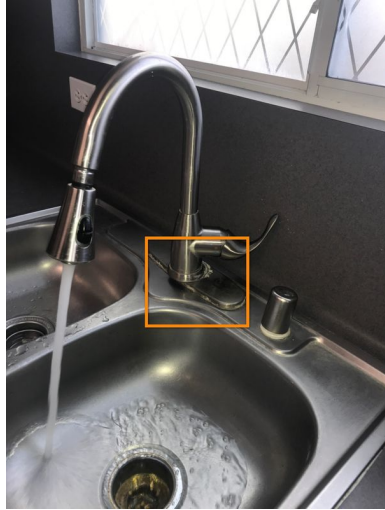
Recommend a licensed plumber or handyman evaluate and remedy as needed.

Recommendation: Contact a qualified professional.

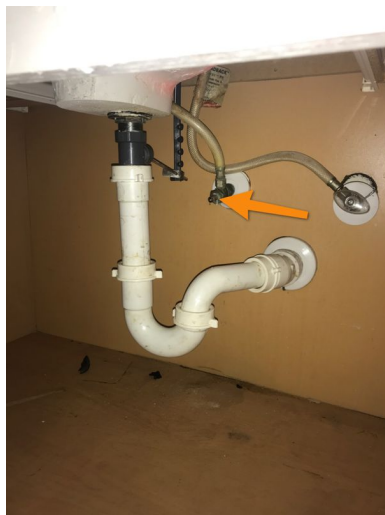
Primary Bathroom

6: Stem handle is broken.

Evaluate and remedy as needed.

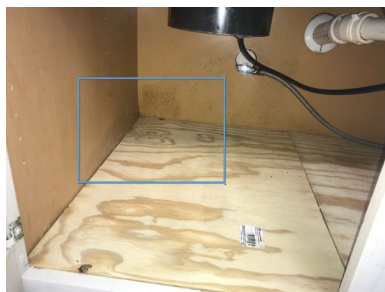
Kitchen

Note: Evidence of a previous leak was noted under the sink. No leaking occurred at time of inspection and the area remained dry.

Recommendation: Recommend monitoring.

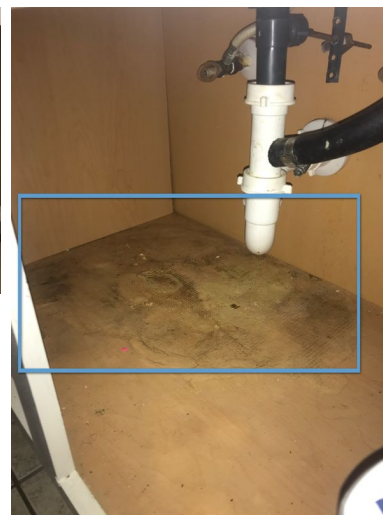
3: Drain piping: Slow Drains

Poor/slow drainage was observed at time of inspection. Evaluation and/or remediation by a licensed plumber is recommended.

Recommendation: Contact a qualified plumbing contractor.

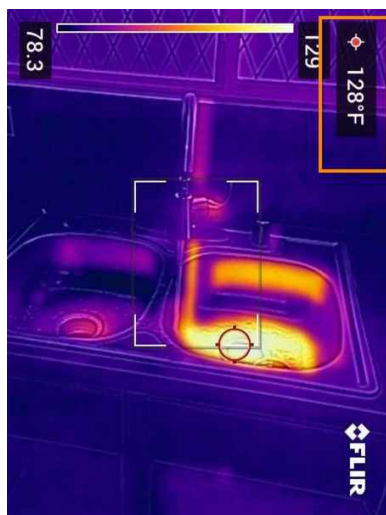
The hot water temperature was measured and exceeds 125-Degrees F, which can cause burns from scalding. Refer to the Operating Instructions in the manual for this specific unit for detailed instructions on setting the proper water temperature for your needs. Contact a licensed plumber for further information.

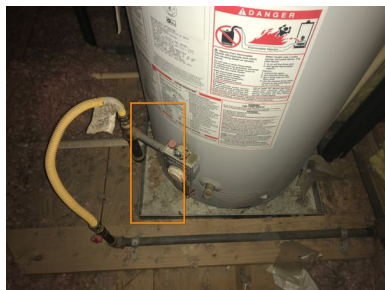
3: Tank: Insulation/debris in pan

There was insulation/debris in the overflow pan. This can clog the drain if the unit were to leak in the future. Evaluation and remediation is recommended.

Recommendation: Contact a qualified professional.

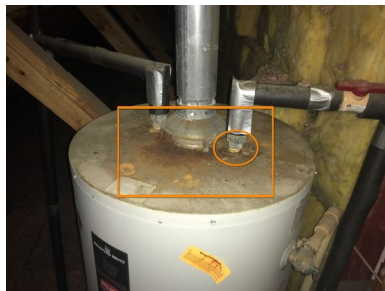
5: Tank: Rusted/Damaged Tank

Evaluate and remedy as needed.

Recommendation: Contact a qualified professional.

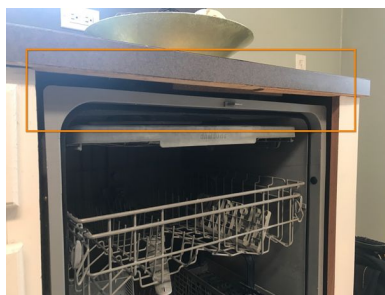
The dishwasher was not mounted securely. This may cause the unit to shift during operation which may compromise the plumbing connections. Evaluation and remediation is recommended.

Recommendation: Contact a qualified professional.

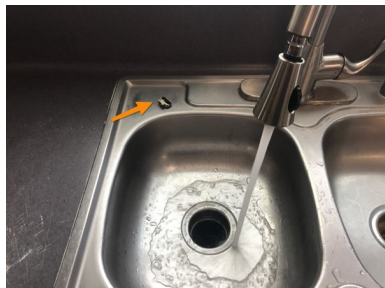
The garbage disposal sounded as if it had debris in it. Evaluation and remediation is recommended.

Recommendation: Contact a qualified professional.

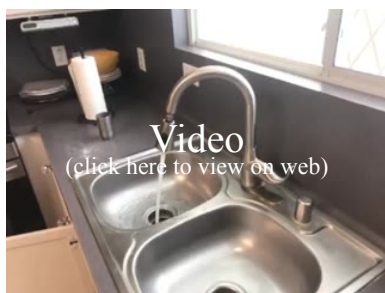
2: Excessive Noise

Garbage disposal was excessively noisy. Evaluation and/or remediation by a licensed plumber is recommended.

Recommendation: Contact a qualified plumbing contractor.

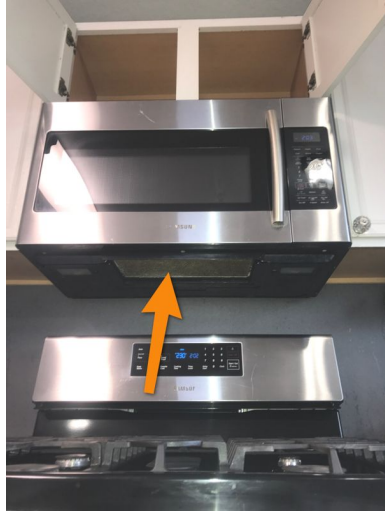
Kitchen exhaust filter had excessive grease build-up. Clean and/or replace as needed.

Recommendation: Contact a qualified professional.

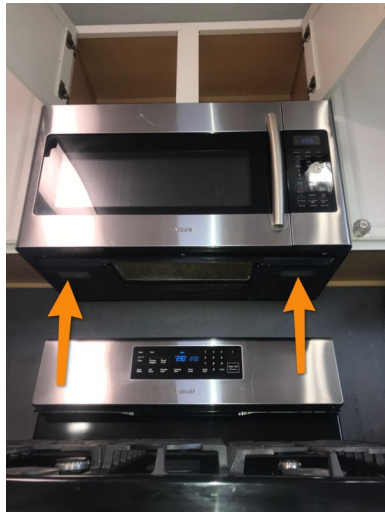
2: Exhaust Light Out

The light did not function at the kitchen exhaust. This may be the result of a bad bulb. Replace and test or remedy as needed.

Recommendation: Contact a qualified professional.

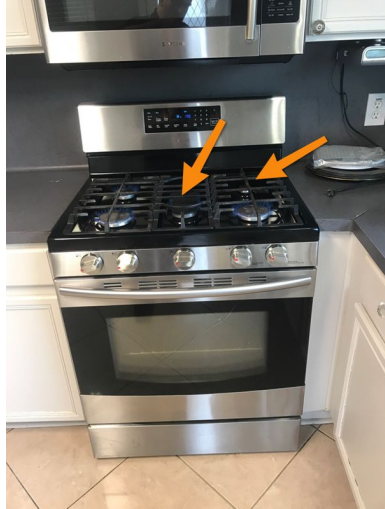
One or more burners/heating elements did not heat up when turned on. Evaluation and remediation by a qualified professional is recommended.

Recommendation: Contact a qualified handyman.

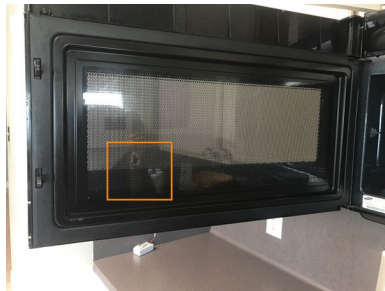
1: Damaged Door

Evaluation and remediation is recommended.

Recommendation: Contact a qualified professional.

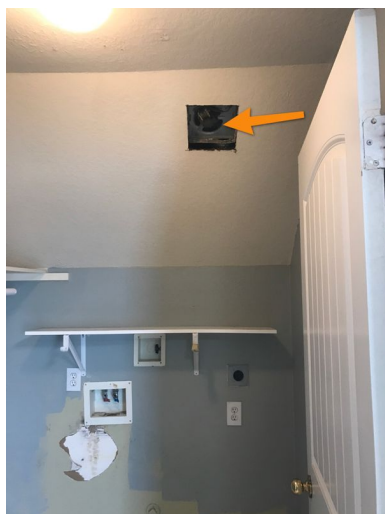
The vent cover for the exhaust fan was either missing or damaged. Evaluation and remediation is recommended.

Recommendation: Contact a qualified professional.
