SUMMARY
1826 10th St, Hempstead, TX 77445
Katherine French
December 1, 2023

Coleman Schultz
7 plus years as a home inspector in the
Houston area. TREC#21983
Integrity Inspections/Integrity First
Inspections LLC
936-548-7141
txintegrityinspections@gmail.com

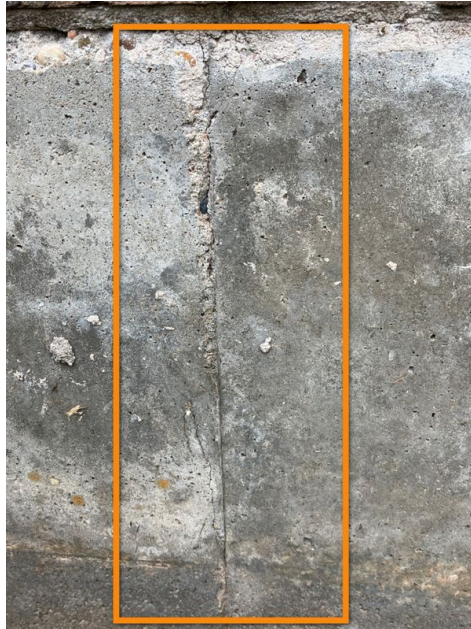
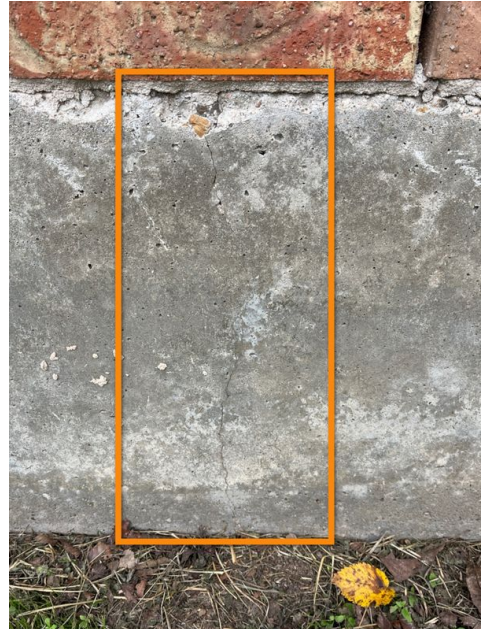
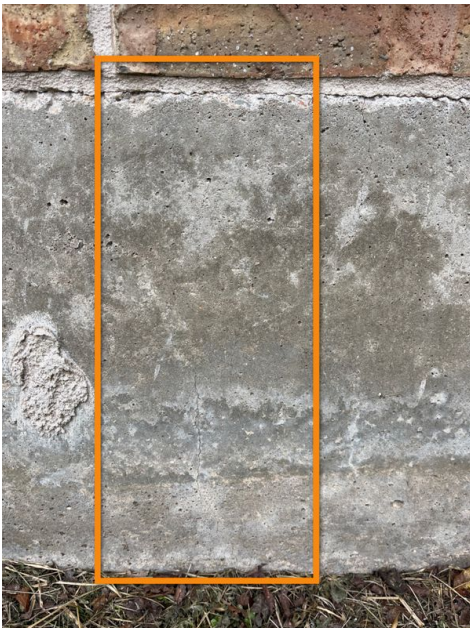
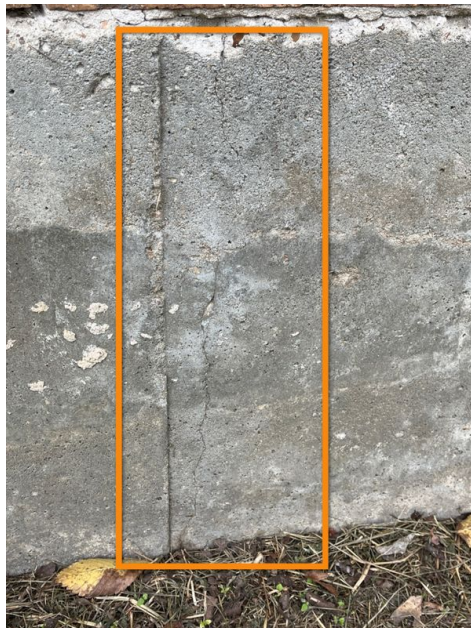
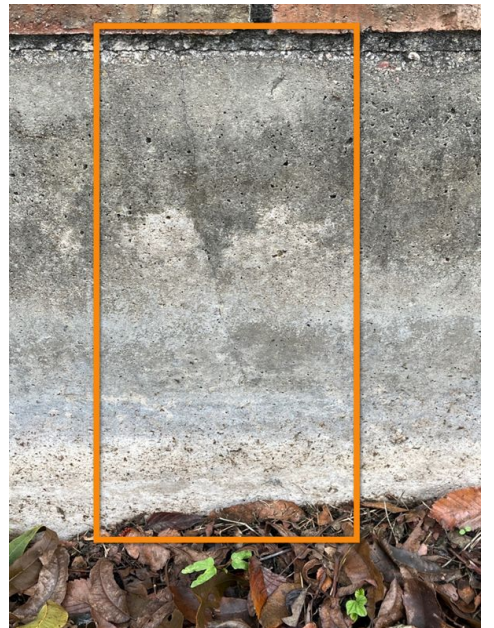
Left Side of Home

SLAB - FOUNDATION CRACKS

Cracking noted on the foundation wall. This is typically consistent with soil movement and could lead to serious damage to structural components, foundation and/or slabs. Recommend a foundation company evaluate and provide a report on course of action and remedy.

Contact a foundation contractor.

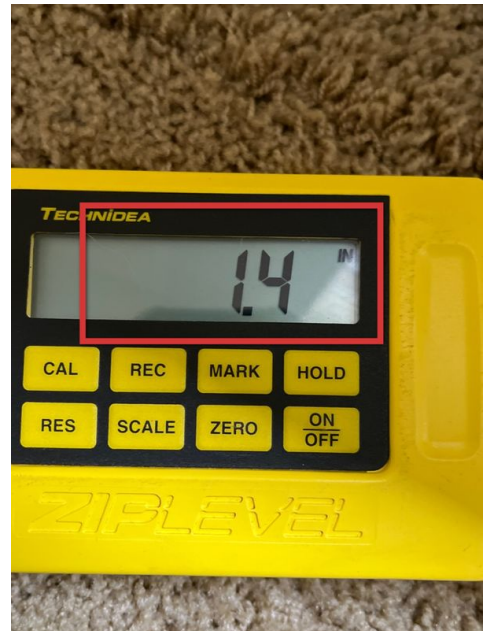
Front right corner

The foundation appears to have had some type of movement that may be beyond normal. A Professional Engineer licensed by the State of Texas should be consulted on the current integrity of the foundation and any repairs that may be necessary (If Any). The observations made to support the rendering of this opinion are listed but not limited to the following:

In my opinion, this foundation is showing signs of movement that exceeds normal tolerances.

- The changes in the floor elevation of the house were greater than would normally be expected
- Deflection cracks were observed in the exterior veneer.
- Misalignment of interior doors due to foundation movement.
- Interior door(s) stick and/or not closing due to foundation movement.
- Separations of the exterior veneer and window frames were observed.
- Frieze board separations were observed.
- Cracks were observed in the floor of the foundation.
- Floor slopes and/or unlevelness were observed.
- Stress crack(s) were observed in the exterior foundation perimeter beam.
- Interior sheetrock cracks and/or stress indicators.

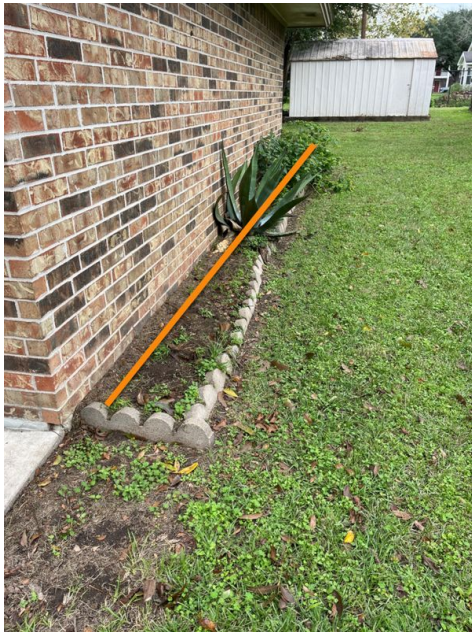
Right Side of Home

Grading is sloping towards the structure(s) in some areas. This could lead to water intrusion into the wall cavity or the crawlspace (if applicable) and potentially cause foundation issues over time. We recommend a qualified landscaper or foundation contractor regrade so water flows away from home.

Contact a qualified landscaping contractor

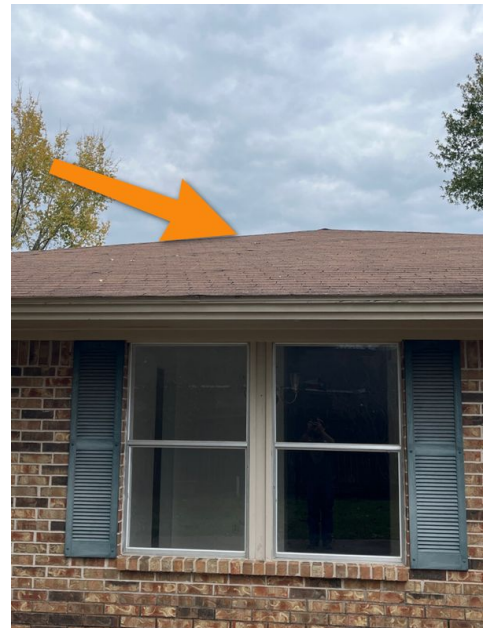
Multiple Areas

Shingles appears lifted at various areas of the roof. Repairs are needed.

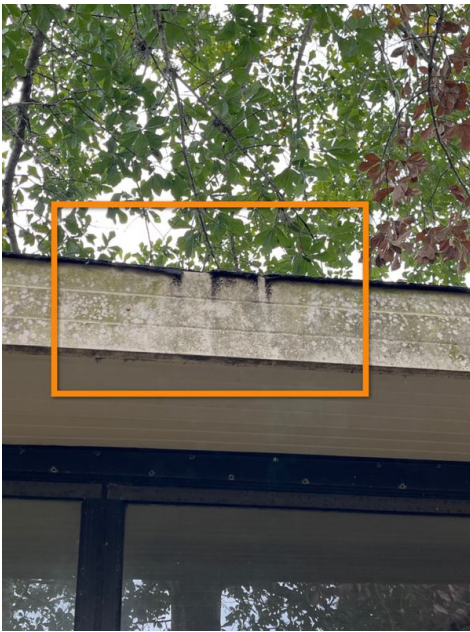
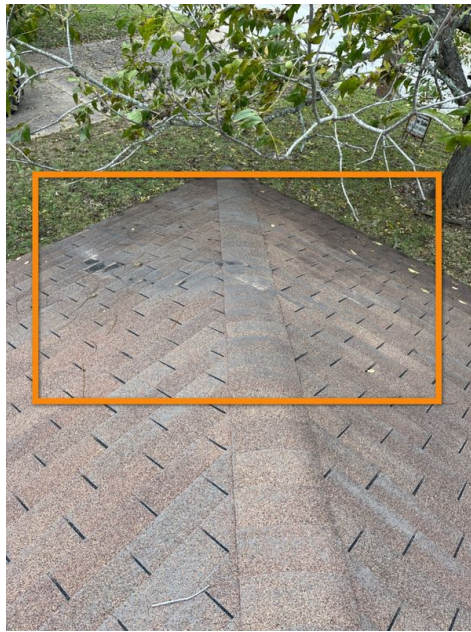
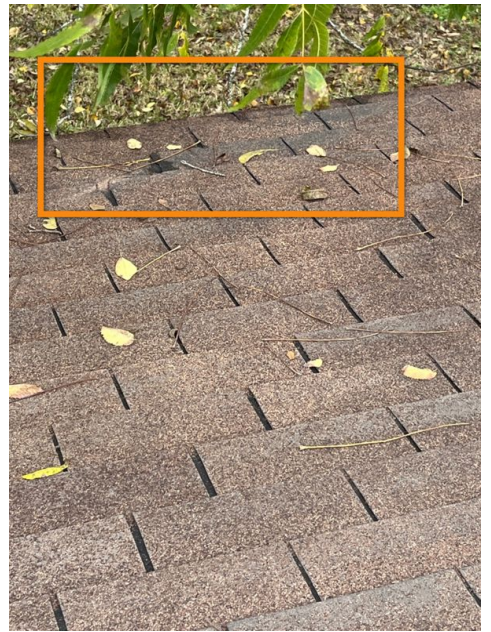
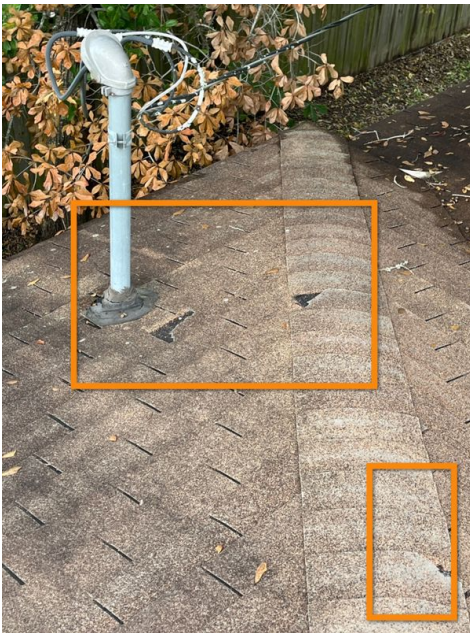
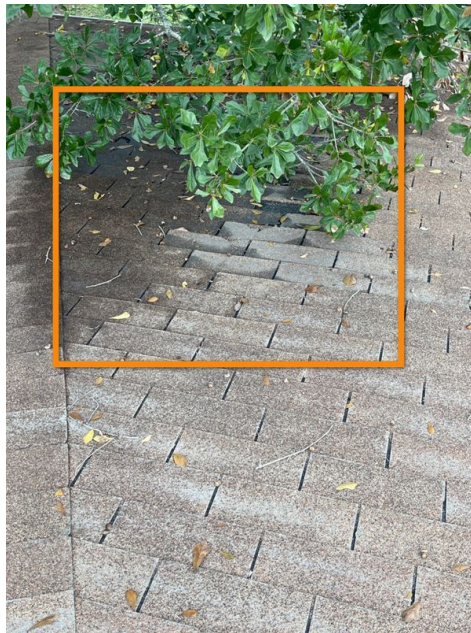
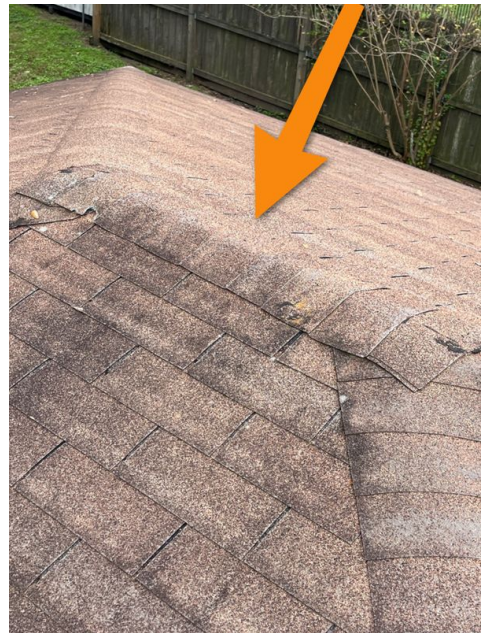
DAMAGED COVERINGS

Roof coverings exhibited general damage that could affect performance. Recommend a qualified roofer evaluate and repair.

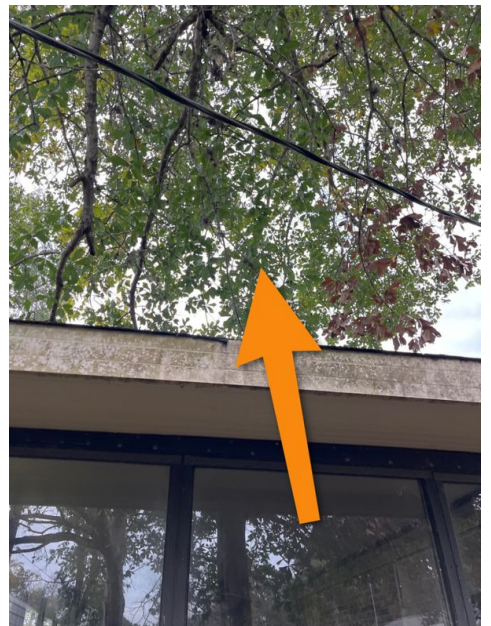
Tree branches impinging roof line can damage a roof even in a gentle breeze. Whenever a tree is in contact with the roof structure, we recommend trimming the tree or branches back aggressively.

Recommendation
Contact a qualified tree service company.

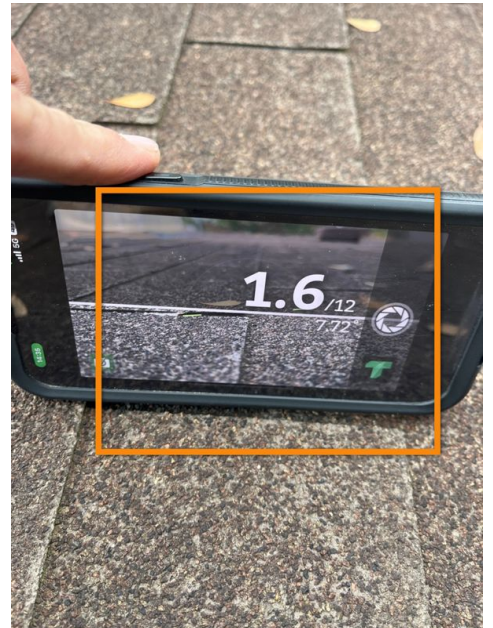
Rear of Home

There are shingles installed on the portion of this home that has a low sloped roof. Shingles should not be installed on sections of roof with a pitch lower than 3/12. The issue with this is that water will stand on this portion of the roof covering and have potential for leaks over time plus it will deteriorate the roof covering at a faster rate than the portion of the roof that has a proper slope.

Contact a qualified roofing professional.

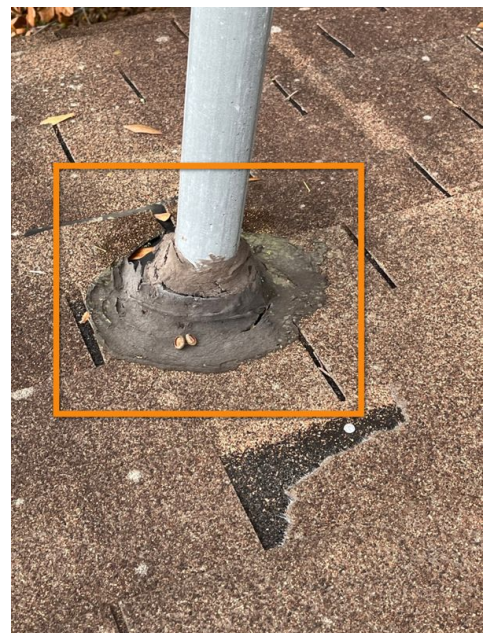
Mast pole at roof

Sealant or caulking is needed in areas of the roof covering. Sealants should only be used as a secondary protection however due to weathering or missing caulking, these areas are in need of repairs.

Contact a qualified professional.

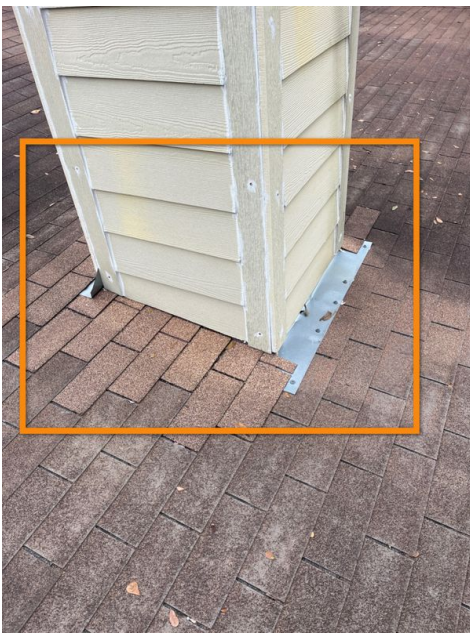
Multiple Areas

Roof covering appears to be improperly installed in areas. I recommend having a qualified roofing contractor inspect and repair as needed.

Contact a qualified professional.

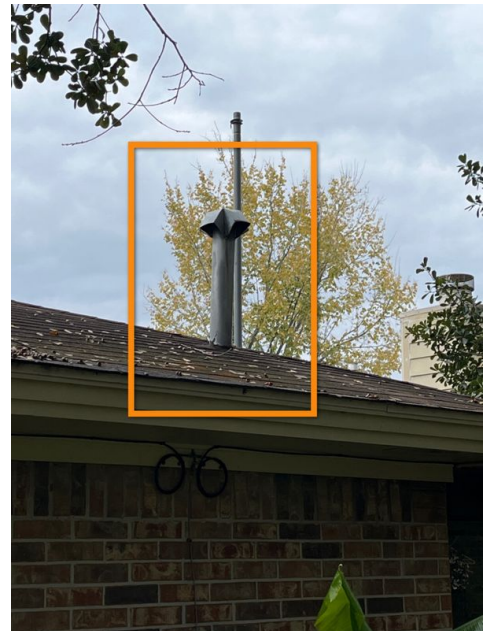
Multiple Areas

Vents are not painted. I recommend having a contractor inspect and repair as needed.

Recommendation
Contact a qualified professional.

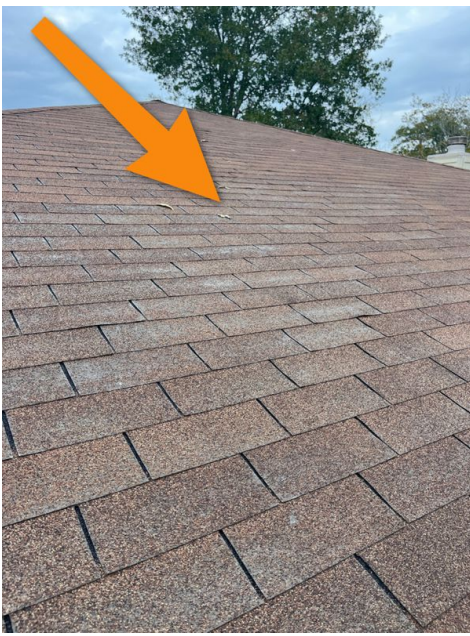
The roof covering appears to show signs of excessive granule loss on multiple areas of the roofing surface. This may indicate that the roof covering may be at or towards the end of its life expectancy. It is recommended to have a qualified roofing contractor further evaluate the roof covering and make any necessary repairs.

Recommendation
Contact a qualified roofing professional.

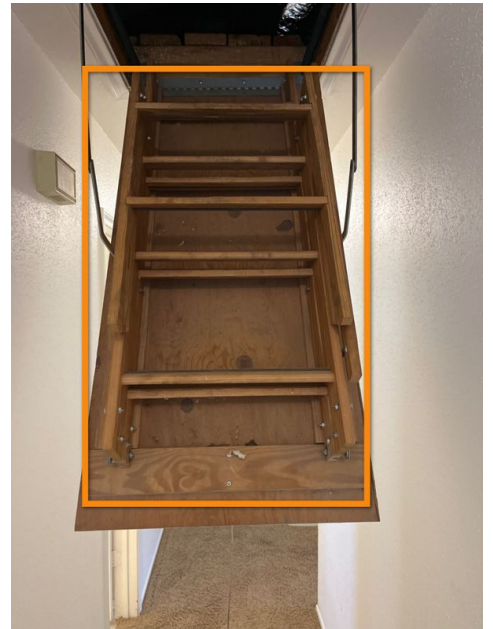
The attic opening or the pull down stairs was not properly insulated. This can affect the energy efficiency and "comfort" level of the home. I recommend adding an insulated cover over the access.

Contact a handyman or DIY project

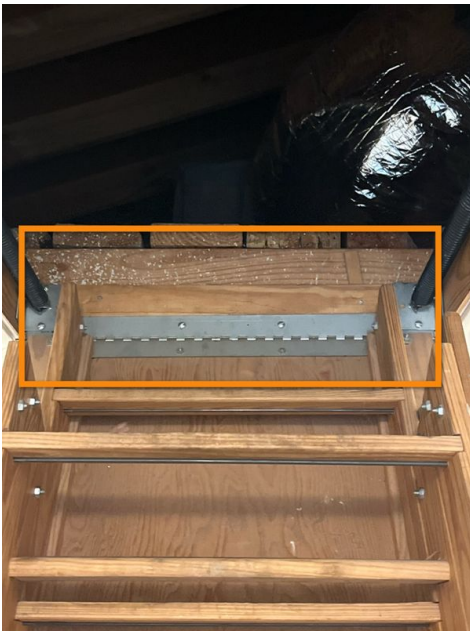
Attic pull down stairs do not appear to be properly secured at hinge areas. This is a safety issue. I recommend repairs as needed by a contractor.

Contact a qualified professional.

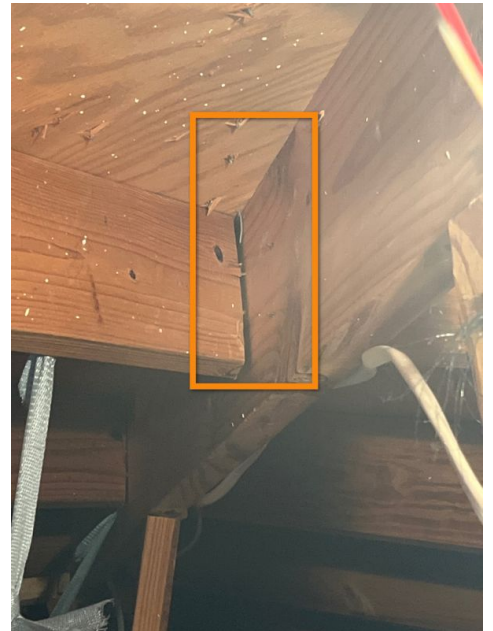
Various Areas

Rafters in the attic space appears to show sings of separation from ridge beam. This could be due to sub standard contractor work. Further evaluation by a qualified contractor is recommended.

Recommendation
Contact a qualified professional.

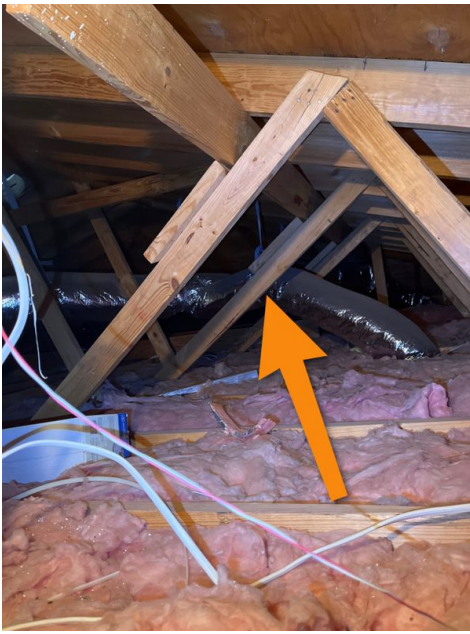
The roof structure attic space ventilation appears to be marginal at the time of this inspection. It is recommended to increase the amount of lower and upper ventilation to help prevent heat buildup in the attic space area.

Recommendation
Contact a qualified professional.

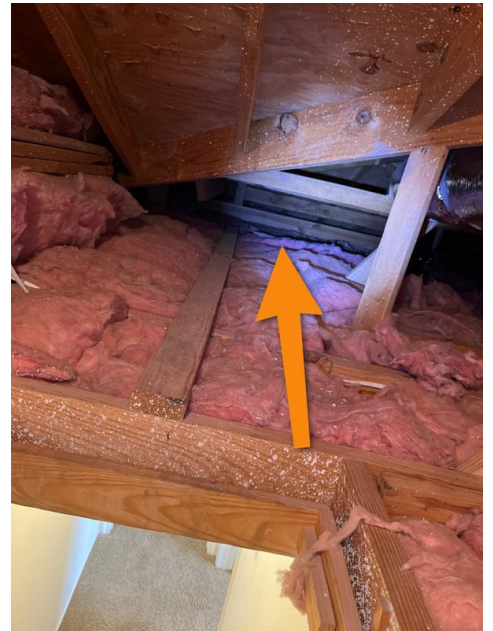
Perimeter of Home

The baffle plates did not appear to be installed. This can cause various issues. I recommend having a qualified contractor inspect and repair as needed.

Recommendation
Contact a qualified professional.

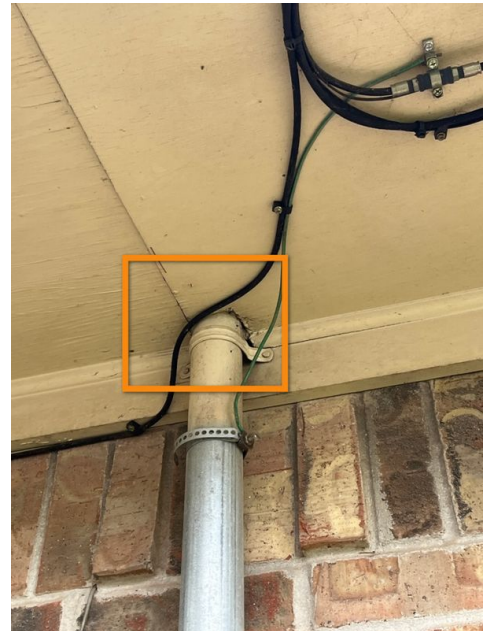
Left Side of Home

Anywhere where electrical, plumbing and piping penetrate through the walls should be sealed to prevent possible damage. I recommend repairs by a qualified contractor.

Recommendation
Contact a qualified professional.

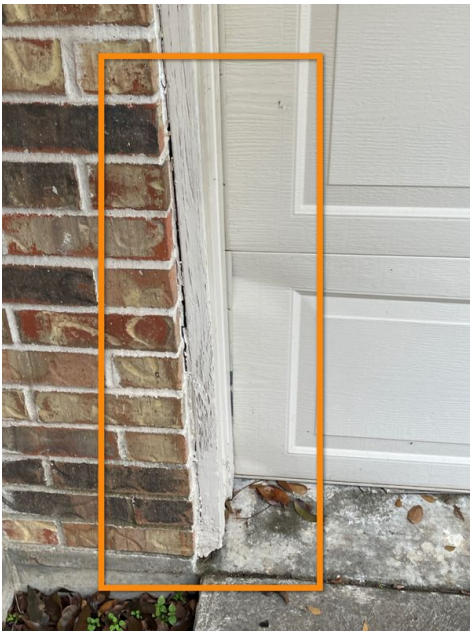
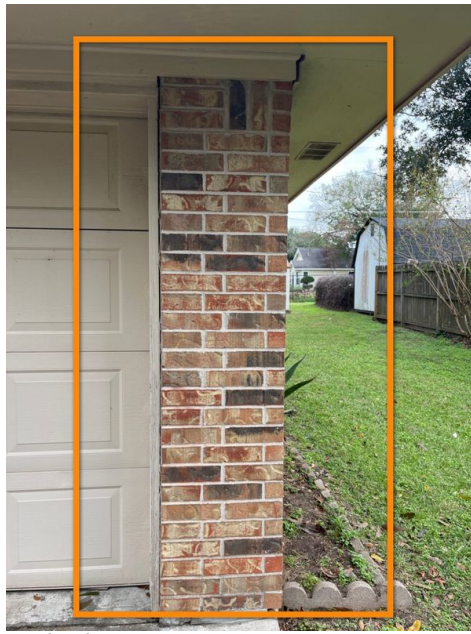
Various Areas

All exterior gaps should be sealed to prevent moisture or pest intrusion.

Recommendation
Contact a qualified professional.

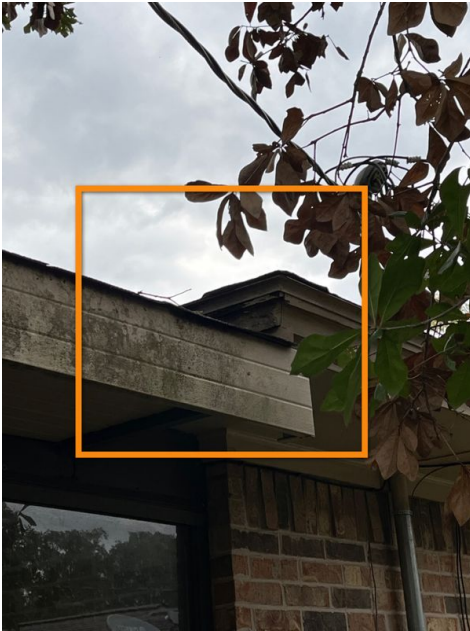
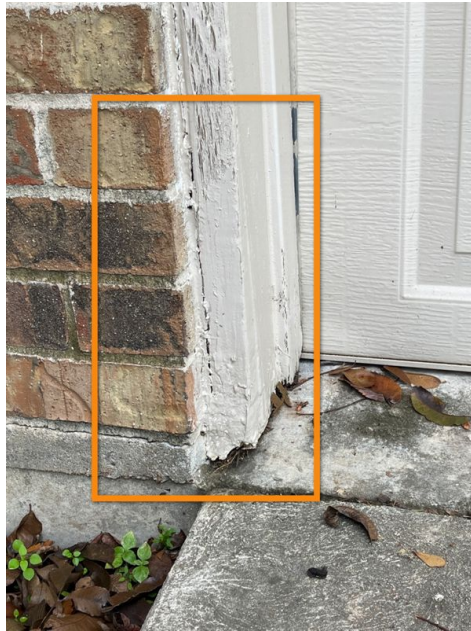
Roof Line Areas

2.5.3 E. Walls (Interior and Exterior)
EXTERIOR SIDING IS DAMAGED.

Exterior siding in areas is damaged or deteriorated. I recommend repairs by a qualified contractor.

Recommendation
Contact a qualified siding specialist.

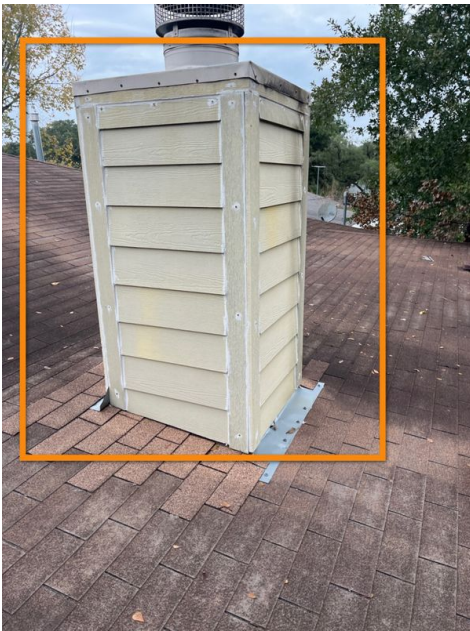
Roof Line Areas

2.5.7 E. Walls (Interior and Exterior)
PEELING OR MISSING PAINT IN AREAS

The exterior paint is peeling or missing in areas. This is a cosmetic issue. I recommend having a qualified contractor inspect and repair as needed.

Recommendation
Contact a qualified professional.

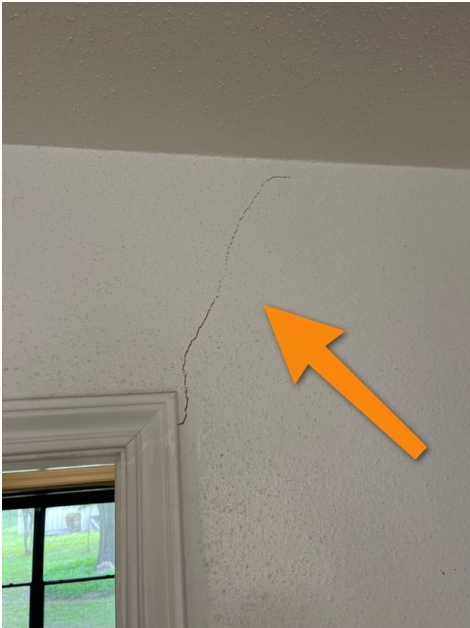
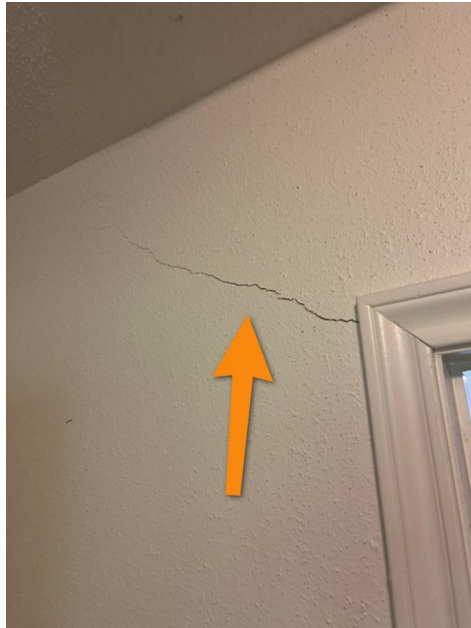
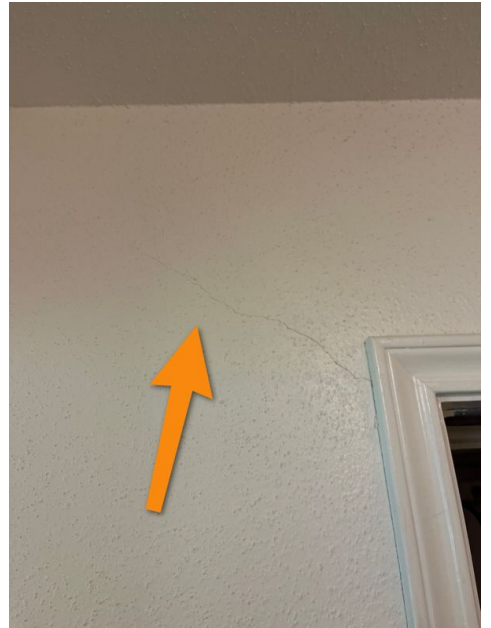
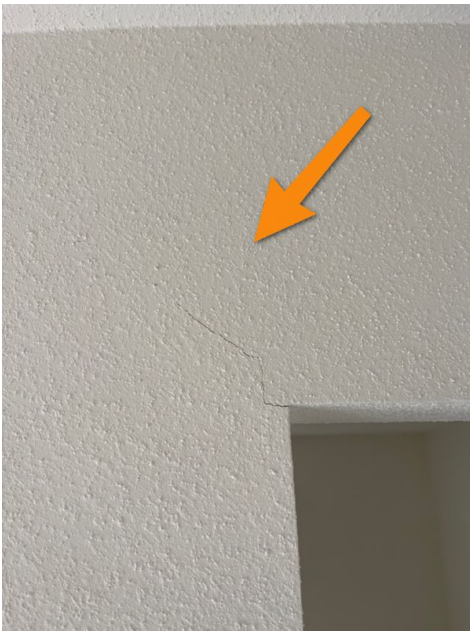
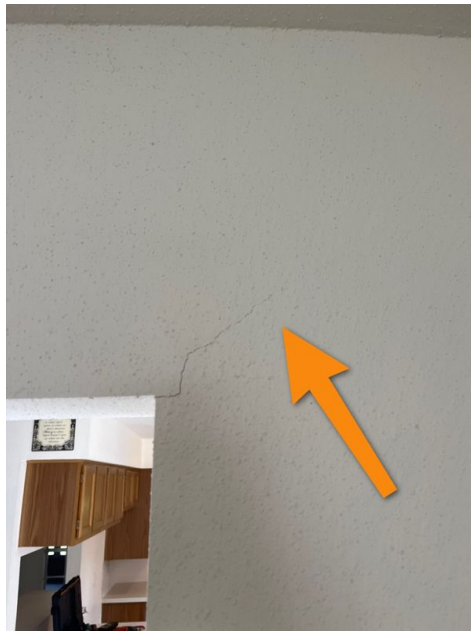
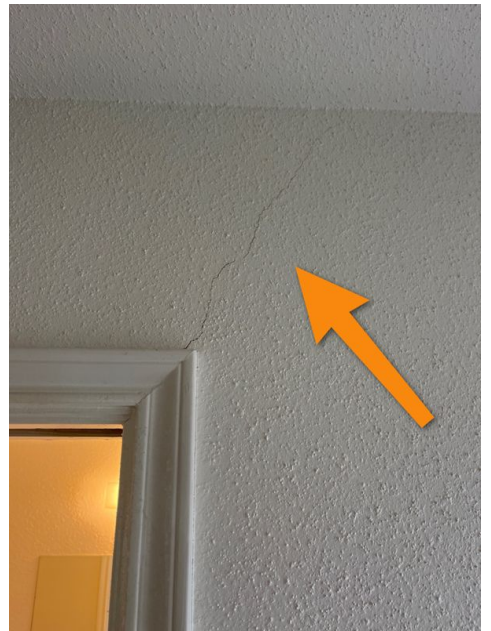
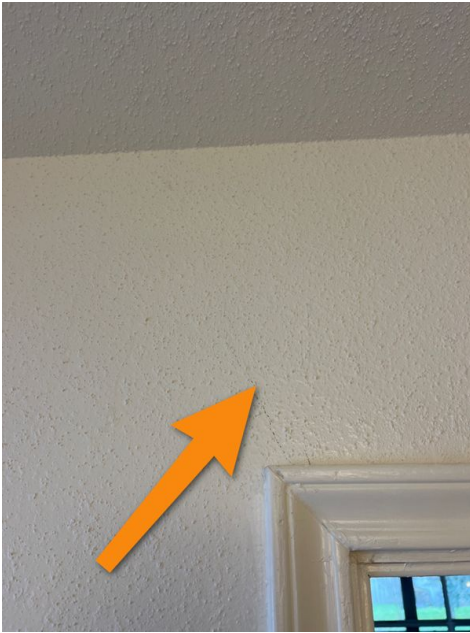
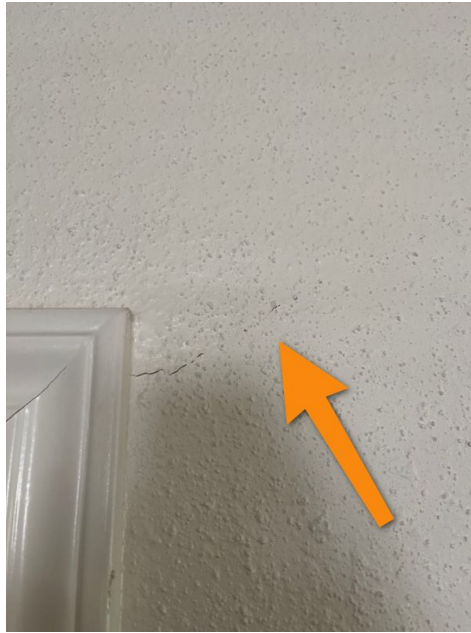
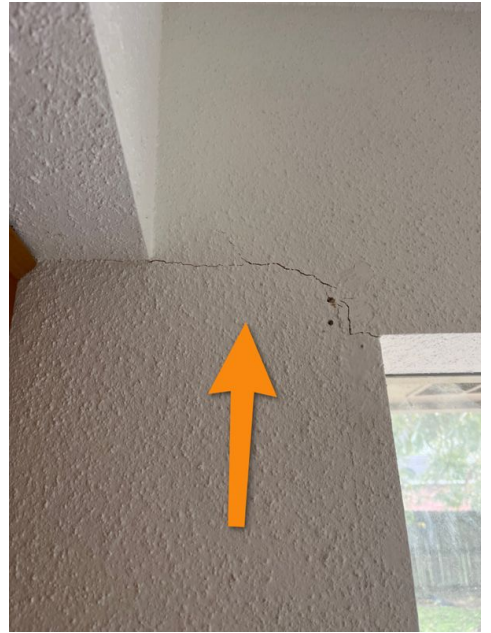
CRACKS - CRACKS (DRYWALL SETTLEMENT)

Settlement cracking observed in drywall. These area (s) may need further evaluation by a structural engineer.

Recommendation
Contact a qualified professional.

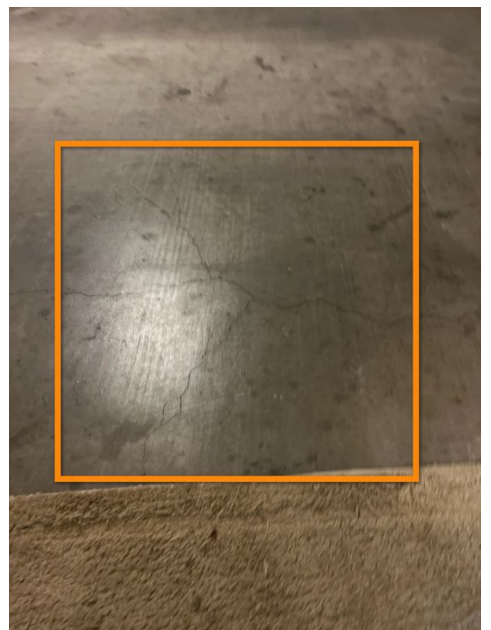
Garage areas

There are shrinkage cracks in the garage floor. These cracks are typical, however we do recommend that you seal and monitor these cracks for further movement over time.

Contact a qualified professional.

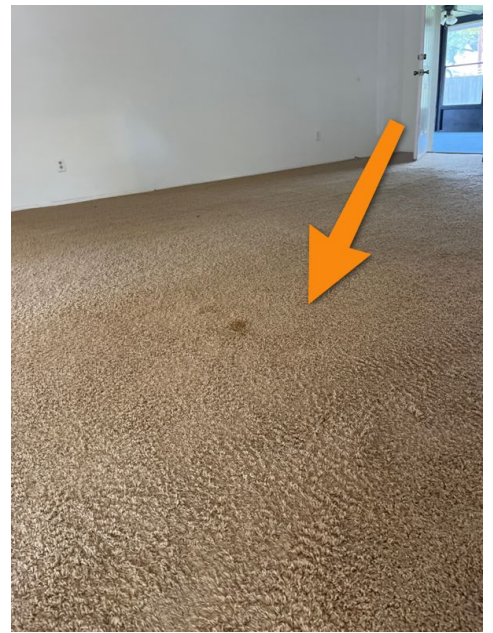
Various Areas

There are areas where the carpet is damaged or stained in areas. This is cosmetic and should be repaired as needed.

Recommendation
Contact a qualified professional.

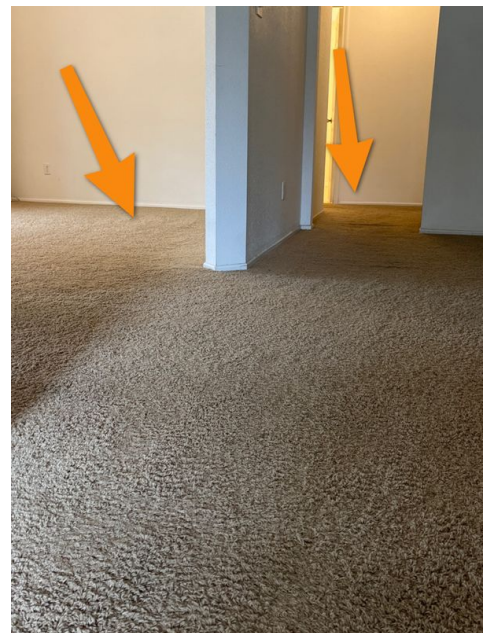
Multiple Areas

There are one or more areas throughout the home where the carpet could use stretching so that it does not become a trip hazard.

Recommendation
Contact a qualified professional.

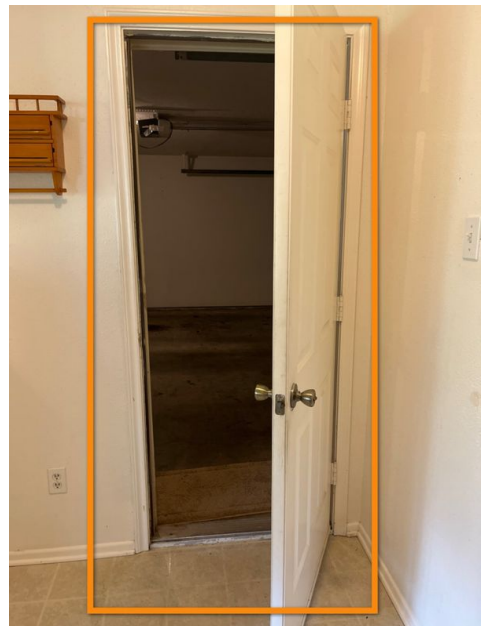
Interior doors leading into an attached garage are recommended to be equipped with self closing hinges per today's standards.

Recommendation
Contact a qualified professional.

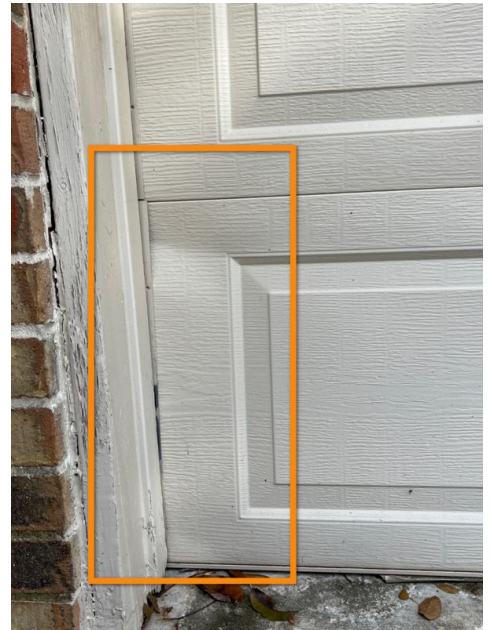
Garage door

There are one or more doors that are damaged in this home. These doors will need repair if possible and possibly replacement.

Contact a qualified professional.

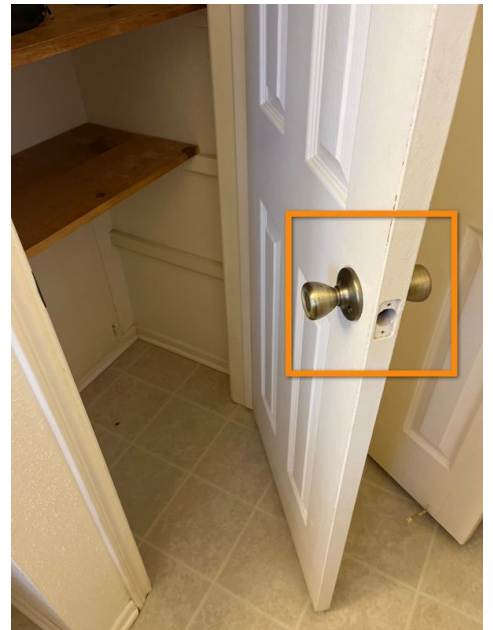
Guest Bath Closet

One or more doors have missing or loose hardware. We recommend repairs or replacement as necessary.

Contact a qualified professional.

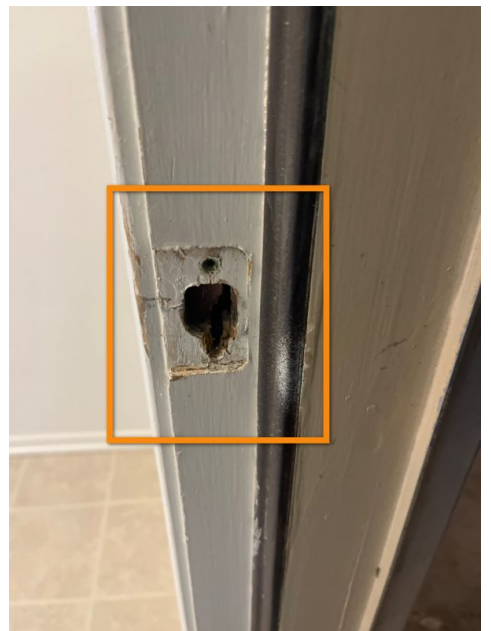
Garage

There are one or more striker plates in the door jambs that are in need of repair/adjustments.

The screws on the garage door strikerplate are loose and the holes in the frame are wallowed out so that the screws will not tighten.

This door also will not operate both directions due to the strikerplate being loose.

Contact a handyman or DIY project

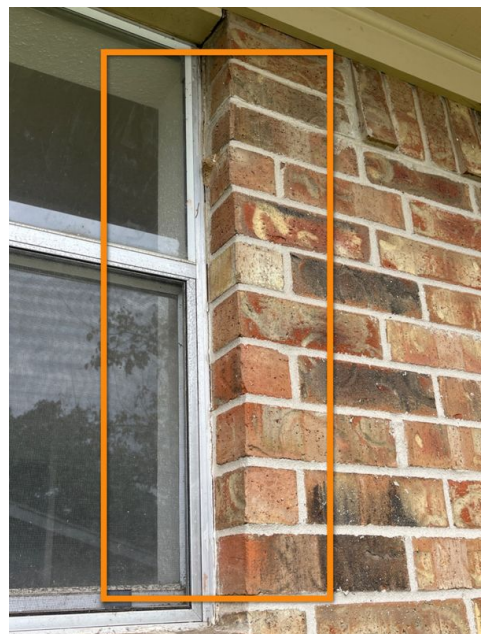
Multiple Areas

Caulking around window at the interior/exterior in areas is missing or weathered and needs repairs.

Contact a qualified professional.

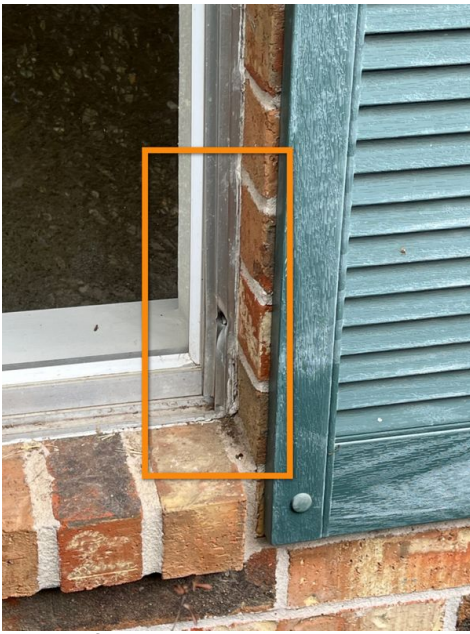
Front of Home

One or more windows appears to have general damage, but are operational. Recommend a window professional clean, lubricate & adjust as necessary.

Contact a qualified window repair/installation contractor.

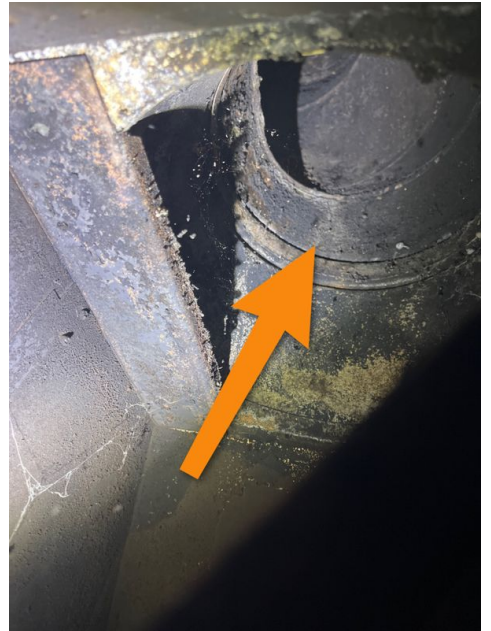
Chimney liner had layer of creosote dust, so underlying structure couldn't be inspected for cracks. Recommend qualified chimney sweep company inspect and/or clean.

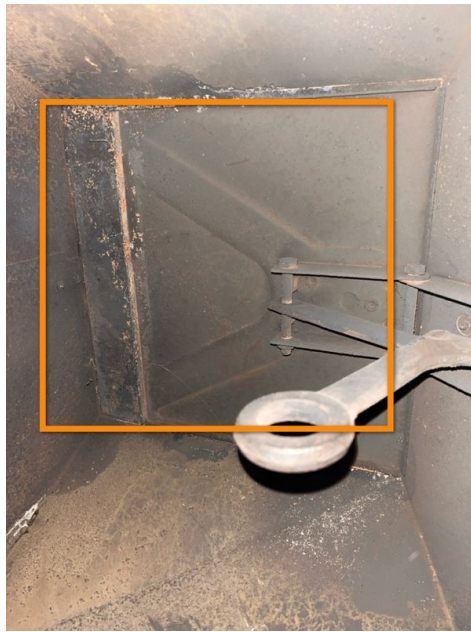
There is not a damper clamp installed on the chimney flue. We recommend that as a safety upgrade that a damper clamp be installed on the damper to keep it open a little so that if the gas were to accidentally be turned on it could have somewhere to go.

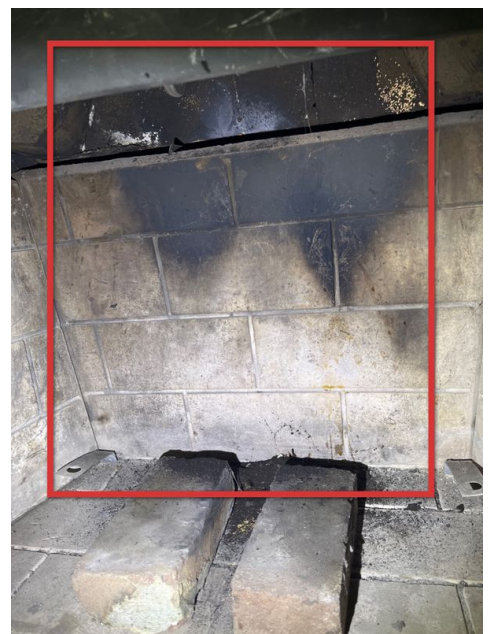
Fireplace firebox needs to be cleaned.

Recommendation
Recommended DIY Project

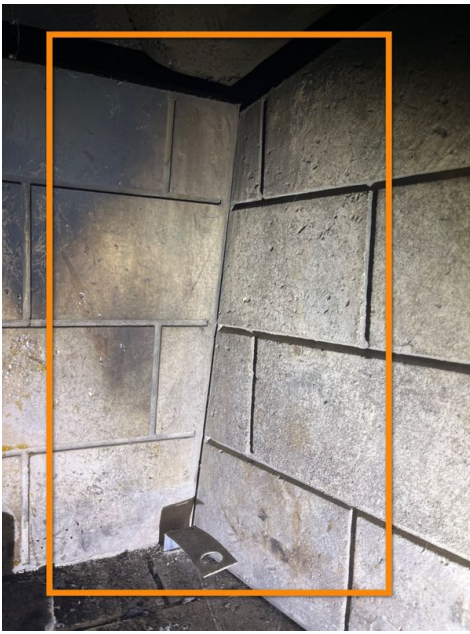
Burn area is not properly sealed.

Recommendation
Contact a qualified professional.

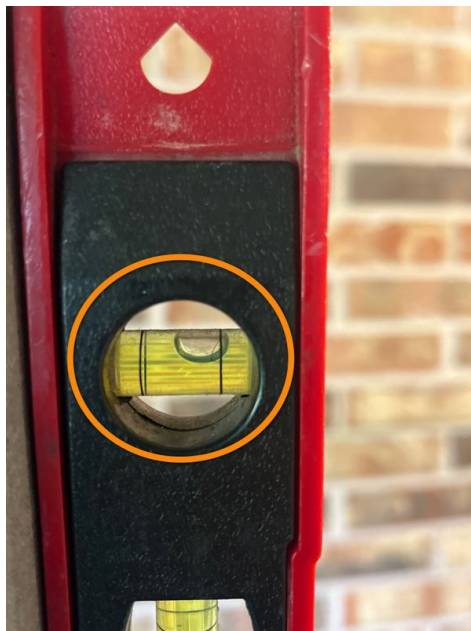
Enclosed rear patio

Support column does not appear to be properly installed. The pole is leaning. I recommend having a qualified contractor or structural engineer inspect and repair as needed.

Recommendation
Contact a qualified professional.

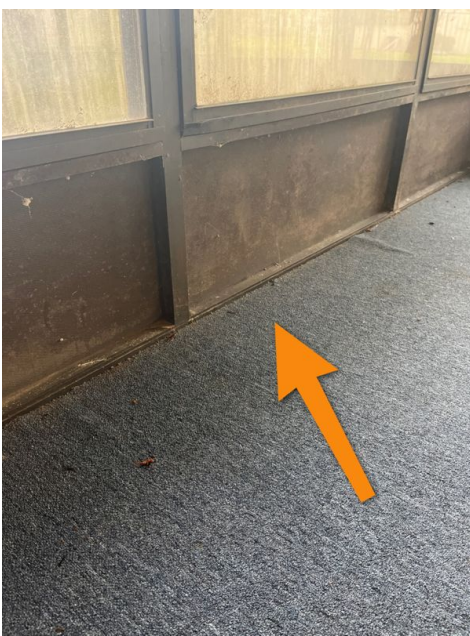
Perimeter of enclosure

The patio enclosure does not appear to be properly sealed at floor. This can cause various issues. I recommend having a qualified contractor inspect and make all necessary repairs.

Recommendation
Contact a qualified professional.

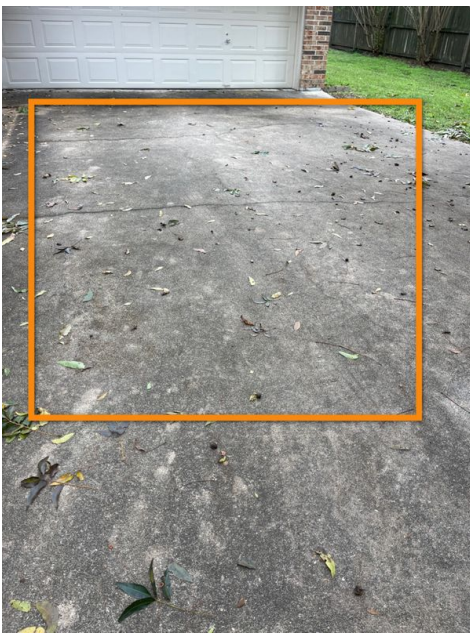
Various Areas

There are cracks or pitted areas in the driveway of this home that are in need of sealing or repairs. Some appear to be pitted. I recommend having a qualified contractor repair as needed.

Contact a qualified concrete contractor.

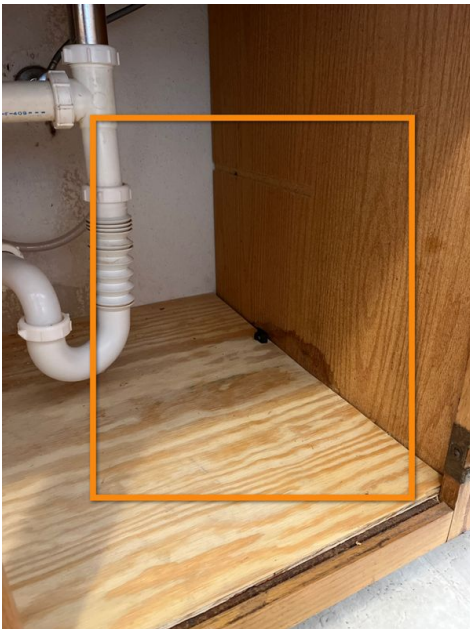
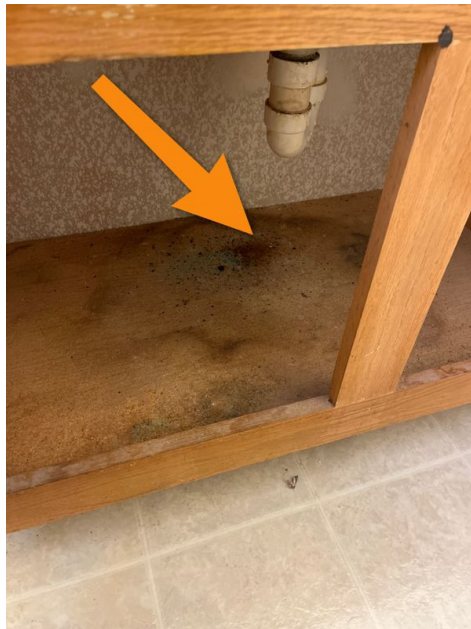
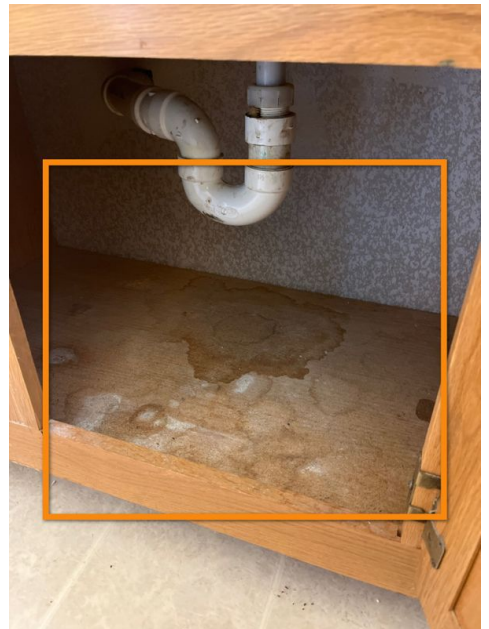
Kitchen sink

There were areas under sinks that had evidence of past moisture. Although there were no visible leaks at the time of inspection, we recommend that these areas be monitored for leaks in the future since there has been a problem in the past and if a leak occurs it is important that it is repaired as soon as possible to prevent damage to the home.

Recommendation
Contact a qualified professional.

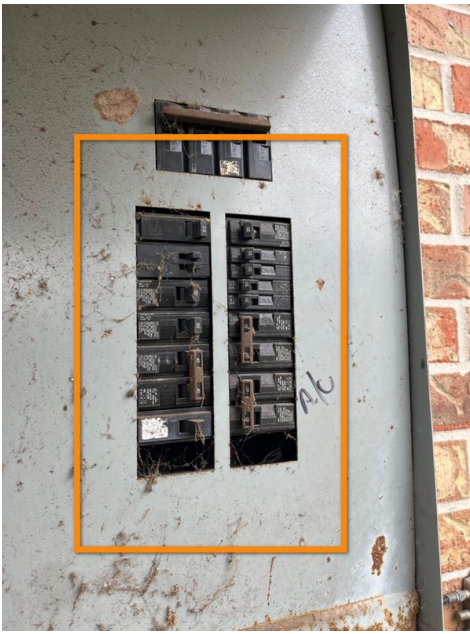
House does not have whole home surge protector present. I recommend further evaluation by a qualified electrician as needed.

Recommendation
Contact a qualified professional.

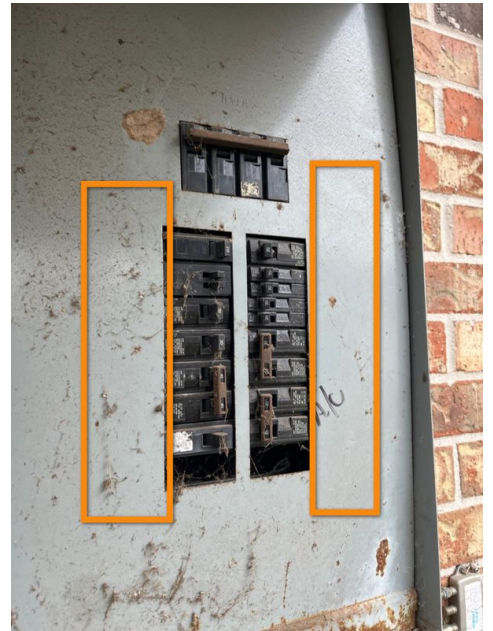
Electrical panel does not have all circuits labeled and/or these circuits are not legible. Recommend a qualified electrician test and properly label all switches.

Contact a qualified electrical contractor.

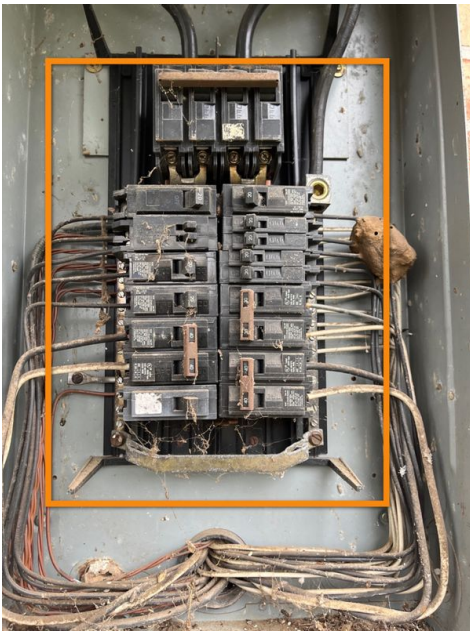
Unable to verify if electrical system is properly bonded. All panel boxes appear to have bonding screw installed. I recommend having a licensed electrician inspect and repair as needed.

Contact a qualified electrical contractor.

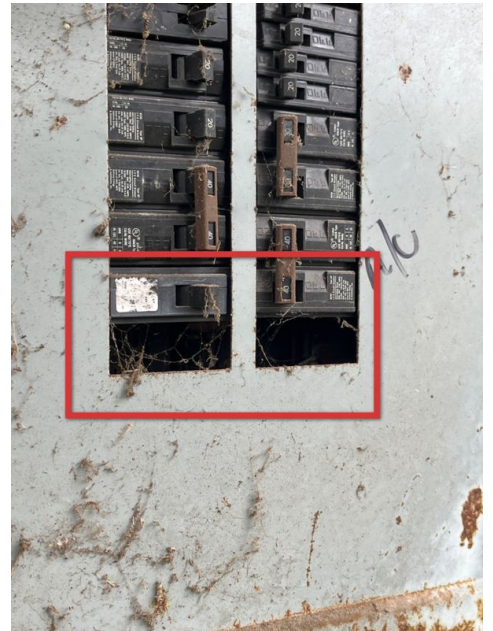
Blanks or covers are missing at electrical panel.

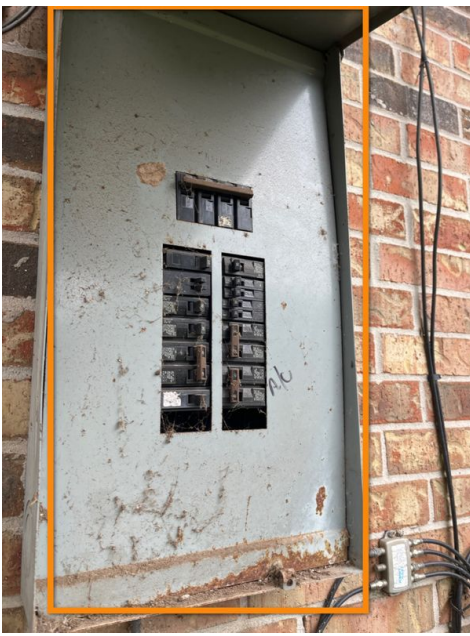
The panel appears to show signs of rust and deterioration. Repairs may be needed.

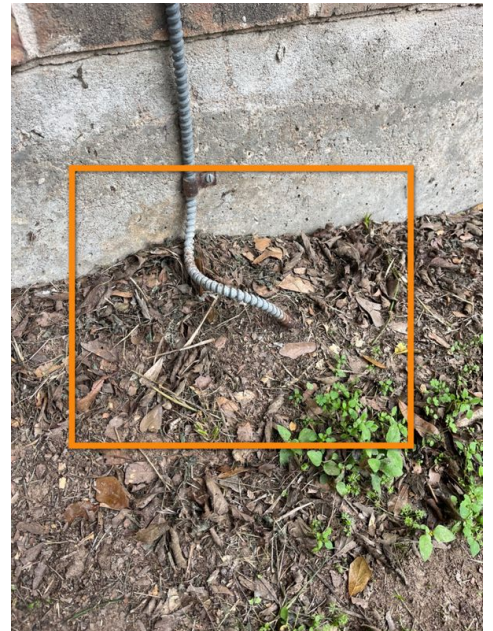
I was unable to locate a grounding clamp or rod to ensure panel is properly grounded. I recommend having a qualified electrician further evaluate.

Recommendation
Contact a qualified electrical contractor.

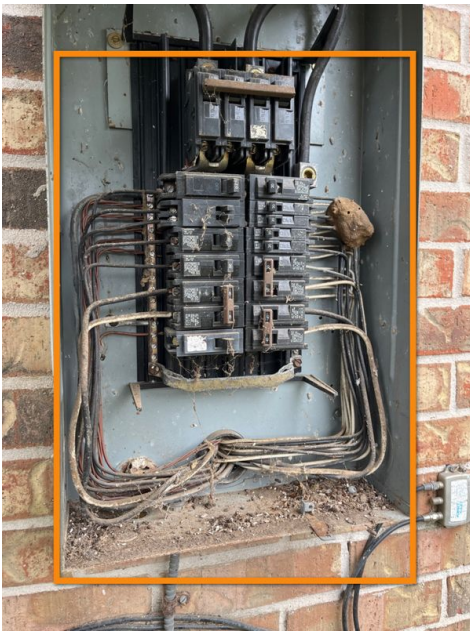
Debris inside panel or not properly sealed . This can be a safety issue. I recommend having a qualified electrician inspect and repair as needed.

Recommendation
Contact a qualified professional.
