SUMMARY
1826 10th St, Hempstead, TX 77445
Katherine French
December 1, 2023

Coleman Schultz
7 plus years as a home inspector in the
Houston area. TREC#21983
Integrity Inspections/Integrity First
Inspections LLC
936-548-7141
txintegrityinspections@gmail.com

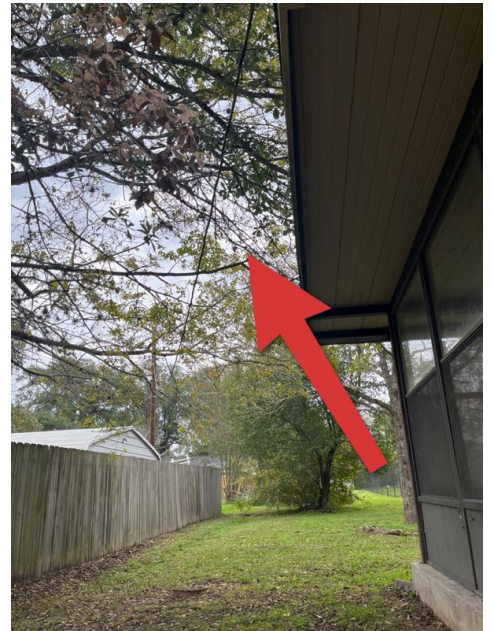
The electrical service conductors clearance (outside) from the ground is lower than 12 feet, and needs correcting for safety.

Recommendation
Contact a qualified professional.

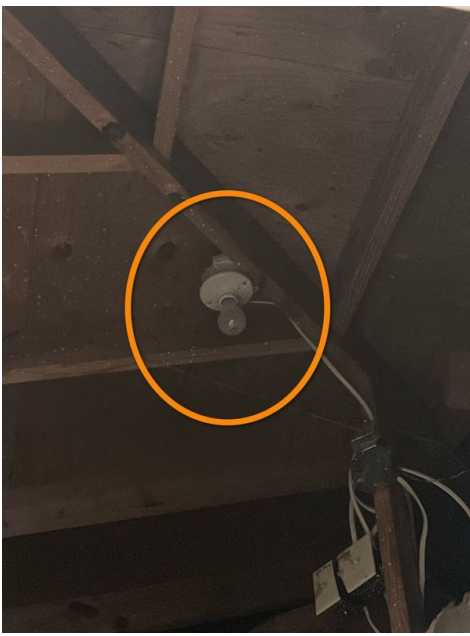
Attic space is missing recommend light cover. Recommend repairs as needed.

Recommendation
Contact a qualified professional.

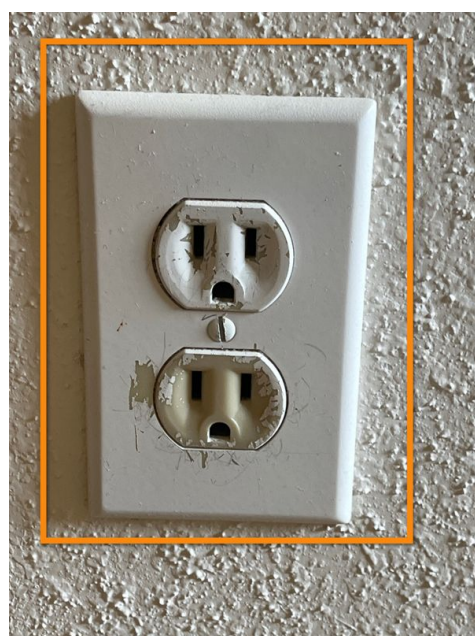
Throughout home

Home is missing tamper resistant outlets in areas. I recommend consulting a qualified electrician.

Recommendation
Contact a qualified professional.

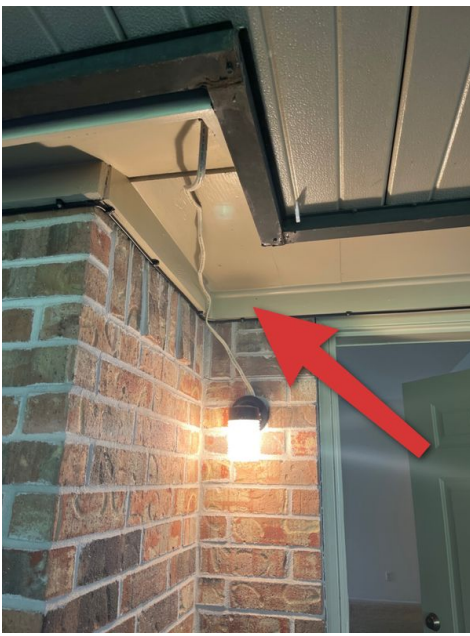
Rear patio

There are areas around the home that have exposed electrical wiring. Wiring should not be exposed where someone can touch or where wiring can be damaged.

Recommendation
Contact a qualified electrical contractor.

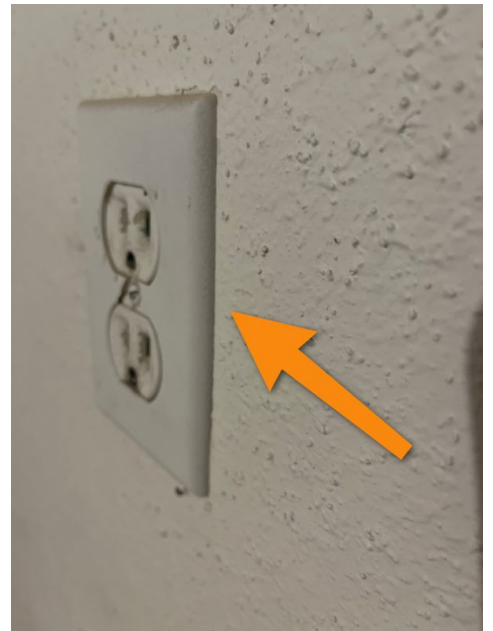
Various Areas

Receptacle or light switch is loose in wall and is not properly secured. I recommend having a licensed electrician inspect and repair as needed.

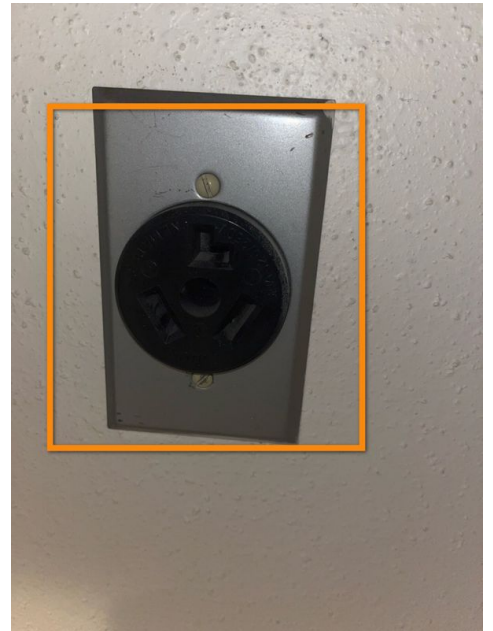
Laundry Room

The dryer has a 3 prong outlet. This is not considered today's standard. I recommend having a qualified electrician inspect and repair as needed.

Recommendation
Contact a qualified professional.

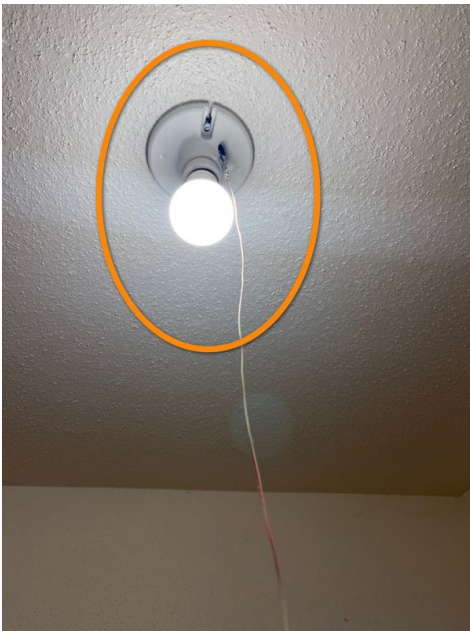
Front bedroom closets

The fixture is only pull string operated. This is not considered today's standard. I recommend having a licensed electrician inspect and repair as needed.

Recommendation
Contact a qualified professional.

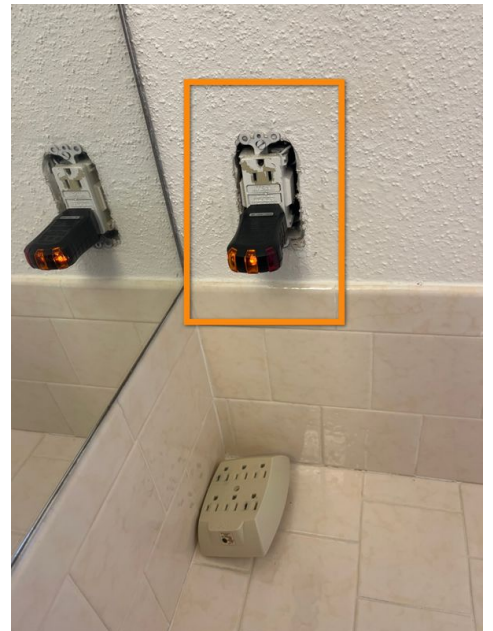
Master Bath

GFCI will not trip. This is a safety issue. I recommend having a licensed electrician inspect and repair as needed.

Recommendation
Contact a qualified professional.

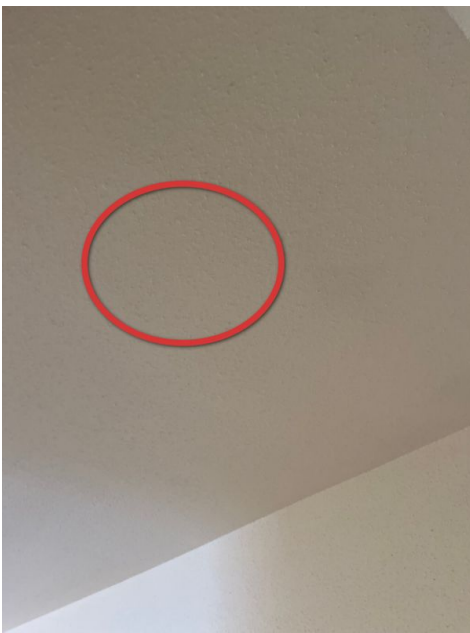
All required areas

Smoke alarms are missing in required/recommend areas.

Recommendation
Contact a qualified electrical contractor.

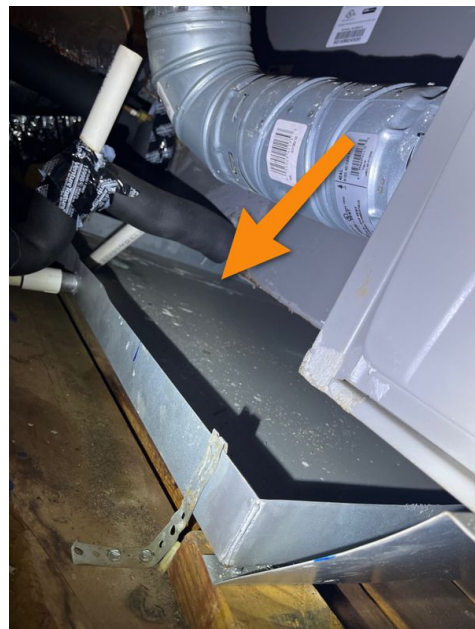
Unit did not appear to have a pan switch. U it is located in the attic. I recommend having a qualified hvac contractor inspect and repair as needed.

Recommendation
Contact a qualified professional.

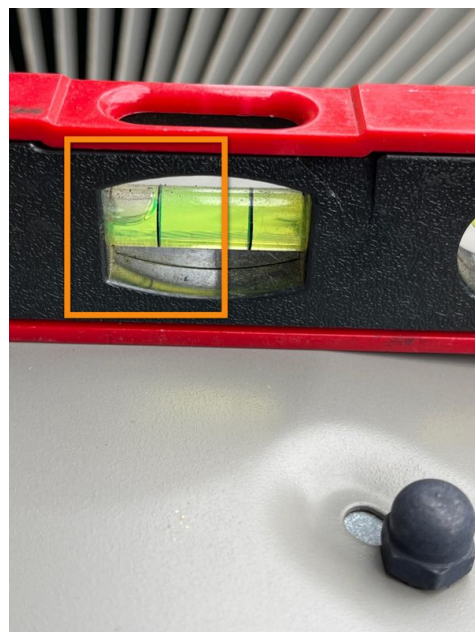
The condensing unit(s) were not level. This can put strain on the fan motor, prevent proper lubrication of the compressor, and affect system performance. I recommend that the units are leveled as needed by an HVAC contractor or other qualified person.

Recommendation
Contact a qualified HVAC professional.

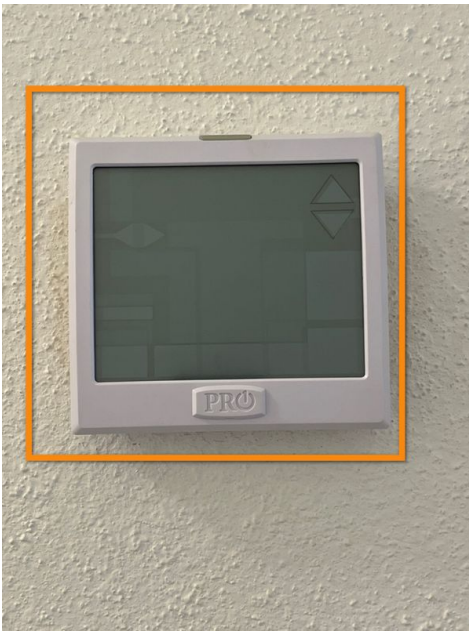
The thermostat was not operational at time of inspection. The u it was not function tested. I recommend having a licensed HVAC contractor inspect and repair as needed.

Recommendation
Contact a qualified professional.

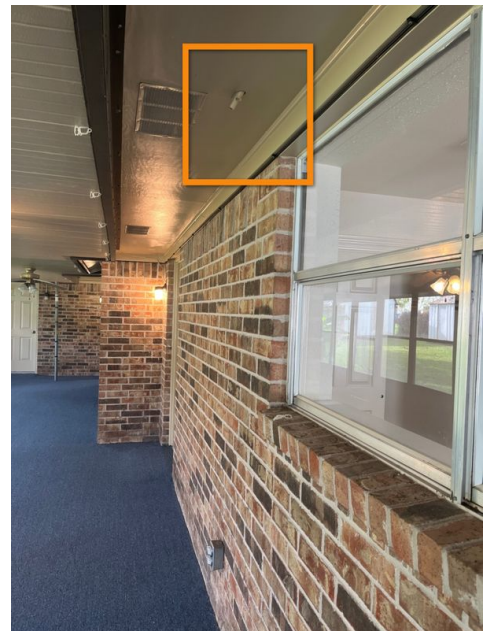
The secondary drain line is in an improper location. The drain line will drip into enclosed patio. This can cause moisture issues. I recommend having a licensed HVAC contractor inspect and repair as needed.

Recommendation
Contact a qualified professional.

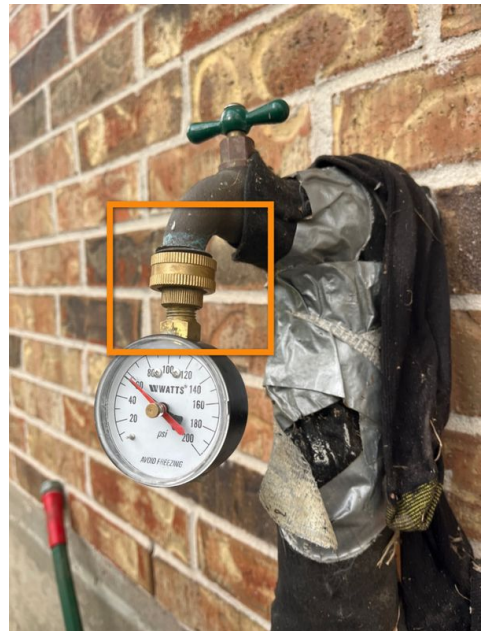
Multiple Areas

Water hose bib's (spigots) on the exterior of the home should have anti-siphon/ back flow prevention devices installed on them to keep the supply lines from being contaminated with trash or severe flood waters. In some cases hose bibs may have a built in antisiphon but it is difficult to tell unless the tag is left on the hose bib.

Recommendation
Contact a handyman or DIY project

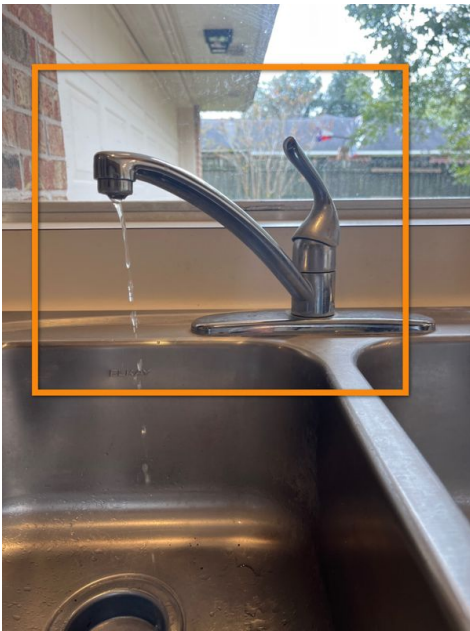
Kitchen sink (no pressure fittings are in open position)

There is low pressure at some fixtures at the time of inspection. It would be a good idea to replace the faucets in this home if this does not remedy the pressure fluctuation then there is an issue in the line at some point and it will need to be assessed by a licensed plumber.

Recommendation
Contact a qualified plumbing contractor.

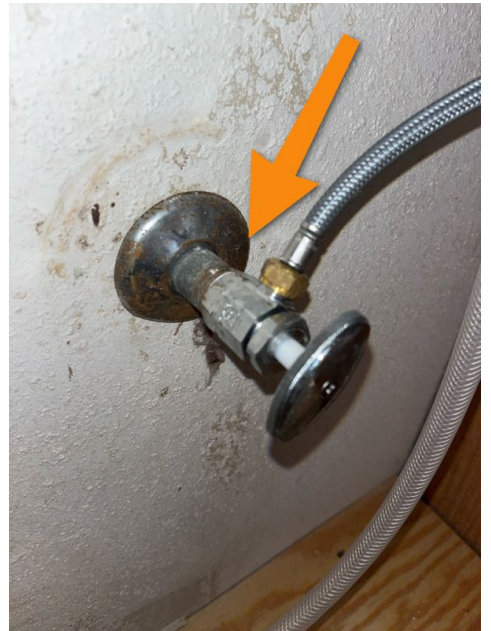
Throughout home

The supply piping in this home is galvanized steel piping. The galvanized piping can corrode and leak. This can be an issue with most older homes.

In the process of purchasing this home there needs to be the knowledge that galvanized piping is going to have to be replaced at some point in the future if you start seeing rusty water or lack of water pressure at the faucets it is getting close to time for galvanized piping to be replaced.

Also know that rusty water may be seen if a particular fixture is not regularly operated and may not mean that piping necessarily needs replacement right then but it is something to take into account when purchasing an older home.

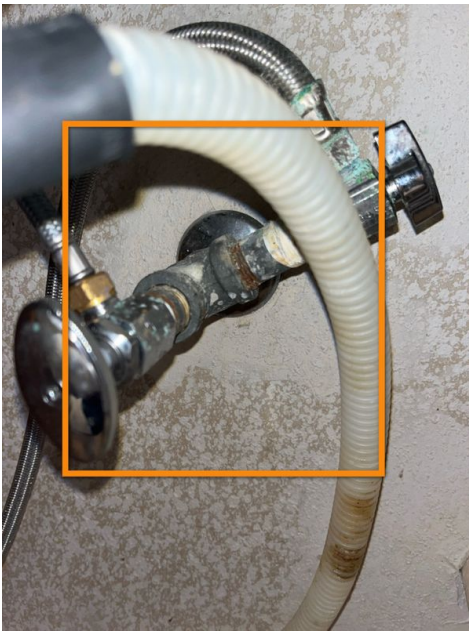
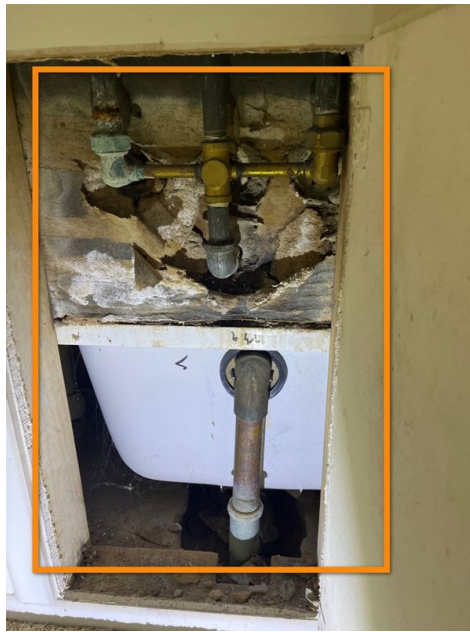
Various Areas

CORROSION ON PLUMBING FITTINGS

Corrosion was noted on one or more plumbing fittings or supply lines. These areas will need repair/replacement in the future. We recommend that you monitor these areas for leaks and repair as needed.

Example of areas most if not all areas

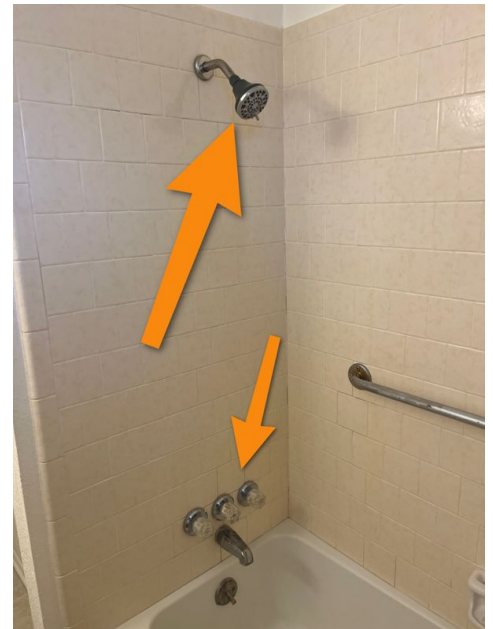
Guest Bath shower

Fixture did not have pressure at time of inspection. I recommend having a qualified plumber inspect and repair as needed.

Recommendation
Contact a qualified professional.

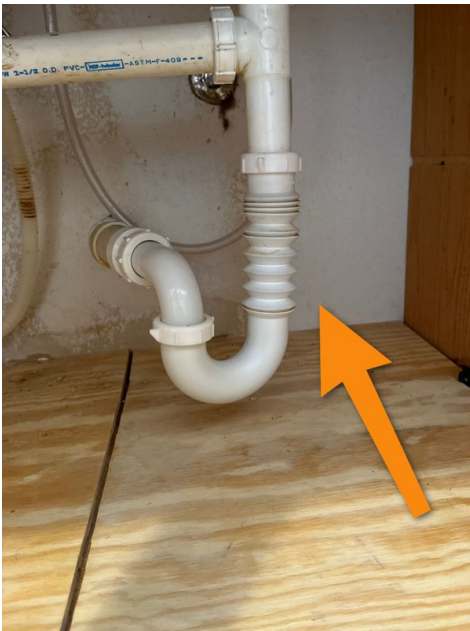
Kitchen sink

IMPROPER DRAIN PIPING MATERIAL

There appears to be improper drain line material present for sink. Drain line appears to be rigid flexible piping which is not recommended to use. Inner walls of piping should be a smooth surface.

Recommendation
Contact a qualified plumbing contractor.

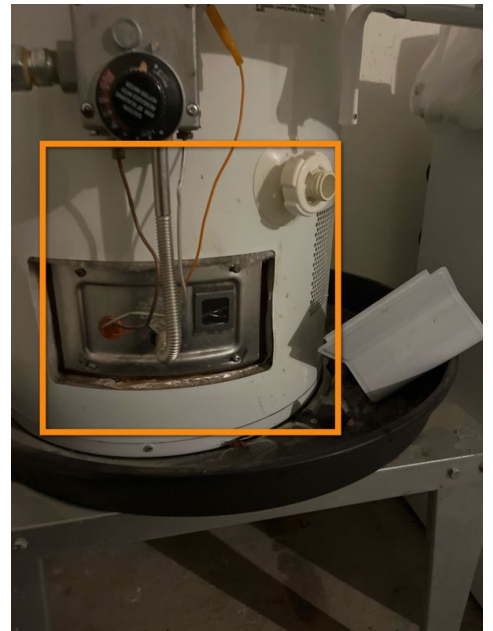
Water heaters have missing/not installed cover plates.

Recommendation
Contact a qualified professional.

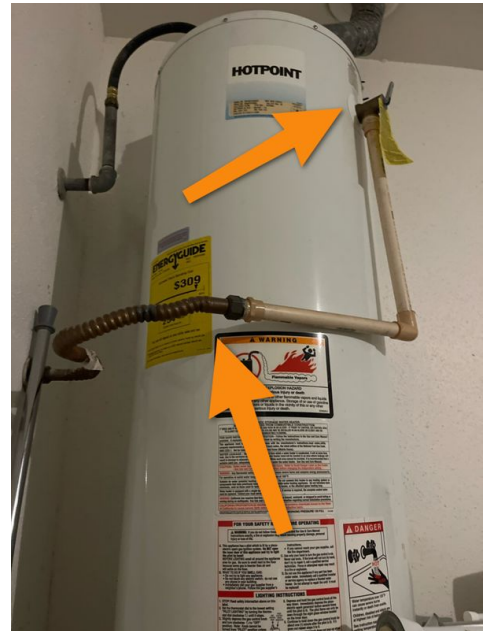
The TPR does not appear to be installed in a proper configuration. I recommend having a qualified plumber inspect and repair as needed.

Recommendation
Contact a qualified professional.

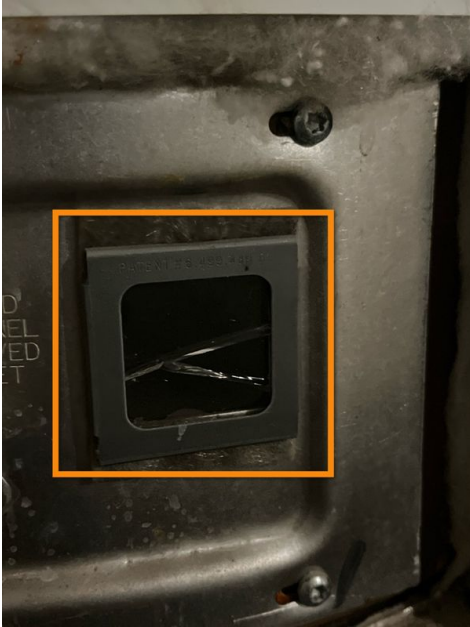
The water heater sight glass is damaged. This is a safety issue. I recommend having a licensed plumbing contractor inspect and repair or replace as needed.

Recommendation
Contact a qualified professional.

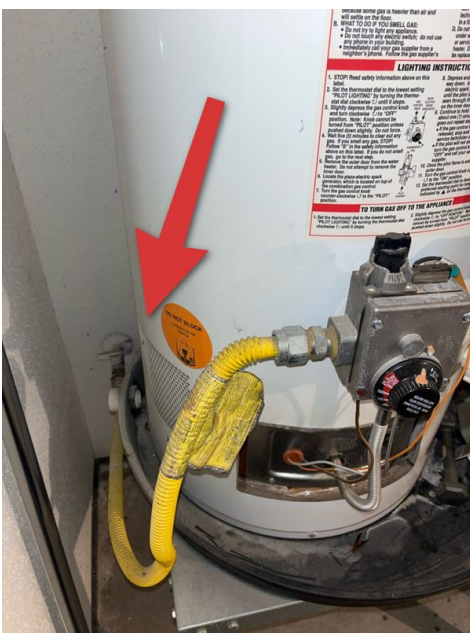
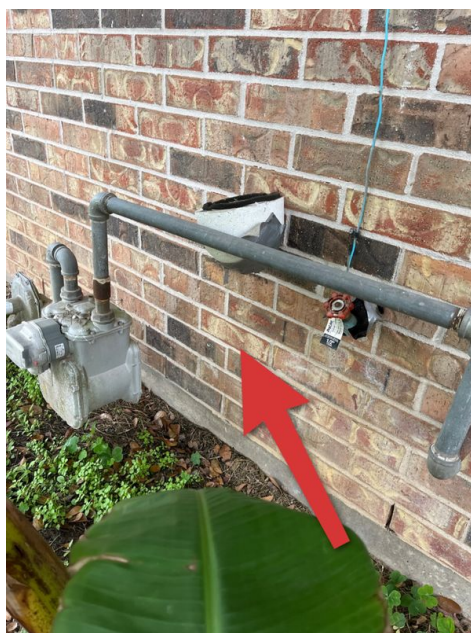
G2411.1 (310.1) Pipe and tubing other than CSST. Each above-ground portion of a gas piping system other than corrugated stainless steel tubing (CSST) that is likely to become energized shall be electrically continuous and bonded to an effective ground-fault current path. Gas piping other than CSST shall be considered to be bonded where it is connected to appliances that are connected to the equipment grounding conductor of the circuit supplying that appliance.

Recommendation
Contact a qualified electrical contractor.

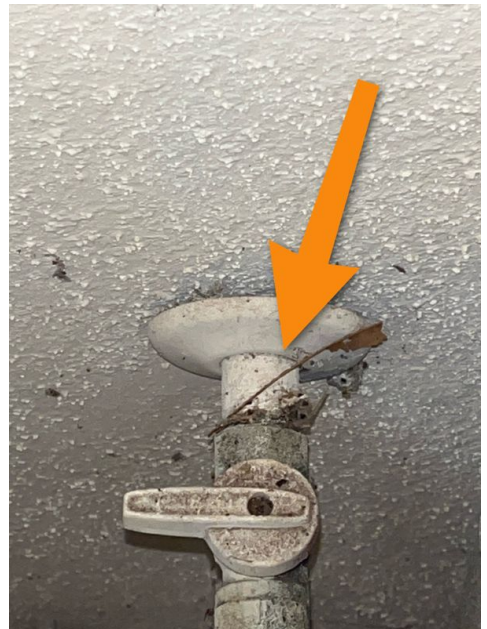
GALVANIZED GAS PIPE

Galvanized piping should not be used for gas because of the galvanized coating. Over time pieces of the galvanized steel will flake off and clog your gas regulators and burner units. Never mix galvanized and black iron or where they touch corrosion will be accelerated.

Recommendation
Contact a qualified professional.

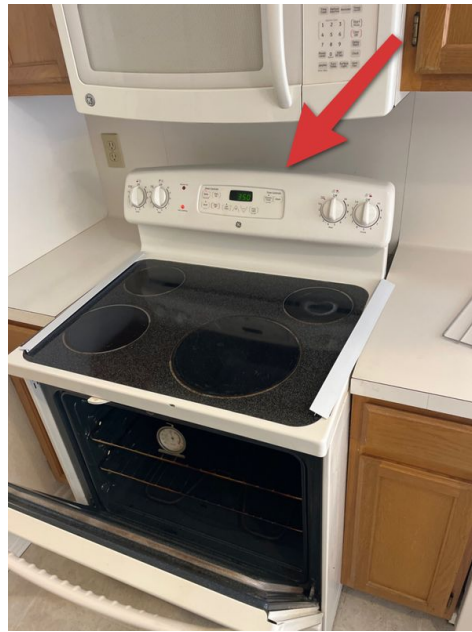
ANTI TIP BRACKET MISSING

Recommendation
Contact a qualified appliance repair professional.

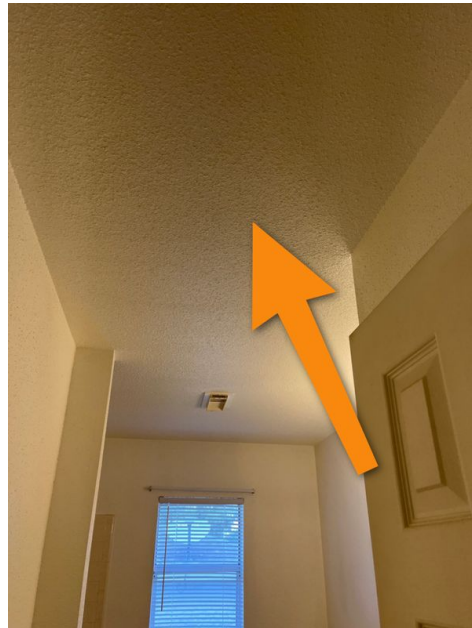
Guest Bath

MISSING EXHAUST FAN

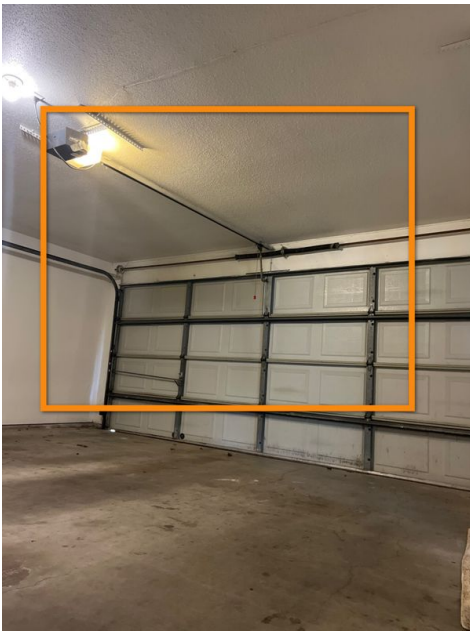
Garage door had power but was not operational at time of inspection. I recommend having a qualified contractor inspect and repair as needed.

Recommendation
Contact a qualified professional.

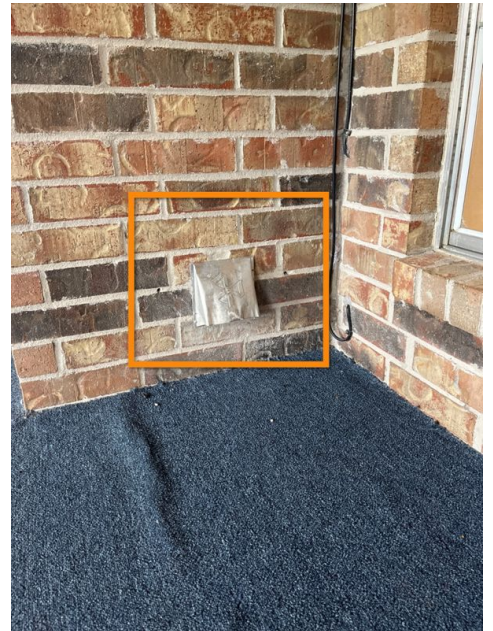
Rear patio (closed in)

IMPROPER VENTING
