**Texas WDI Inspection Report For: 7805 Shiloh Court, College Station, TX 77845**  
**Prepared For: Austin & Dianne Robinson**

5. **Home & Garage**  
 List structure(s) inspected that may include residence, detached garages and other structures on the property. (Refer to Part A, Scope of Inspection)

**TEXAS OFFICIAL WOOD DESTROYING INSECT REPORT**

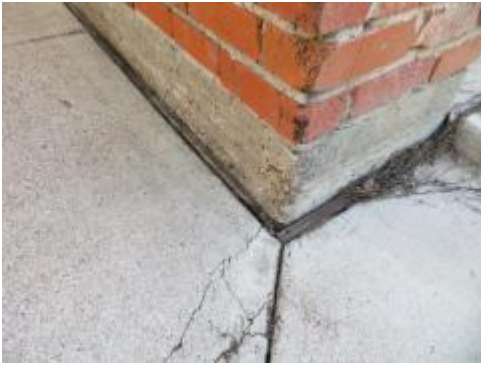
I=Form Boards Left in Place

**Increases the Chance of:** Termites, Carpenter Ants, Fire Ants.

**Remedies:** Remove when they rot out and replace with caulk or sand.

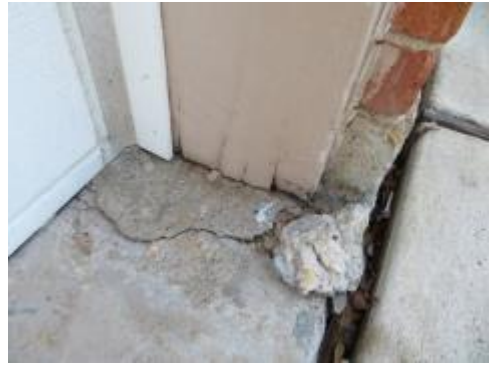
M=Wood Rot

**Increases the Chance of:** Termites, Carpenter Ants, Carpenter Bees, Wood Boring Beetles, all other Insects.

**Remedies:** Replace all wood rot, caulk and seal, keep all exterior wood painted and sealed.

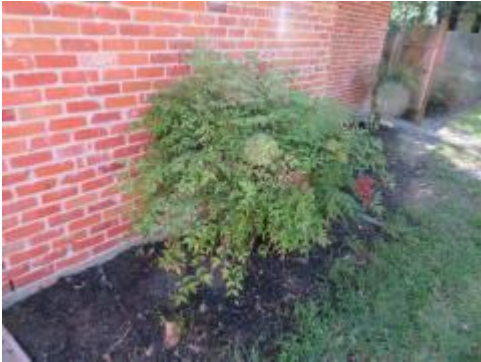
N=Foliage in Contact w/Structure

**Increases the Chance of:** Carpenter Ants, Spiders, Wood Rot.

**Remedies:** Keep all tree limbs trimmed back 4 foot from structure. Keep all shrubs, vines, and crepe myrtles 18 inches to 2 foot off the structure.

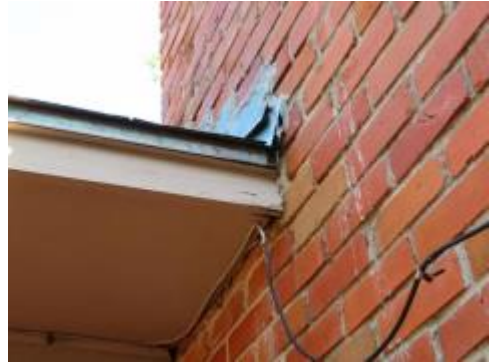
M=Wood Rot

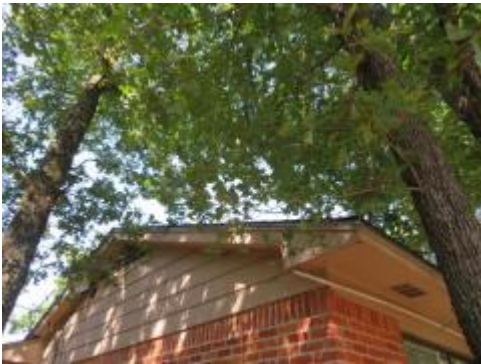
N=Foliage in Contact w/Structure

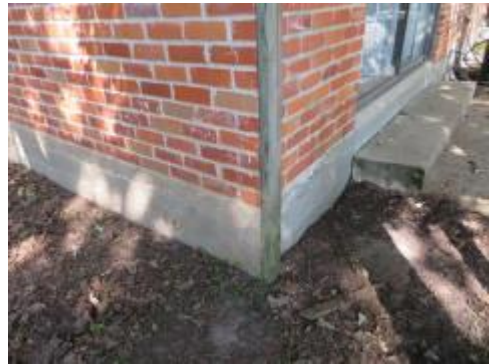
G=Wood To Ground Contact

**Increases the Chance of:** Termites, Fire Ants, Wood Rot, and all other Ants.

**Remedies:** Correct all Wood to Ground Contact, no Siding or wood trim in contact with the ground.

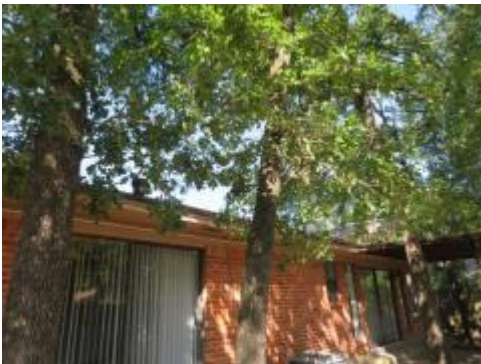
N=Foliage in Contact w/Structure

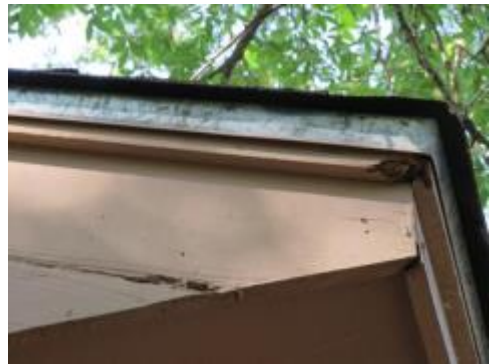
M=Wood Rot

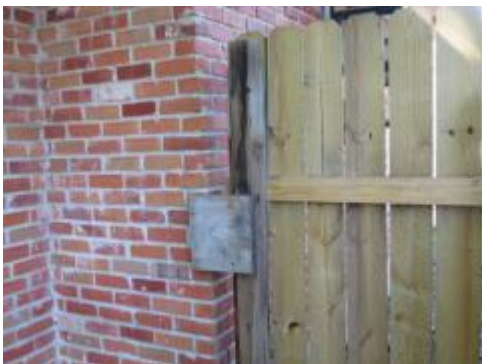
R=Wooden Fence in Contact w/Structure

**Increases the Chance of:** Termites, Carpenter Ants, Crawling Insects.

**Remedies:** Keep fence off structure. Try not to connect fence to the structure.

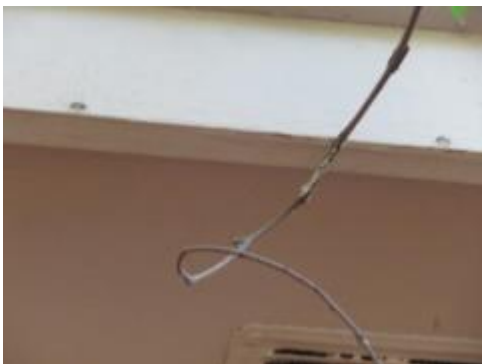
AH=Active Carpenter Ants

9A. Corrective treatment recommended for active infestation or evidence of previous infestation with no prior treatment as identified in Section 8. (Refer to Part G, H, and I, Scope of Inspection)  Yes  No   
 9B. A preventive treatment and/or correction of conducive conditions as identified in 7A & 7B is recommended as follows:  Yes  No   
 Specify reason Active infestation of carpenter ants  
 Refer to Scope of Inspection Part J

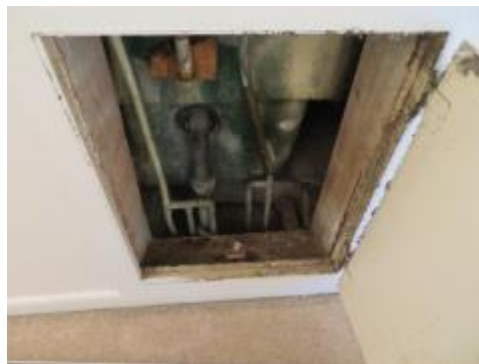
PS=Previous Subterranean Termites
