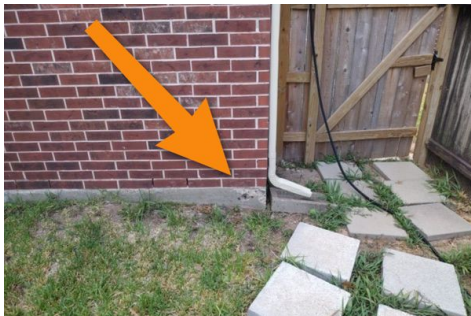
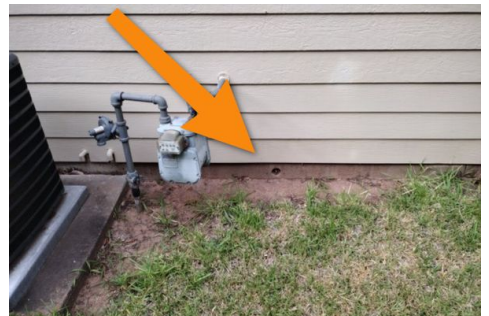
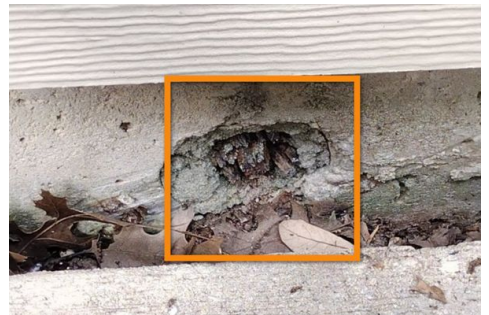
SLAB - EXPOSED REBAR

The foundation has exposed rebar. Rebar is used to strengthen the foundation concrete and hold the foundation in tension. Exposed rebar on the outside of the foundation should be repaired with mortar or monitored for further evidence of foundation issues. Limited amounts of exposed rebar is not an indicator of foundation problems unless it is coupled with other foundation concerns (such as spalling concrete, cracking, shifting, etc.).

Recommendation
Recommend monitoring.

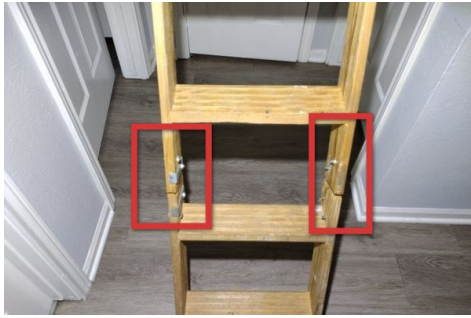
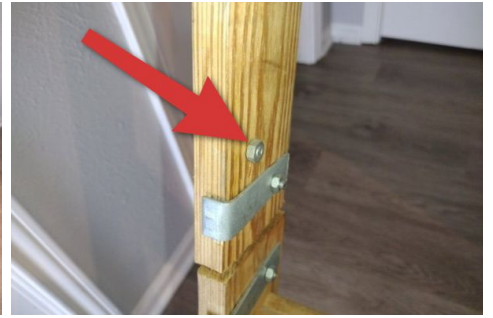
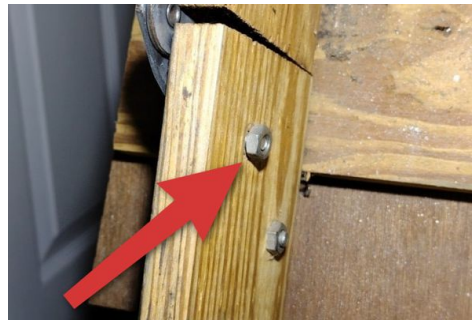
2.4.1 D. Roof Structures and Attics
ATTIC LADDER DAMAGED

The attic ladder is damaged or was installed at an incorrect height. Unsafe. Recommend replacement of the ladder.

Recommendation
Contact a qualified general contractor.

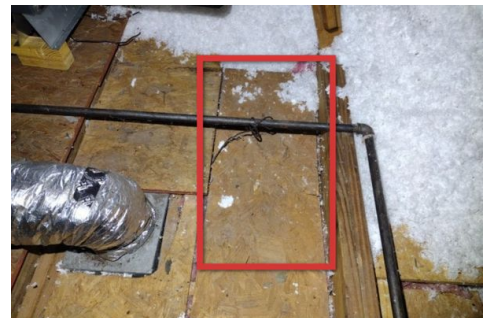
ATTIC DECKING IS UNSAFE

Attic decking is unsafe; Areas of the decking are missing fasteners and are not safe to traverse. Recommend stabilizing by re-securing the decking to the floor joists.

Recommendation
Contact a qualified general contractor.

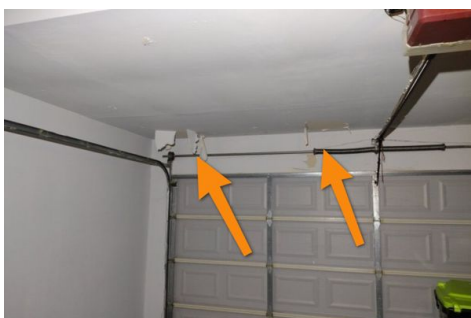
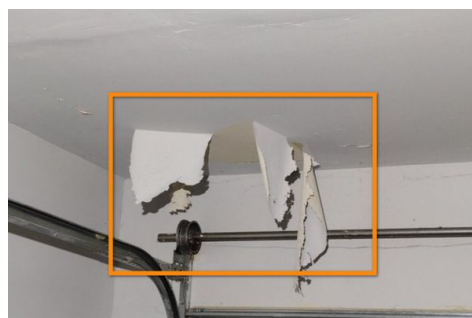
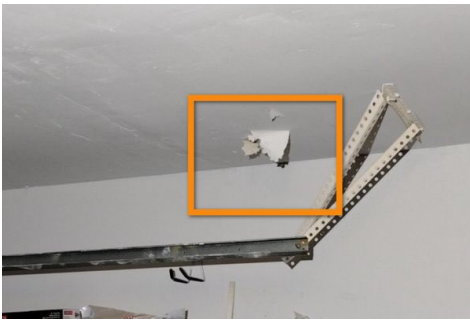
WOOD ROT AND/OR PEELING PAINT

There exists evidence of non-structural rot and/or peeling paint in these areas. Areas of wood that are exposed to the elements and missing paint will begin to rot if not corrected. Recommend sanding and repainting. Recommend areas of rotten wood to be replaced.

Recommendation
Contact a qualified general contractor.

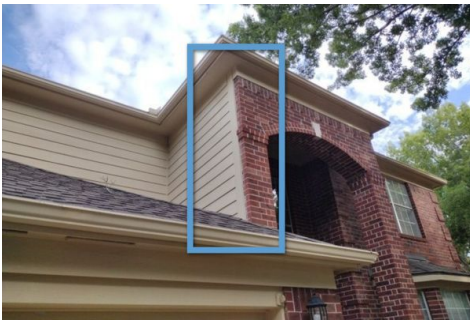
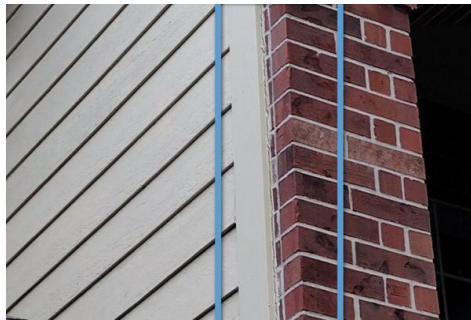
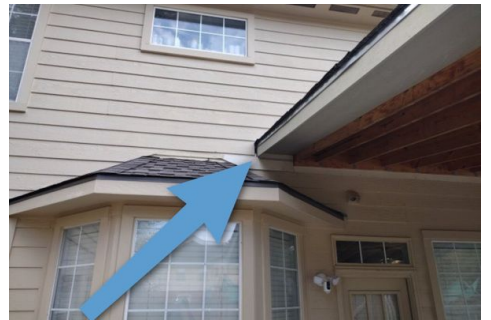
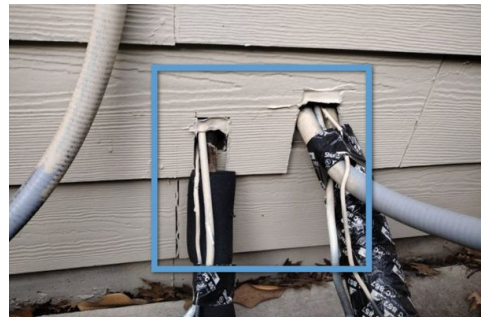
CAULKING DETERIORATED AND/OR MISSING

Caulking is necessary to seal gaps less than 1/2-inch. Caulking that is missing can provide for water penetration and allow insect access into the structure.

Contact a qualified general contractor.

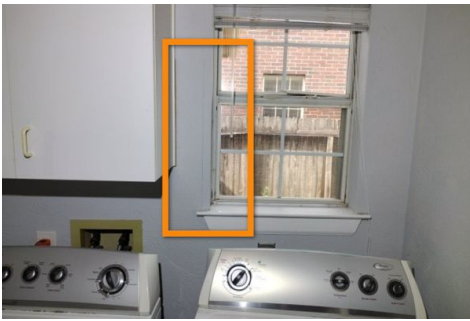
CRACKS MINOR

Minor cracking was observed in wall structure. This is common in structure this age and is often determined to be cosmetic. That said, cracking is a first sign of foundation failure and cracks can grow over time; recommend monitoring. The best way to monitor a crack is to patch it (with mortar or caulk) to see if the crack reappears.

Contact a qualified Do It Yourself

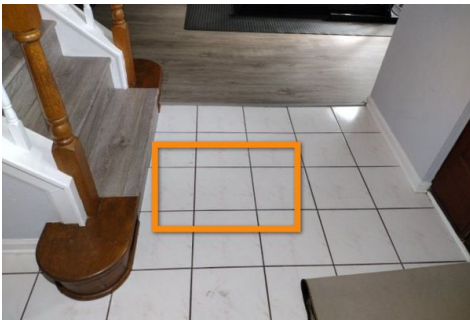
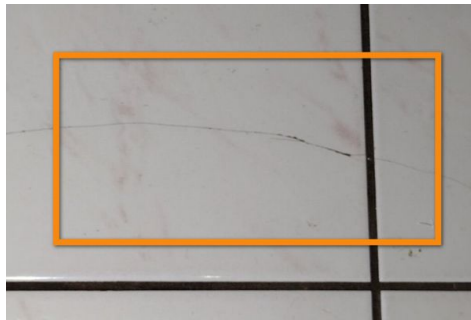
FLOORING - TILES LOOSE / CRACKED OR MISSING

Loose tiles that are popped or missing and/or cracking was observed. This is possibly due to structural foundation issues and is considered evidence of a structural deficiency if on the interior of the structure. Recommend a qualified foundation repair company / contractor evaluate and advise on course of action prior to repair of the flooring.

Recommendation
Contact a qualified professional.

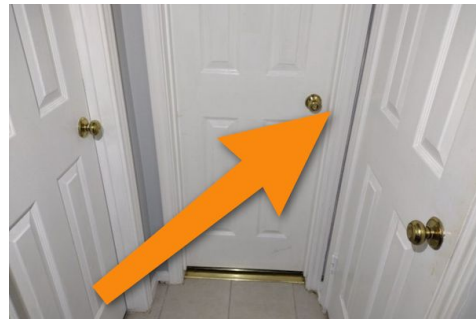
DOOR DOESN'T LATCH TO CLOSE

Door doesn't latch to close properly. Recommend handyman repair door, latch, frame, and/or strike plate.

Recommendation
Contact a qualified handyman.

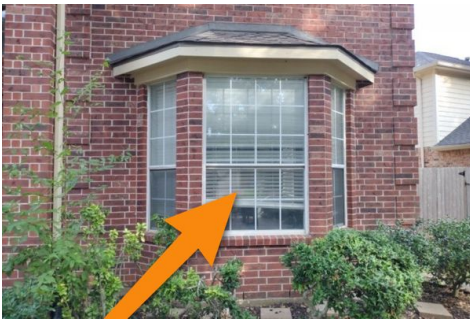
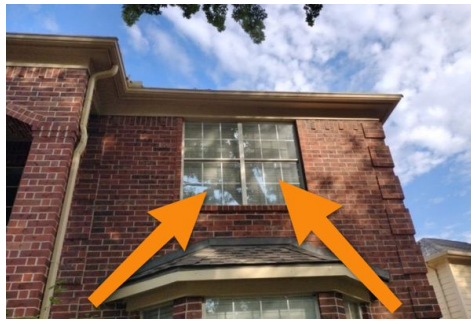
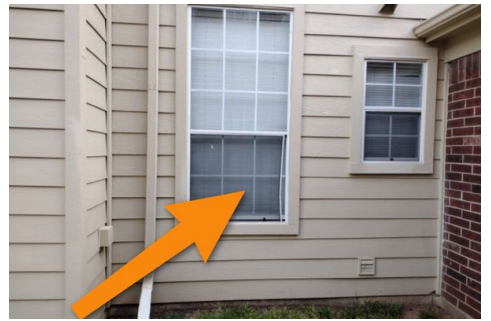
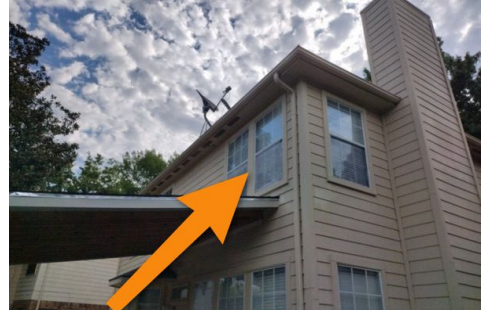
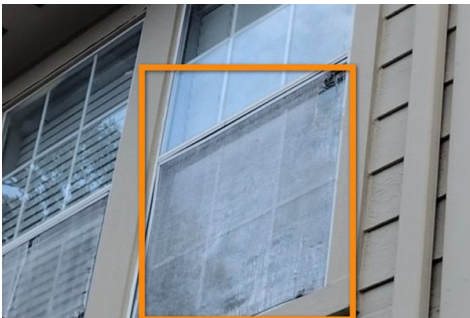
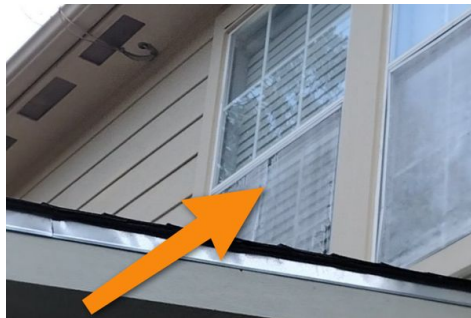
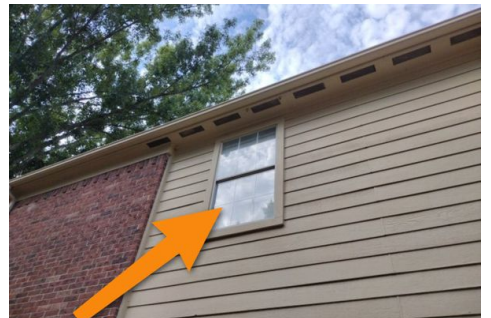
WINDOW SCREEN IS MISSING OR DAMAGED

One or more windows has a missing or damaged screen. Recommend replacement depending on preference.

Recommendation
Contact a qualified window repair/installation contractor.

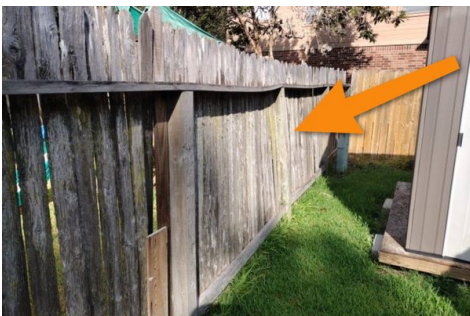
Left

MAJOR FENCE DEFICIENCIES - ROT AND/OR STRUCTURAL ISSUES

Fence appears to have significant rot damage and/or structural issues. Recommend contract a fencing contractor for repair and/or replacement of the elements that are exhibiting rot or structural issues.

Contact a qualified fencing contractor

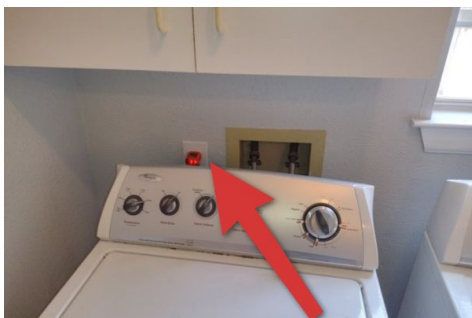
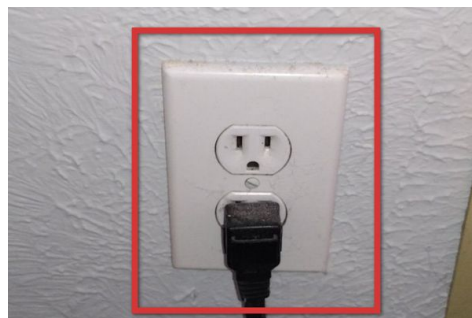
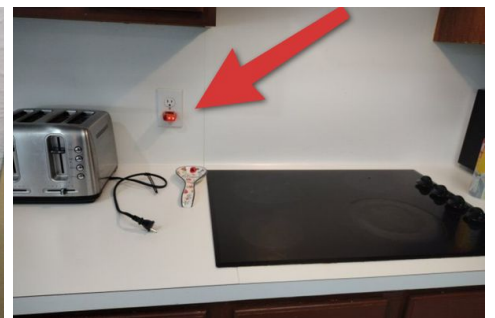
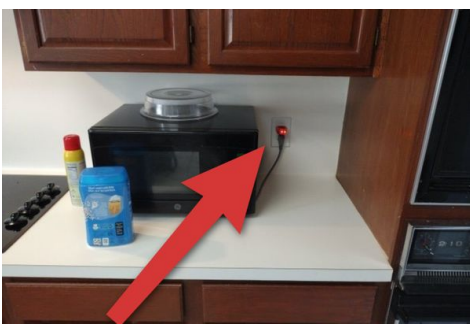
3.2.1 B. Branch Circuits, Connected Devices, and Fixtures **OUTLET - NO GFCI PROTECTION**

No GFCI protection present. Recommend licensed electrician upgrade by installing ground fault receptacles in missing locations.

Recommendation
Contact a qualified electrical contractor.

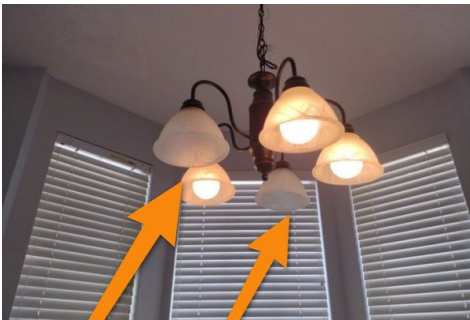
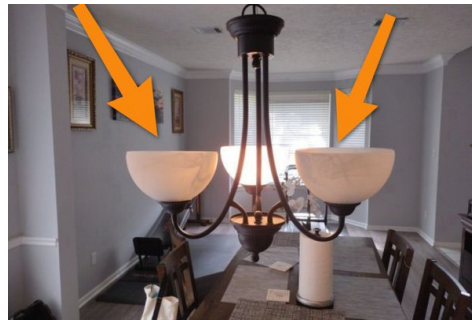
FIXTURE - LIGHT INOPERABLE / BULB NEEDS REPLACEMENT

One or more light fixtures were inoperable (didn't turn on when nearby switches were operated). Recommend further evaluation by replacing bulbs and/or consulting with the property owner. If replacing bulbs doesn't work and/or no other switch(es) can be found, then recommend that a qualified electrician evaluate and repair or replace light fixtures as necessary.

Contact a qualified electrical contractor.

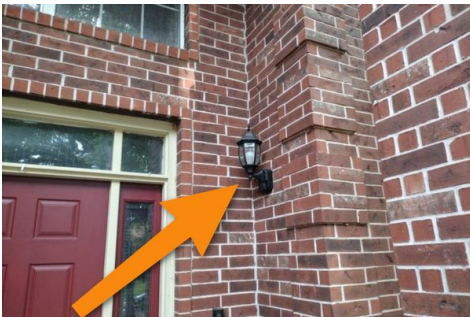
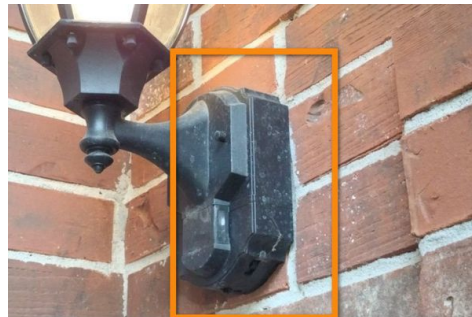
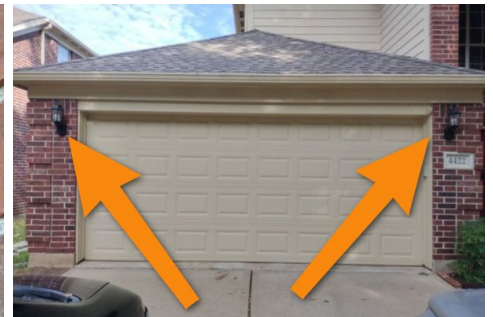
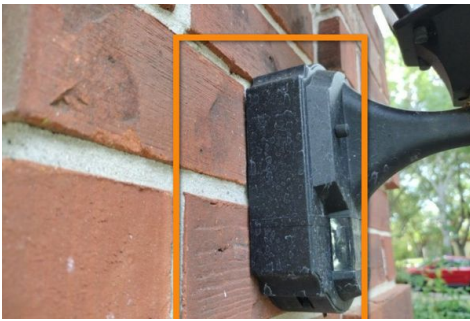
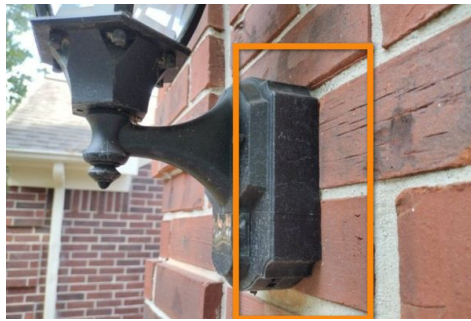
FIXTURE - IMPROPERLY SEALED

Light fixture improperly sealed from the outdoor elements. Will allow for water penetration and could cause interior damage to structure. Recommend reinstallation using approved caulking, sealants, etc.

Contact a qualified professional.

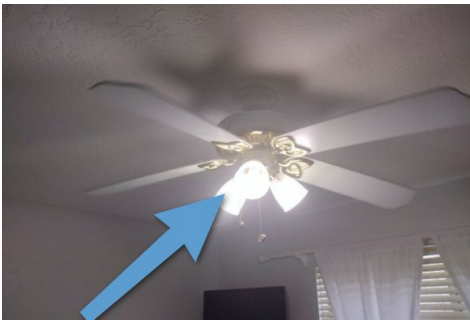
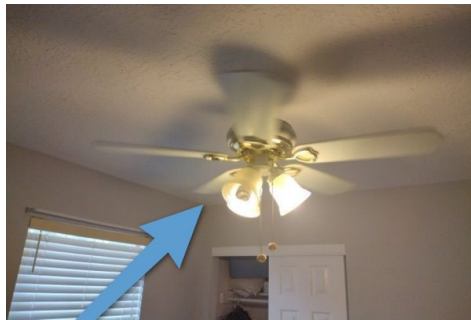
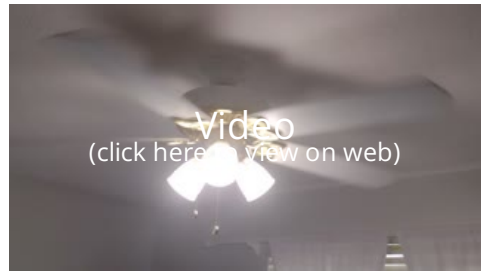
FIXTURE - IMPROPERLY MOUNTED

Lighting fixture and/or ceiling fan is improperly mounted, damaged, and/or loose. Recommend tightening and sealing, or replacement by an electrical professional.

Contact a qualified Do It Yourself

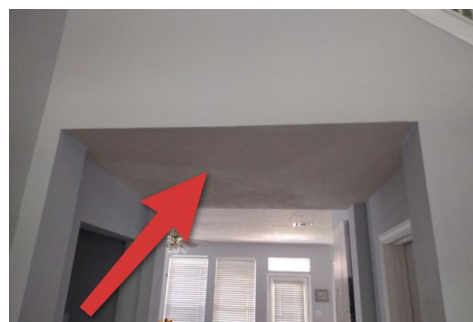
1st Floor Hall

CO ALARM - MISSING

A CO (carbon monoxide) alarms/detector is missing. It is recommended that CO alarms be installed, at a minimum, on every level of the structure. Because carbon monoxide is slightly lighter than air and also because it may be found with warm, rising air, detectors should be placed on a wall about 5 feet above the floor. The detector may also be placed on the ceiling. Some fire alarm brands are combination CO/fire detectors. Recommend installation of CO detector.

Contact a qualified Do It Yourself

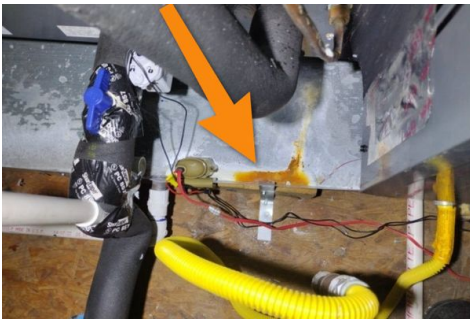
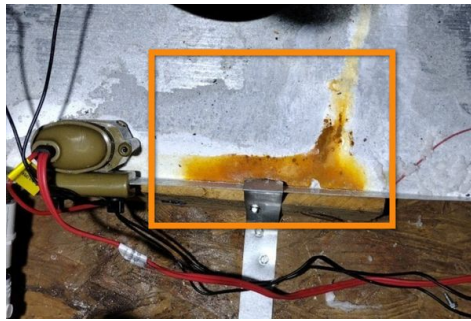
EVAPORATOR - RUST PRESENT IN PAN

Rust is present in the cooling system emergency overflow pan under the AC evaporator (inside unit). This could be caused by malfunctioning with consistent overflows. No active condensation leak into the pan is observed. Recommend careful monitoring.

Contact a qualified HVAC professional.

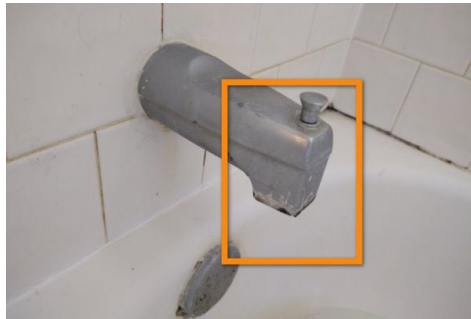
5.1.1 A. Plumbing Supply, Distribution Systems, and Fixtures
FAUCET / FIXTURE / SPIGOT DRIPPING

A faucet, fixture, or spigot is dripping. Recommend qualified handyman or plumber evaluate and repair.

Recommendation
Contact a qualified plumbing contractor.

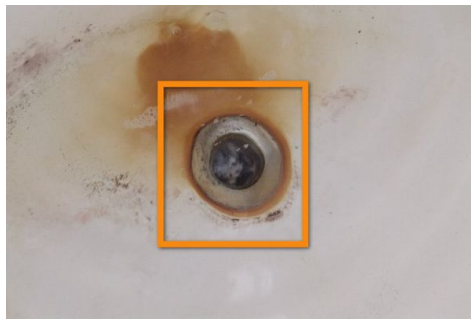
5.2.1 B. Drains, Wastes, and Vents
POOR / SLOW DRAINAGE

Poor/slow drainage was observed at time of inspection. Recommend a qualified plumber evaluate and repair.

Recommendation
Contact a qualified plumbing contractor.

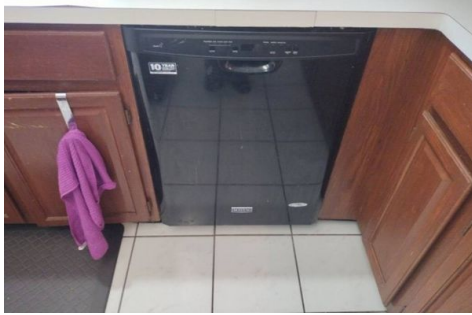
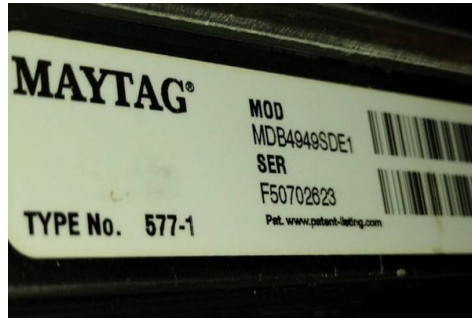
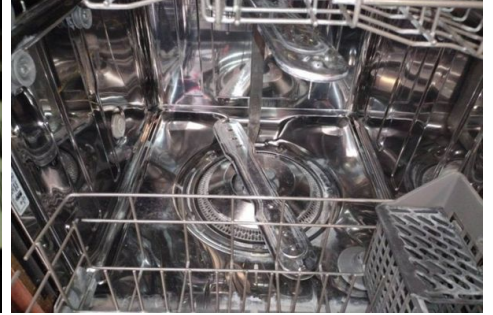
6.1.1 A. Dishwashers
DISHWASHER INOPERABLE

Dishwasher appliance was inoperable at the time of inspection. Recommend qualified appliance professional to repair.

Recommendation
Contact a qualified appliance repair professional.

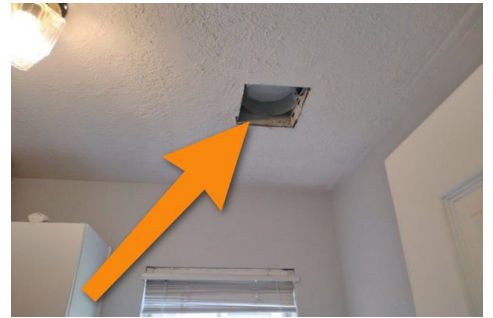
Laundry

VENT FAN INOPERABLE

The vent fan is inoperable and will not power on. Recommend further investigation to determine the cause of the problem.

Recommendation
Contact a qualified electrical contractor.
