BPG Inspection, LLC

**246 Jim Hall Lane
New Waverly TX 77358**

Client(s): Dublin
Inspection Date: 7/7/2022
Inspector: Murray Campbell , TREC #22455 (TX)

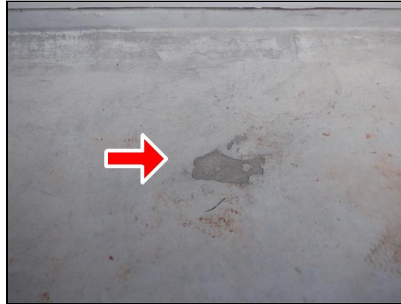
Noted cracks and slab shifting at driveway, patio slabs and sidewalks. Recommend having all concrete slab cracks filled with exterior grade sidewalk repair flexible caulking. This will allow sealant of cracks preventing water infiltration into area that causes further damage until full concrete seal can be applied or total replacement of slabs. Sidewalk repair caulking is the typical product used for this repair.

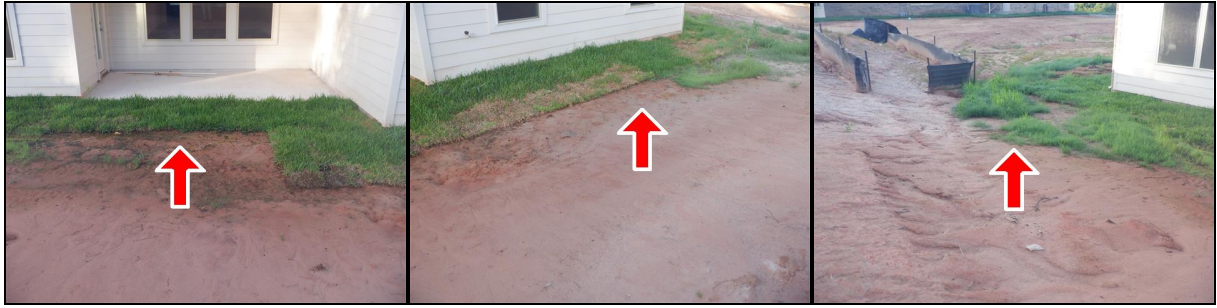
The grade is negatively sloped at the rear of the structure. Proper drainage is needed to prevent water from standing / ponding next to the foundation. All grades should drop away from the structure at a rate of 6 inches for every 10 feet. Corrective action (grading improvement, engineered swales and/or gutters) may be required if water stands within 10-feet of the foundation for more than 24-hours.

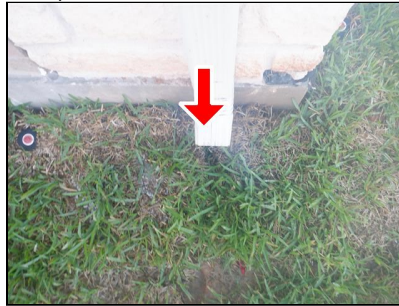
Gutter downspouts should discharge water at least 36 inches away from the foundation. Storm water should flow freely away from structure at points of discharge. (Discharging roof water next to the structure has the potential of causing foundation movement)

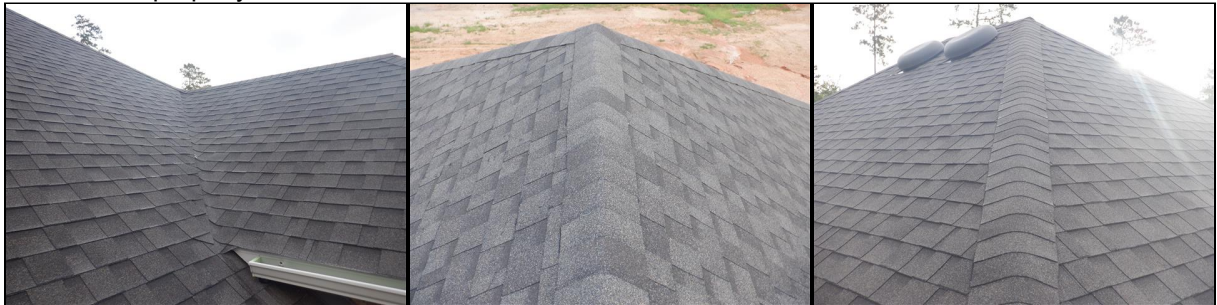
The roof covering appeared in good condition. No leaks were active at time of inspection. The covering appeared to be properly fastened.

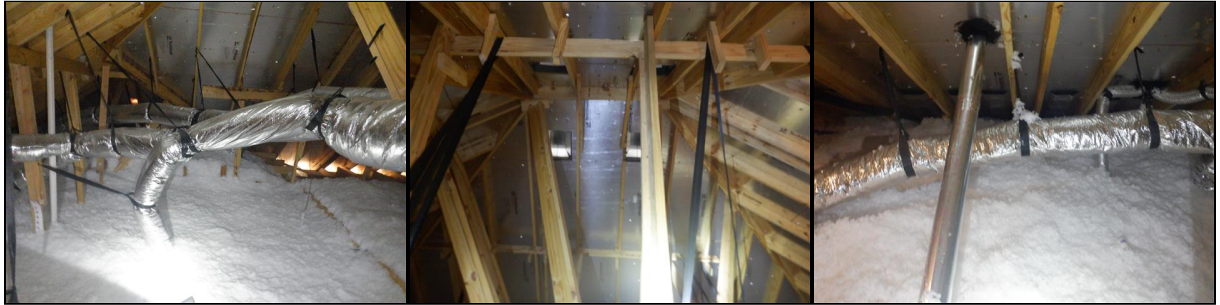
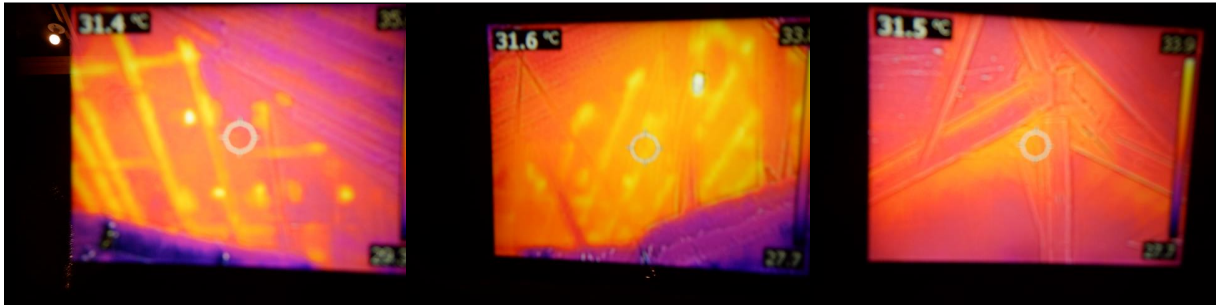
The structure was in good condition. No leaks were active or apparent at time of inspection.

Remove storage items from directly on insulation. Compressing insulation degrades its performance.

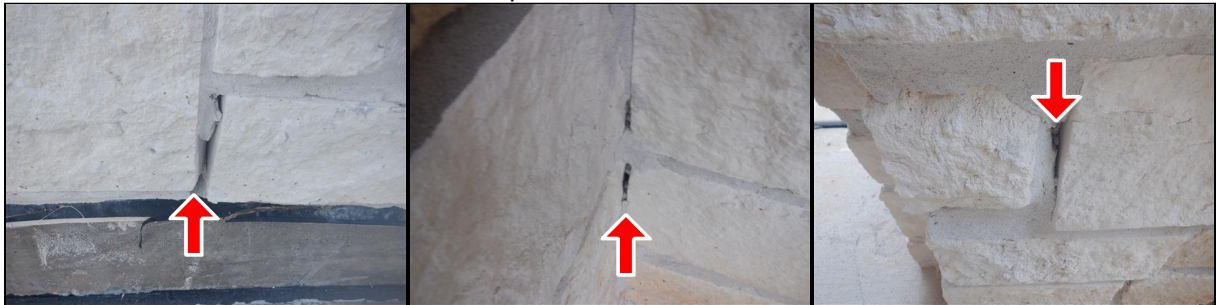
☒ There are joint cracks on the walls in various locations. These cracks appear to be typical settlement/ shifting joint cracks with no other visible displacement. Recommend sealing (mortar) crack to prevent moisture incursion and monitor for further settlement/separation.

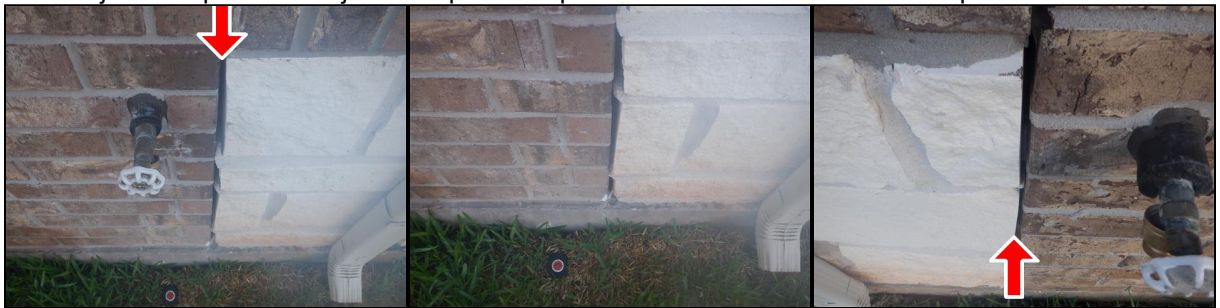
☒ Control joints require added joint compound to prevent water incursion into wall space.

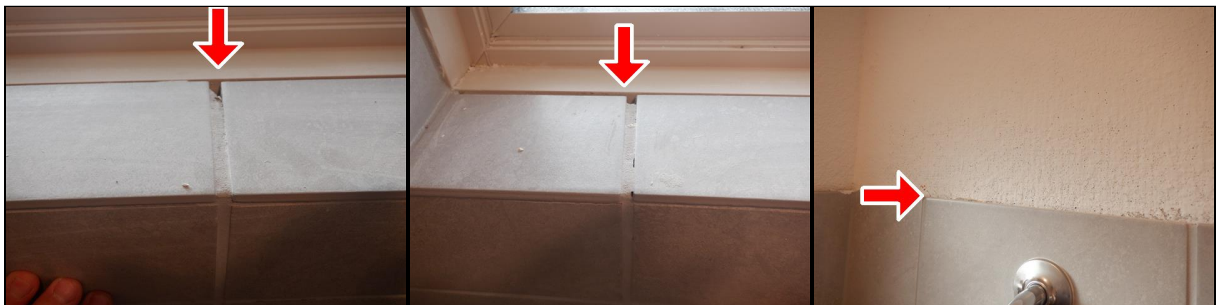
☒ Seal (grout/caulk) around the tub and shower tile/fixtures to wall abutment joints in the master bath guest bath.

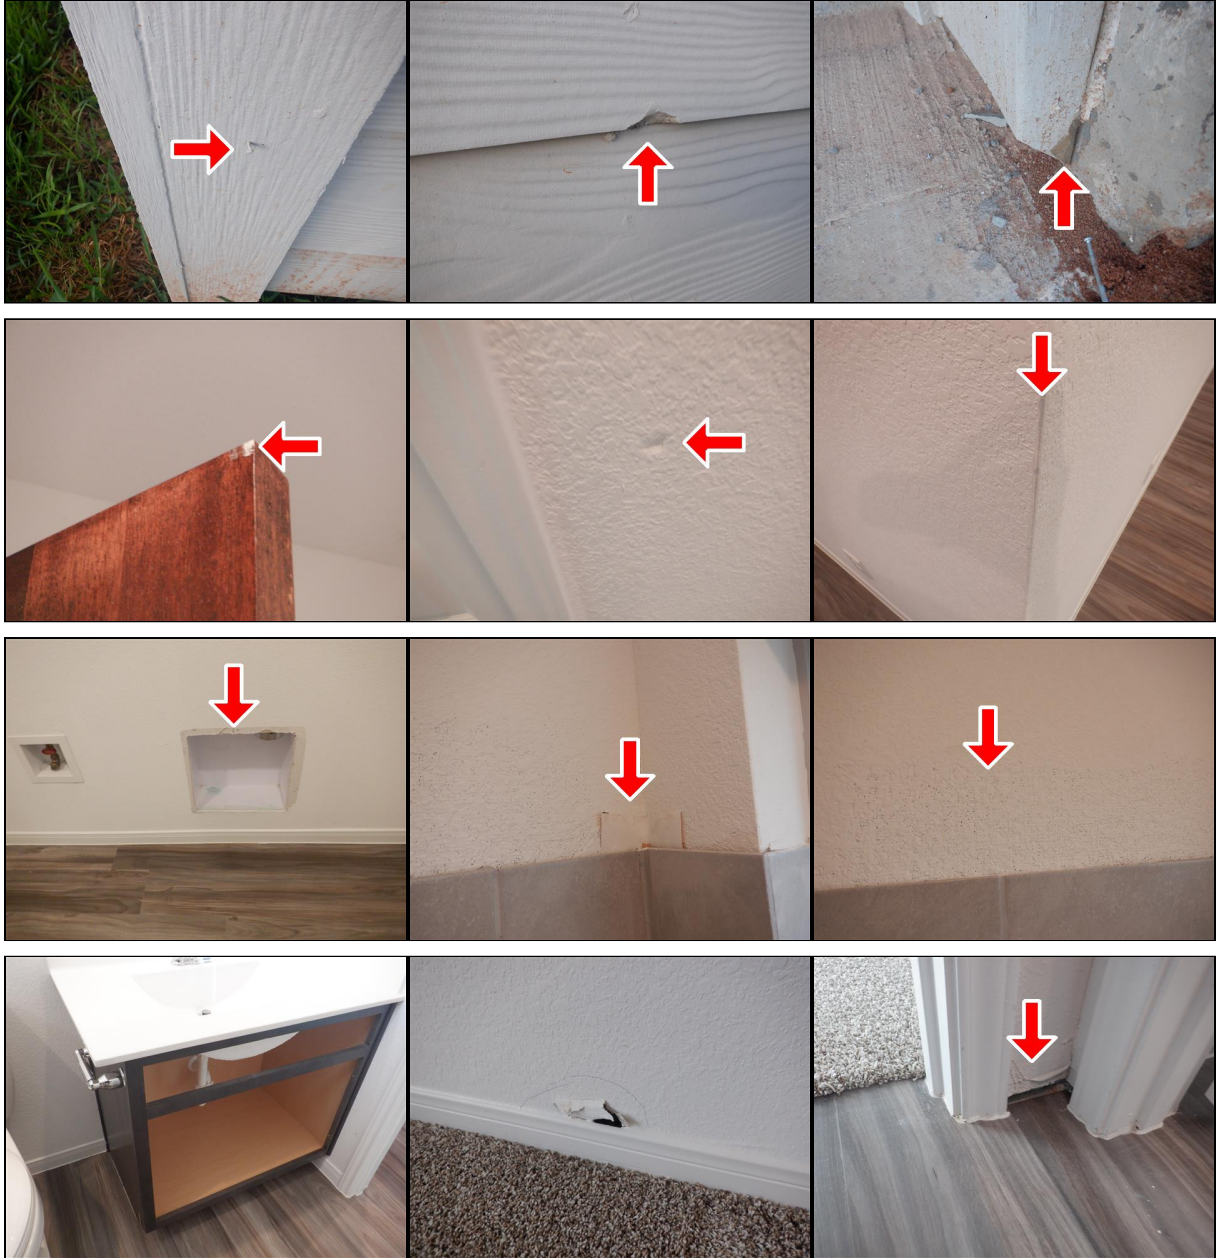
There is punch out work to be completed throughout residence, Paint, caulk, etc.

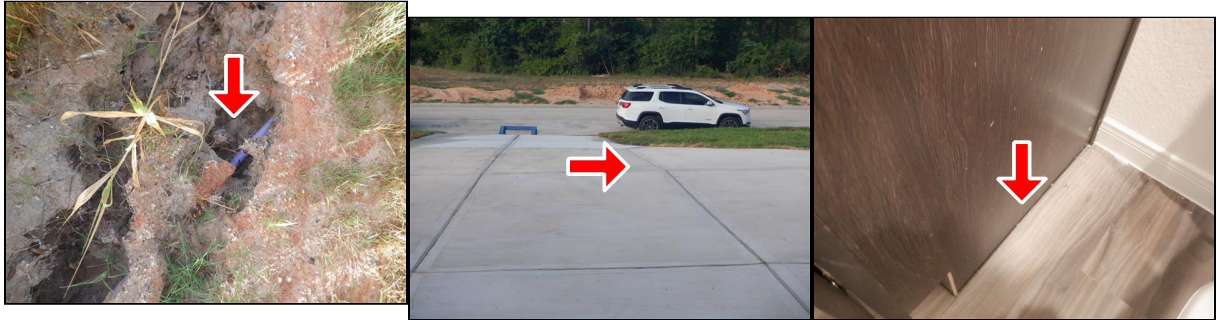
Exposed plumbing at septic system.

Driveway uplift.

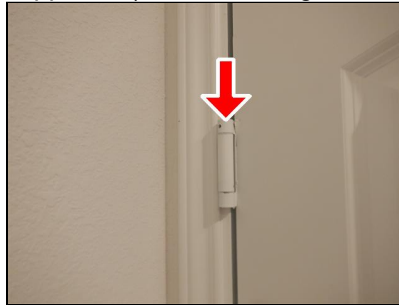
☒ The occupant door leading from the attached garage into the house is not self closing. I recommend installing/adjusting self closing hinges on the door leading from the garage to the living space as a safety feature to prevent exhaust gases (car, appliance) from entering the house.

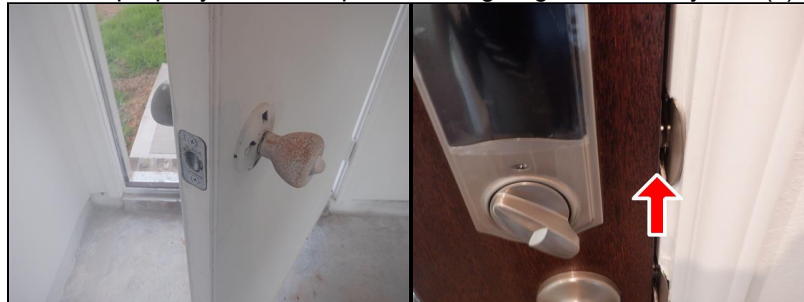
☒ Door does not close/latch properly into strike plate at the garage, main entry door(s).

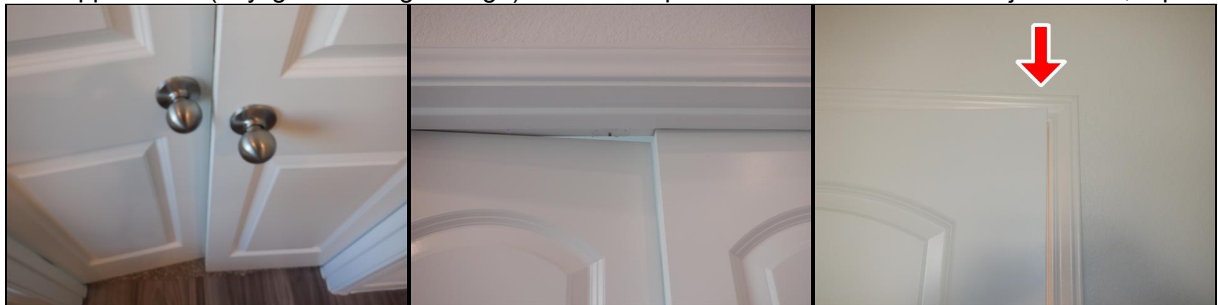
☒ Bedroom, and bath door out of square/plumb in jamb. The doors are not making contact with seal along top and upper sides (daylight showing through). Have a carpenter evaluate and make adjustments, repairs.

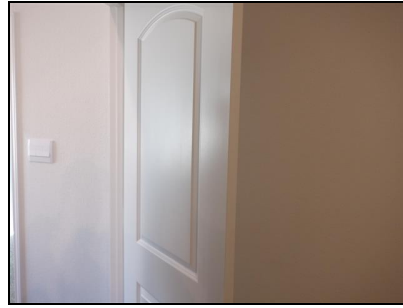
Noted in the bedroom room door is not plumb. Door attempts to close with no assistance and has door wedge currently holding door open. Recommend having door properly re-hung and aligned to operate as designed.

Recommend replacing all missing door stops.

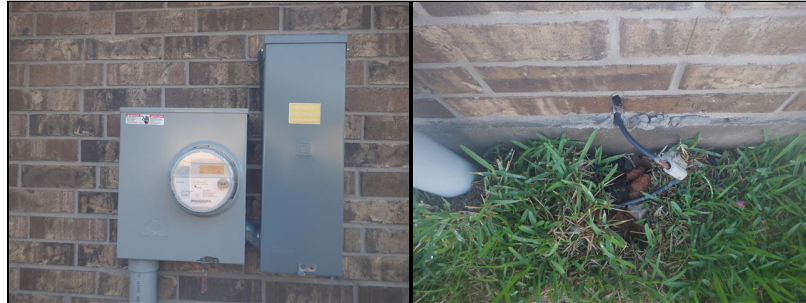
System panels installed correctly, grounded and bonded. Noted no concerns with infrared scan of panel at time of inspection.

The main panel box is located in the garage. Main service disconnect located at left exterior. No main breaker at panel box in garage.

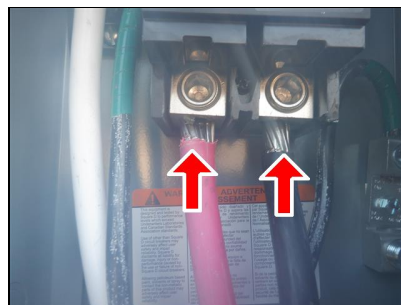
The aluminium service wires should be coated with anti-oxidation grease where they are stripped back to be connected to the mains, main or branch circuit breakers.

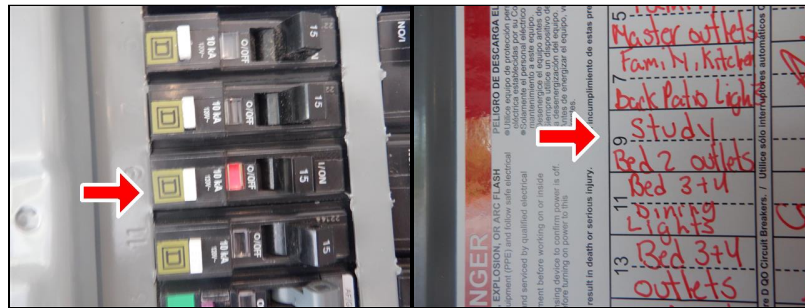
The number #9 breaker trips upon testing septic system. I recommend a licensed electrician to evaluate and repair.

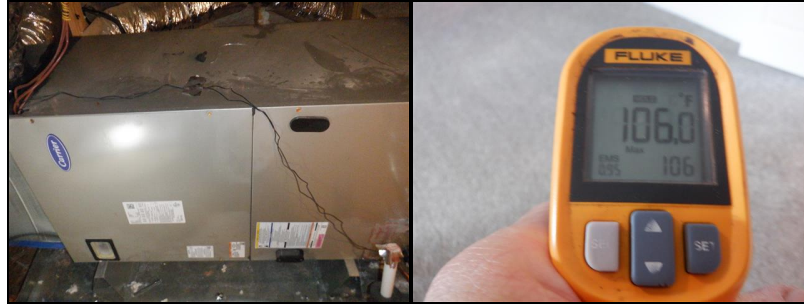
The unit functioned at the time of inspection. Proper heating operation is determined by at minimum of 100 degrees being supplied from all home supply grills.

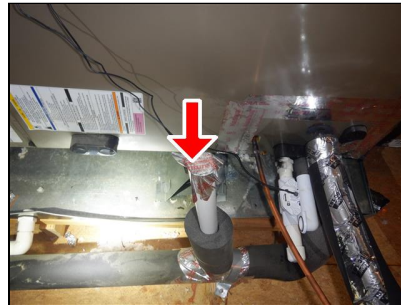
The main A/C cooling system did not pass the temperature differentials tests. Normal supply and return temperature drops should be between 15 to 22 degrees. The system registered 10 degree temperature differential. Both interior and exterior units were operating during this test.

Further evaluation for service, repairs or component replacement by a professional HVAC company is recommended to return unit to functioning as intended from factory.

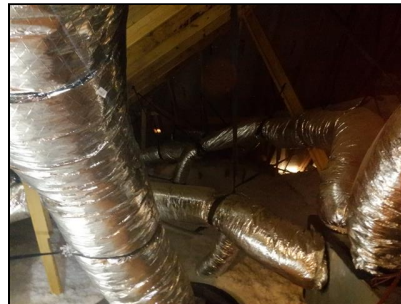
The main air filter(s) are soiled, dirty and require replacing.

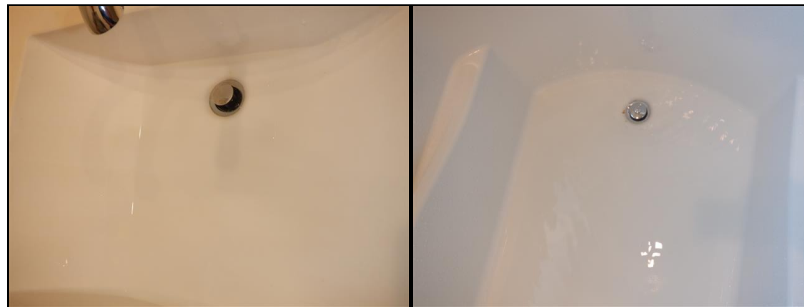
The drain was slow, and may be clogged in the guest bath sink master bath tub. I recommend repair by a plumber.

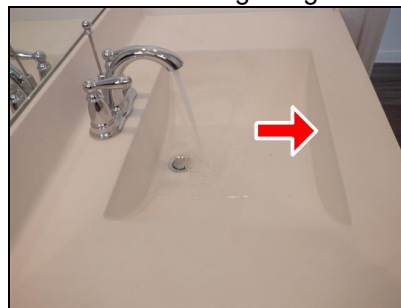
The master bath guest bath sink does not have an over-flow drain and there is a drain stopper present. Client should ensure that the sink is never left unattended during filling.

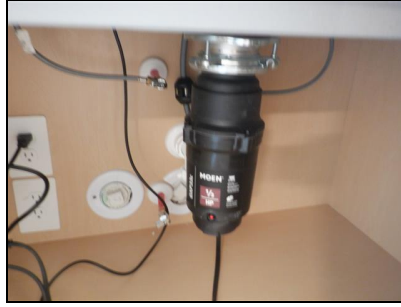
Appliance was functional at time of inspection.

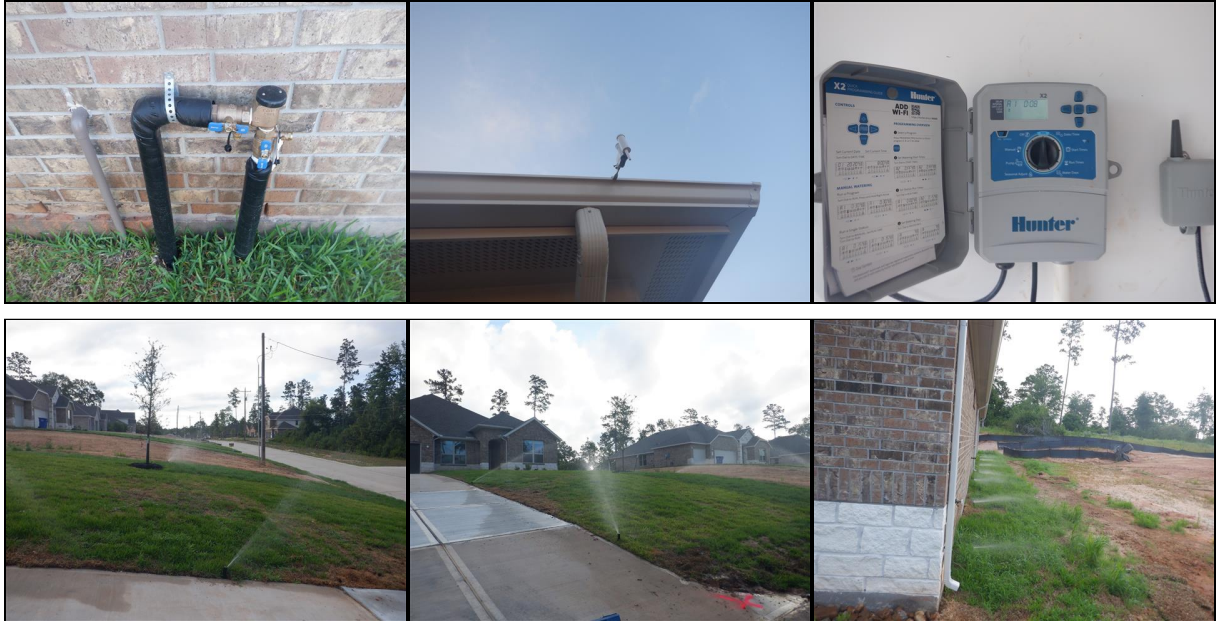
There are damaged sprinkler heads at the front of the house. The system is in need of further review and repair by a licensed irrigator.
