PROPERTY INSPECTION REPORT

Concerning: 40219 S Hill Pass, Magnolia TX
(Address or Other Identification of Inspected Property)

By: Chad Ware – TREC #9144 3/30/2021 – 9:00 AM
(Name and License Number of Inspector) (Date)

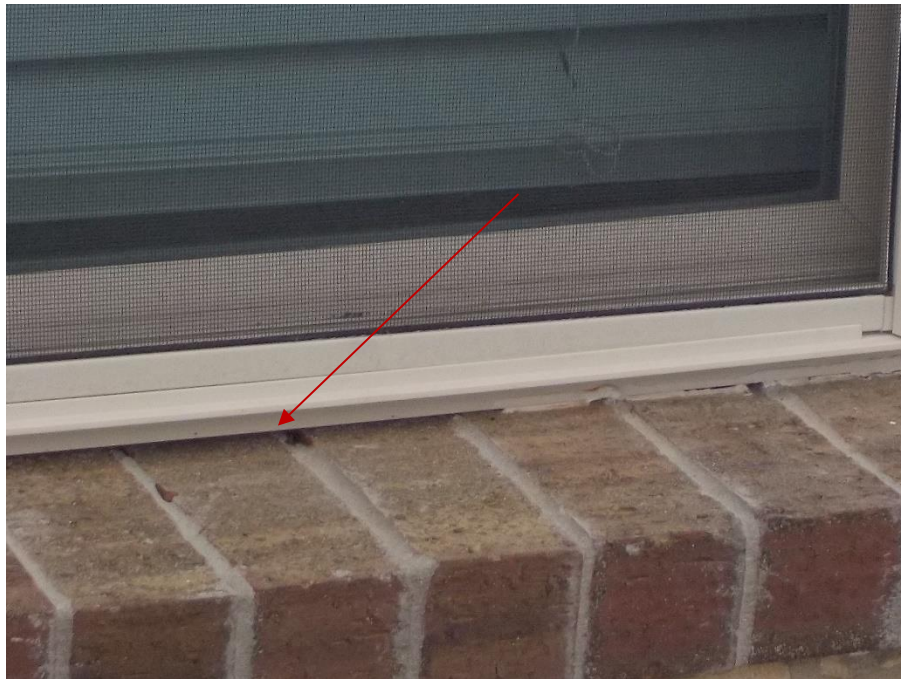
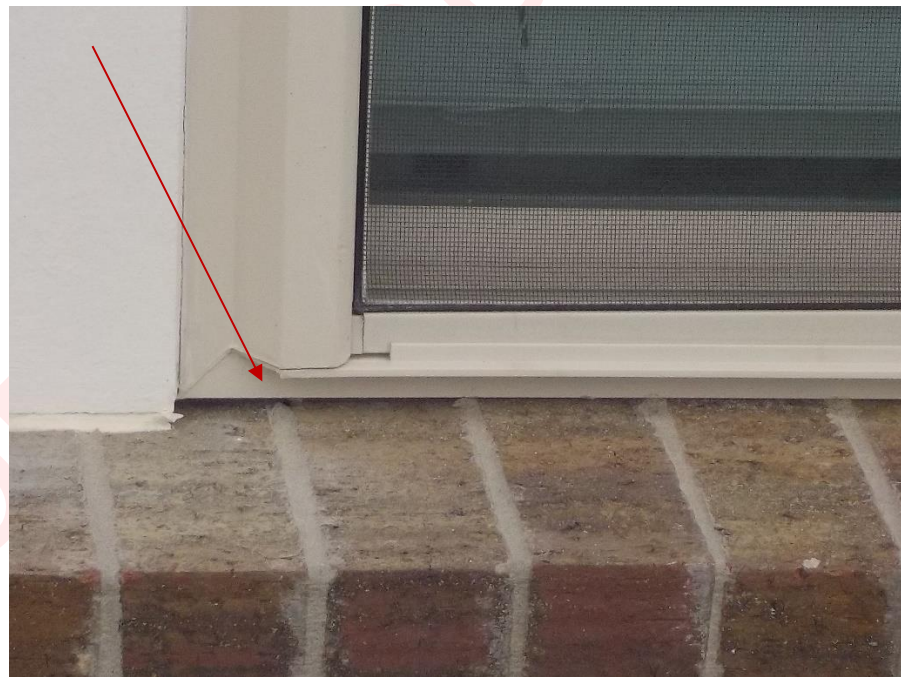
There Are A Few Areas Where The Caulking Around Some Of The Exterior Windows Is In Need Of Repair Or Replacement To Prevent Possible Moisture Entry.

There Are A Few Areas Where The Caulking Around Some Of The Exterior Windows Is In Need Of Repair Or Replacement To Prevent Possible Moisture Entry.

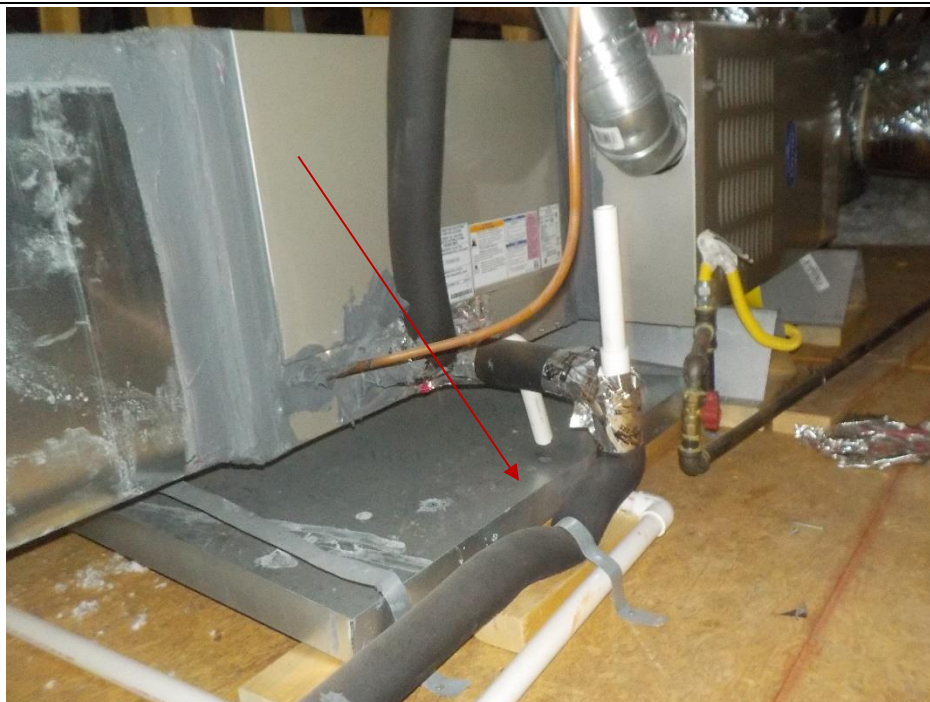
The A/C Drain Pan Is Missing A Suggested Overflow Switch.

The A/C Drain Pan Is Missing A Suggested Overflow Switch.
