KTX HOME INSPECTIONS, LLC.

KTX FULL REPORT REI 7-6 (22')

28202 Hazel Trl
Katy, TX 77494

PROPERTY INSPECTION REPORT FORM

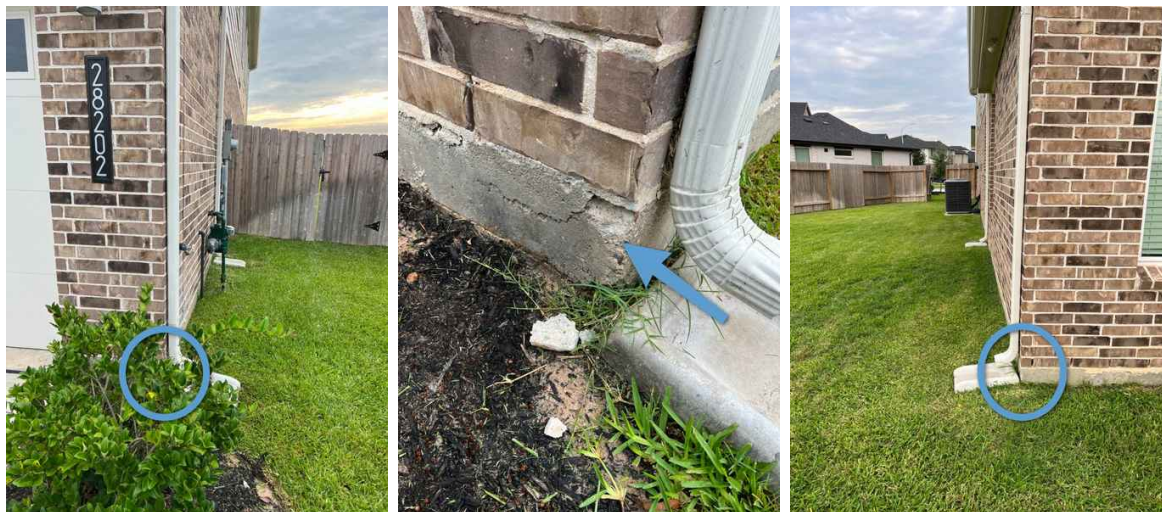
1: Corner pop

Southeast & Southwest

Foundation corner fracture(s) existed, "Corner pop". Although this condition did not appear to adversely affect the structure, sealing these areas may be desired as they could provide hidden access for wood destroying insects and moisture intrusion. Recommend repair by a qualified professional.

Recommendation: Contact a qualified professional.

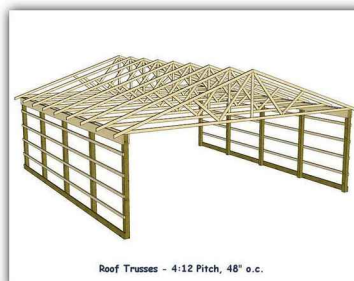
Roof Structure Description: The roof structure is framed using conventional stick framing. Stick framing utilizes lumber constructed on site by contractors.

The attic appears to be ventilated and insulated to minimum standards at the time of construction: The attic appears to be ventilated and insulated to minimum standards at the time of construction

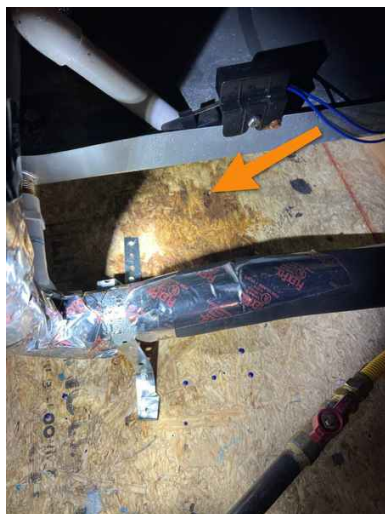
1: Water stains in attic

Water stains were observed on the roof framing and/or decking at one or more locations. Recommend repair as needed.

Note: moisture dripping onto the floor decking in the attic

Recommendation: Contact a qualified professional.

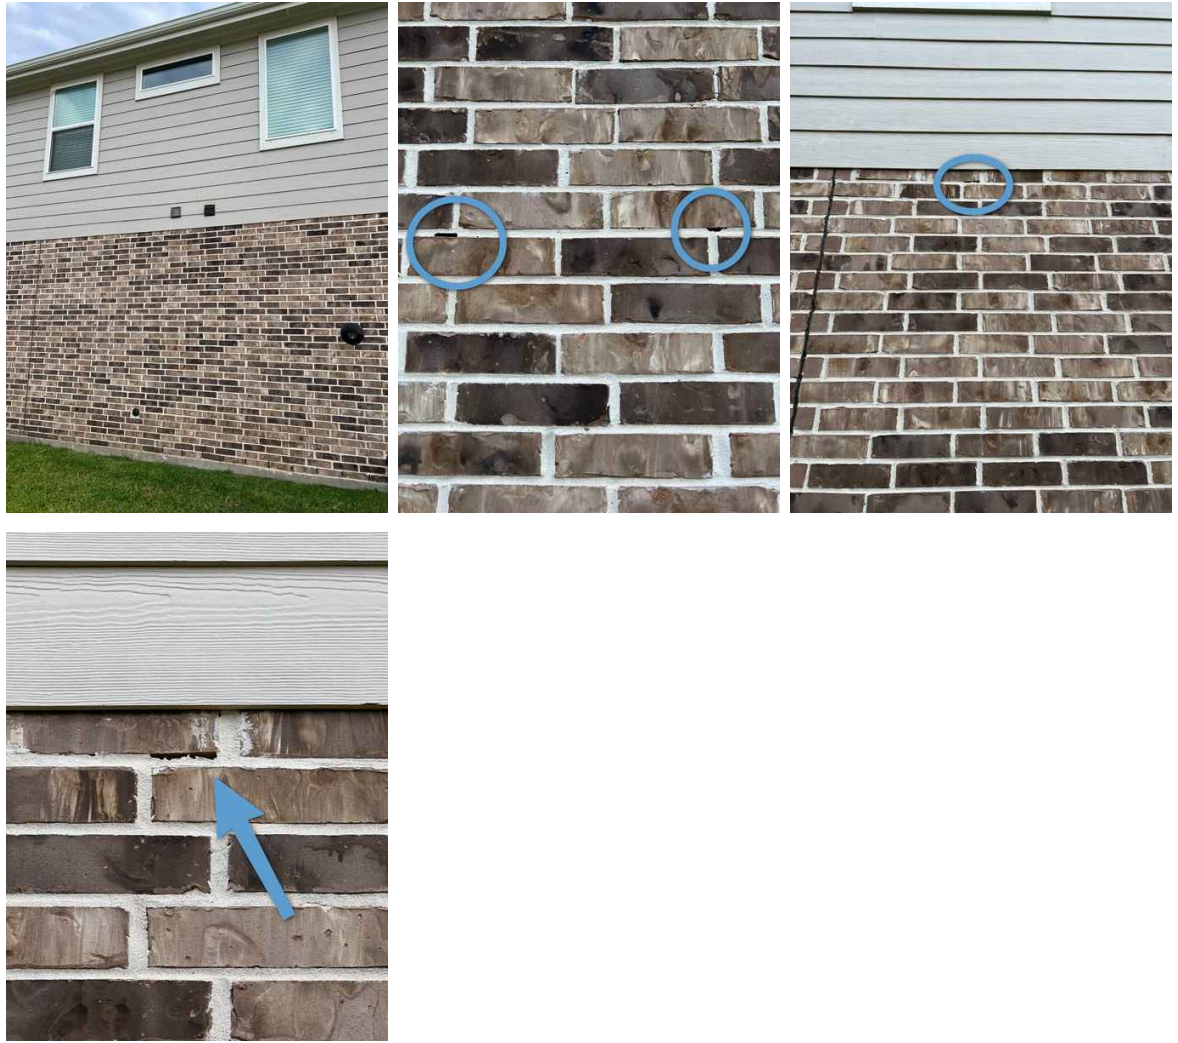
1: Openings in the brick veneer and/or stone mortar

South wall

There are openings in the brick veneer and/or stone at one or more locations. The brick veneer should be repointed to help prevent moisture and/or pest intrusion in those areas.

Note: all walls should be checked and corrected as needed.

Recommendation: Contact a qualified professional.

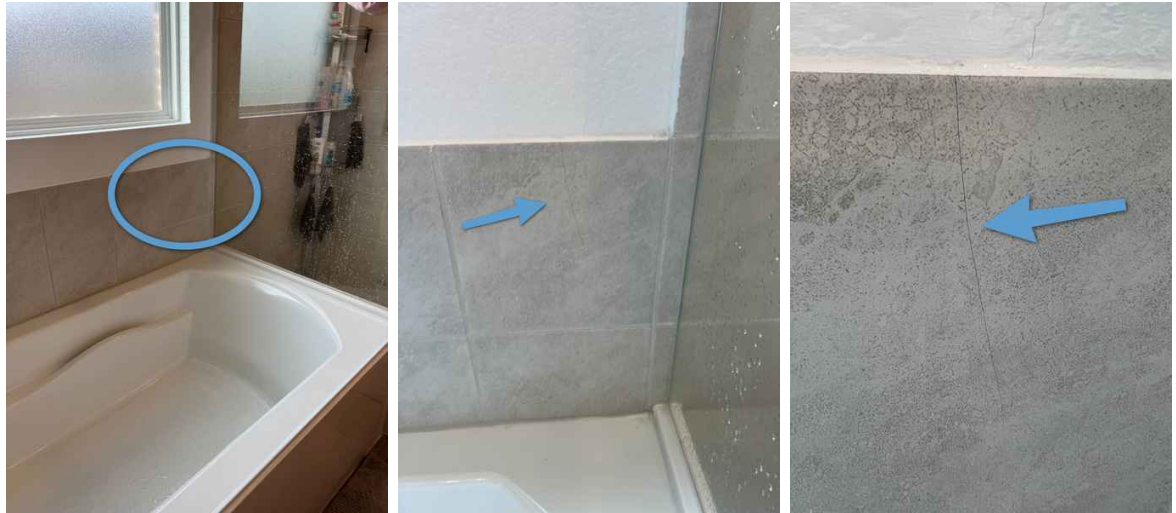
2: Chipped/cracked tile

Main bathroom

The tile is chipped/cracked on the interior walls at one or more locations. Repair as needed.

Recommendation: Contact a qualified professional.

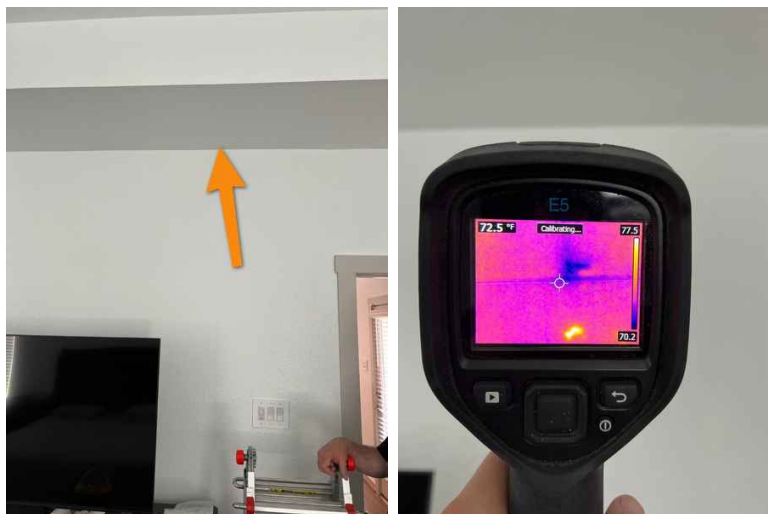
1: Cold spot observed

Main bedroom

A cold spot was observed in one or more areas using a thermal camera. Cold spots can be an indication of moisture. Where cold spots are observed and/or moisture is detected: further evaluation is advised and repair/replacement by a licensed professional contractor as needed.

Recommendation: Contact a qualified professional.

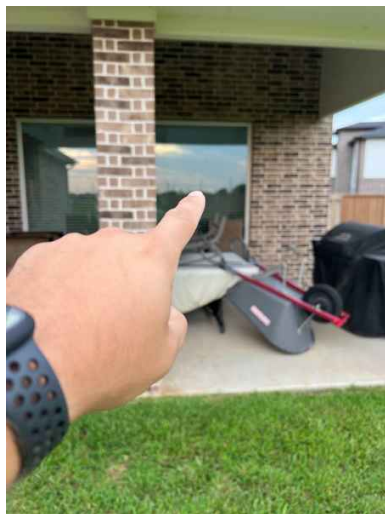
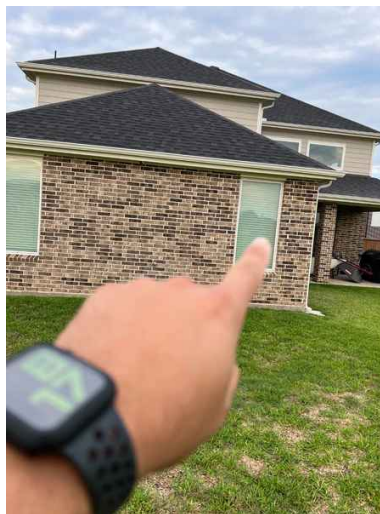
1: Failed thermal window seals

Backyard side

There are one or more window(s) with visible evidence of a broken thermal window seal. This causes condensation to form between the window panes leaving water deposits that cause discoloration between the panes over time. Recommend repair by a qualified professional.

Note: early signs of failure

Recommendation: Contact a qualified professional.

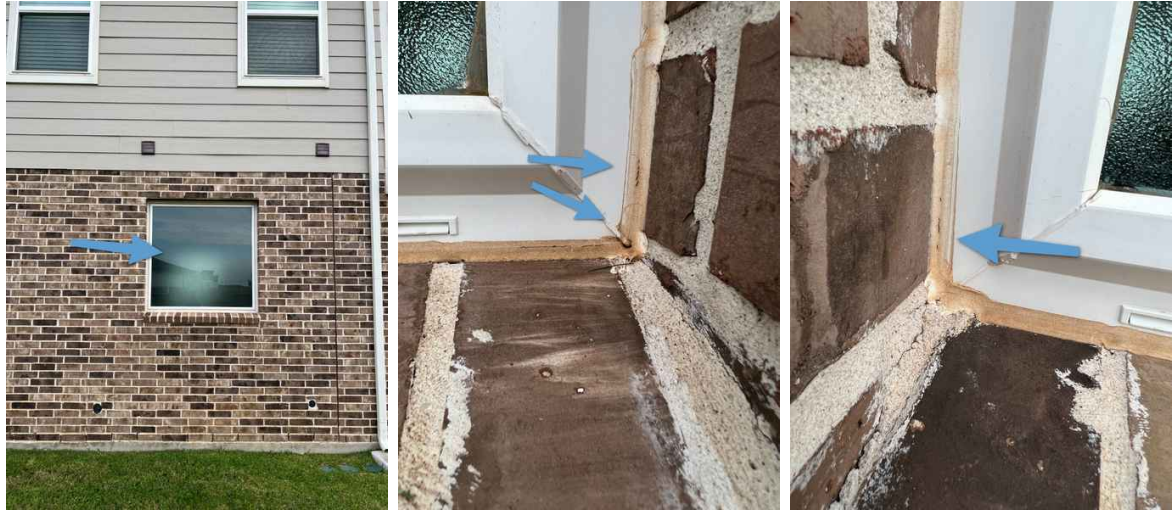
2: Exterior window separated caulk joint

There are separated caulk joints around the exterior window frames at one or more locations. The caulk should be touched up or replaced to exclude pests and moisture from those areas. Recommend repair by a qualified professional on all exterior windows as needed.

Note: minor separations observed. All windows should be checked as needed. This is a common maintenance item for homeowners.

Recommendation: Contact a qualified professional.

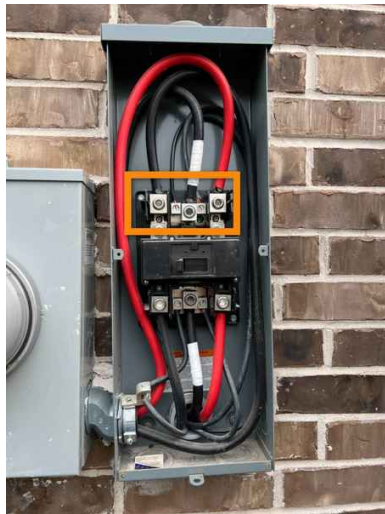
1: Main lugs no covers

Main lugs have no covers/barriers. Recommend repair by a qualified licensed electrician.

Recommendation: Contact a qualified electrical contractor.

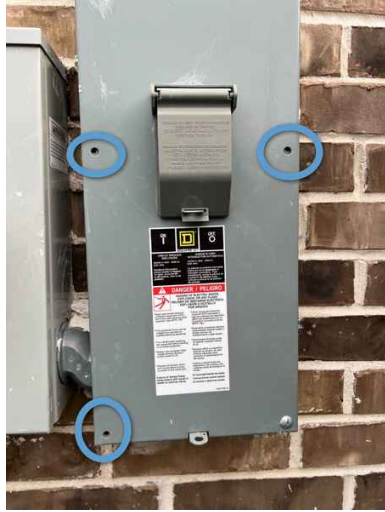
2: Missing screws in cover panel

One or more screws are missing from the cover panel. These should be replaced with the proper screws with butt ends. Recommend repair/replacement as needed by qualified professional.

Recommendation: Contact a qualified professional.

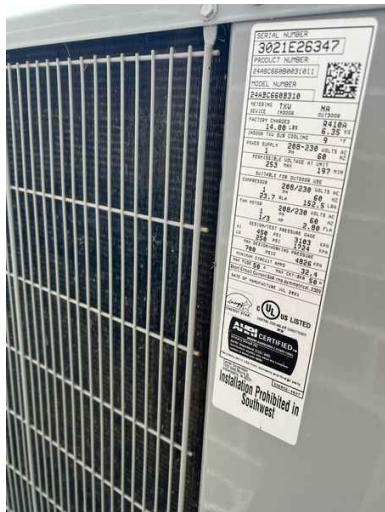
Unit(s) video and manufactures tag photos:

Size in tons: 5

Year manufactured: 2021

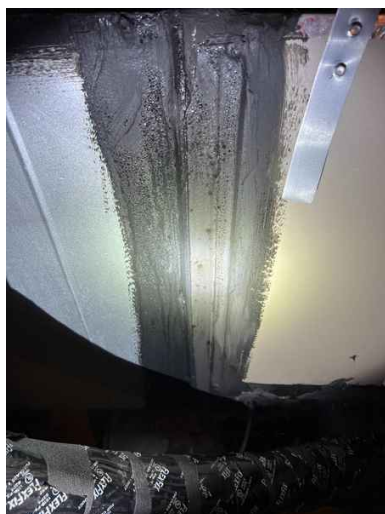
Fungal growth is forming on the duct plenum. This may indicate this area is not properly insulated. Further evaluation and/or repair by a licensed HVAC technician is advised.

Recommendation: Contact a qualified professional.

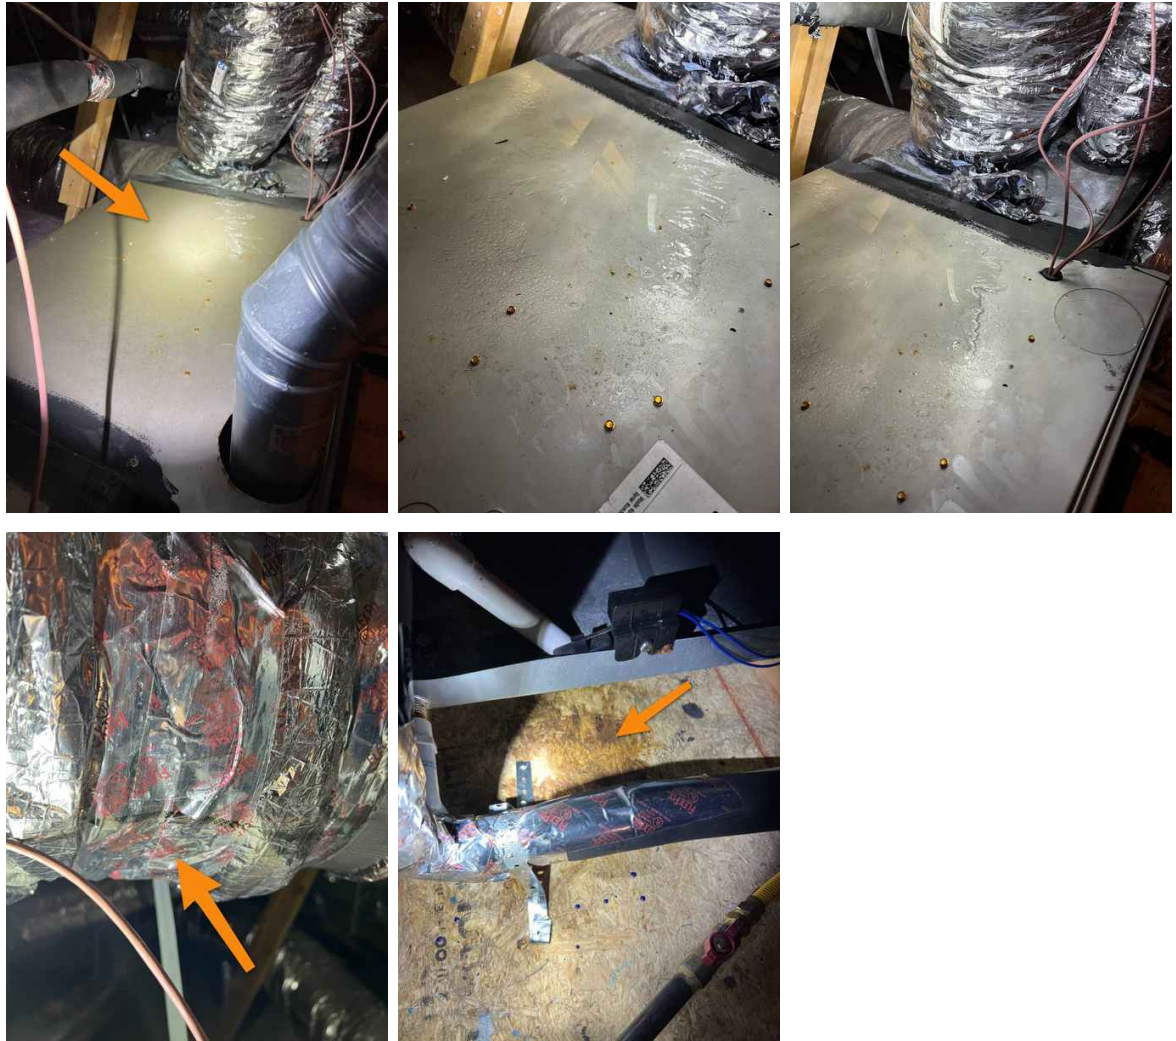
2: Moisture observed on air handler cabinet

Moisture was observed on the air handler cabinet. Recommend further evaluation to determine and correct the cause by a licensed professional HVAC specialist.

Note: excessive moisture observed in several areas. Moisture is dripping onto the attic decking. Moisture observed on the ductwork also.

Recommendation: Contact a qualified HVAC professional.

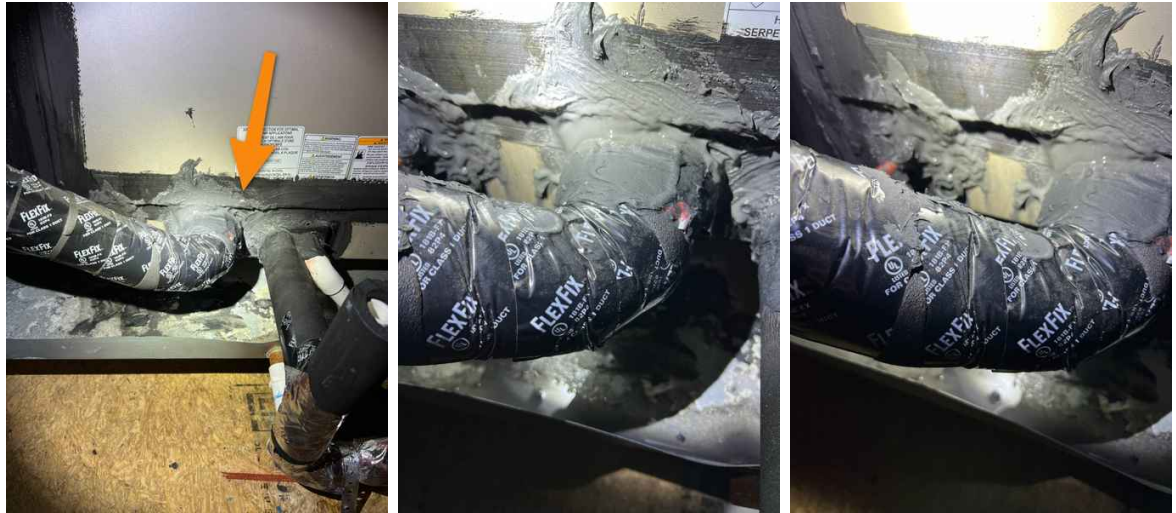
3: Seal in need of improvement

The material used to seal AC handler was in need of improvement in one or more areas. Recommend further evaluation and repair/replacement by a licensed professional HVAC specialist.

Recommendation: Contact a qualified HVAC professional.

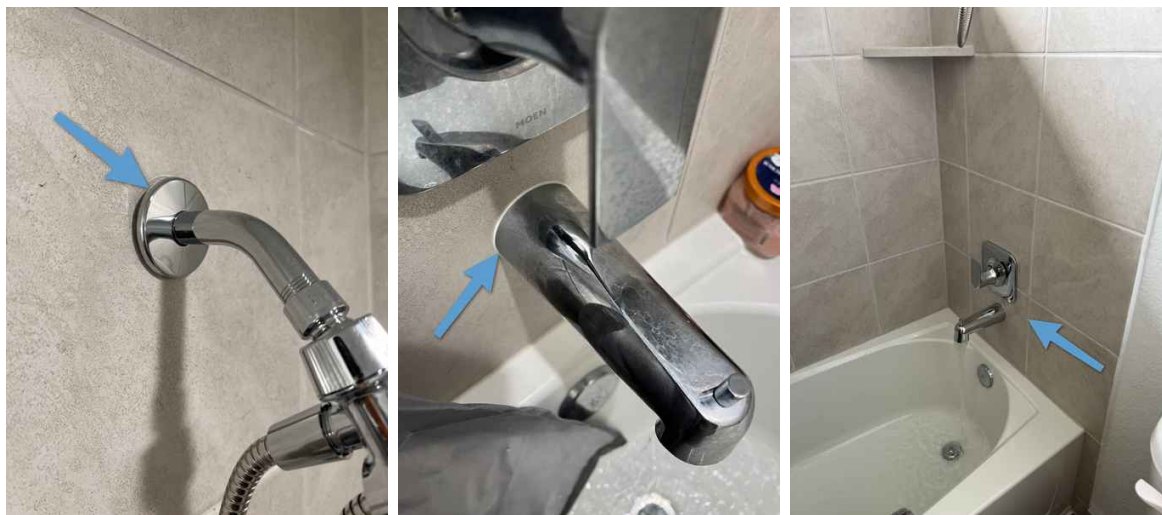
The bathtub and/or shower fixtures are not properly sealed to the wall. Recommend repair by a qualified professional.

Recommendation: Contact a qualified professional.

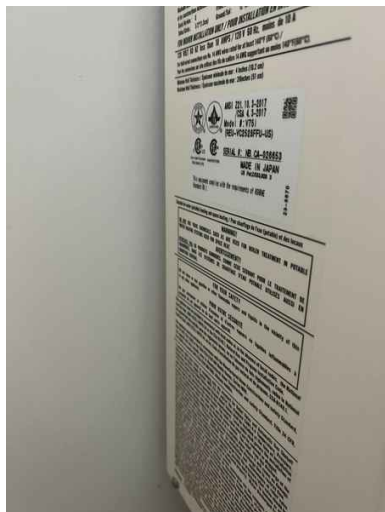
Water temperature test range: Below 120 degrees -

Note: The water temperature at the fixtures tested at the range indicated above. Water temperatures should be 120 F or below to help prevent accidental injury from scalding.

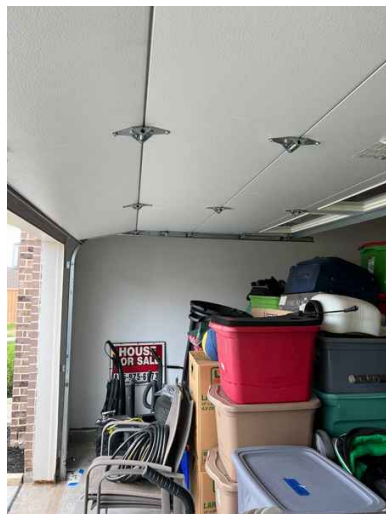
Excessive noises were observed when opening/closing garage door. Recommend further evaluation by a qualified professional and repair as needed.

Recommendation: Contact a qualified professional.
