I. STRUCTURAL SYSTEMS

A. Foundations

Type of Foundation(s): Concrete slab on grade

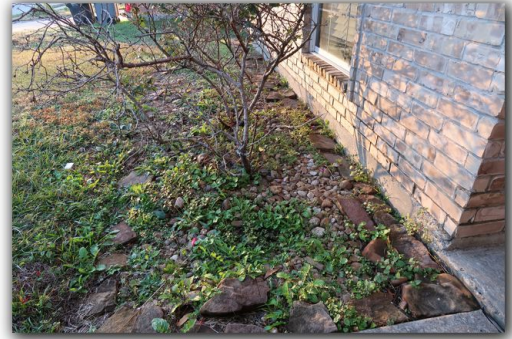
☑ Rainwater is coming off the roof and splashing up against the doors, windows, and the house. Steps (addition of gutters) should be taken to facilitate the removal of rainwater away from the foundation and eliminate the soil erosion.

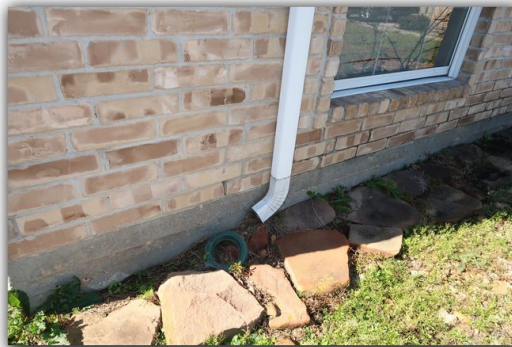
☑ At ground level, the water from the downspout should be directed at least 5 feet away from your house. It is best to have the water flowing onto a hard surface (like a driveway, a fiberglass or concrete splash guard) designed to spread the water and prohibit it puddling on the ground near your home.

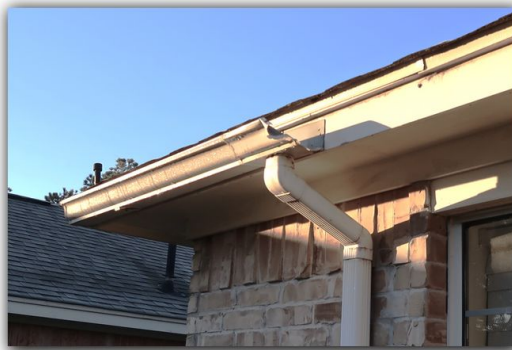
☑ Damage gutters were observed at front of home at the time of inspection. Repair as necessary.

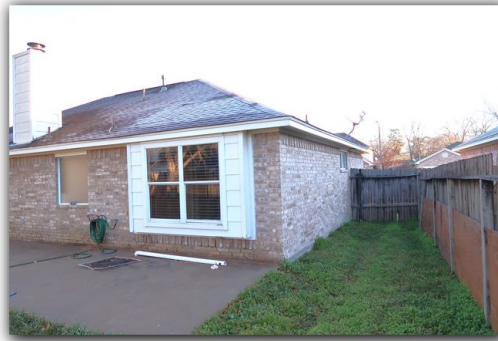
Special note: the drainage in the back and side area is totally dependent on the french drains and/or an under ground drainage system which was not checked for performance and/or adequacy.

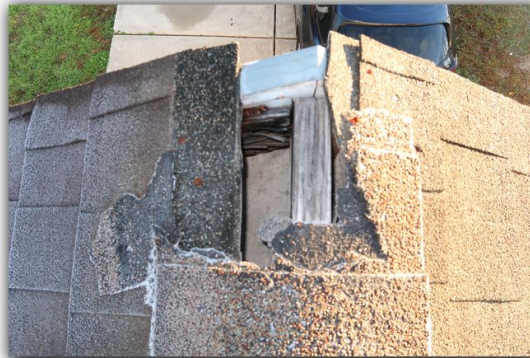
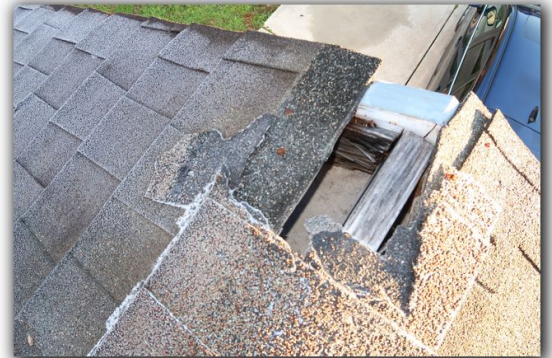
Repairs to the roof system are recommended. Damaged or missing roofing material should be repaired. All roof penetrations should be examined and sealed as necessary.

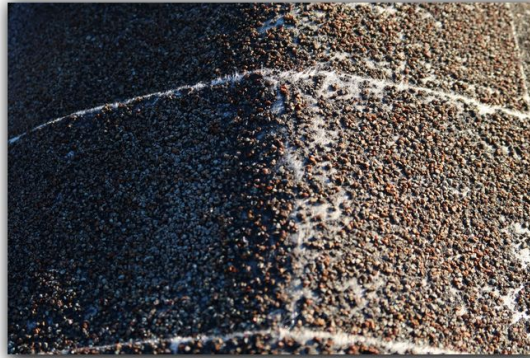
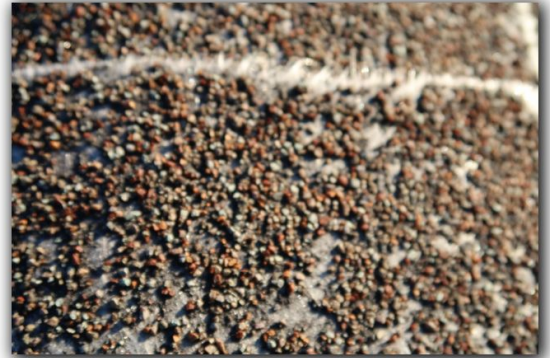
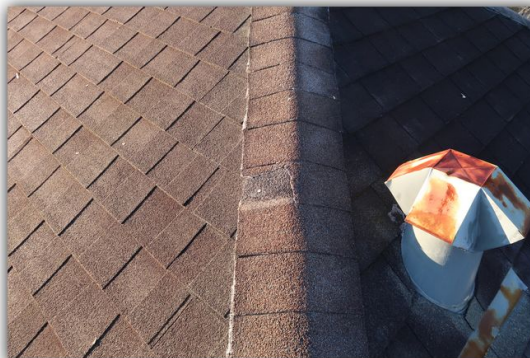
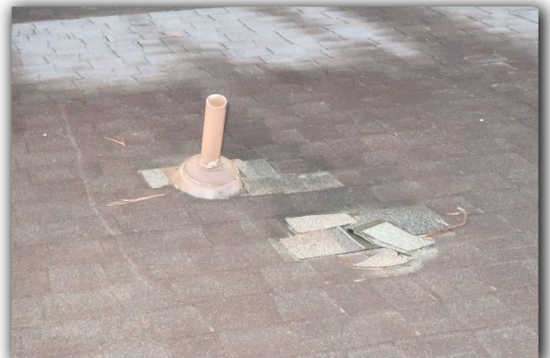
The roof covering is old, and the life of covering has expired. Roof is old; shingles show evidence of deterioration; recommend estimate from roofing company

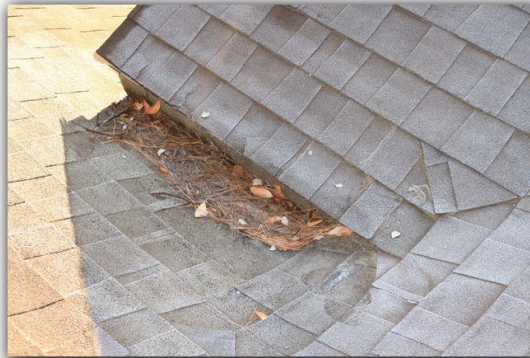
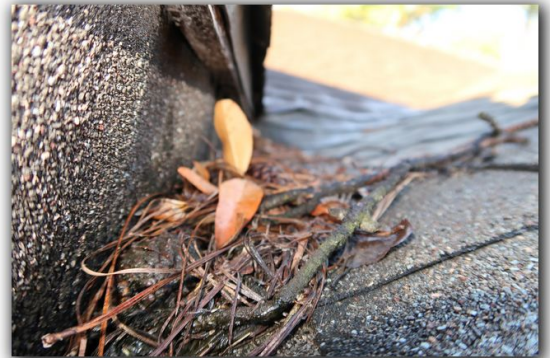
Pine tree needles and any organic material on a roof especially on a valley area, then the organic material will remain wetter for an extended period of time and thus, also allow a possible growth of lichen or roof algae to set root into the organic shingle causing deterioration and roof leaks. Remove the tree debris from the roof

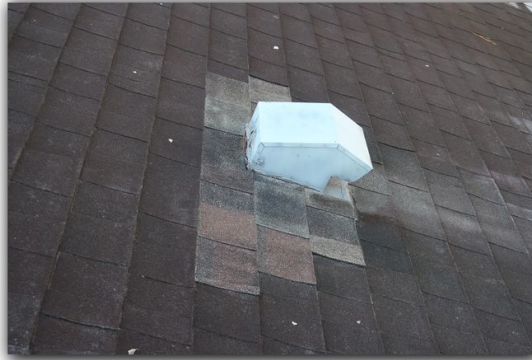
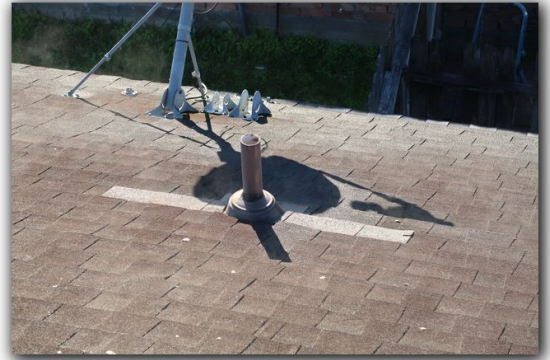
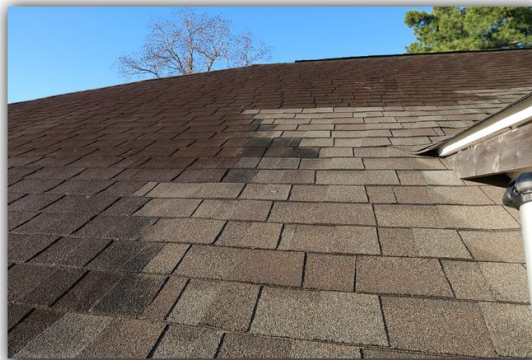
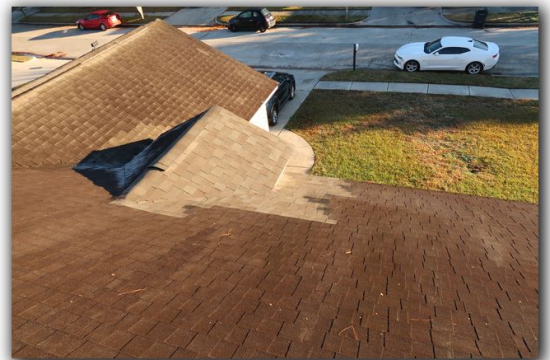
Prior repairs to the roof system are evident. This would suggest that problems have been experienced in the past. This area should be monitored.

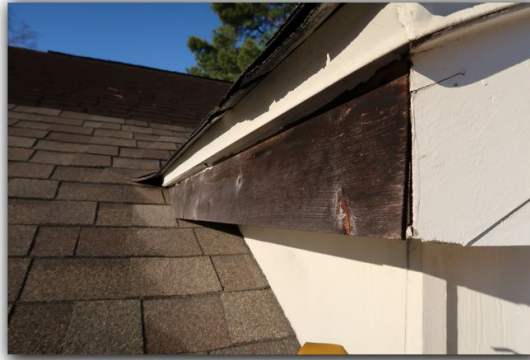
Wood trim(s), eaves and overhangs (soffit). Open areas where either caulking has dried out and/or paint has started to peel could be locations of moisture penetration and related damage! Repairs are needed at this time to these areas.

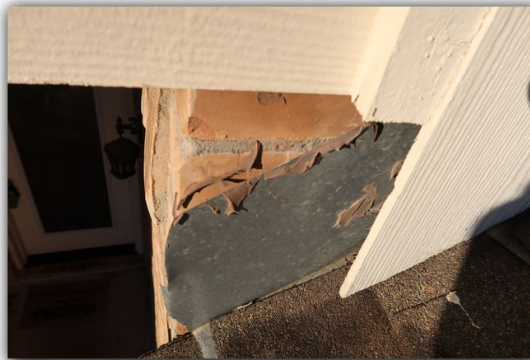
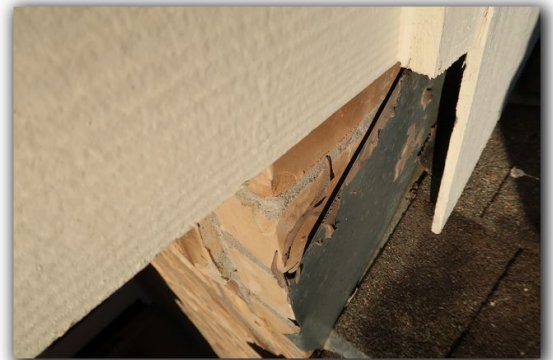
Loose flashing was observed at exterior wall where the wall meets the roof. this area should be sealed to prevent water intrusion into the home

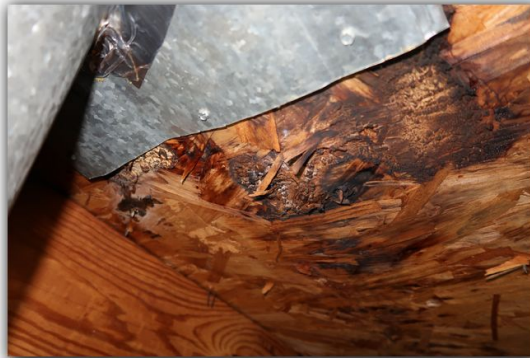
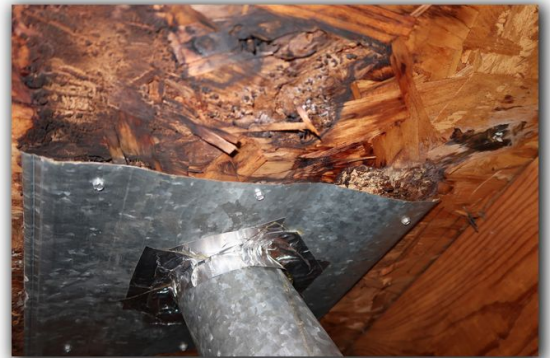
Moisture stains in attic. Condition typically is caused by roof leaks; other causes or multiple causes are possible. Roof drainage problems cannot be adequately determined during dry weather. Recommend determining and eliminating source of moisture stains, and repair or replacement, as necessary.

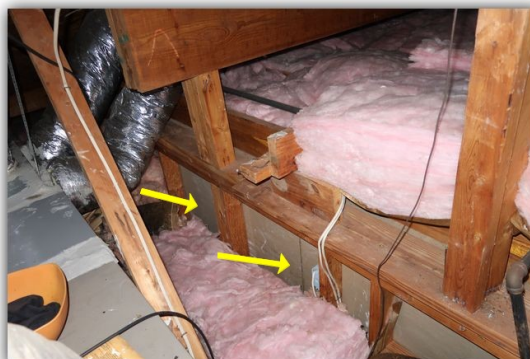
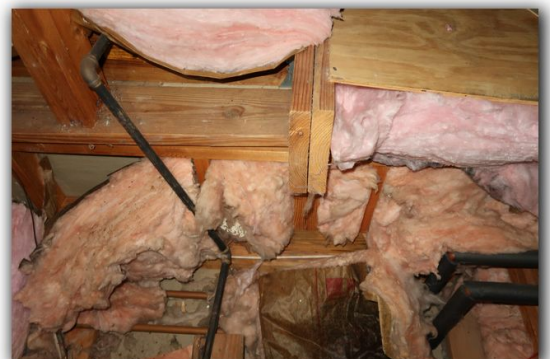
Some of the insulation has been or is: improperly cut/fit, fallen out of place, missing or does not fit correctly. All of these small areas will add up to less effective insulation for the house.

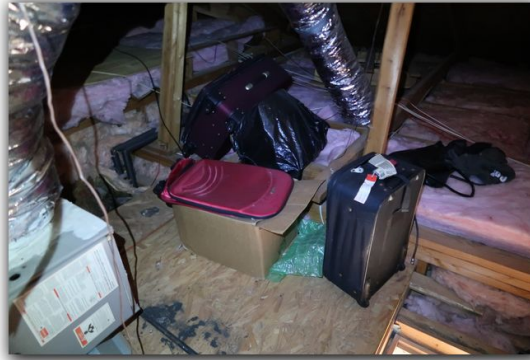
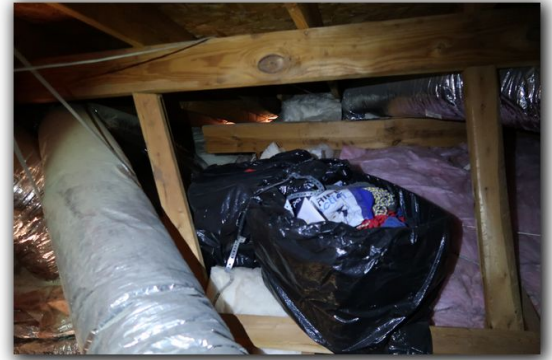
The construction debris and other material should be removed from the attic or appropriately placed out-of-the-way

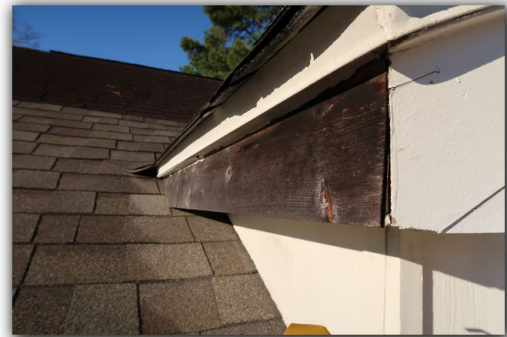
Wood siding and/or fascia/trim boards has water damage in several areas. There are areas around the garage/house's siding and trim that should be repaired. It is suggested that a detailed list be compiled, prioritized and the necessary repairs started.

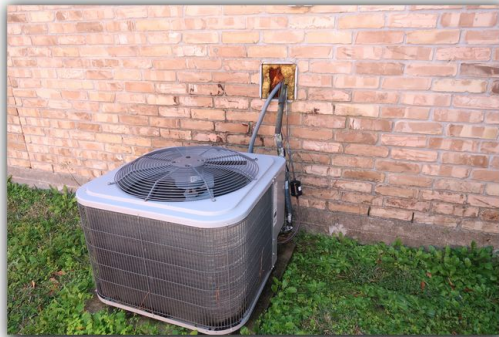
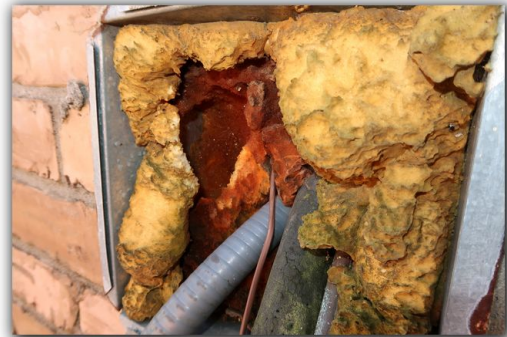
Improper foam material was observed to be used to seal exterior penetrations. A none degradable/waterproof sealant is recommended in these areas.

It is recommended that a detailed inspection of the house be implemented to guarantee all possible entry points for insects, rodents and moisture have been properly sealed.

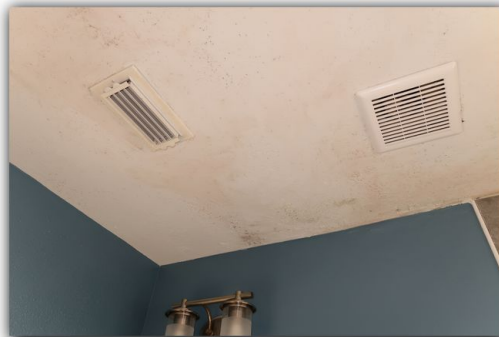
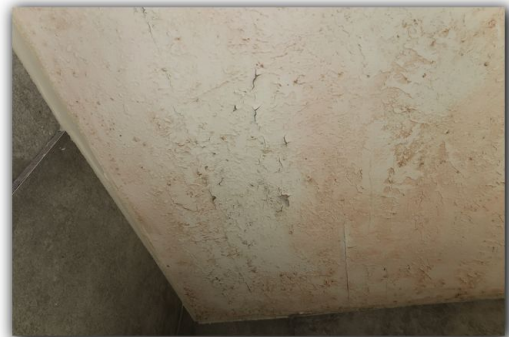
- Ceiling cracks in some areas
- Signs of structural settling

- There was water damage and/or black staining in the hallway bathroom ceiling.

The black staining around these areas will need to be inspected by a professional inspector in this matter to ensure there are no health hazards in relation to the black staining and if remediation is required

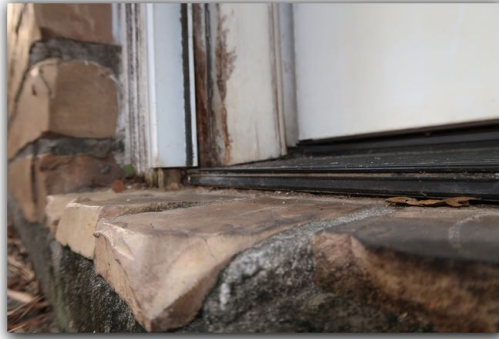
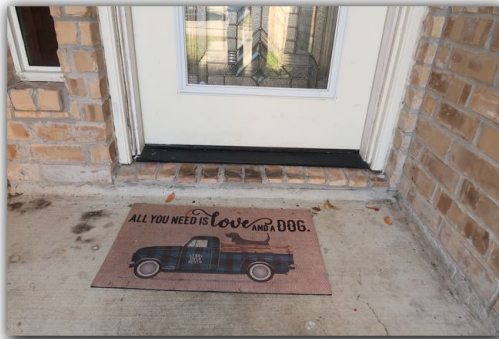
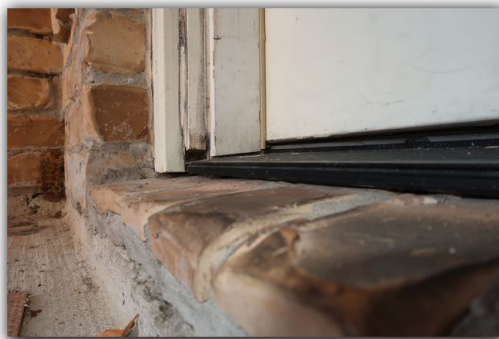
The weather stripping and/or caulking around the exterior door(s) should be improved, as well as, under the threshold should be sealed.

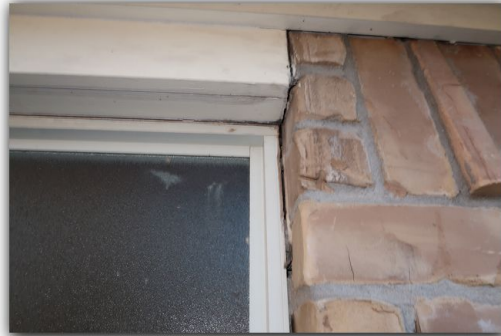
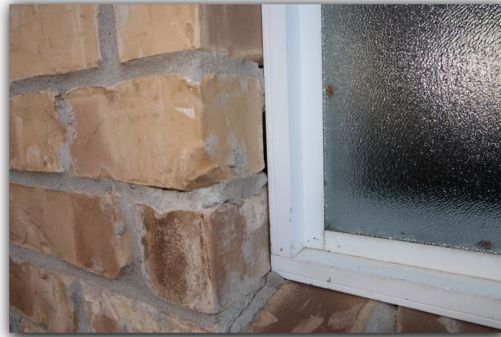
Where windows meet the brick, repairs are needed.

Each window should be individually inspected and sealed as necessary. There are areas where moisture can penetrate into the structure.

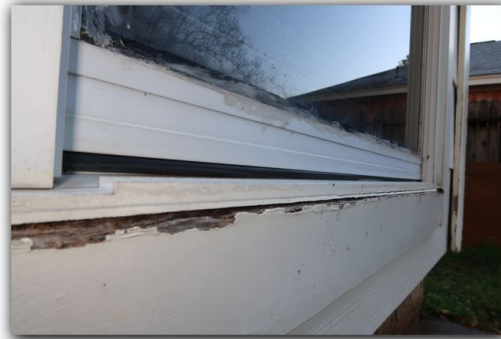
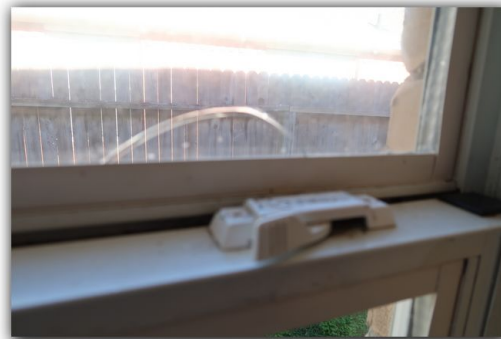
One or more damaged and/or broken window panes were observed at the time of inspection. Repair is necessary.

- Some absence of safety glass
- Some missing and/or damaged screens

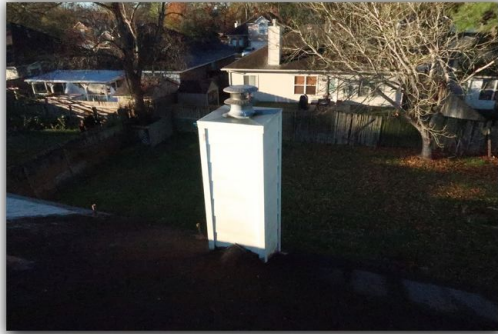
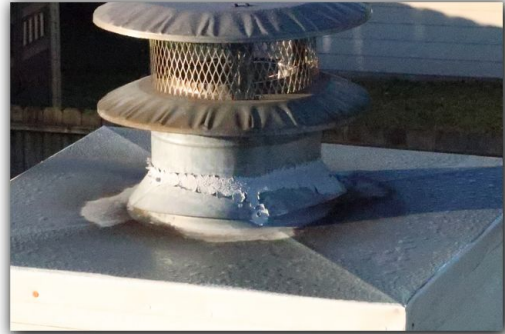
Chimney cap needs to be repaired and/ or properly sealed. This is important because rain flowing down the chimney can get inside the house, attic, and/or in the firebox

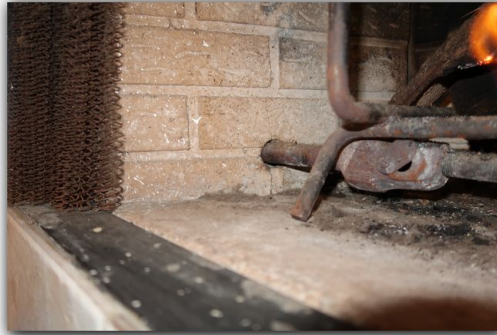
Water stains and/or rust was observed in the firebox at the time of inspection

The gas line entry is not sealed . A tight seal between the gas pipe and the side wall of the firebox is needed to prevent the passage of heated gases into the wall cavity. This seal should be supplied and maintained with an approved material.

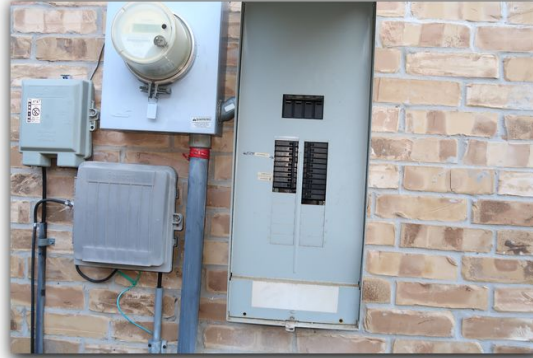
Panel(s) are not labeled properly

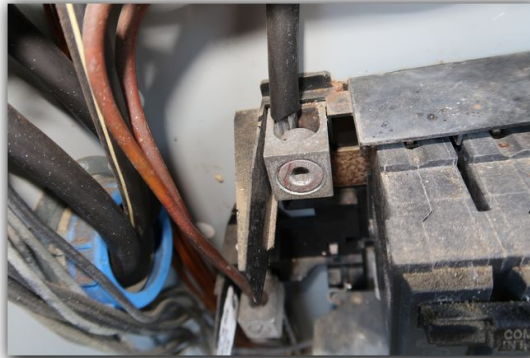
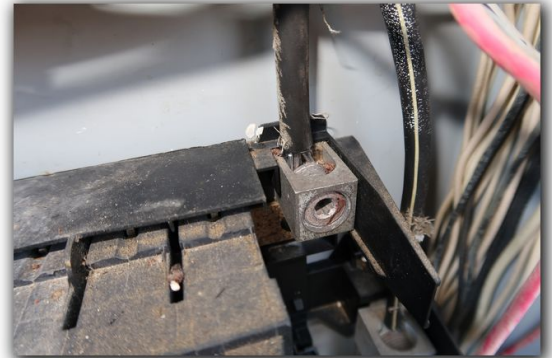
The aluminum service entrance conductors were not coated with an anti-oxidant solution. This can allow the conductors to oxidize, which can be a fire hazard.

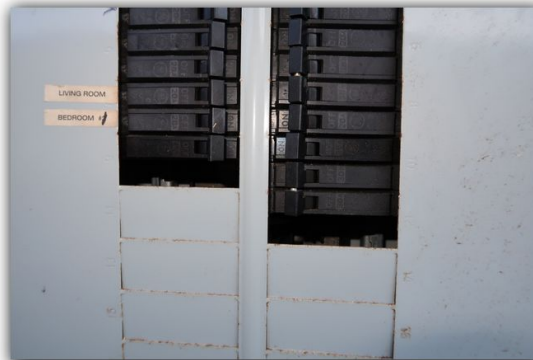
One or more knockouts are missing

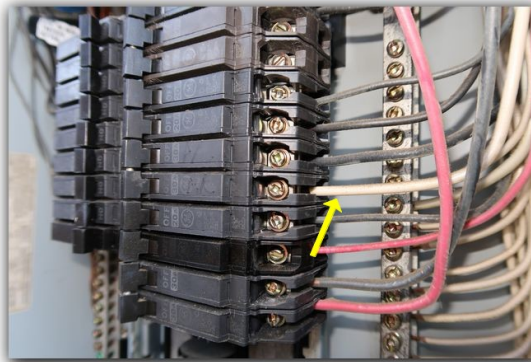
The white conductors were not marked to identify if the conductors are carrying a life load at multiple

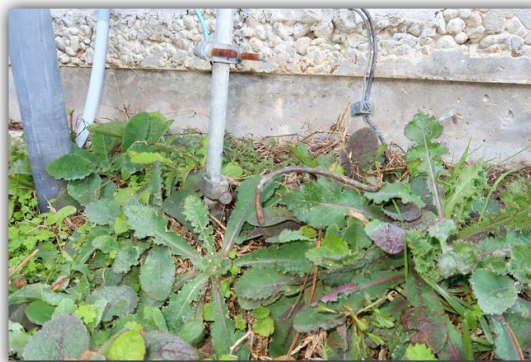
The ground connection for the electrical service was not properly connected at the time of the inspection.

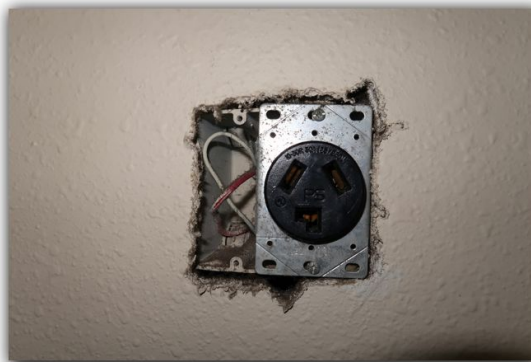
Missing cover plate. Repair is necessary as this represents a safety hazard that must be corrected

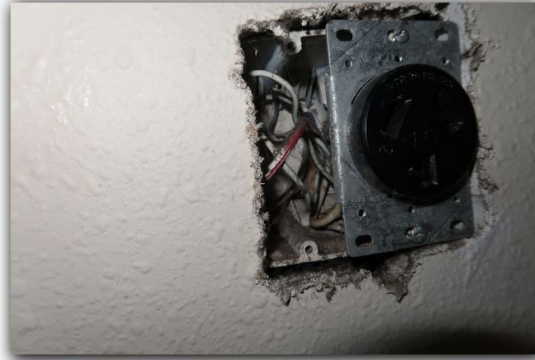
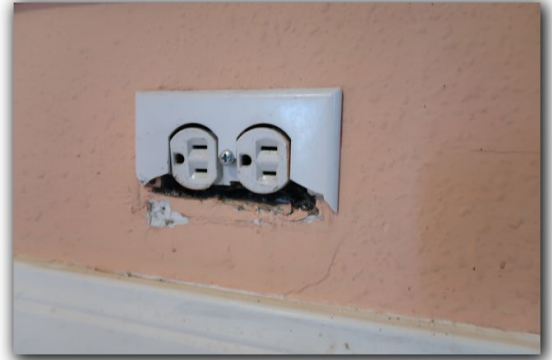
- Loose/damaged/missing outlets and/or covers
- Neutral and hot wire reversed at: Kitchen

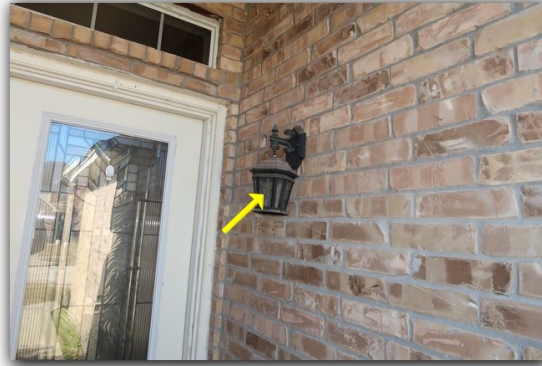
Some light fixtures are damaged/missing

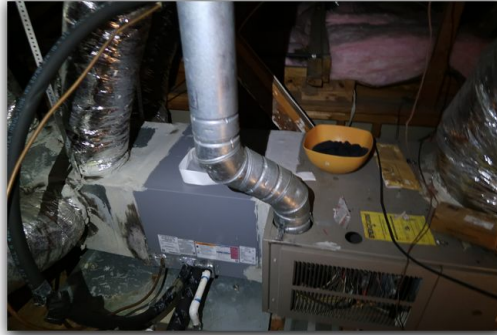
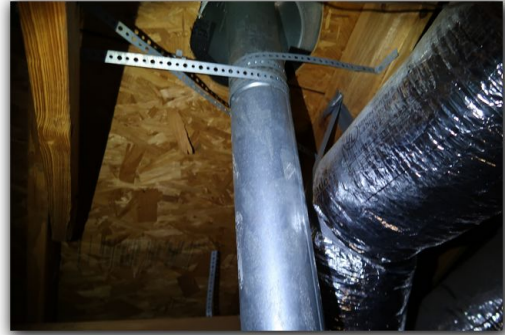
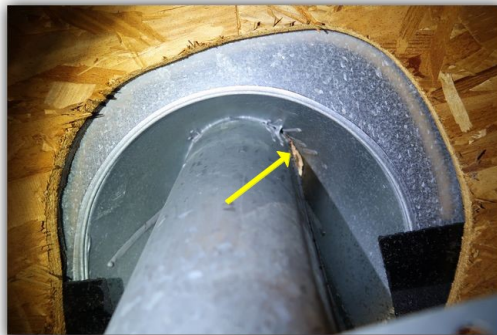
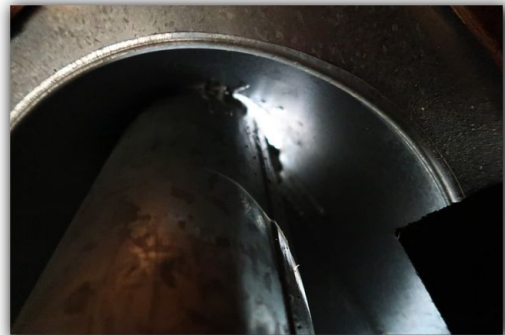
Roof Leak: Type B Vent Pipe Through the Roof Deck. The furnace exhaust vent pipe was loose and/or was not properly installed, Water Leak Residue Trail was observed on the pipe at the time of inspection

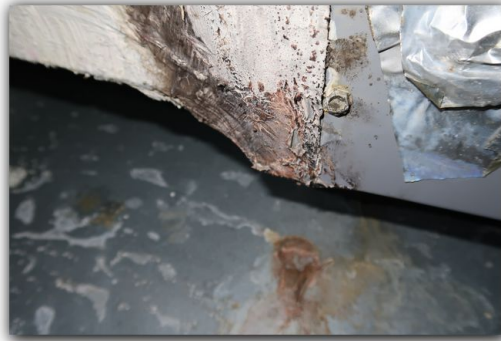
Air handler plenum/ductwork/air-conditioning unit is not properly sealed. Air is leaking from the edge seams of the blower/plenum unit in the attic. This should be sealed/taped to improve efficiency and eliminate condensation.

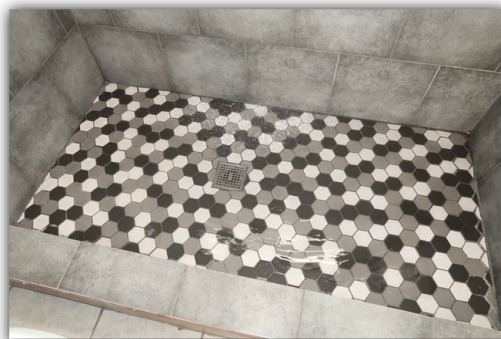
Slow drain was observed at the Walk-in shower - Hall Bathroom

No tub drain access panel installed as required by most current codes, due to lack of access no evaluation of internal plumbing components was made.

Recommend access be made to evaluate for leaks, wood destroying insects, mold or other defects prior to closing of escrow.

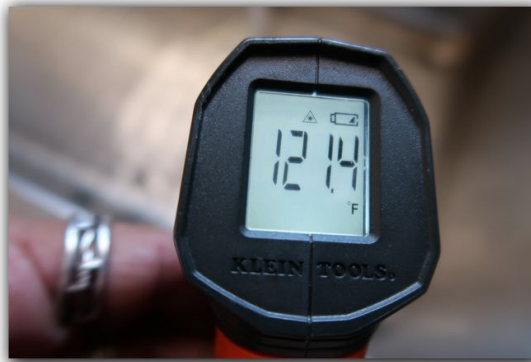
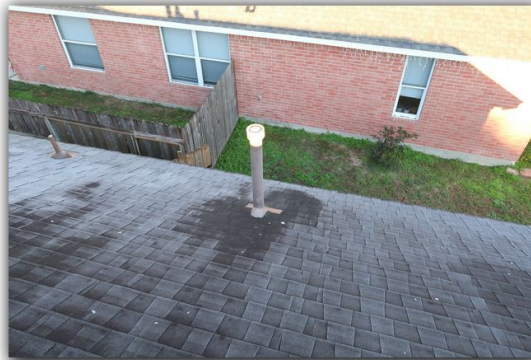
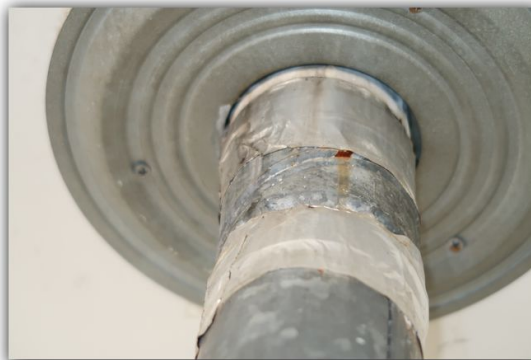
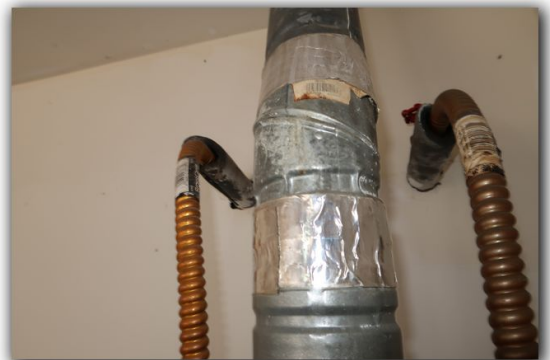
Roof Leak: Type B Vent Pipe Through the Roof Deck. The water heater exhaust vent pipe was loose and/or not properly sealed, Water Leak Residue Trail was observed on the pipe at the time of inspection

Water heater is old rusted and/or damage was observed on top of the unit at the time of inspection. The water heater must be replaced.

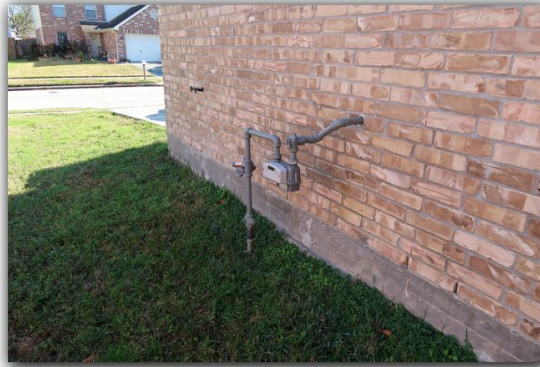
Location of gas meter: Right side facing front of home

Type of gas distribution piping material: Galvanized

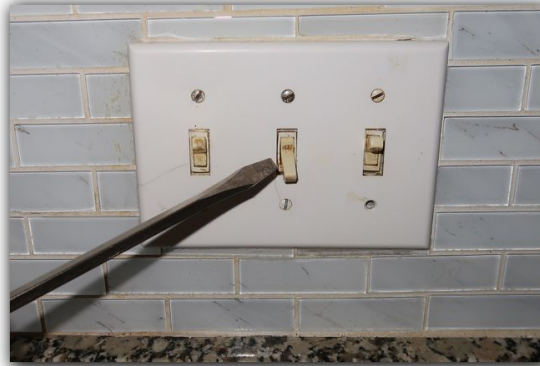
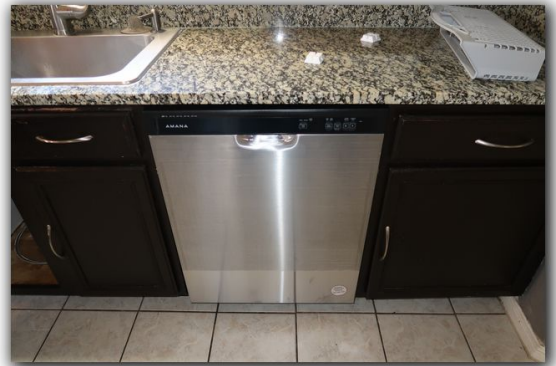
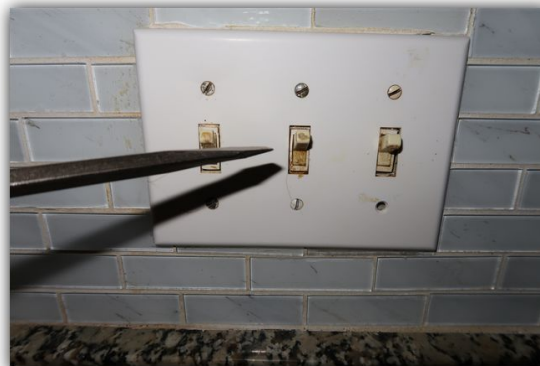
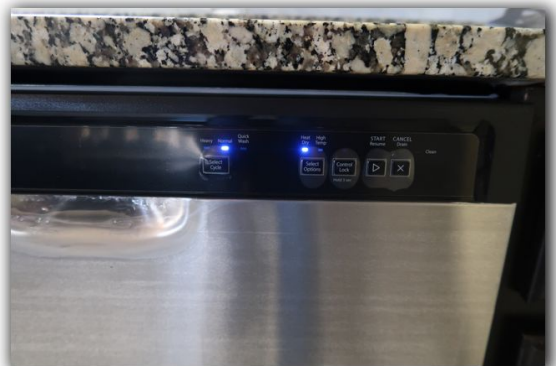
Inspection of the dishwasher was limited and/or the inspector could not run the unit at the time of inspection as the dishwasher was connected to the garbage disposal.electrical switch Repair is necessary

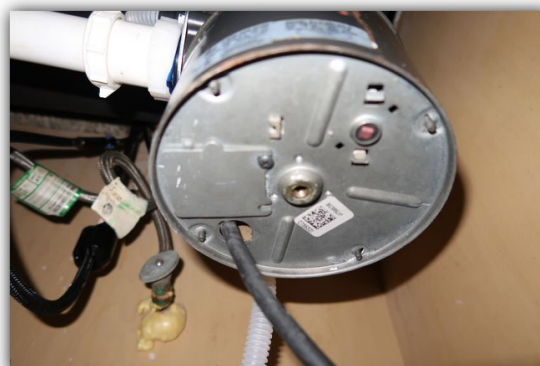
Electrical wire connection is not protected from damage. The term electrical conduit refers to a durable tubing or other type of enclosure. Conduit is typically required where wiring is exposed or where it might be subject to damage

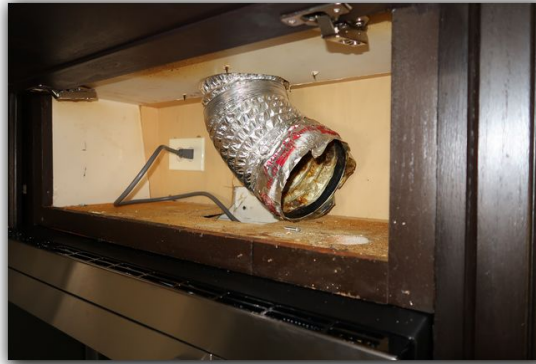
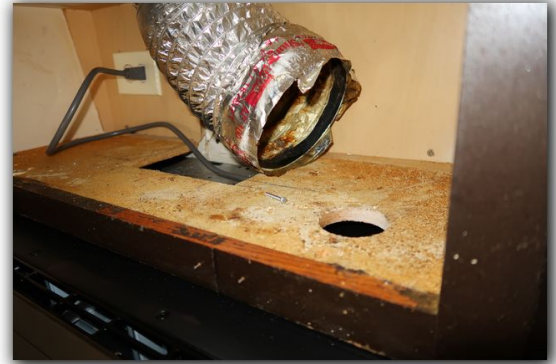
Not properly connected in cabinet. Repair as necessary

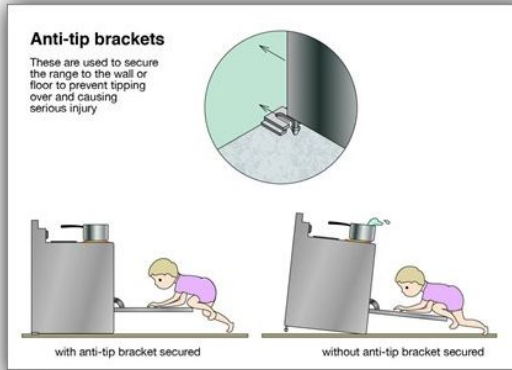
Absence of anti-tilt device

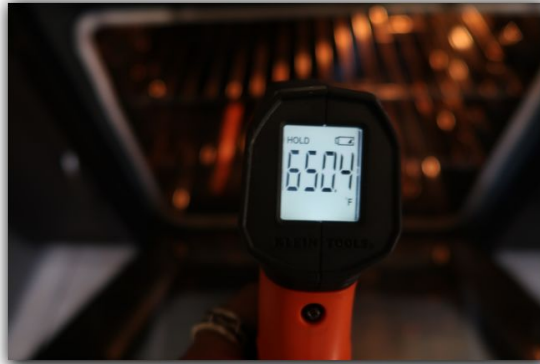
Unit #1: Electric Gas
Tested at 350°F, Variance noted: 650°F (max 25°F)

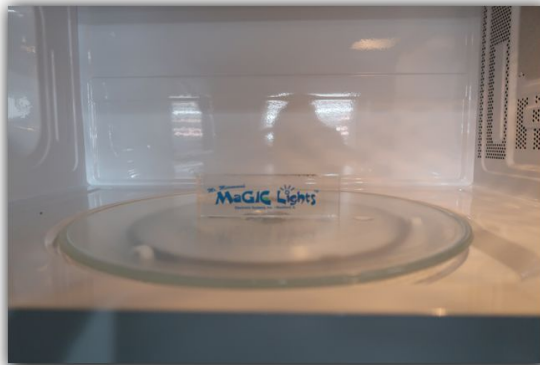
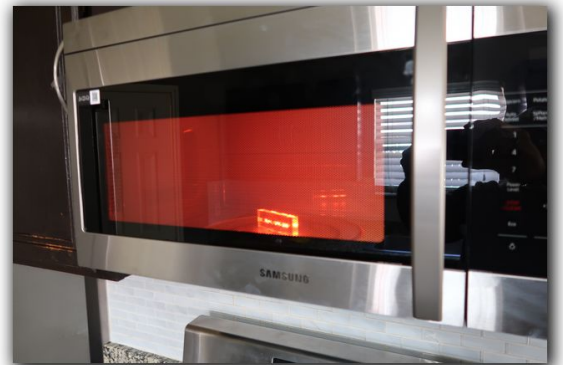
The unit was tested using an LED microwave indicator. No deficiencies are present to report

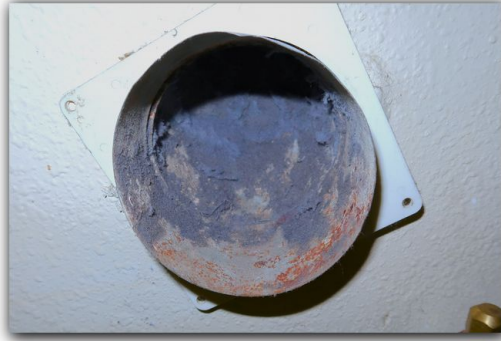
- The dryer's vent should be cleaned out completely before the new dryer is hooked up. This includes the termination point of the vent system. This material is very flammable. The dryer's vent should be cleaned out yearly. This material is very flammable.
