BPG Inspection, LLC

**12822 Southbridge Road
Houston TX 77047**

Client(s): Corona
Inspection Date: 4/5/2024
Inspector: Daniel Neuman , TREC #25268 (TX)

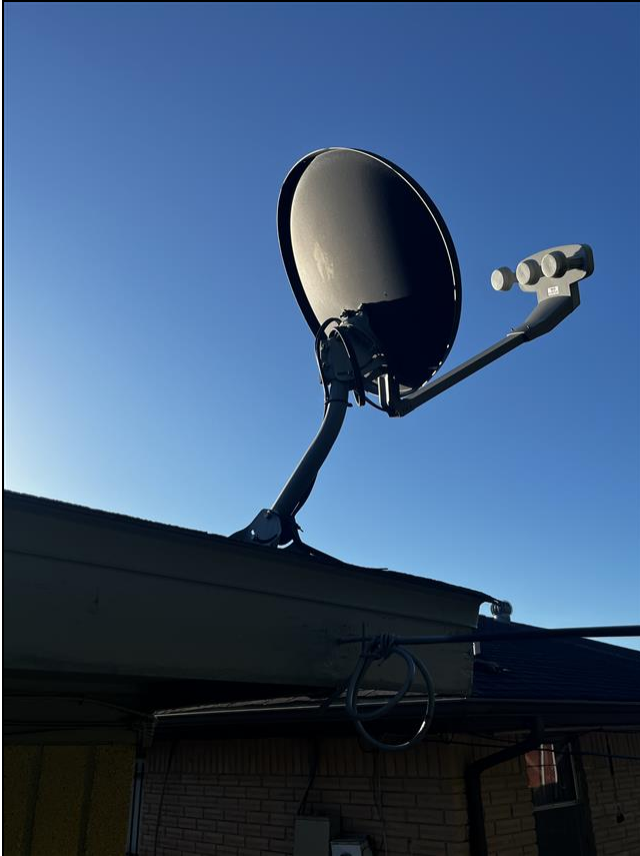
Mounting a satellite dish directly through the roof deck is not recommended. The preferred installation is on side of wall or eaves. In it's current installation, extra sealant is recommended on the fastening bolts.

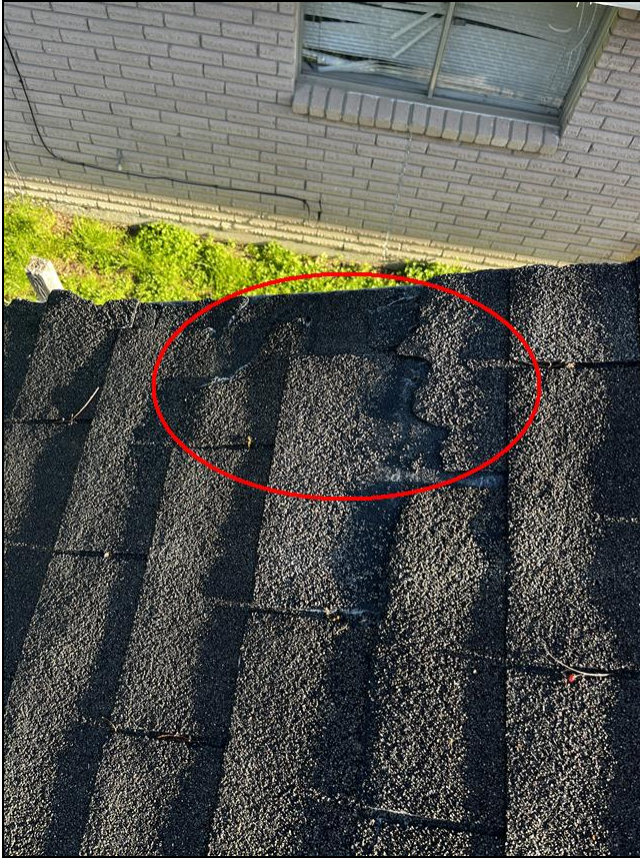
Minor damaged observed in some areas of the roof

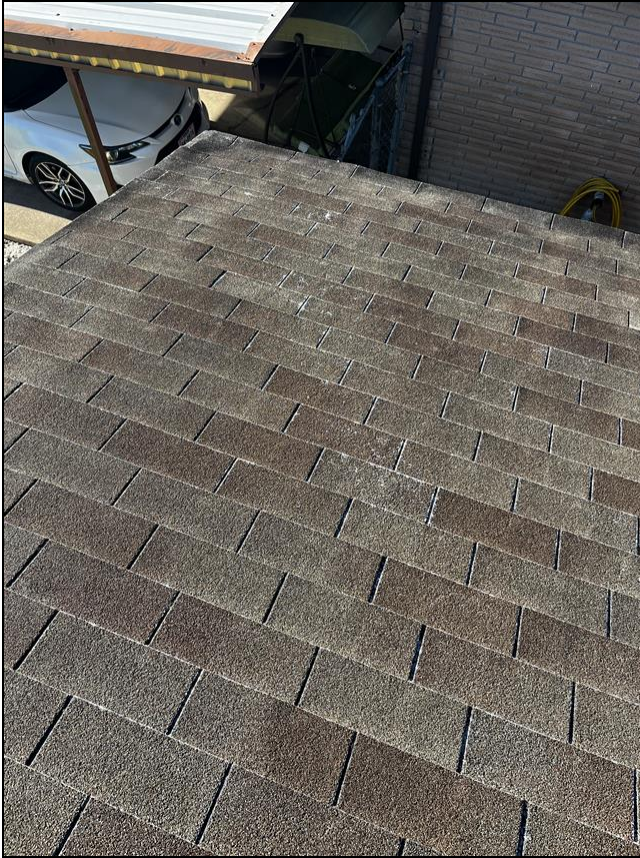
There are slightly worn shingles with some granular loss in some areas throughout the roof. A roofer should perform a maintenance check on the covering for needed repairs, patching or replacement of worn shingles.

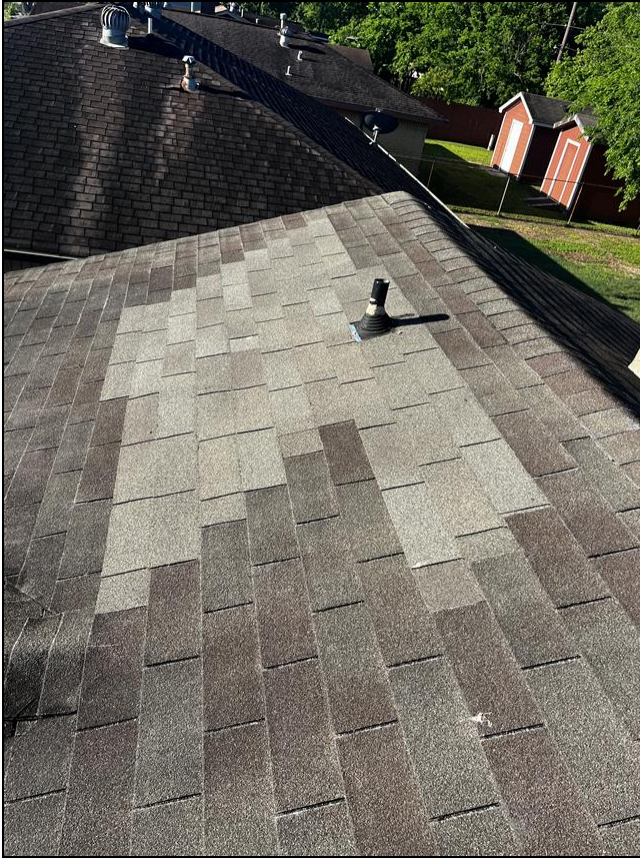
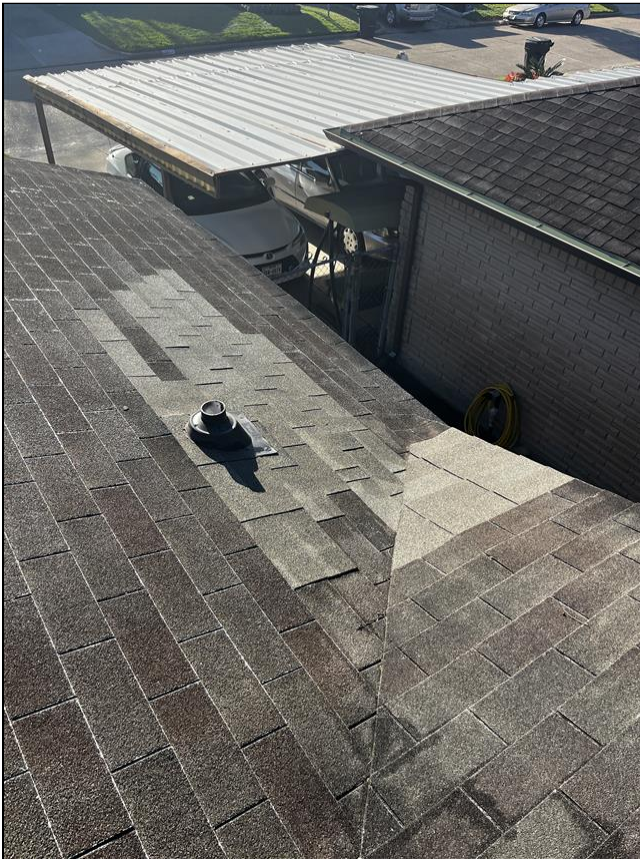
There were previous repairs observed. I recommend you query the owner for documentation on all roof repairs.

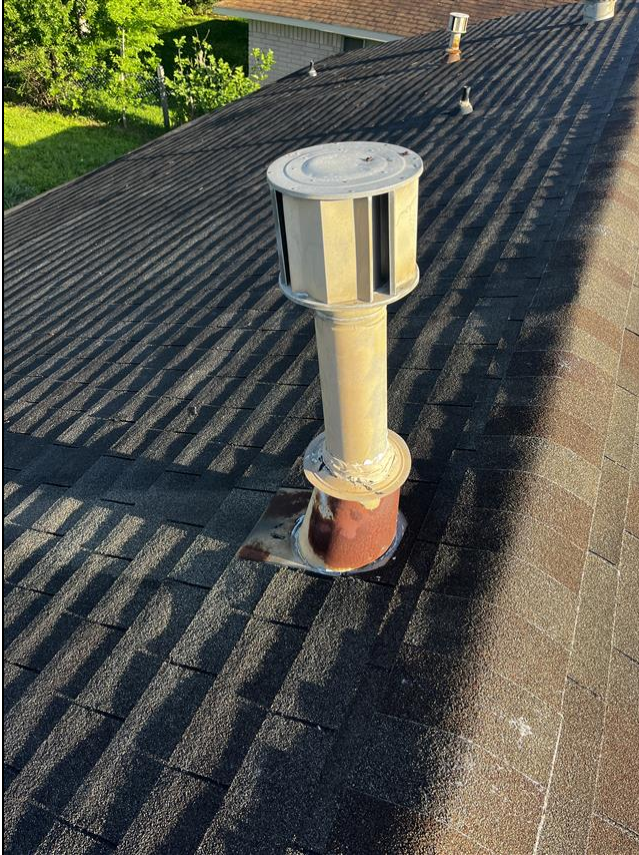
☒ There were several roofing fasteners observed to be improperly sealed or exposed. Left unsealed the fastener penetrations could present a point of water penetration into the roof structure. Seal (caulk) all exposed roofing fasteners (i.e. plumbing vents, flue pipe roof jacks, flashings, and ridges lines).

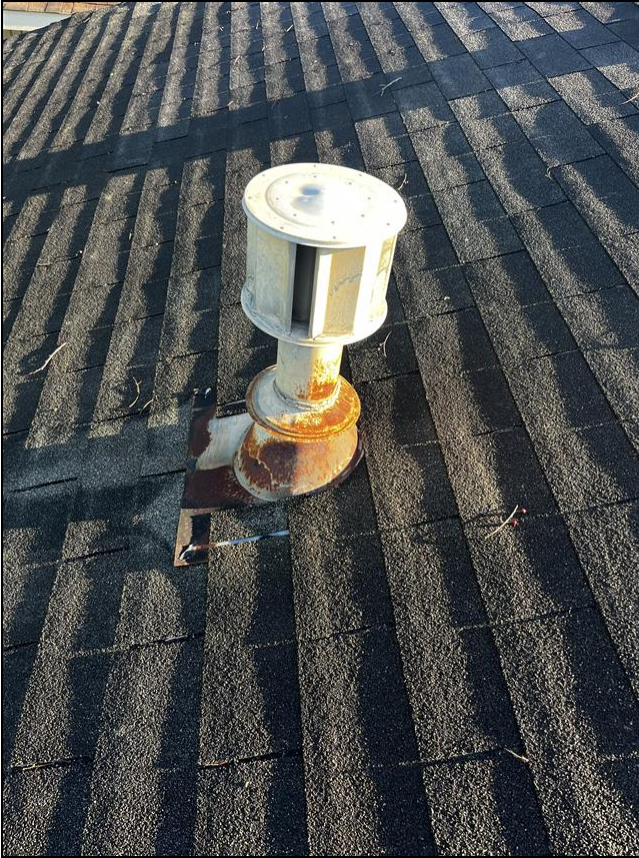
☒ Paint is needed on bare metal vent pipes. This will prevent rust and also UV damage to the pipes.

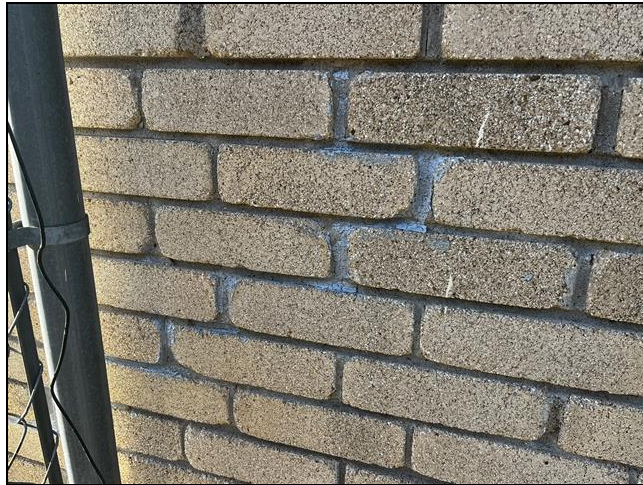
Previous repairs observed

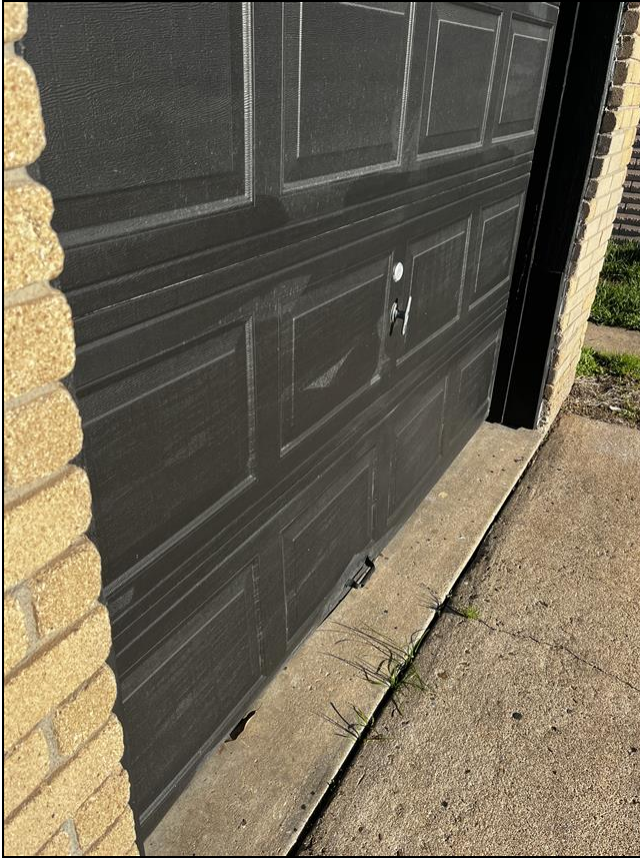
Some damage observed in the front door frame

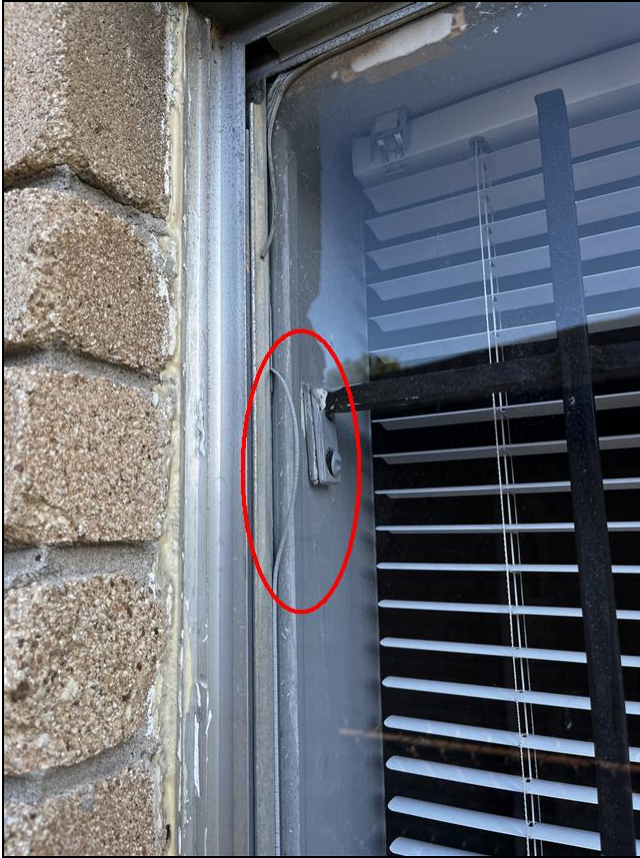
There were window screens missing at all window(s). I recommend the owner have all the screens re-installed to ensure there are none missing. Have any missing screens replaced.

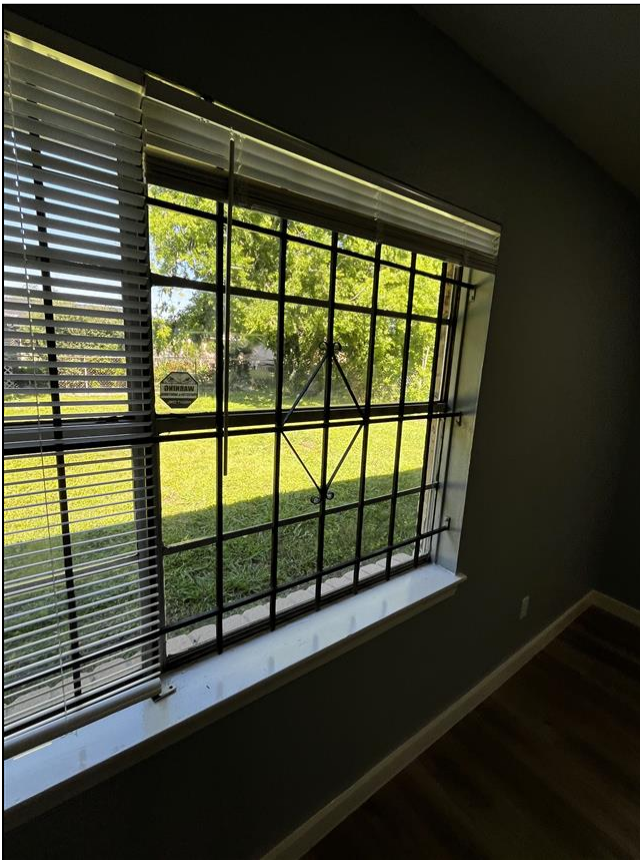
Locking hardware is missing or damaged in some windows . Replace as needed.

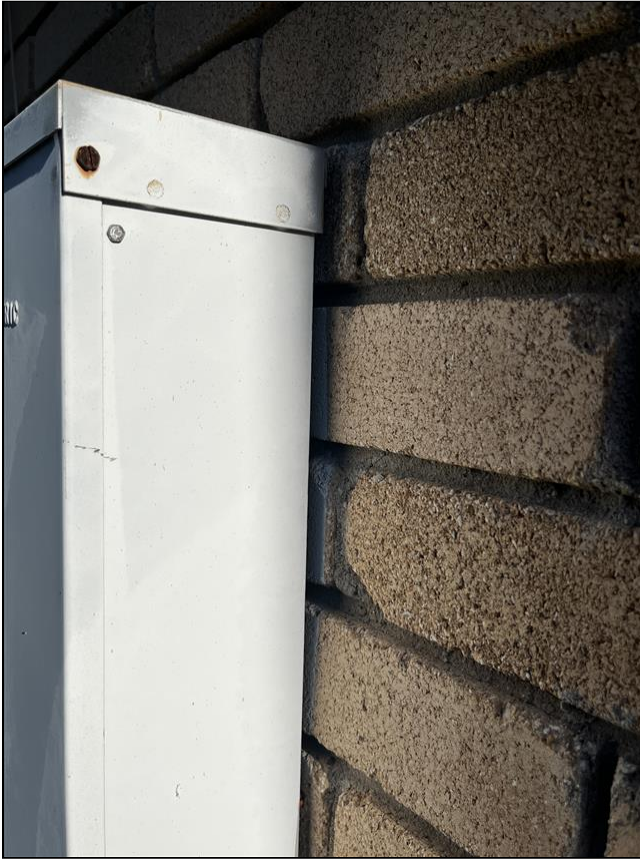
Recommend sealant between panels/meters and wall to prevent moisture entry into wall.

Unsealed openings

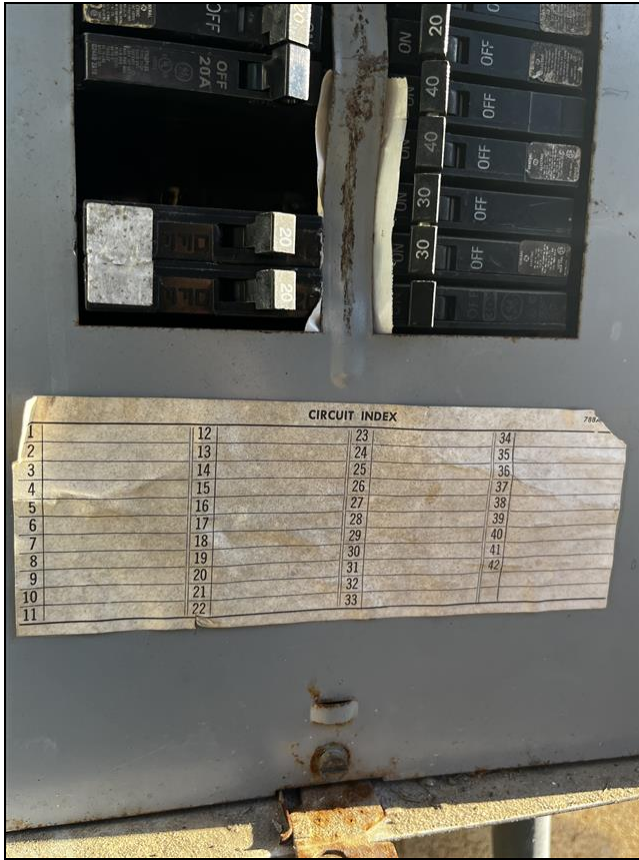
Missing "Emergency Disconnect" label

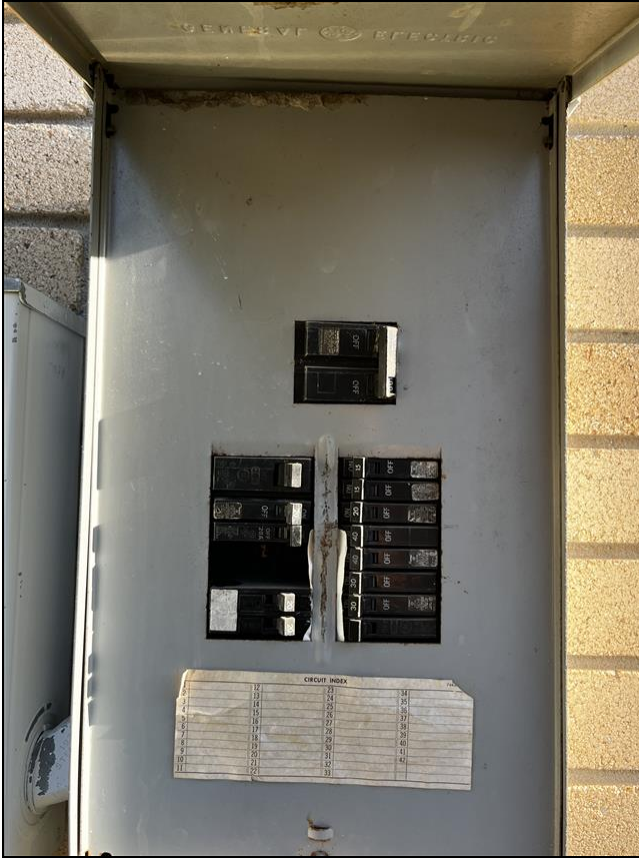
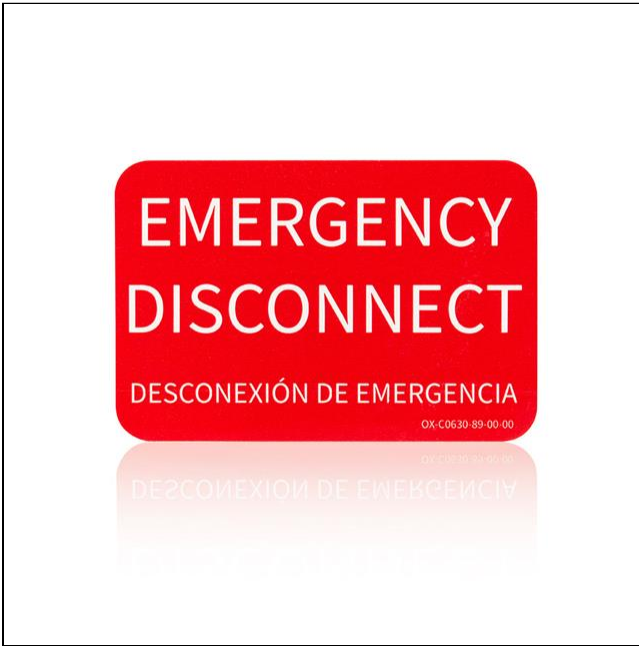
Multiple neutral wires are installed on an individual bus screw terminal(s). This "double tapping" is an improper short-cut wiring technique and can be a safety hazard. Only one wire should be connected to each screw. A qualified electrician should correct all double taps.

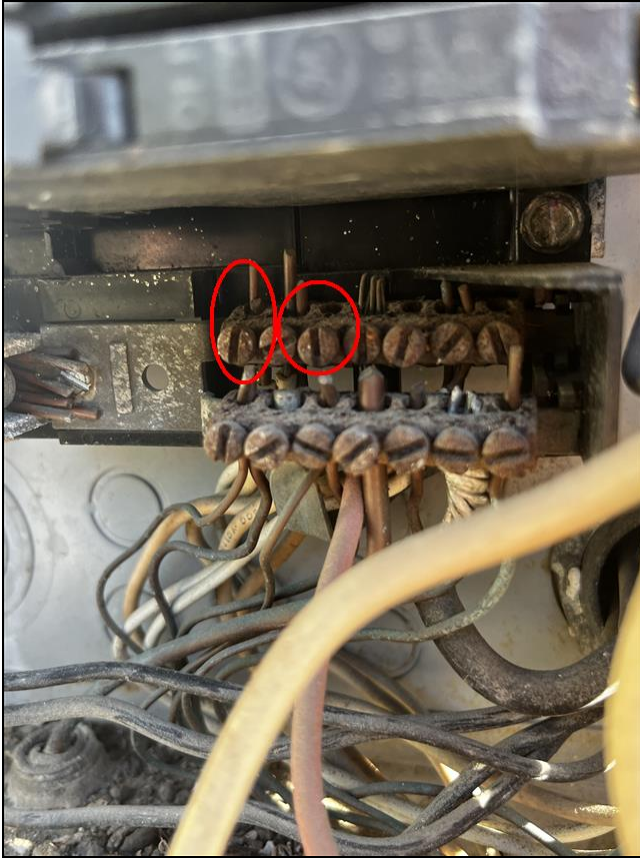
Missing ground bushing on metal service entrance

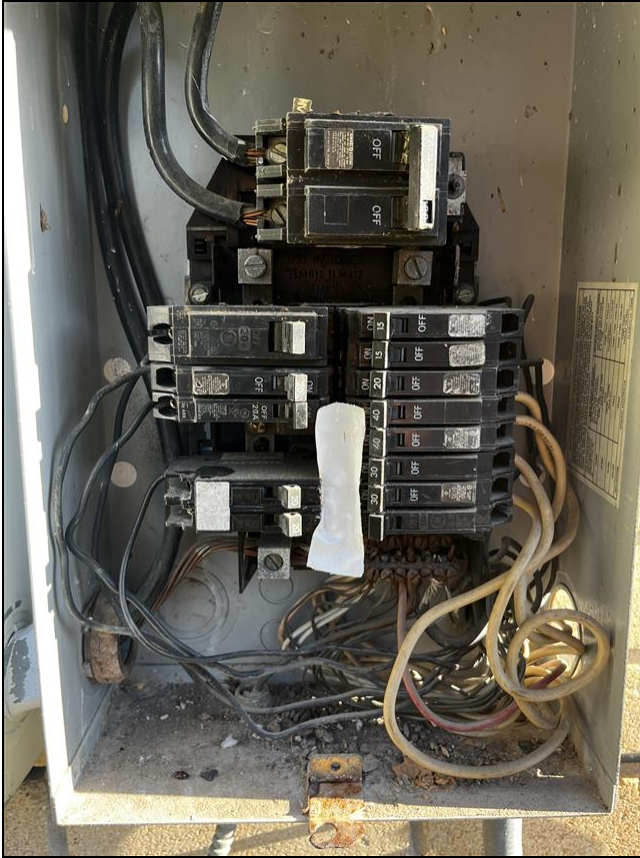
Missing service entrance side barriers

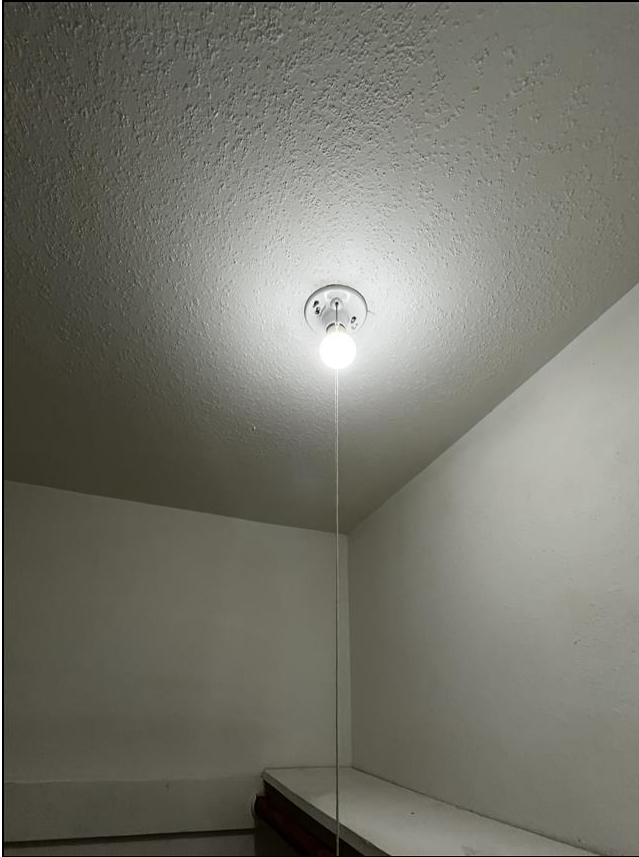
front bedroom closet

One or more interior/exterior light fixtures are missing proper bulb protection (wire cages/glass globes).
Replace these items as needed.

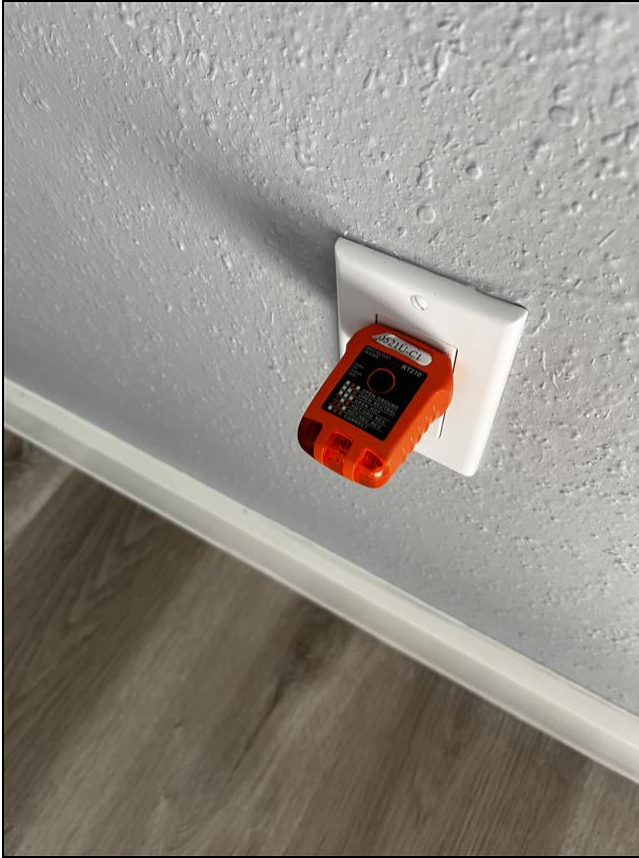
Den

There was a circuit with reversed polarity (hot/neutral reversed) observed in/at the Den. The cause should be diagnosed and repaired by a licensed electrician.

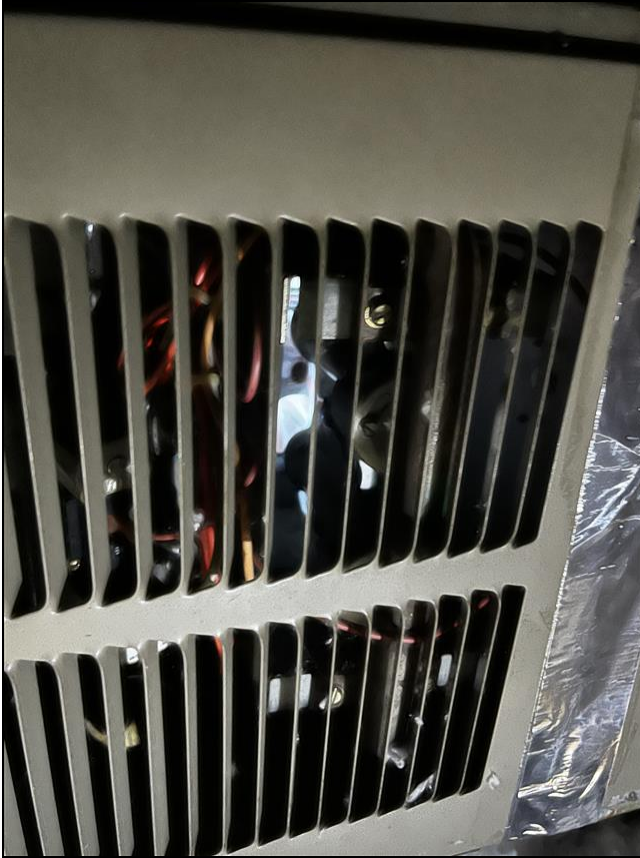
Flexible gas line is being used, entering the cabinet penetration unprotected and there is no drip leg trap installed as called for by current standards. Today's standards now require rigid gas piping for cabinet knock-out penetration to prevent line damage due to unit vibration, along with a sediment drip leg to capture debris in gas line. Foam insulator around pipe acceptable until unit is replaced.

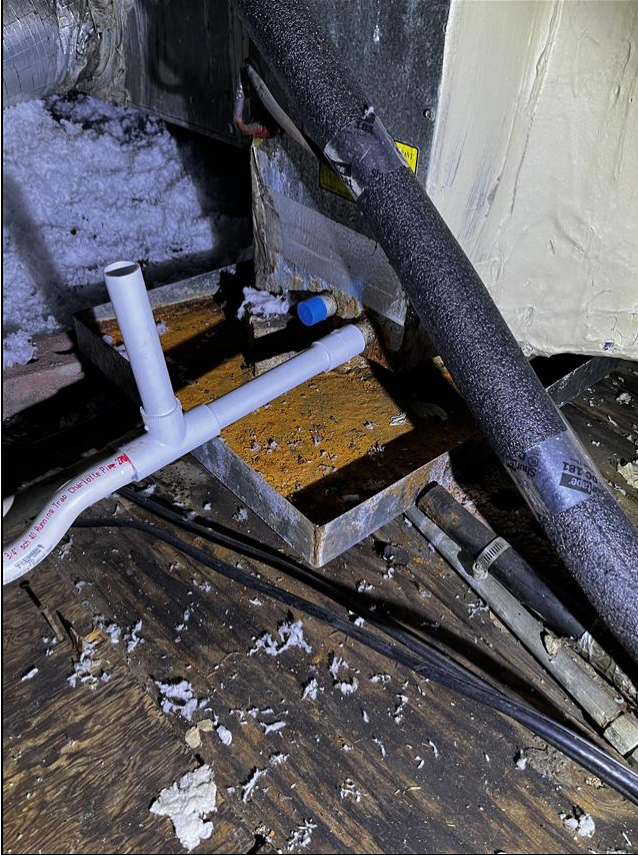
☒ Rust was observed in the main unit drain pan. The rust may extend to the bottom of the pan, which may result in water leaking onto the surrounding area. This is typically from excess condensation, most times produced from a soiled evaporator coil. I recommend replacing or repairing pan as needed. I also recommend that the system be serviced by a licensed HVAC technician to address the cause of excess condensate before closing.

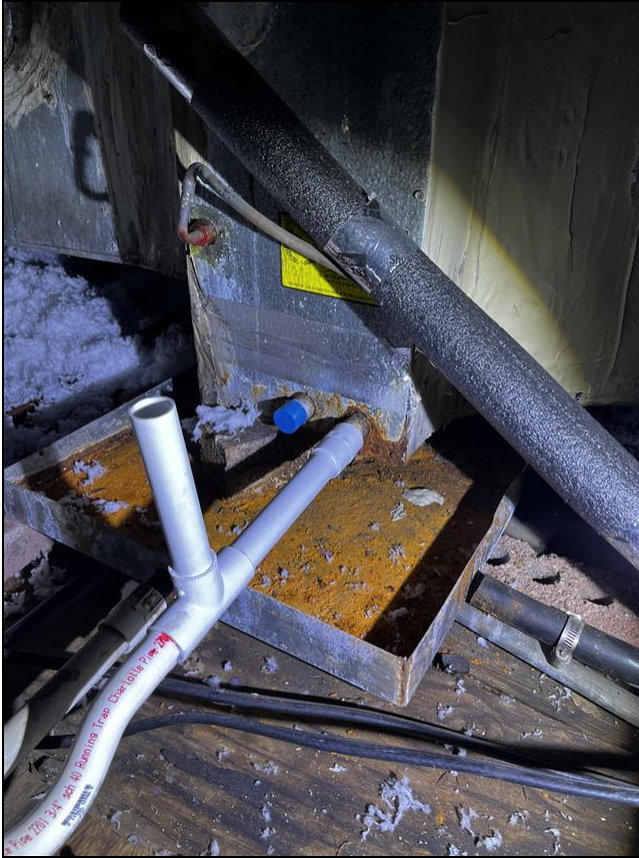
☒ There is no secondary condensation drain line or an emergency float electrical cutoff switch installed as called for by today's standards in locations where condensation overflow could cause interior water penetration. (During the cooling season line should be periodically flushed with a 50-50 mixture of bleach and water to prevent bio-growth blockage) Though it may not have been required at initial construction, it is recommended that you have a licensed HVAC technician retrofit your unit with one of these devices to prevent water overflow to the interior.

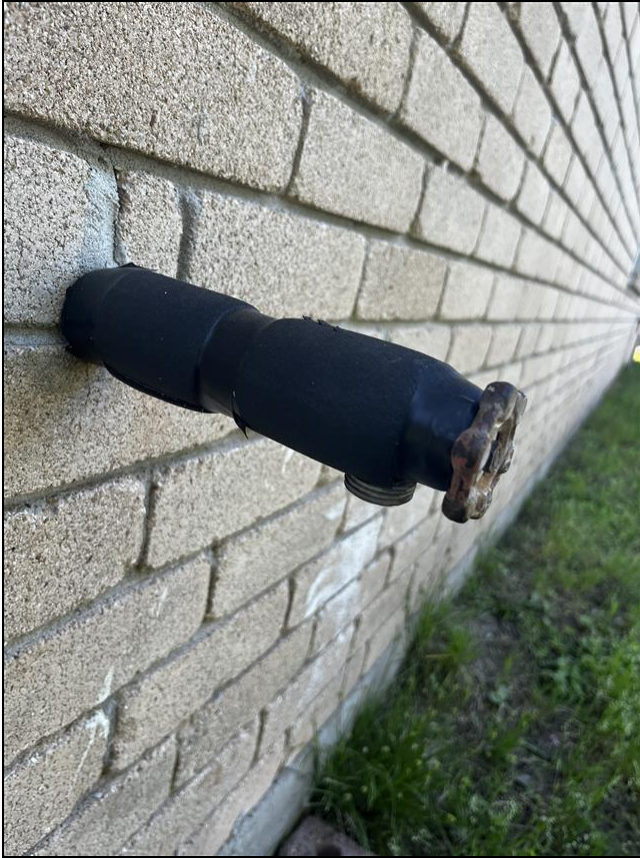
Hose bib leaking at the stem valve

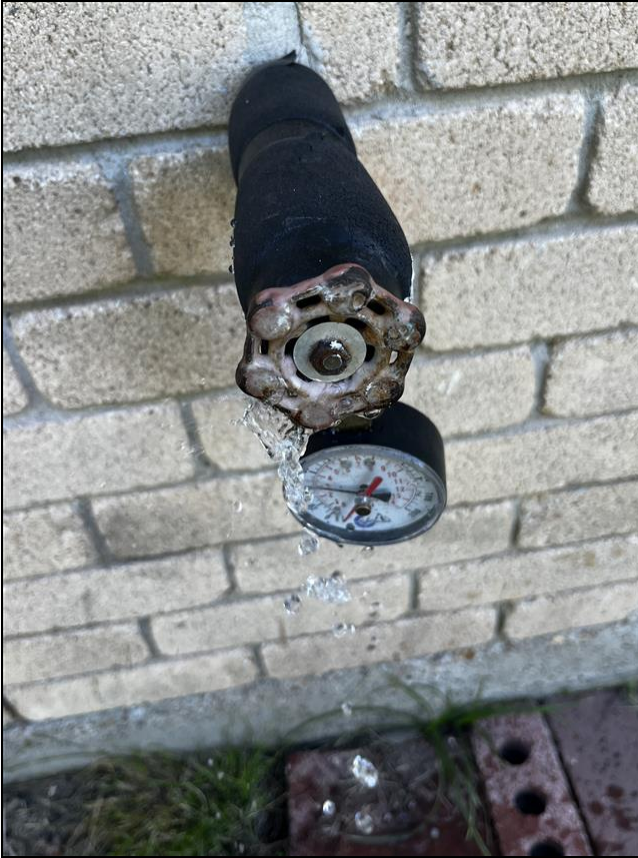
back

The controls are reversed in the kitchen sink. The position of the hot and cold water controls on all plumbing fixtures should meet accepted industry standards. These standards dictate that hot water controls are always located on the left and cold controls are located on the right. With single handle faucets, turning the handle to the left should increase the flow of hot water, while turning the handle to the right should increase the flow of cold water. Fore and aft action fixtures should have the hot to the rear.

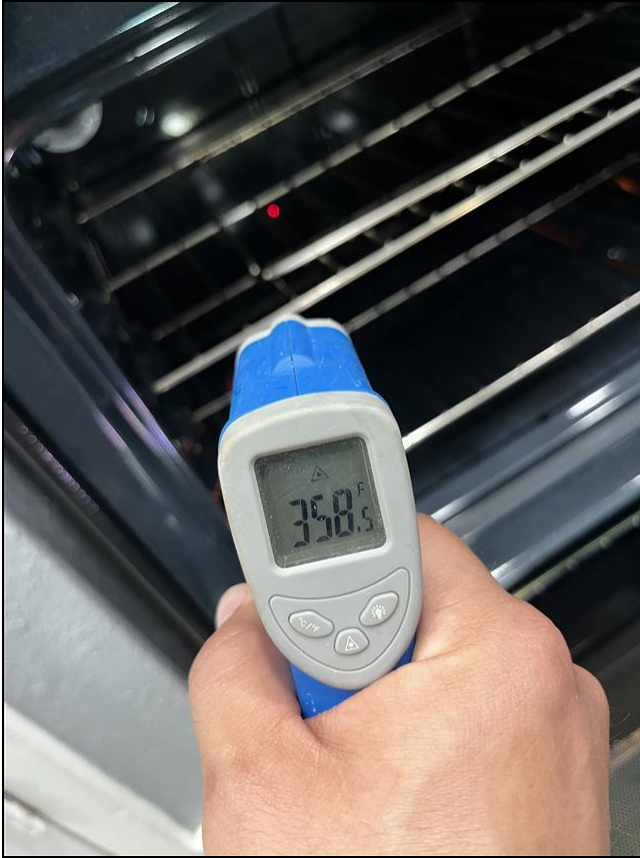
There is no child protection anti-tip device installed. Anti-tip brackets prevent the stove from accidentally tipping over if weight is placed on the oven door
