TPI HOME INSPECTION REPORT

4064 Crestmont Dr
College Station TX 77845

Tyler Connor
MAY 29, 2020

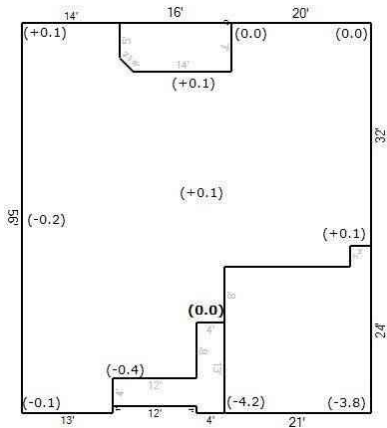
Elevation Survey:

Elevation measurements can be useful, but should not be relied on as a definitive statement of foundation condition. Elevation is measured against a benchmark "0" and indicated at lower (-) or higher (+) than the benchmark. Measurements are in inches.

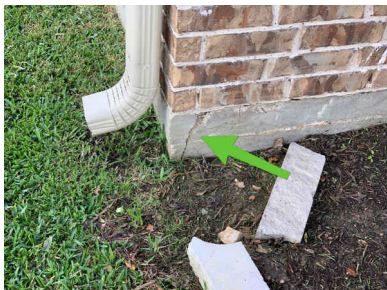
Corner Cracks Noted:

Corner fractures develop at or very close to the outside corners of the foundation and frequently form a wedge at the corner. These develop as a result of the expansion of the brick veneer when it is warmed by the sun. These cracks do not indicate any deficiencies of the foundation.

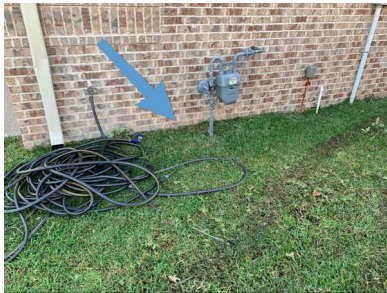
1: Soil level too high adjacent to foundation

Deficient - Maintenance Item

Lower soil to provide adequate clearance from all wall coverings. At least of 4 inches of clearance between soil and siding or masonry wall covering can help prevent water penetration and termite infestation.

Recommendation: Contact a qualified landscaping contractor

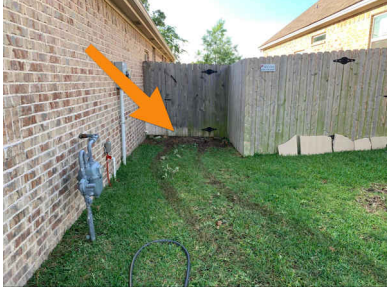
3: Poor yard drainage

Deficiency

Right side

Proper grading of the yard will allow efficient drainage of rain runoff away from the structure. Excessive moisture causes soil expansion and contraction that can move foundations and concrete flatwork. Recommend landscape professional remove soil or install French drain to move water away from the slab.

Recommendation: Contact a qualified landscaping contractor

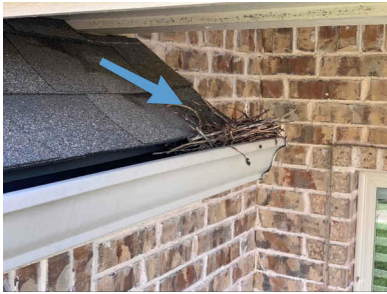
4: Debris in gutter

Deficient - Maintenance Item

Remove debris in gutters to prevent rain runoff from backing up.

Recommendation: Contact a handyman or DIY project

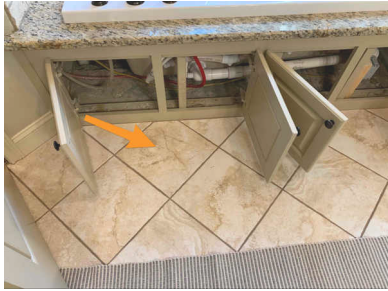
1: Cracked floor tiles - poor install

⊖ Deficiency

Master Bathroom

Cracked tiles appear to be the result of poor installation. Irregularities in the slab or thinset covering can cause uneven surfaces and will crack tiles.

Recommendation: Contact a qualified flooring contractor

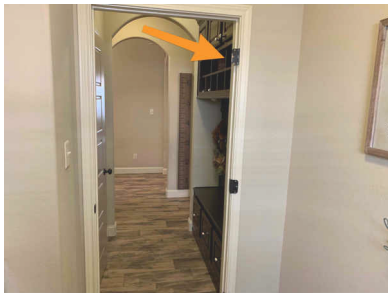
1: Door missing

⊖ **Deficiency**

Laundry room

Door has been removed.

Recommendation: Contact a qualified professional.

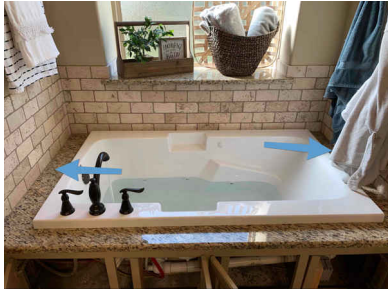
1: Seal tub /shower wall joints

Deficient - Maintenance Item

Master Bathtub

Gaps in tile grout joints in tub/shower enclosure should be sealed to prevent water penetration into wall cavity.

Recommendation: Contact a handyman or DIY project

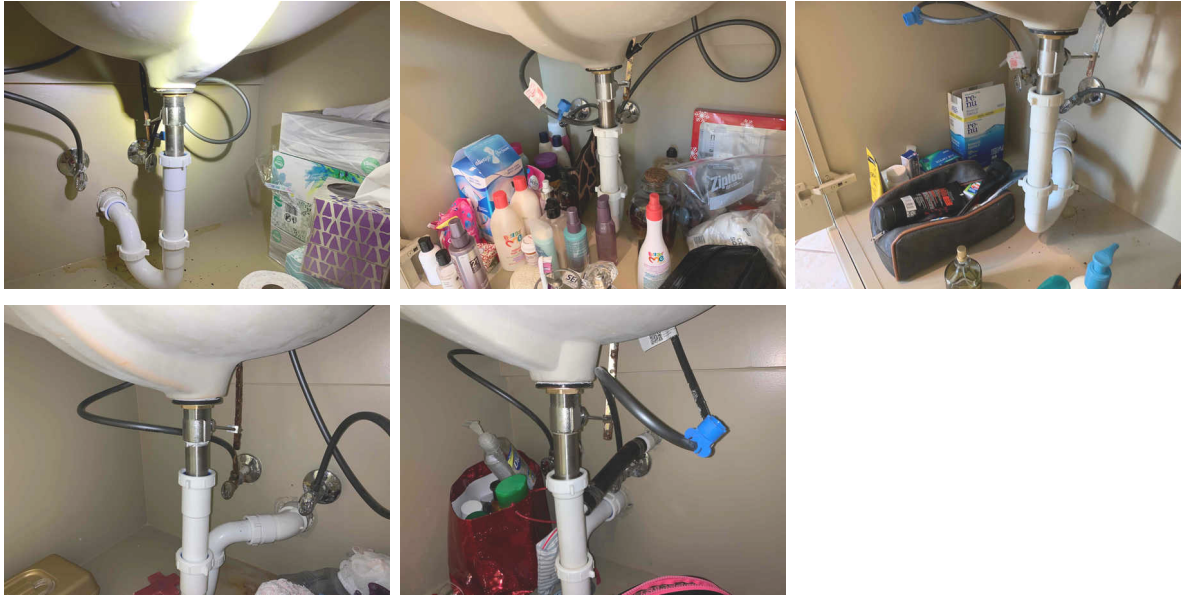
1: Leak in drain

🚫 Deficiency

Recommendation: Contact a qualified plumbing contractor.

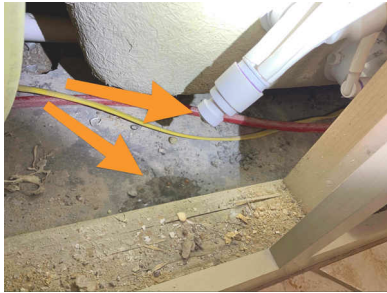
1: Leak at jet plumbing

🚫 Deficiency

Recommendation: Contact a qualified professional.
